Geotechnical Damage due to the 2011 Christchurch, New Zealand

On Gigantic Tohoku Pacific Earthquake in Japan

Ikuro Towhata, Professor, University of Tokyo
 Hiroyuki Goto, Assistant Professor, Kyoto University
 Motoki Kazama, Professor, Tohoku University, Sendai
 Takashi Kiyota, Assistant Professor, University of Tokyo
 Susumu Nakamura, Professor, Nihon University, Fukushima
 Kazue Wakamatsu, Professor, Kanto Gakuin University, Yokohama
 Akihiko Wakai, Professor, Gunma University, Kiryu
 Susumu Yasuda, Professor, Tokyo Denki University, Saitama
 Nozomu Yoshida, Professor, Tohoku Gakuin University, Tagajo

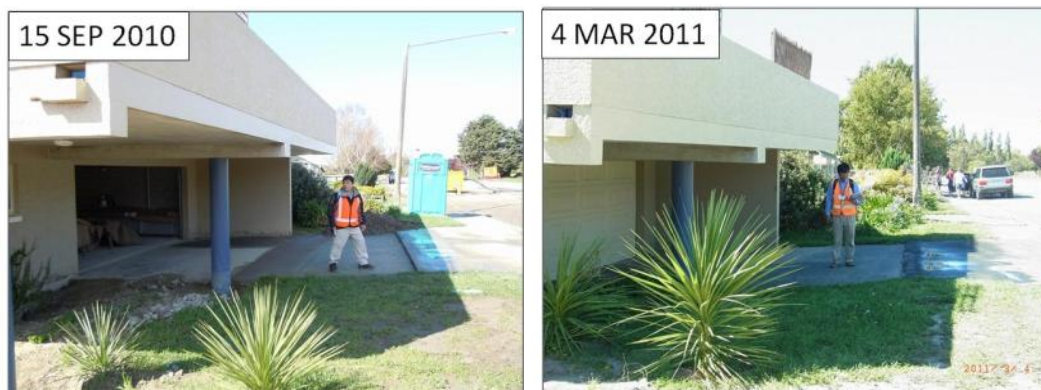
Figure 22 is comparative photos of settlement of a two-story house due to liquefaction. The slope in front of the garage was originally uphill, but it became a downhill after 2010 Darfield earthquake as a result of more than 50 cm of ground subsidence. This house suffered additional 15 cm of subsidence from the 2011 earthquake. The narrowing gap between the roof and the head of a member of the research team can be recognized from the figure. Although the investigators appearing in the photos are actually different, their heights are almost the same.

Figure 22. Further subsidence in two-story house neighboring the stop bank. (North Kaiapoi)

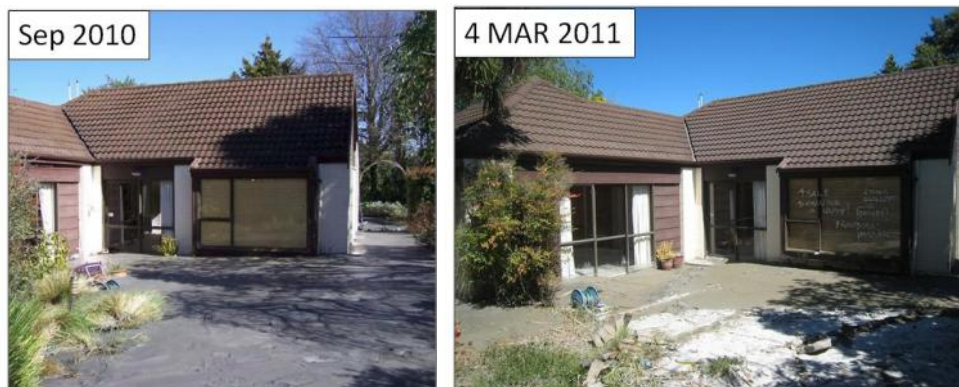
Massive amount of sand ejecta, about 400 mm in thickness, was observed in a property following the September 2010 event (Figure 23). The ejected sand covered a deck in front of the entrance, with thickness of about 10 cm. The observed thickness of sand ejecta after the 2011 earthquake was around 20 cm.

Figure 23. Repeated liquefaction in a residential property in North Kaiapoi.

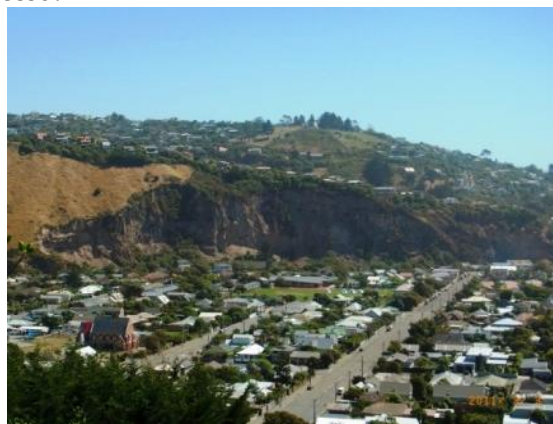
Figure 27 shows a landscape of the affected cliff located at the west side of Wakefield Avenue in Sumner. This cliff is approximately 70 m high and 500 m long in north-south direction. The cliff surface was previously covered with vegetation, but became bare due to earthquake disturbance.

Figure 27. Panoramic view of a disturbed cliff (Sumner).

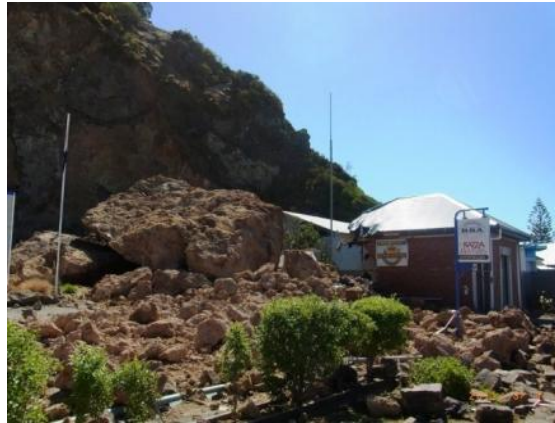
Figure 28 shows a rock fall near a building. The fallen rock is about 4.8 m wide, 6.6 m high and 15.8 m long. Numerous rock falls occurred in other hilly areas adjacent to the epicenter and residential houses and traffic were severely affected.

Figure 28. Huge rock fall adjacent to a building (Sumner).

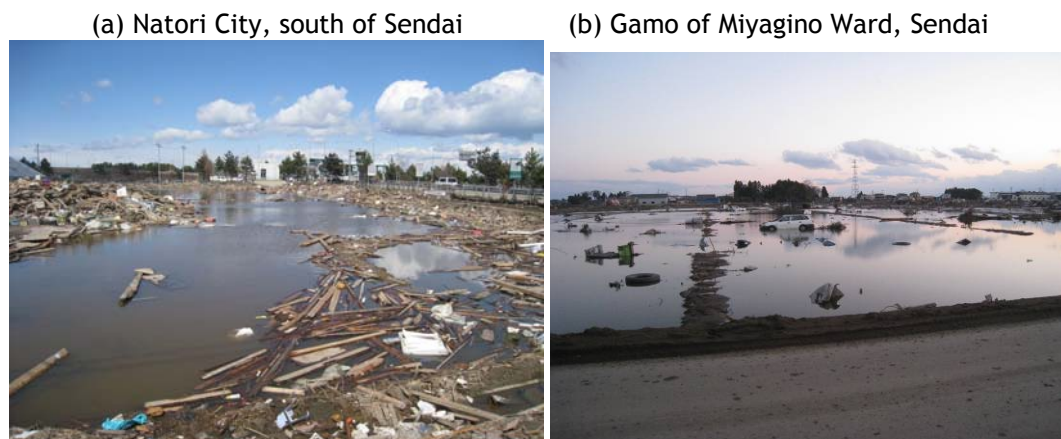
Geospatial Information Authority of Japan announced that the coseismic displacement of the earth crust in the coastal area was at maximum 5.3 m in the horizontal direction towards the Pacific Ocean and 1.2m in subsidence. Thus, many areas along the affected coastal area got under water, the tsunami effect was made more serious, and the tsunami water remained in the area for a longer time, making the rescue very difficult. Fig. 2 illustrates the coseismic subduction in Sendai area. Note that similar subsidence occurred at many places in the world during past gigantic earthquakes: Kohchi of Japan in 1946 and at several more times in the history, Valdivia and surrounding area in Chile in 1960, South Alaska in 1964, and Izmit Bay of Turkey in 1999. Kohchi and Valdivia came upwards again after the quakes.

Fig. 2 Coseismic subsidence in Sendai (Photographs by Daiken Suzuki, former student of University of Tokyo)

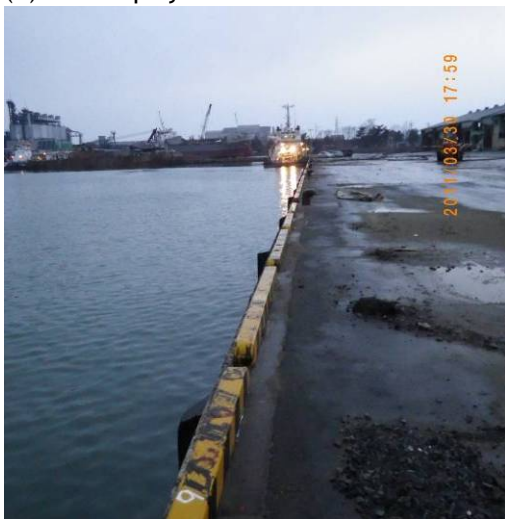
(a) Intact quay wall

Figure 10(a) shows that the quay wall of Ishinomaki Harbor was intact, although the retreating tsunami water was so powerful to erode sand in building foundation (Fig. 10b). Despite this good seismic performance of the quay wall, the operation of the harbor was stopped for many weeks because facilities for cargo handling were destroyed. Hence, rescue stuffs could not rely on mass transportation by ship. Fig. 11 demonstrates tsunami erosion in bridge abutment. There are local people who have been working hard to reestablish previous life conditions. Fig. 12 shows recovery of fish restaurants in Nakaminato Harbor in Ibaraki Prefecture, 100 km NE of Tokyo, where the tsunami height was 4.2 m, being 1.0 m above the ground surface. The loss of backfill soil behind a coastal levee near the mouth of Abukuma River (Fig. 13) suggests that erosion by the arrival of tsunami was the main cause of the damage, which was more serious than the effect of retreating tsunami.

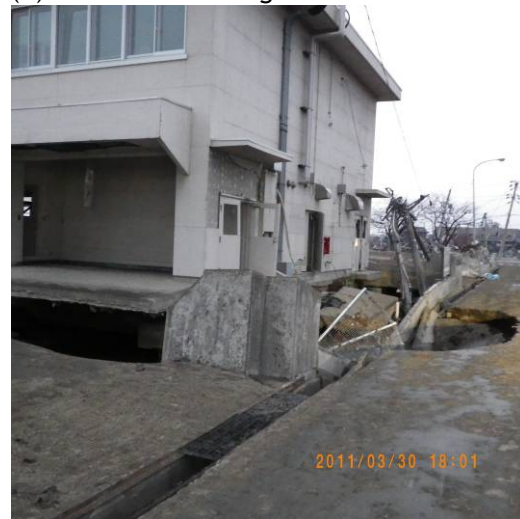
(b) Erosion in building foundation

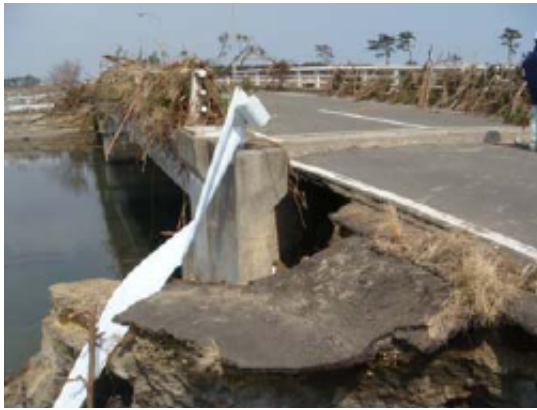
Fig. 11 Erosion of embankment at bridge abutment after tsunami Strike (Iwanuma in Miyagi Prefecture)

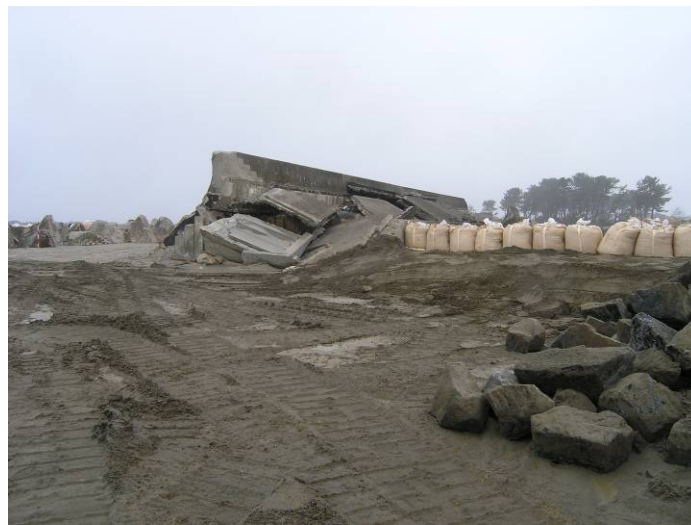
Fig. 13 Destroyed sea wall near Abukuma River mouth

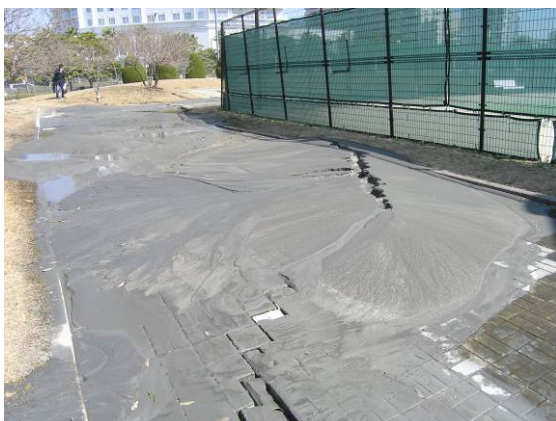
Figure 14 illustrates sand boiling, which is an evidence of subsurface liquefaction, in a sports facility in Urayasu City in the east suburb of Tokyo. Land reclamation took place in 1980s in this area. Fig. 15 shows the consolidation settlement of liquefied sand in the same area. Because the building was supported by a pile foundation, no structural damage occurred therein and this shopping mall was able to start business within a few weeks after the quake. It is possible, however, that the differential settlement between the building and the ground destroyed many lifeline connections. Fig. 16 indicates road pavement that distorted substantially because of liquefaction. One important feature of the liquefaction problem is the damage in private properties. Overall liquefaction in residential development in manmade islands caused subsidence and tilting of many houses (Fig. 17). Lack of liquefaction mitigation measure in private lands and houses and their restoration at reasonable cost are now attracting public concern. Moreover, damage to lifeline, which is in particular sewage pipeline, is important. Figs. 18 and 19 demonstrate floating of manholes in Urayasu and another northern city of Sukagawa. Floating and surface subsidence imply need for more efficient compaction of backfill sand. Noteworthy is that quay walls around the manmade islands were maintained stable, being different from those in Niigata (1964) and Port Island in Kobe (1995), and lateral flow of liquefied subsoil did not occur.

Fig. 14 Liquefaction in Urayasu City of Chiba

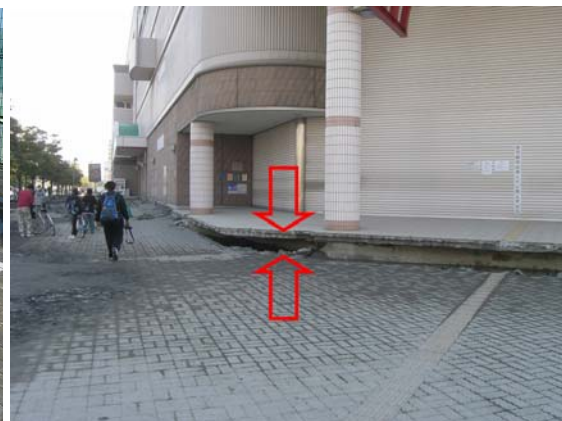
Fig. 15 45-cm subsidence of ground surface in front of a shopping center (Urayasu City)

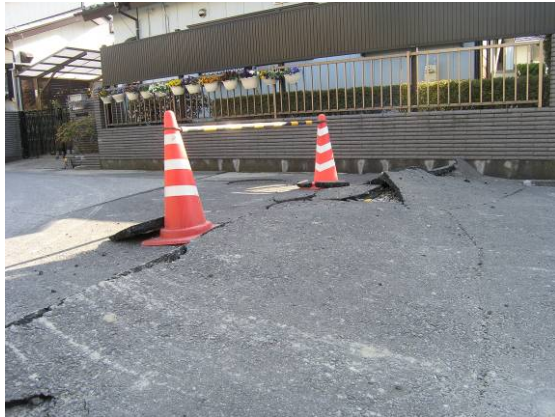
Fig. 16 Distortion of road pavement in residential area (Mihama of Chiba)

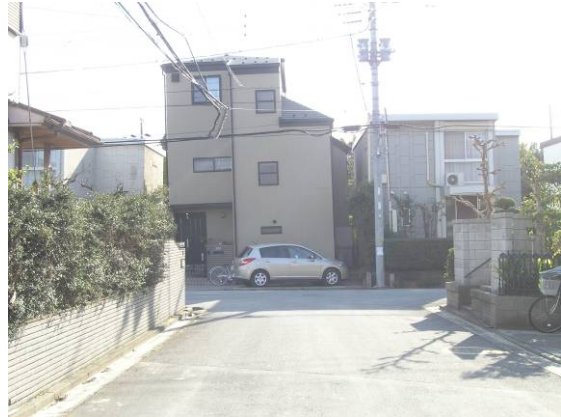
Fig. 17 Tilting of house (Mihama of Chiba)

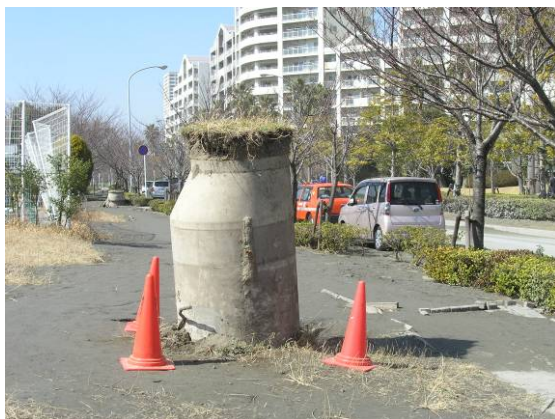
Fig. 18 Uplifting of manhole of 2 meter in Urayasu of Chiba

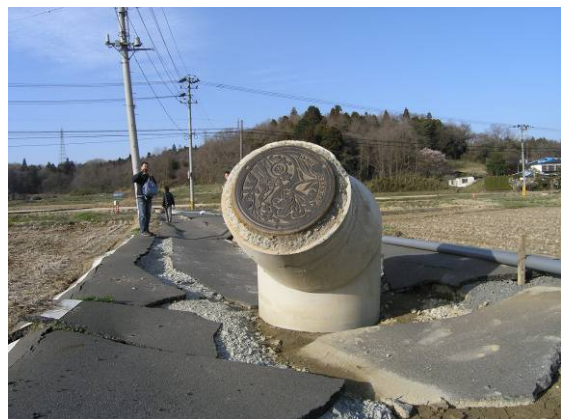
Fig. 19 Uplifting of manhole and surface subsidence in Sukagawa of Fukushima

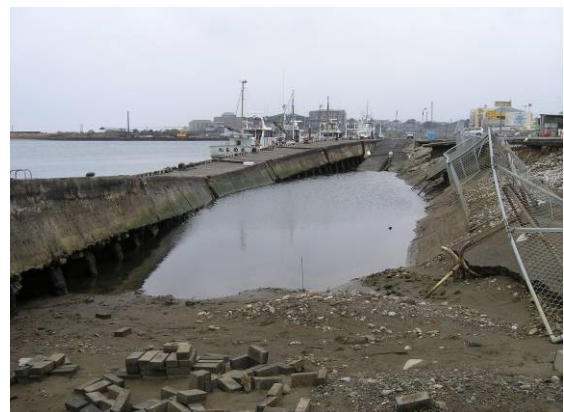
Liquefaction occurred in other areas as well. One part of the sheet piles quay wall at Nakaminato Fishermen's Harbor in Ibaraki Prefecture was distorted as illustrated in Fig. 20. Because this particular place is probably situated upon a small river channel, liquefaction occurred and allowed profound outward displacement of the quay wall and subsidence of the backfill where a later tsunami strike eroded the soil. Figs. 21 and 22 indicate distortion and subsidence of a road embankment and associating uplift at the foot of the slope. Boiled sand obviously verifies the occurrence of liquefaction. It seems that the higher embankment subsided and the lower ground surface came up because of volumetric balance during soil movement. It is noteworthy that the industrial site next to this place did not liquefy probably because of soil improvement.

Fig. 20 Damaged quay wall in Nakaminato Harbor

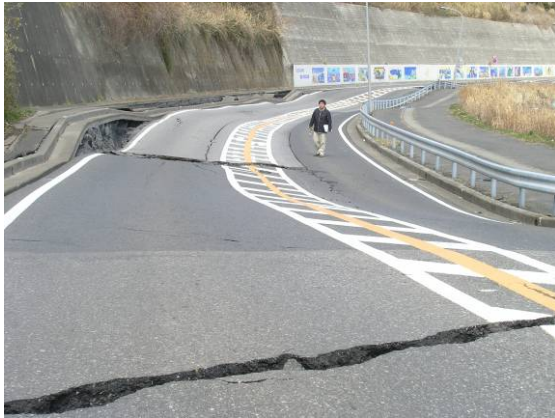
Fig. 21 Distortion of road embankment in Nakaminato of Ibaraki Pref.

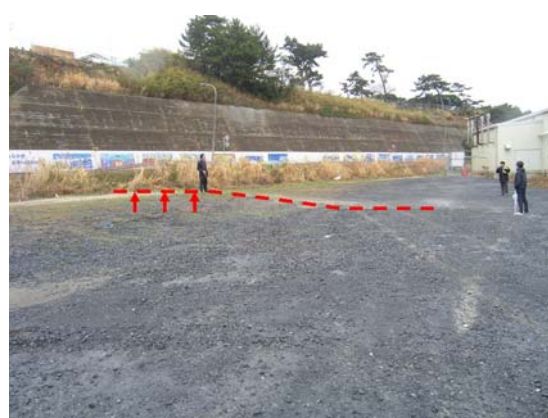
Fig. 22 Uplift near the toe of distorted slope in the previous figure

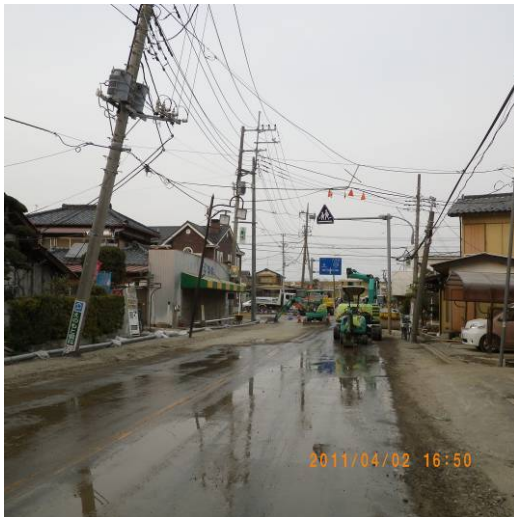
Urbanization and development of residential area have been conducted out of Tokyo area as well. Fig. 23 indicates house damage in Abiko City of Ibaraki. Liquefaction was concentrated in a small area which used to be a small pond that was filled with sand in 1950s for urban expansion. Liquefaction damage occurred in a residential area in Kuki City (Fig. 24) to the north of Tokyo where originally swampy topography was converted to a residential area.

Fig. 23 Liquefaction in residential area of Abiko City (Fusa area)

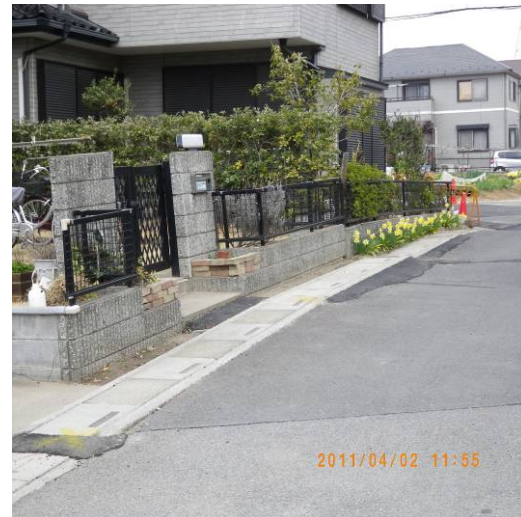
Fig. 24 Liquefaction-induced tilting of house in Kuki City of Saitama Prefecture

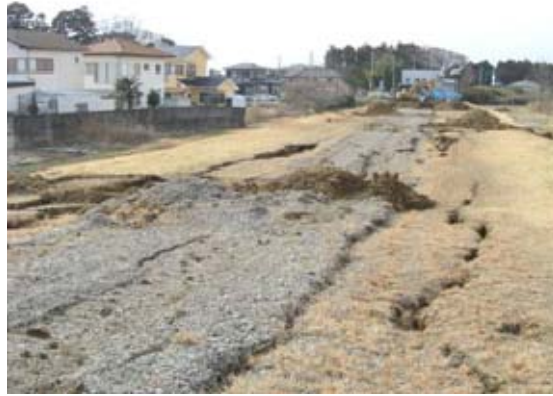
Fig. 25 Liquefaction-induced lateral spread of Naka River levee

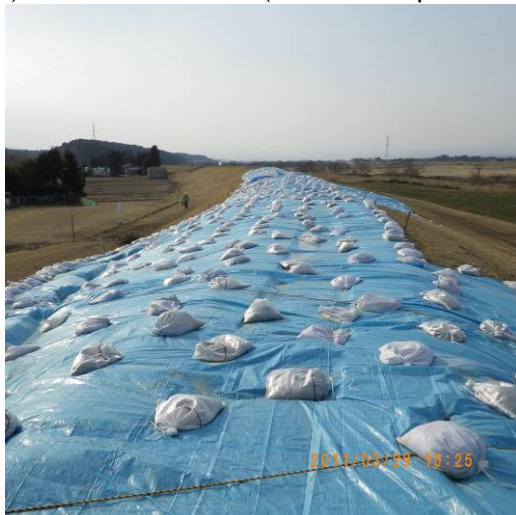
(a) Crack on the crest (covered for protection)

Fig. 26 Distortion of Naruse River levee on right bank near 40.0 km post

Figure 26 illustrates significantly distorted levee of Naruse River to the north of Sendai City. Longitudinal deep cracks and sliding of slope towards the toe are remarkable. Liquefaction was found as well on the river side. A very significant subsidence and lateral motion occurred at a levee of Hinuma Lake near Mito (Fig. 27). The entire body of the levee became almost level because of liquefaction at the bottom.

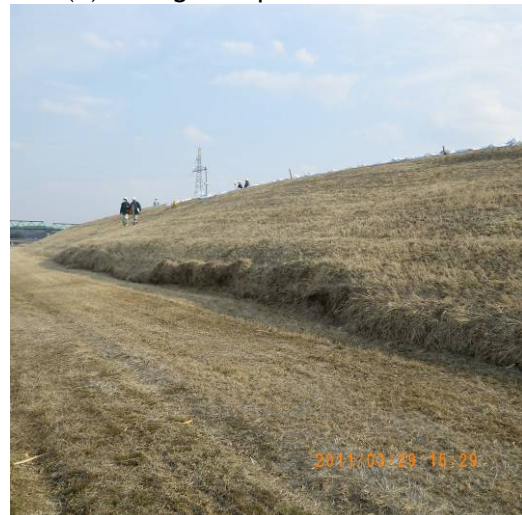
(b) Sliding in slope on river side

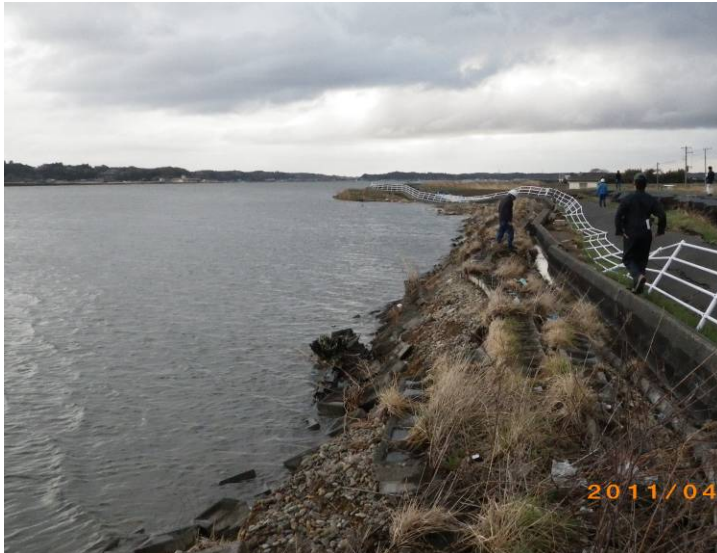
Fig. 27 Flattened Levee of Hinuma Lake near Mito City (Pechanko!)

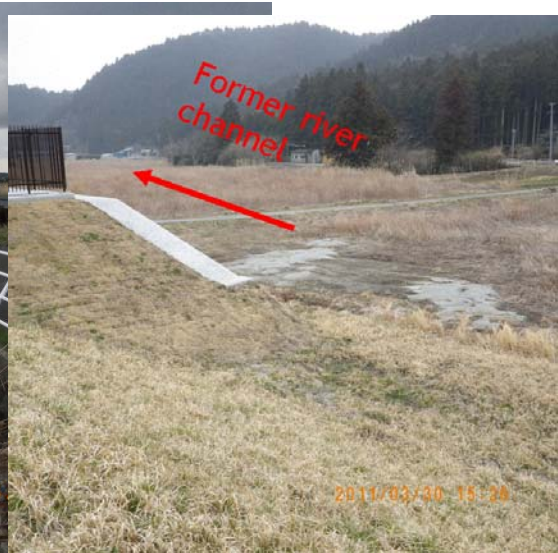
Fig. 28 Repeated liquefaction behind Eai River levee at Kita Wabuchi site

Liquefaction in an abandoned river channel in Fig. 28 indicates repeated liquefaction during the main and after-shocks in 1978, another earthquake in 2003 and finally in 2011. In spite of liquefaction, the levee was maintained intact.

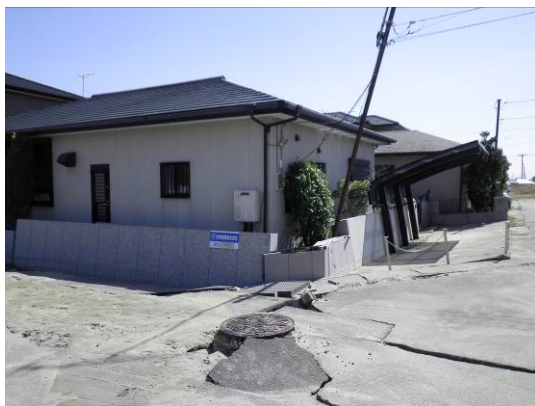
Fig. 29 Liquefaction-induced house damage in Hinode area of Itako City, Ibaraki

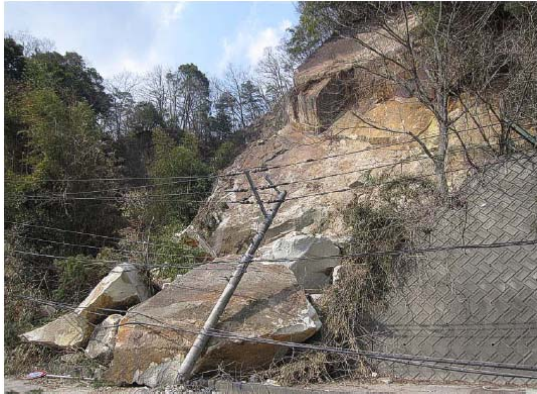
Shear failure of slopes and embankments occurred at many places. As far as natural slopes are concerned, the size of failures is not very large. Fig. 31 indicates an example in Ibaraki, north of Tokyo. A bigger slope failure occurred in Shirakawa City of Fukushima Prefecture (Fig. 32). This failure developed within a layer of weathered welded tuff and claimed 13 victims. Noteworthy is the long distance of run-out that suggests the apparent friction angle of 5 degrees approximately. It is necessary to further watch the slope behavior during aftershocks to come and the rainy season.

Fig. 31 Rock fall at Ohgo of Ibaraki

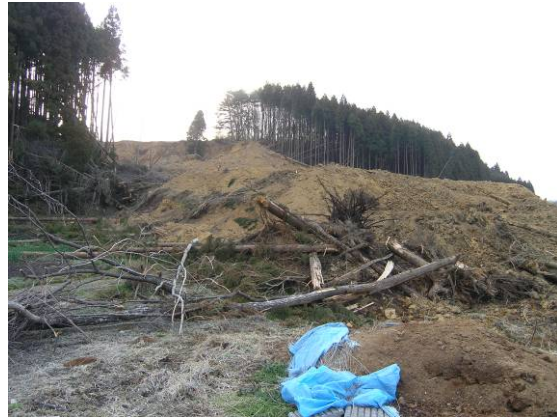
Fig. 32 Failure of natural slope at Hanokodaira of Shirakawa City

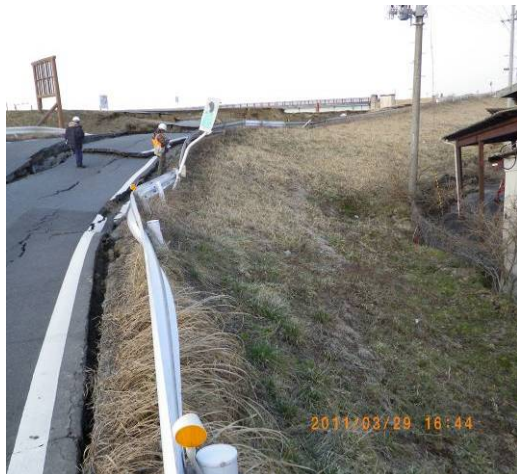
Fig. 33 Distortion of Shida Bridge approach Naruse River, north of Sendai

Distortion of embankment occurred at many places and hindered operation of transportation. Fig. 33 is a distorted road embankment. Fig. 34 shows ongoing restoration of railway truck resting on distorted embankment. Although railway service was stopped for many weeks, the earthquake did not kill any passenger in trains. It is particularly remarkable that the bullet trains (Shinkansen) successfully stopped at the onset of earthquake when they were running at a velocity greater than 200 km/h. This success was achieved by combination of many safety technologies.

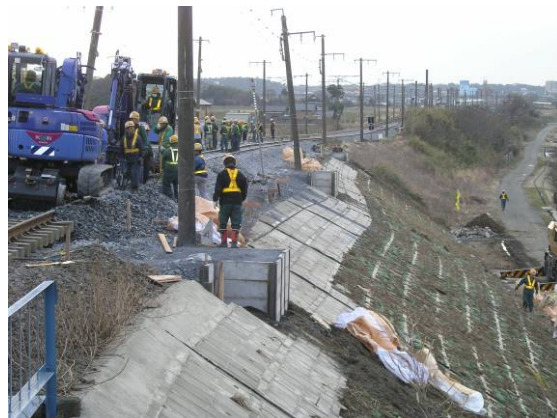
Fig. 34 Distortion of railway embankment (Joban Line of Japanese Railway East, near Mito, Ibaraki)

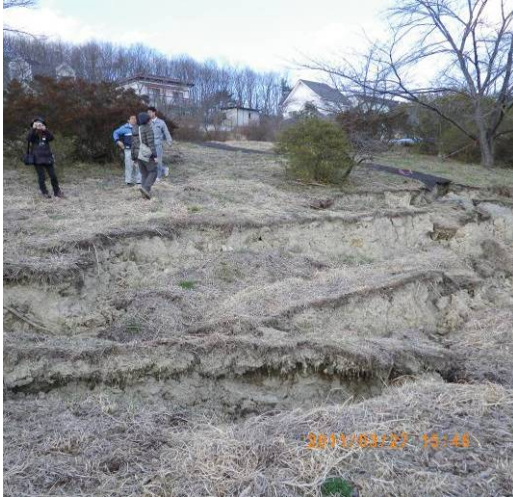
On the contrary, many problems were detected in artificial earth fills for residential land development in hill areas. Fig. 35 demonstrates a slope failure at Midorigaoka area of Shiroishi City, south of Sendai. Formerly known as Kotobuki-Yama, this development slope failed during the 1978 Miyagiken-Oki earthquake when the earth filling was going on. It appears that engineers in those days judged that the slope would not be perfectly stabilized, and the land was converted to a green park instead of selling it for residence. That decision was right because the upper part of the slope failed once more (Fig. 35a). Note that part of the lower half of the slope has been stabilized by drainage of ground water (see drainage well in Fig. 35b) and was stable during the 2011 earthquake.

(a) At the top of slope

Fig. 35 Slope failure at Midorigaoka of Shiroishi City of Miyagi Prefecture, south of Sendai

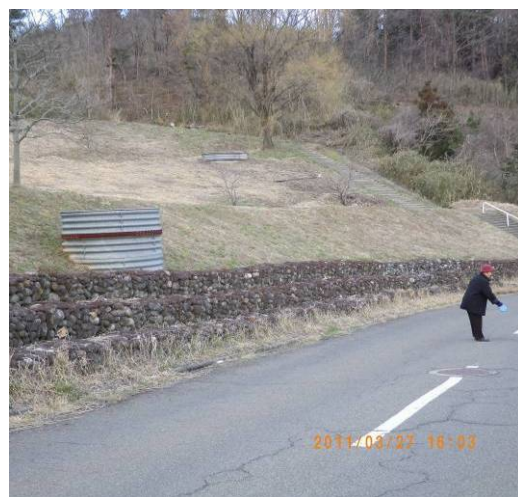
(b) Drainage wells near the bottom of slope

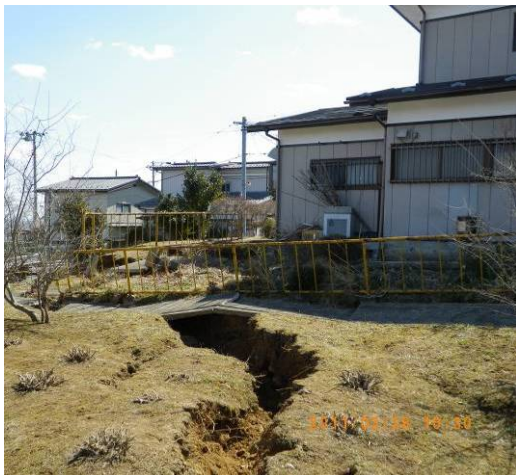
Fig. 36 Failure of residential development slope in Midorigaoka of Sendai City

Slope failure was repeated similarly in a land development area in Sendai City. Fig. 36 shows that the slope failure during a future earthquake was feared and this area has been left vacant until the slope failed once more in 2011. This right decision, however, was not made in a nearby area of Fig. 37. This figure indicates that ground was subjected to compressive distortion at the bottom of a moving slope. Fig. 38 shows soil liquefaction in a hilly area of Sendai City. A local person said that there used to be a small stream here and that it was backfilled at the time of land development. Therefore, the mechanism of this liquefaction is similar to what has happened in larger artificial islands near Tokyo.

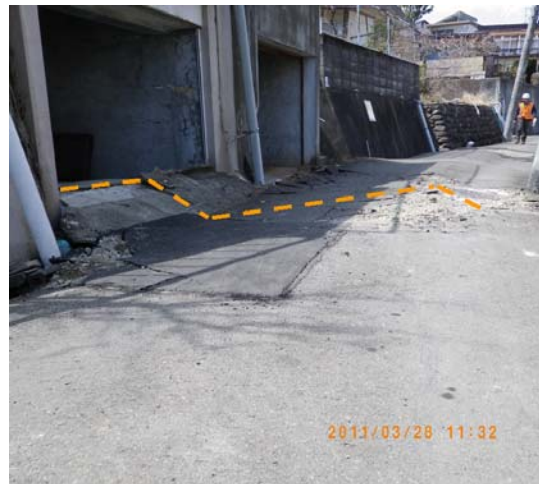
Fig. 37 Compressive distortion of ground surface near bottom of unstable slope (Midorigaoka of Sendai)

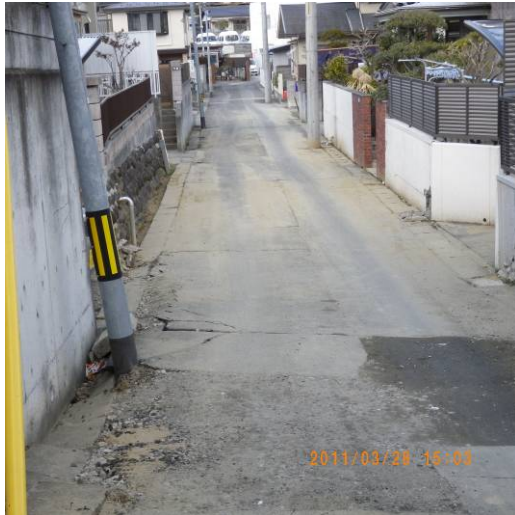
Fig. 38 Soil liquefaction in Asahigaoka 2 of Sendai City

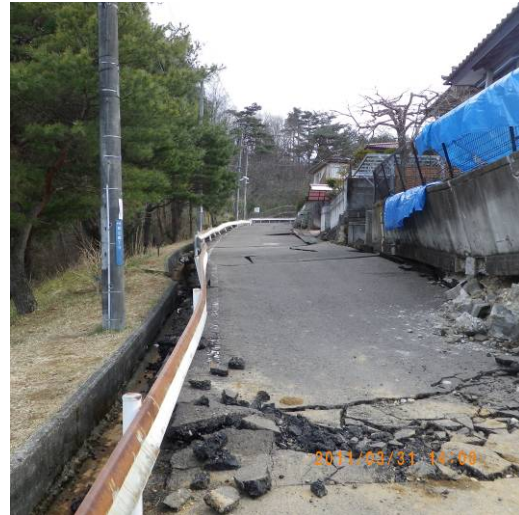
Oritate area in the western part of Sendai City is a new residential development in hills. Cut-and-fill construction was practiced here and Fig. 39 indicates significant damage in a fill part. In contrast, the cut part was free of damage. Thus, the recent fear about seismic stability of residential fill was verified. Note, however, that there are stable fill as well because of the good quality of construction.

Fig. 39 Damage that was limited to filled part of residential development in hilly area (Oritate 4 of Sendai)

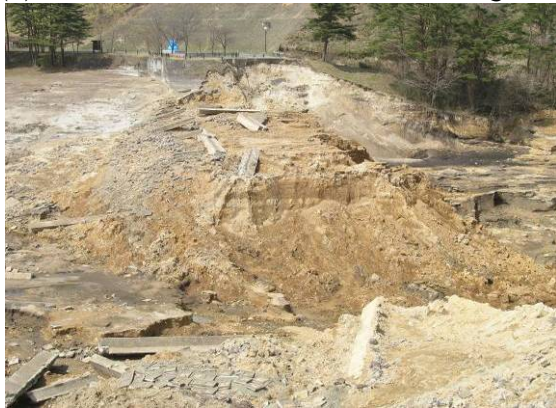
Fujinuma earth dam (Fig. 40) in Sukagawa City was constructed from 1937 to 1949. Its height was 17.5 m and the slope gradient was 1:2.5 on the downstream side, while 1:2.8 on the reservoir side. Being of uniform cross section, this dam was probably not well compacted because modern compaction machine was not available in those days. There were two dams here and No. 1 Dam was eroded and breached (Fig. 41a) and caused flooding of 1.5 million cubic meters of water. No. 2 Dam failed towards the reservoir but did not breach (Fig. 41b). The flooding torrent rushed downstream from No. 1 Dam through a narrow small valley (Fig. 42) and attacked a village (Fig. 43) to destroy houses where 8 people were killed.

(a) No. 1 Dam after erosion and breaching

Fig. 41 Seismically breached Fujinuma Dam

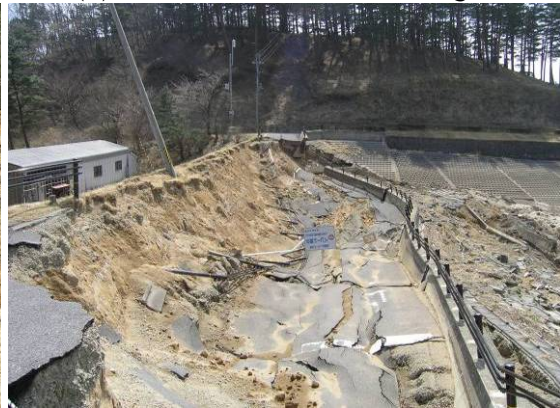
(b) No. 2 Dam without breaching

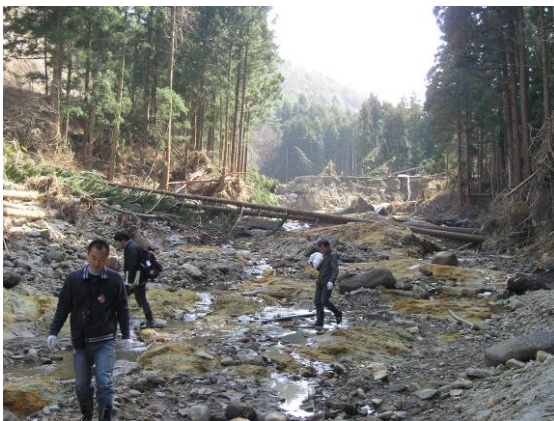
Fig. 42 Valley after torrent

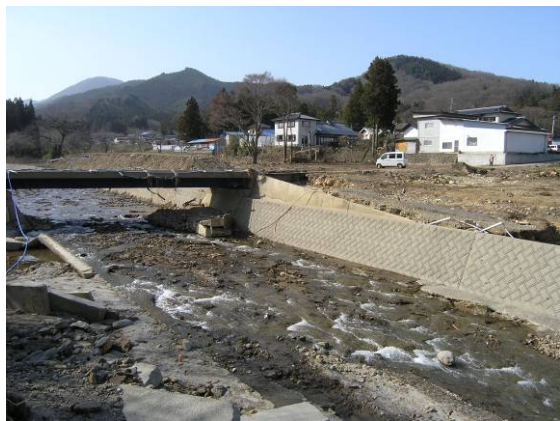
Fig. 43 Village attacked by flood
