VISIT OF ATC3 COMMITTEE ON SLOPE INSTABILITY SITES IN BHUTAN

Ikuo Towhata, University of Tokyo, towhata@geot.t.u-tokyo.ac.jp
Mitsu Okamura, Ehime University, okamura@cee.ehime-u.ac.jp
Hirofumi Toyota, Nagaoka University of Technology, toyota@vos.nagaokaut.ac.jp

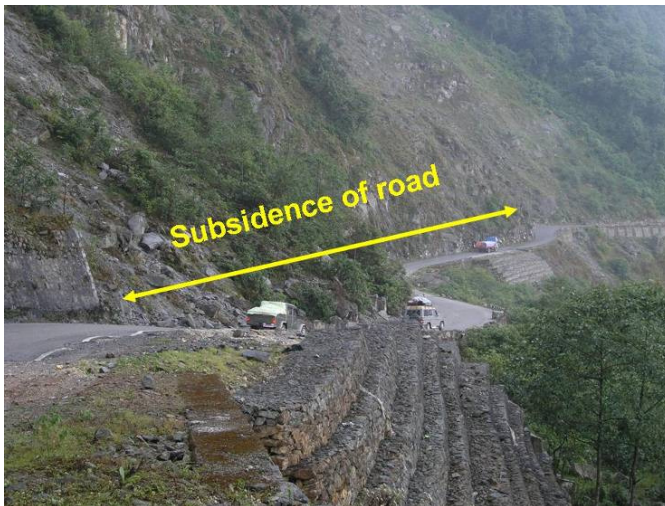
The road was opened in 1961. Fig. 4 shows that the road has subsided by 6 m over the distance of 200 m or so. The Road Department states that the subsidence occurred between 1998 and 2009, implying that the annual subsidence was about 60 cm. The typical type of rock here is gneiss and other metamorphic rocks.

It appears that this slope movement is caused by a deep-seated sliding of the rock mass, and the consequent distortion of the surface rock mass results in fracturing and stone falls (left side in Fig. 4). Another possible cause of stone fall (Fig. 5) is the mechanical weathering of the surface rock that was probably fractured by blasting construction of the road. It deserves note that major stone fall stopped in 2009 for unknown reasons.

Fig. 4 Jhumja slide.

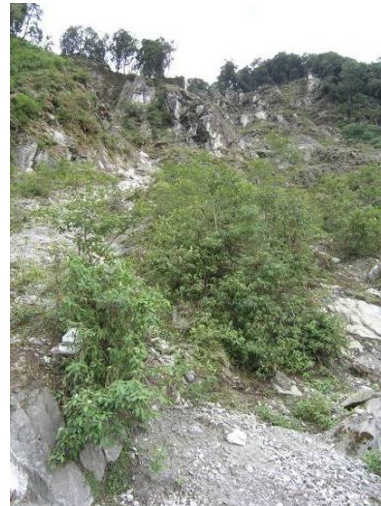
Fig. 5 Rock falls in Jhumja slide.

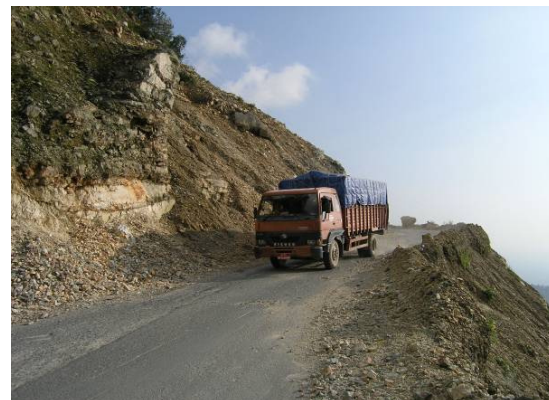
Road is affected by stone falling and slope instability at Sorchen (Fig. 6). The fallen stones deposit in the lower part of the slope (Fig. 7) and are prone to further failure, closing the road, in rainy seasons. The base of the slope consists of fractured Quartzite which is subject to hydration, weathering, and deterioration.

Fig. 6 Failure of cut slope at Sorchen.

The surface weathering and instability may be mitigated by removal of unstable materials at the slope surface and then covering the surface by shotcrete, thus isolating the rock from external actions. However, this mitigation measure is temporary and the problem may start again in near future. The fundamental problem at the Sorchen site is the geology. Fig. 8 indicates that three slope failures are aligned in a narrow range, suggesting the effects of the regional distribution of vulnerable rock (Quartzite and Phyllite). Because of this reason, the mitigation at the slope surface is nothing more than a temporary action and more fundamental mitigation such as changing the road route is desired.

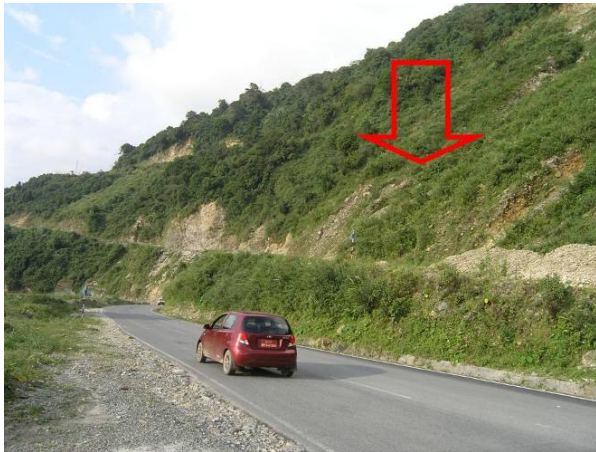
Fig. 7 Deposit of stones at bottom of Sorchen site.

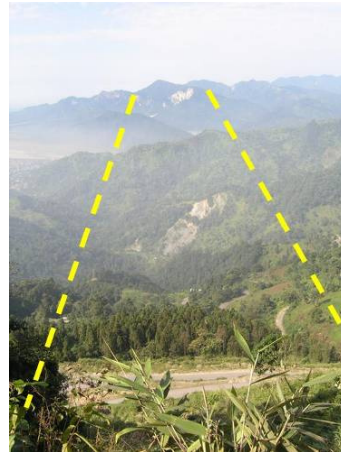
Fig. 8 Series of slope instability to the south of Sorchen site.

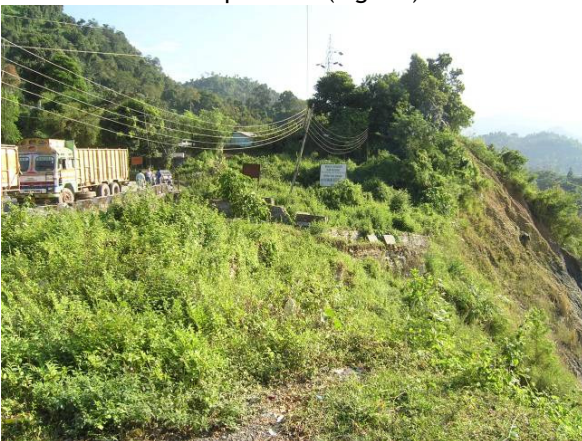
The Karbandi site is located immediately behind the town of Phuntsholing and the road is located at the top of a saddle topography. Fig. 9 shows that the head scarp of the eroded cliff is approaching the main road. The rate of erosion is approximately of the order 1 m / year at the slope shoulder, according to the past observation. Fig. 10 indicates the erosion and gully formation. Phyllite forms this valley. At some time in the past, a minor action at the bottom of the valley triggered a small erosion and instability, and then the problem has been developing into a bigger scale. At this moment there is no efficient measure to stop this erosion at a reasonable cost, and the nation's most important road is going to be in a critical situation.

Fig. 9 Karbandi slope subjected to material deterioration and erosion.

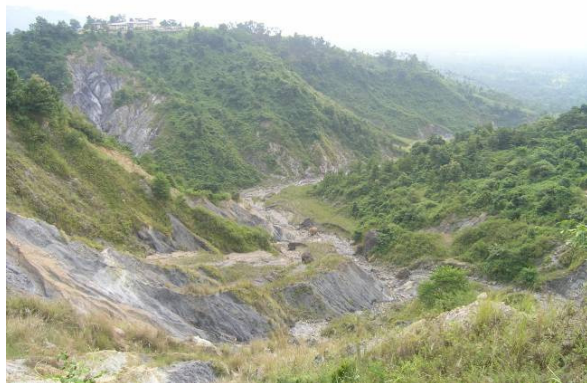
Fig. 10 Ongoing erosion at Karbandi.

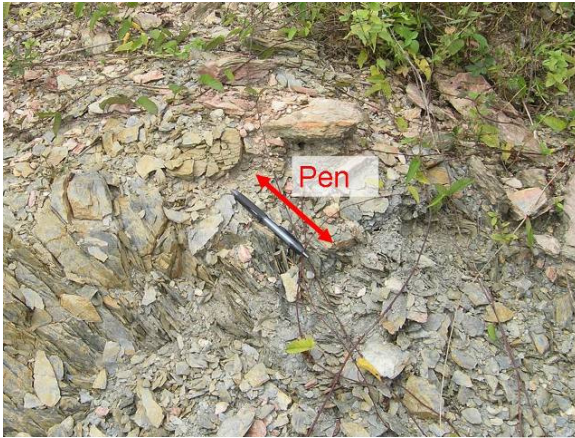
The local geology is composed of phyllite which is vulnerable to fracturing caused by hydration and reduced overburden pressure (Fig. 11). There are some more sites of similar problem (Fig. 12).

Fig. 11 Breakage of Phyllite rock by weathering and water action.

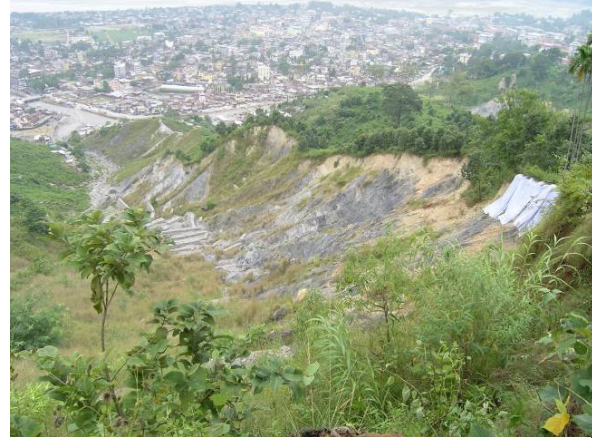
Fig. 12 Instability of Phyllite slope near Phuntsholing.

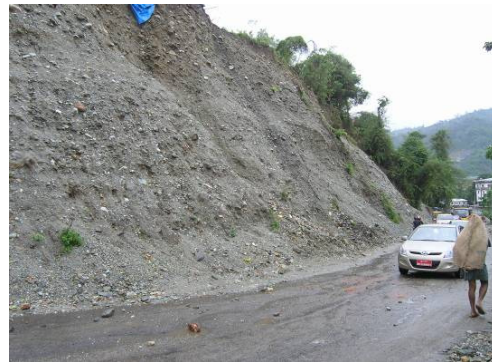
Figure 13 illustrates the site of stone falls during an earthquake in neighboring Sikkim on September 18th, 2011, with $M=6.9$. This cliff was formed in a terrace deposit and is composed of rubbles and stones. After the seismic disturbance, more stones are falling during rains and the road traffic at the bottom is not safe. Currently there is no rule in Bhutan about responsibility for the stabilization of such a slope. It is interesting that some parts of the top of this cliff are stabilized by simple masonry walls, thereby causing no slope instability.

Fig. 13 Seismic falling of debris from cliff of terrace deposit in Phuntsholing.

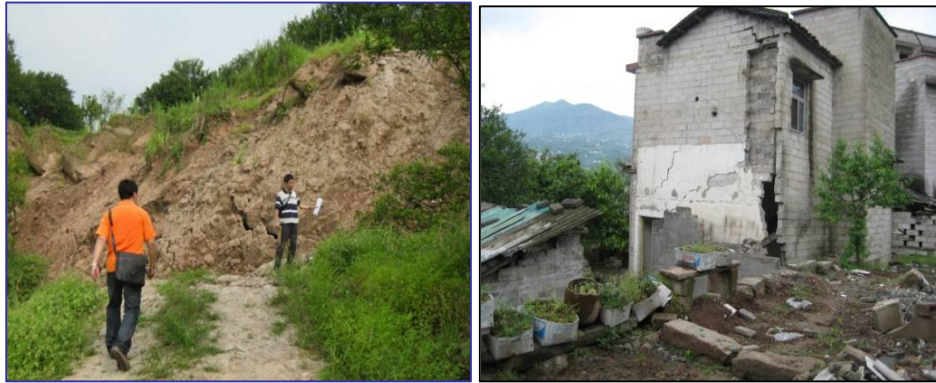
One of the monitored slopes failed on June 7th and 8th, 2009, during rain (Fig. 17). Fig. 18 shows the monitored records of tilting angles and precipitation. It is seen that the final failure (large angle) was preceded by minor rate of ground distortion. By comparing the recorded rate of tilting with the current proposal of threshold rates of tilting;

Fig. 17 Failed slope at Three Gorge Dam Reservoir

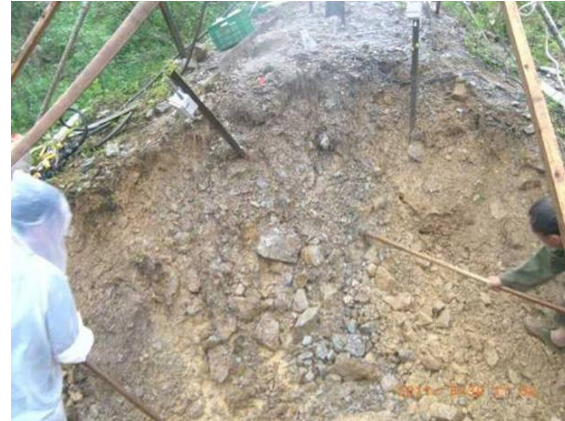
An artificial rainfall test was conducted in Sichuan Province of China in June 2011 in collaboration with the Chengdu Institute of Mountain Hazards and Environment. Fig. 19 illustrates the ongoing artificial rainfall, and finally an excavated trench face fell down (Fig. 20). The obtained record in Fig. 21 demonstrates that the rate of tilting angle is consistent with the proposed threshold as mentioned above.

Fig. 20 Rainfall-induced failure of a cut slope.

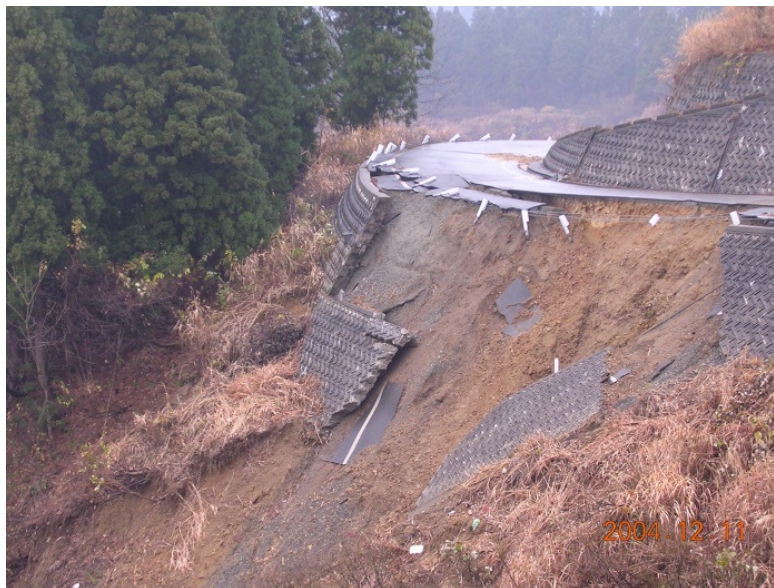
Fig. 22 Retaining wall sliding down with road embankment.
