TECHNICAL ARTICLE

OVERVIEW OF GEOTECHNICAL DAMAGE CAUSED BY THE 2010 CHILE EARTHQUAKE

Ramon Verdugo, Ph.D. and Principal of CMGI - Chile rverdugo@cmgi.cl

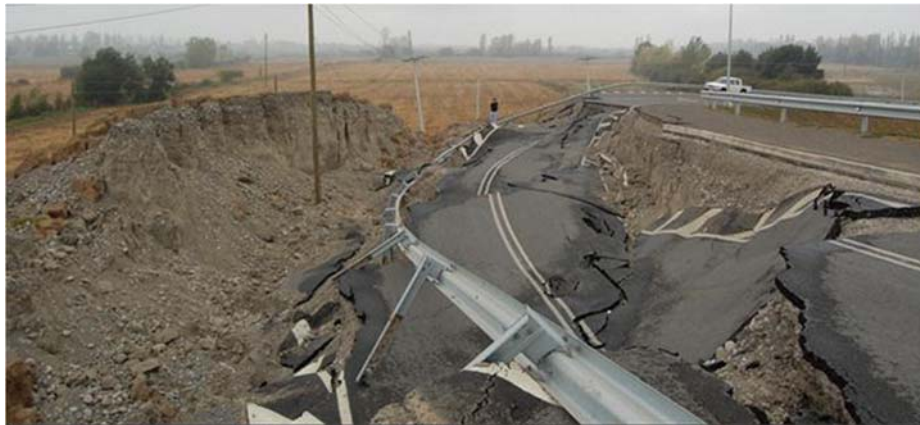
There were several failures of highway embankments of well compacted fill (structural fill). The failures were caused by the existence of weak natural ground, which was neither appropriately investigated nor treated. Three typical examples of this type of geotechnical failure are shown in the photographs of Figs. 3 to 6.

Fig. 3.- Failure of a fill triggered by foundation failure. Cruce Villaseca, Km37-Ruta5

In all these cases, due to the abundance of native vegetation, the presence of a shallow water table was undoubtedly identified. Obviously, the well compacted gravelly materials that constituted the structural fills were not able to maintain the global stability, which was controlled by inappropriate foundation condition.

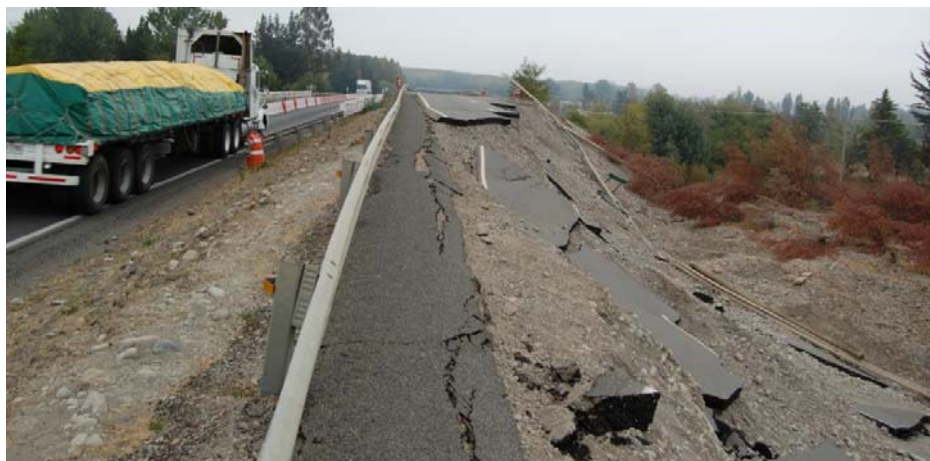
Fig. 4.- Failure of Paso Superior Copihue

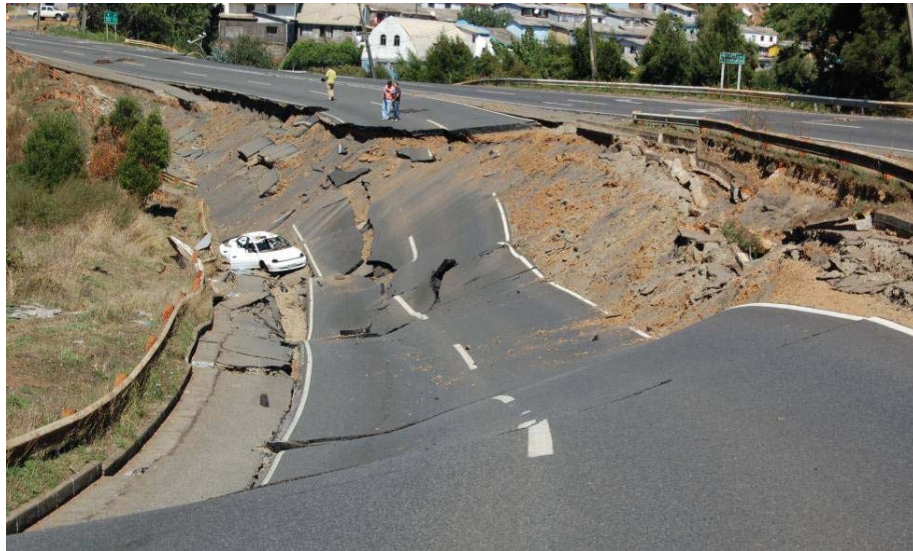
Fig. 5.- Failure of a fill triggered by foundation failure, Sector Polvorín, Ruta P160

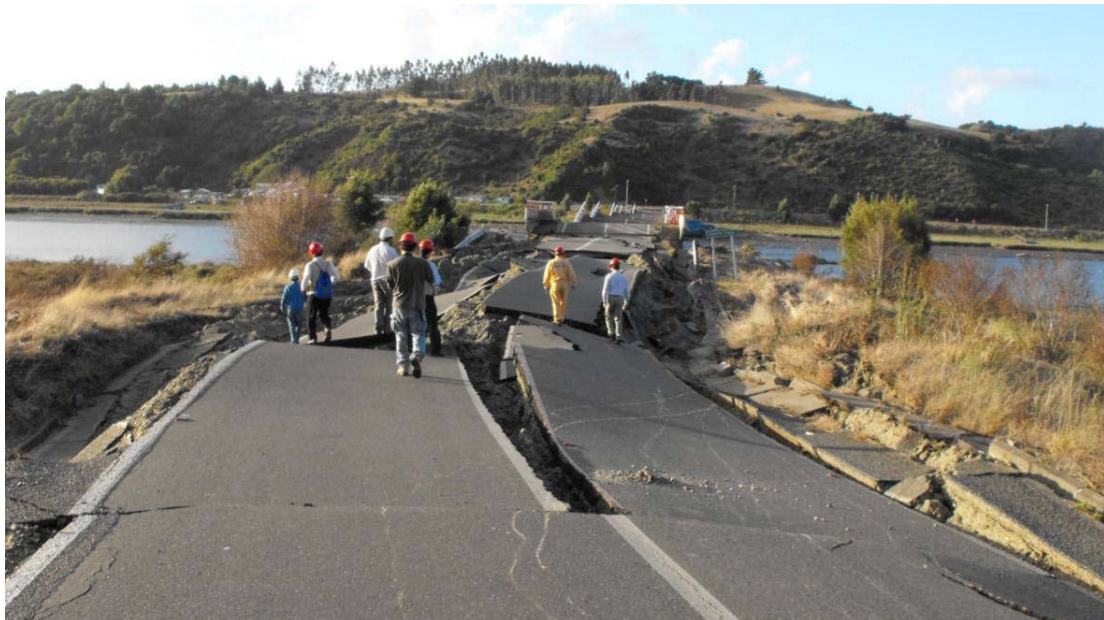
Fig. 6.- Failure of the access at bridge Tubul

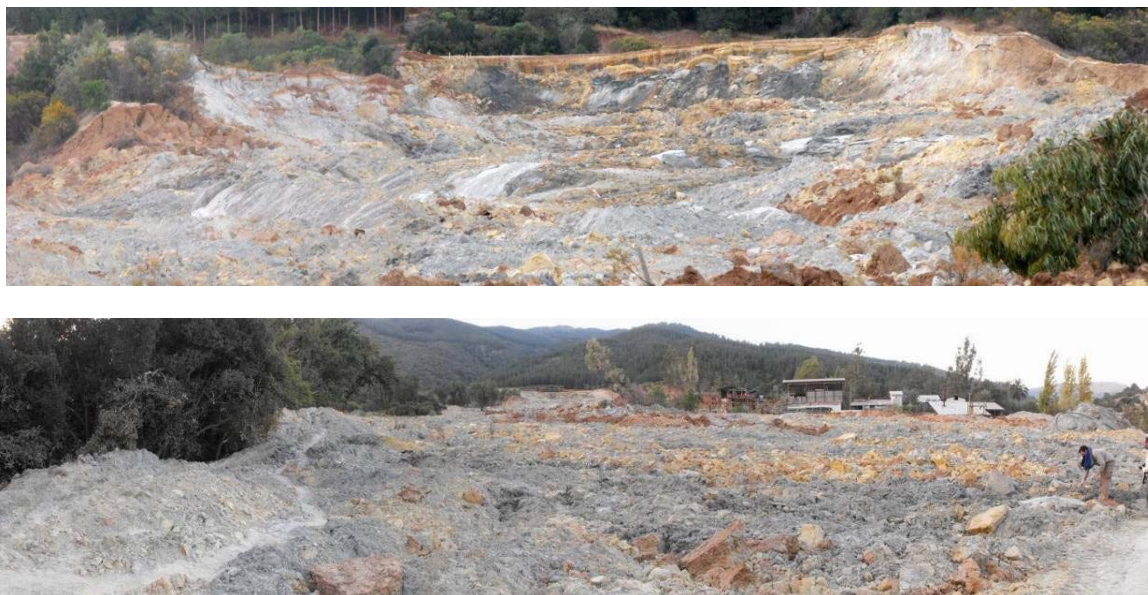
In the area affected by the strong motion, there are eight major tailings dams that seismically performed well. However, out of more than 50 small to medium tailings dams, five developed seismic failures. Limited seismic displacements were experienced by four tailings dams, without major problems. Unfortunately, one tailings dam underwent flow failure (liquefaction) that resulted in four fatalities (Verdugo et al, 2012). In the photographs presented in Fig. 7 the mass of tailings remaining after the flow can be observed. Therefore, considering the significant number of tailings dams existing in the area, it is possible to indicate that in general the seismic behavior was almost optimum with only one catastrophic failure.

Fig. 7.- Mass of tailings remaining after flow failure

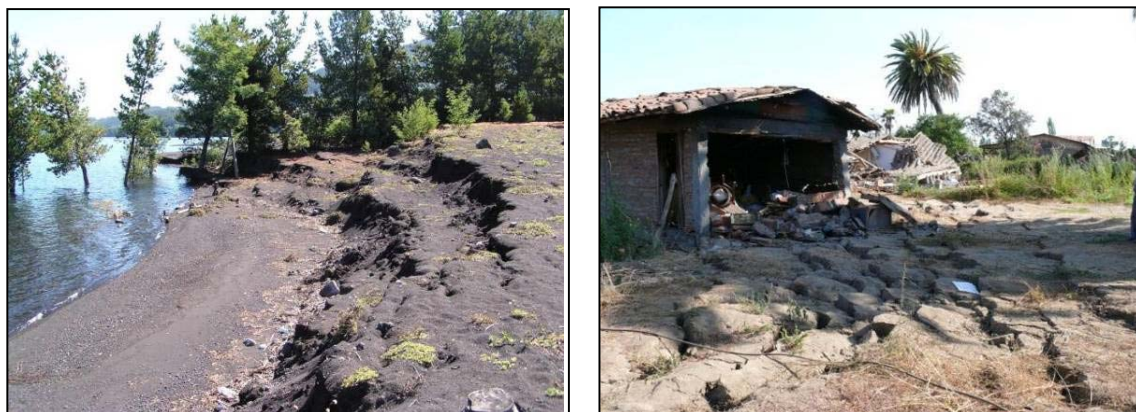
The phenomenon of lateral spreading was extensively observed in the vicinity of rivers and lakes, as shown in Fig. 9. In the area of Licanten, Mataquito River, the length of the cracks associated with this mechanism reached about 2000 m, involving displacements and settlements to a distance that exceeded 100 m from the border of the river.

Fig. 9.- Lateral spreading observed in Calafquén Lake and Nancagua

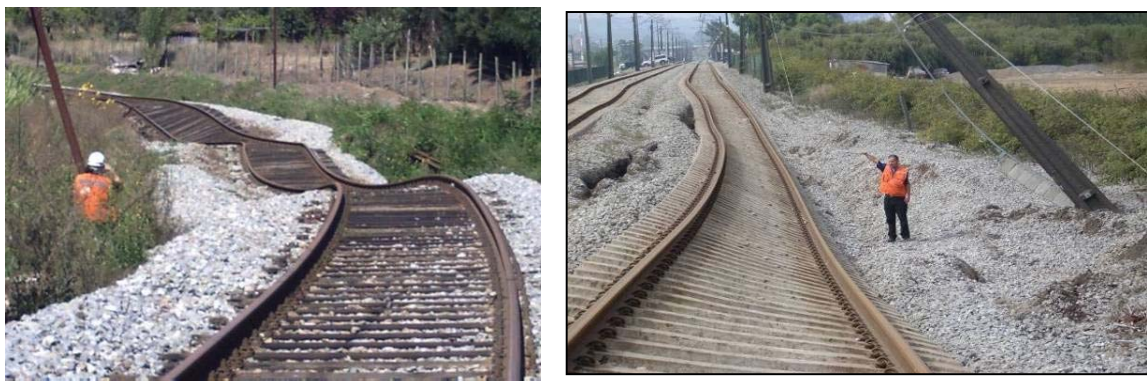
Significant settlements developed after liquefaction was observed at many places along the railway system as shown in Fig 10. Because of this type of failures the transport by this system was stopped for several weeks after the earthquake, with an additional impact on the post seismic recovery of the country.

Fig. 10.- Settlements after liquefaction, near city of Concepcion (courtesy of EFE)

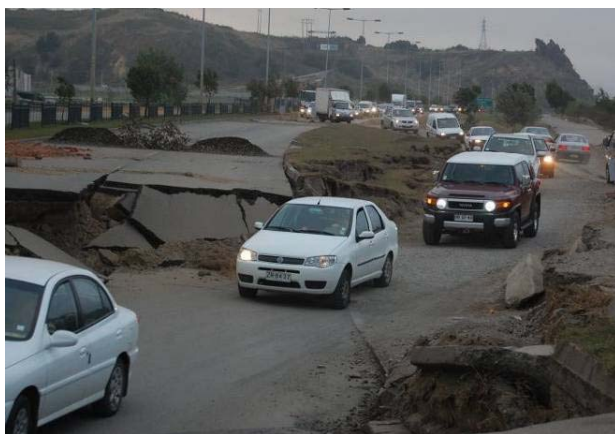
The city of Concepcion is founded on deep sandy soil deposits, with a water table at 3 m to 7 m below the natural surface. Although most of the deposits consist of dense sandy materials, some of them are loose enough to have experienced liquefaction, affecting routes, bridges, houses and buildings. Examples of these failures associated with the phenomenon of liquefaction are presented in Figs. 11 to 14. The large displacements observed in the failure of Fig. 12 occurred in the city of Constitucion.

Fig. 11.- Route Costanera Norte BioBio

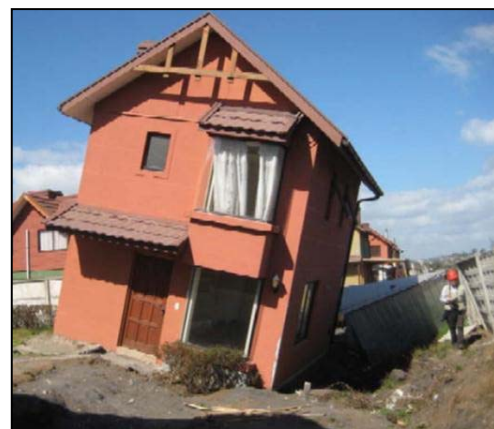
Fig. 12.- House in Talcahuano

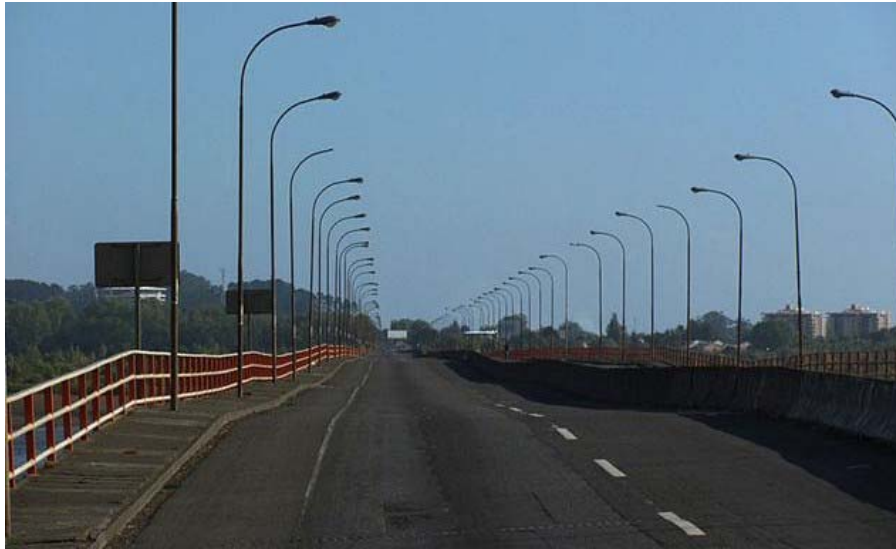
Fig. 13.- Differential settlements observed along Juan Pablo II Bridge, Concepcion

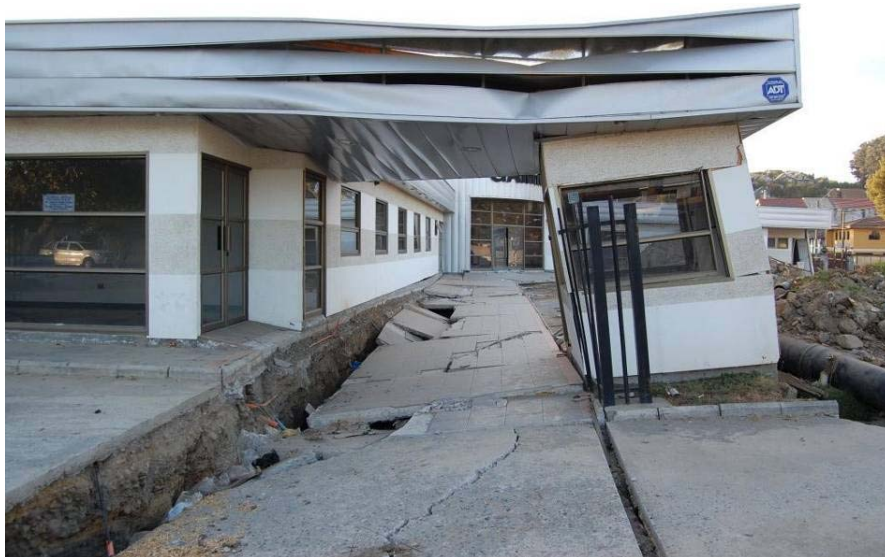
Fig. 14.- Failure observed in Constitucion city

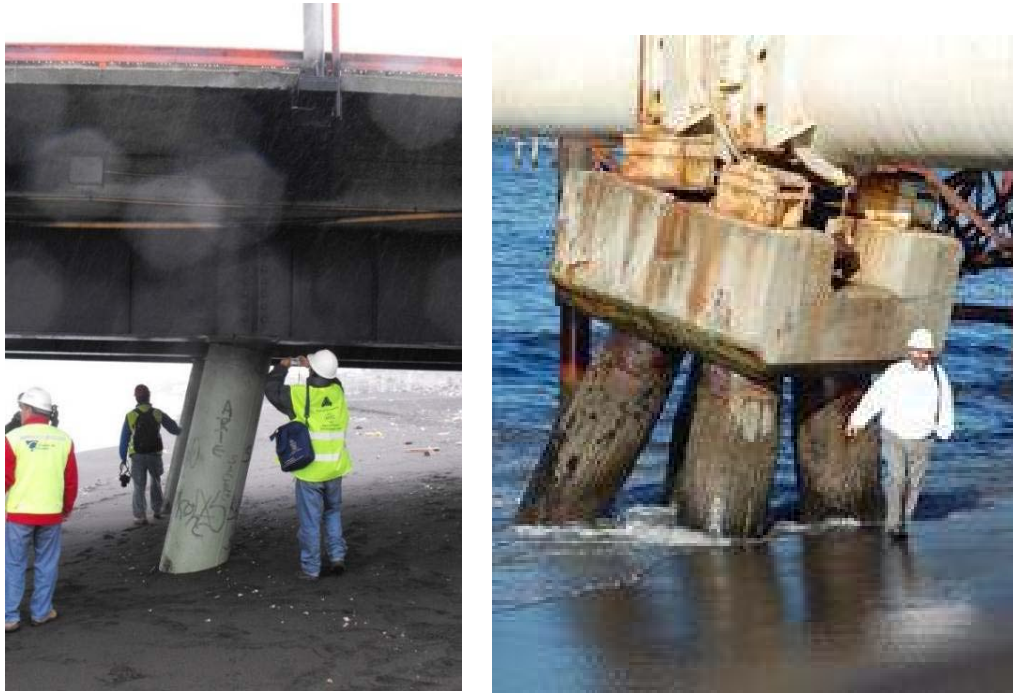
The damages caused by liquefaction in port facilities were especially important because of their economic impact. The most typical failure was the lateral displacement experienced by piles embedded in laterally spreading ground. Some of these failures are shown in Figs. 15 to 18.

Fig. 15.- Pile tilted by the lateral movements of liquefied soil, Coronel, Bocamina

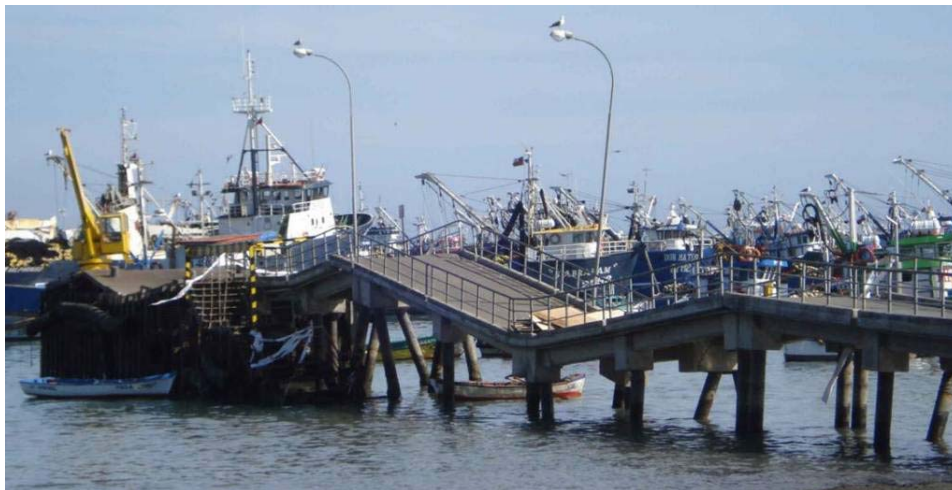
Fig. 16.- Large displacements experienced by a pier of local fishers

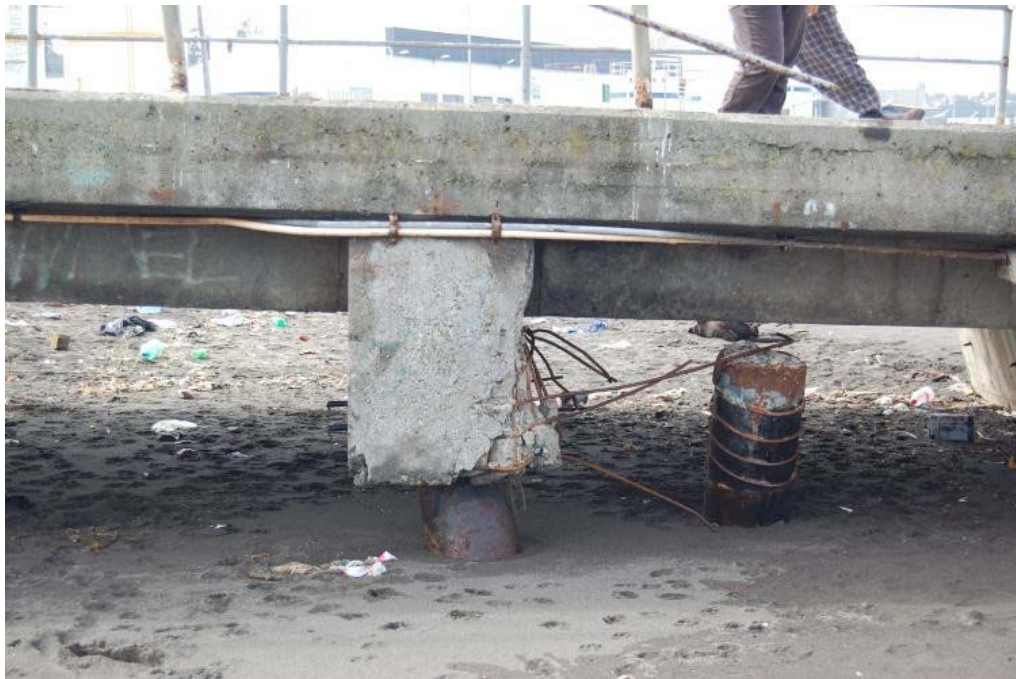
Fig. 17.- Evidence of the lateral displacements experienced by the liquefied ground

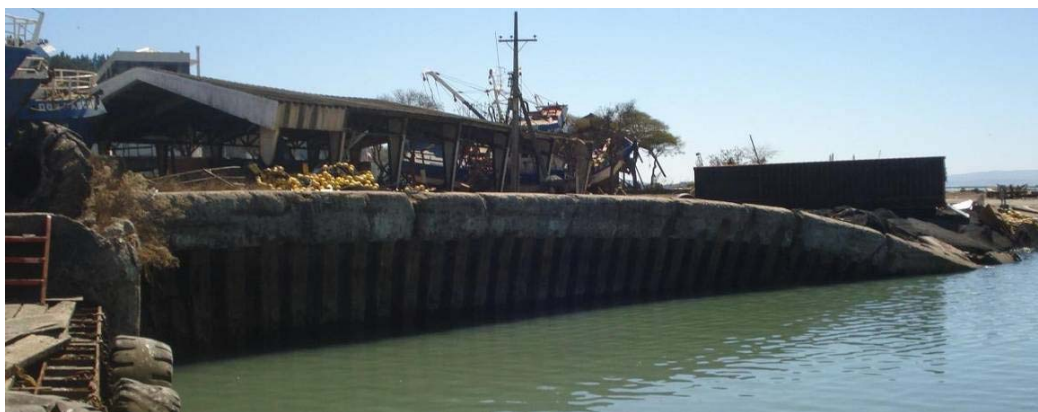
Fig. 18.- Quay wall in La Poza, Talcahuano

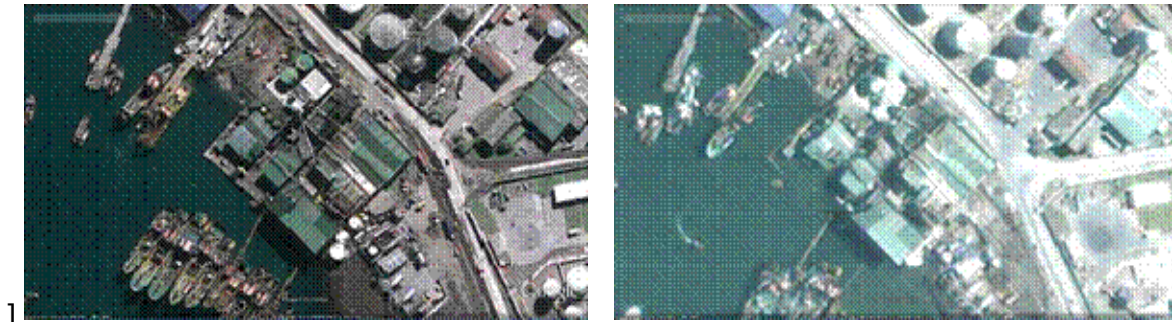
In San Vicente Bay a fishing industry made its facilities on a platform built on reclaimed land. The platform sank dozens of centimeters and moved towards the sea, destroying most of the facilities (Figs. 19 and 20). The limited available information indicates that the natural ground consists of loose sandy soil deposits and mud (materials that would not have been removed or improved) and this is an undesirable condition that may explain the observed failure.

Fig. 19.- Liquefaction failure of a reclaimed land (before and after failure)

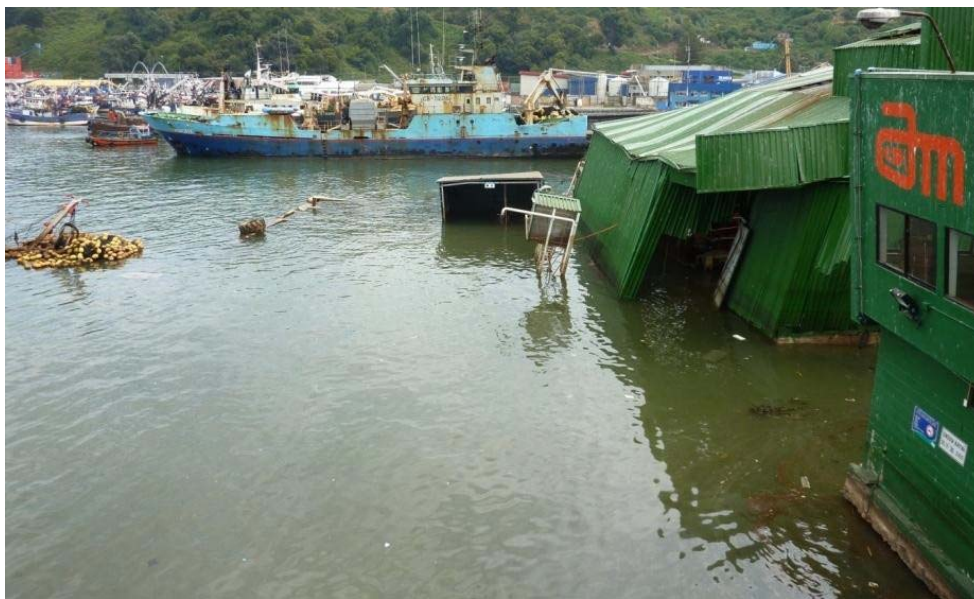
Fig. 20.- Sinking of the reclaimed land under the sea

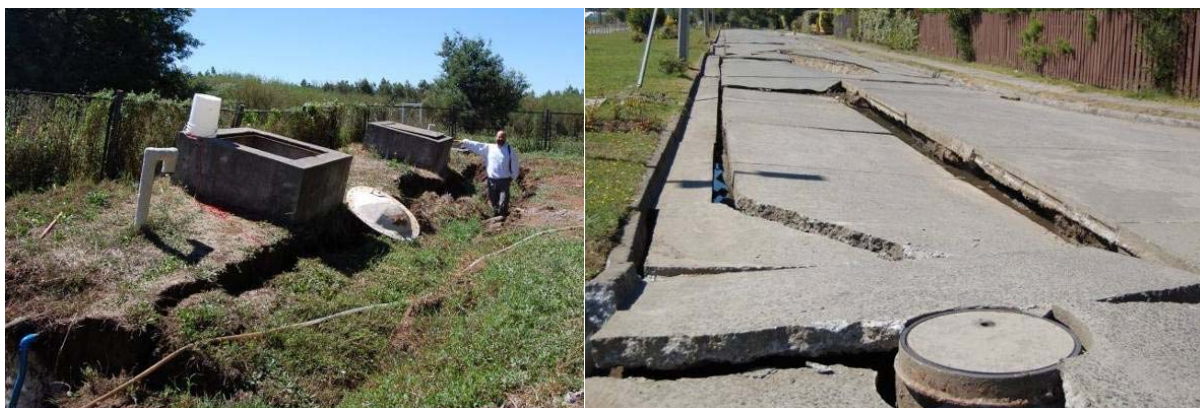
Another clear evidence of liquefaction was the uplift of buried structures such as tanks and manholes, as shown in Fig. 21.

Fig.- 21.- Uplift of buried structures (Chillán and Arauco)
