## TECHNICAL ARTICLE

### Landslides in landfills

By A.O. Landva<sup>1</sup> and S.J.E. Dickinson<sup>2</sup>

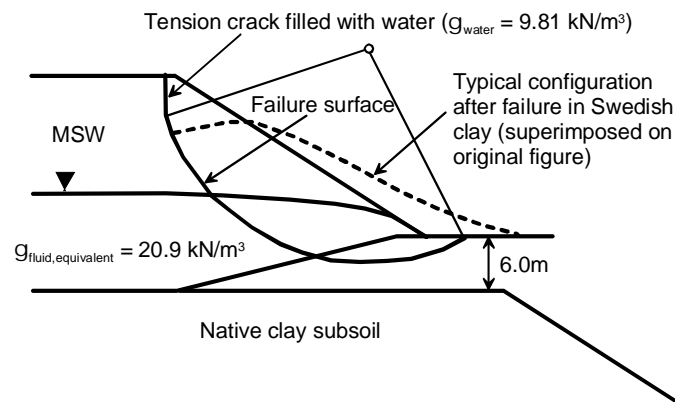
The conventional approach to the analysis of slides in landfill is to treat MSW as a mineral soil and to model such slides on the basis of regular soil mechanics principles, such as shown in Fig. 1. For example, Merry et al. (2005), on analyzing the 2004 Payatas, Philippines, slide described in the review below, considered the section shown in Fig. 1 to be representative of the failed MSW slope. The factor of safety was calculated using Spencer's method. The shear strength parameters for the MSW used in the effective stress analysis were a cohesion intercept of 19 kPa and a friction angle  $\phi'$  of 28°. Their analysis was thus based on a conventional soil mechanics approach. As such, and as indicated in Fig. 1, the displacement during a conventional slide would come to a stop when the final configuration and soil strength combine to produce a factor of safety just exceeding 1.0. In this connection, reference is also made to the well-known 1916 Gothenburg Harbour slide (e.g. Tschebotarioff 1951, p. 178).

Fig.1 Two-dimensional cross section of slope evaluated in stability analyses (Merry et al. 2005).

It seems highly unlikely that the mechanism of this slide as described above can be represented by a circular failure surface such as that shown by Merry et al. (2005). Such failures, originally introduced by Fellenius et al. (1922) in connection with numerous failures in Swedish marine clays, could not in any way be considered to be representative of flow slide failures in landfills such as, for example, this failure.

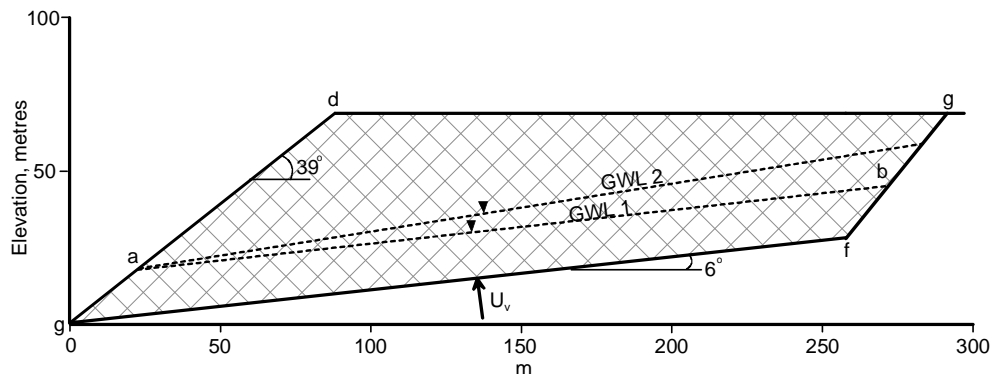
In February 2005, the Leuwigajah dumpsite in Bandung, Indonesia, collapsed causing an avalanche of some 2.7 million cubic metres of waste, killing 147 people (Kölsch et al. 2005). The geometry used by Kölsch et al. in their analysis is shown in Fig. 2 (based on their figs. 3 to 5). The groundwater (or leachate) level used in their study (GWL1) corresponded to a pore water pressure of approximately 150 kPa, as shown. It seems clear that the failure occurred within a thin, very weak layer near the base of the landfill.

Kölsch et al. concluded that the Leuwigajah failure most likely was “triggered by water pressure in the soft subsoil in combination with a severe damage of reinforcement particles due to a smouldering landfill fire”. However, in view of the fact that the subsoil had been consolidated under considerable overburden stress, ranging between 500 and 1000 kPa, for about 30 years, it is unlikely that the seat of failure was located within this zone.

Fig.2 Section through Leuwigajah dumpsite, Bandung (Kölsch et al. 2005)

On the other hand, considering that precipitation in the area of the slide is between 1500 and 2000 mm/year and that heavy rainfall and thunderstorms are common during the wet season, there seems little doubt that a high pore water pressure was the critical factor. However, as with the Rumpke slide, the weak zone was in all probability located within the decomposing waste, and not in the mineral soil beneath the landfill base. If the groundwater level was located at GWL 2, a mobilized angle of friction of 15° could have just triggered a slide along the weak zone.

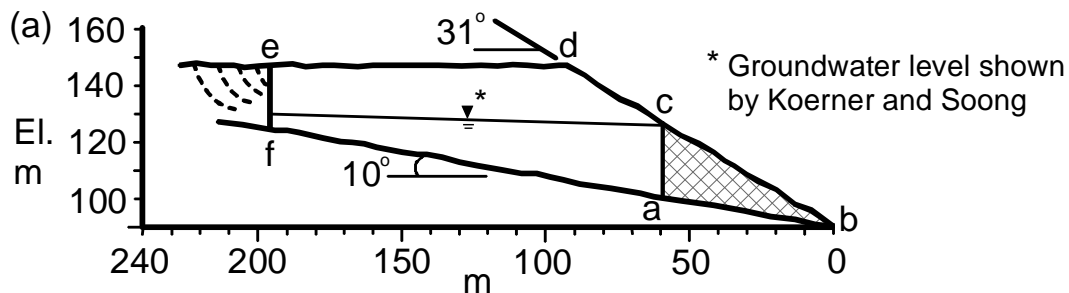
A major failure was experienced at the Ümbaniye Dump Site in Istanbul in 1993. The failure was very sudden and the decomposed waste mass moved down the valley at a high speed for approximately 500 metres. The topography of the failure and the critical cross section are shown in Fig. 3.

The failure was translational in nature and involved the movement of 470,000 m<sup>3</sup> of waste. The section in Fig. 3 is what was used by Koerner and Soong (2000) and labelled “critical 2-D cross section after the failure”. The sliding waste buried numerous homes in its path and resulted in the loss of 27 lives. Excessive leachate level buildup within the old decomposed waste caused by water infiltrating from adjacent surface water ponds was likely the triggering mechanism of the failure (Koerner and Soong, *ibid*).

The mode of failure, as described above suggests that the waste mass was moving on a wet lubricated layer, e.g. on a zone of highly decomposed, mostly organic waste material. With a groundwater level such as that shown in Fig. 3, a mobilized angle of friction of 17° would correspond to a factor of safety of 1.0.

Fig. 3 Ümbaniye Dump Site, Istanbul, section of fill involved in the slide (Koerner and Soong, 2000)

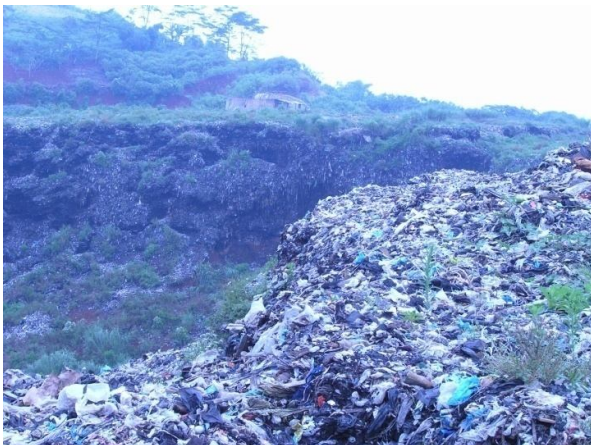
Photo 1 Top scarp of failed landfill

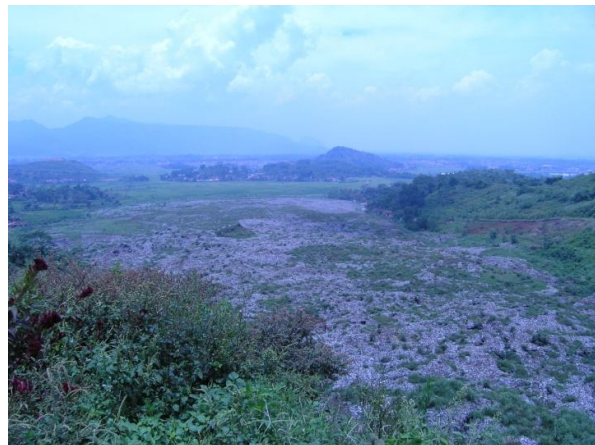
Photo 2 Flow and deposit of waste
