# Deep excavations

## ■ Collapse at Lok Fu Station, HKMTRC

- Collapse of Nicoll Highway on 20<sup>th</sup> April 2004, caused by incident at MRT Circle Line Worksite
  - Contract 824 included
    - ◆ NCH Station, 3-level underground 327 m long
    - ◆ BLV Station, 3-level partly underground 246 m long
    - ◆ 800 m of twin bored tunnels
    - ◆ 2 km of cut-and-cover tunnels, mainly in soft marine clay

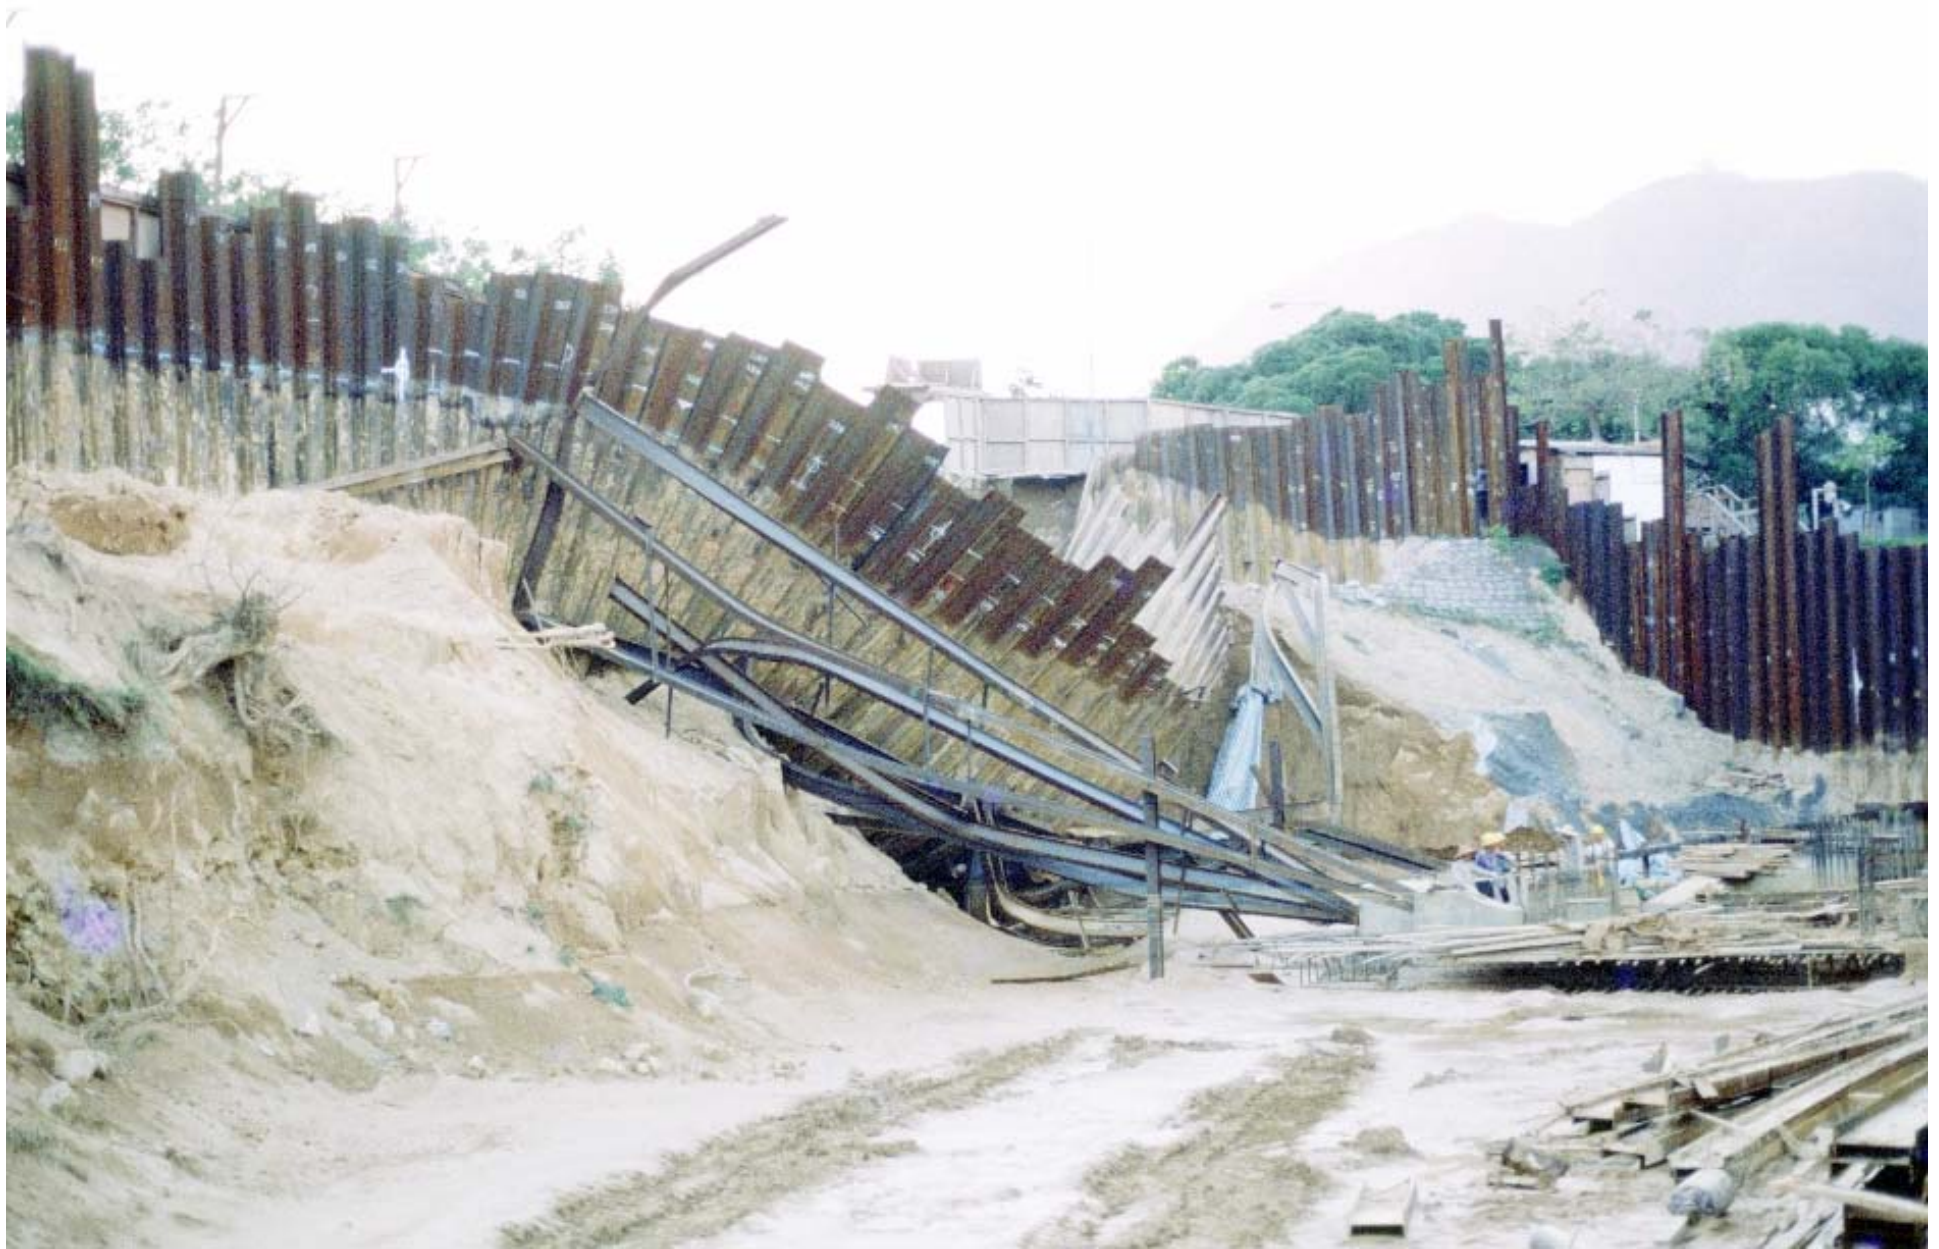
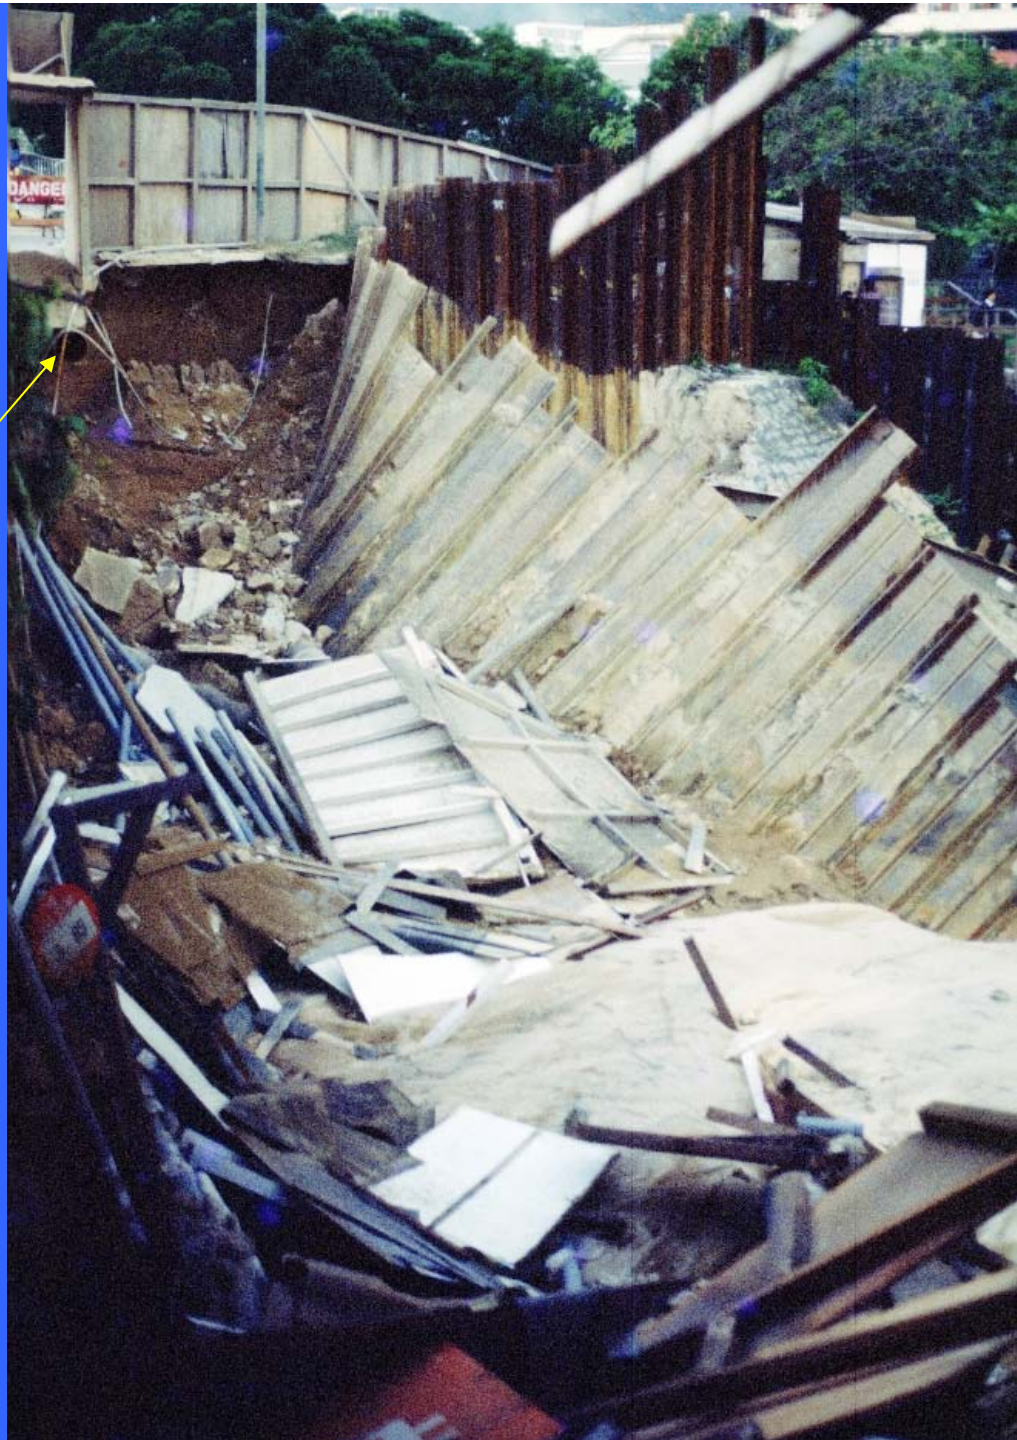
- Checkers queried strutting design
- Designers would not respond
- Checkers insisted on monitoring
- Collapse occurred
- Monitoring survey data in desk drawer
- When plotted showed progressive wall movement
- Firewater main behind wall with T-branch across road
- Firewater main failed in tension

End of  
water pipe

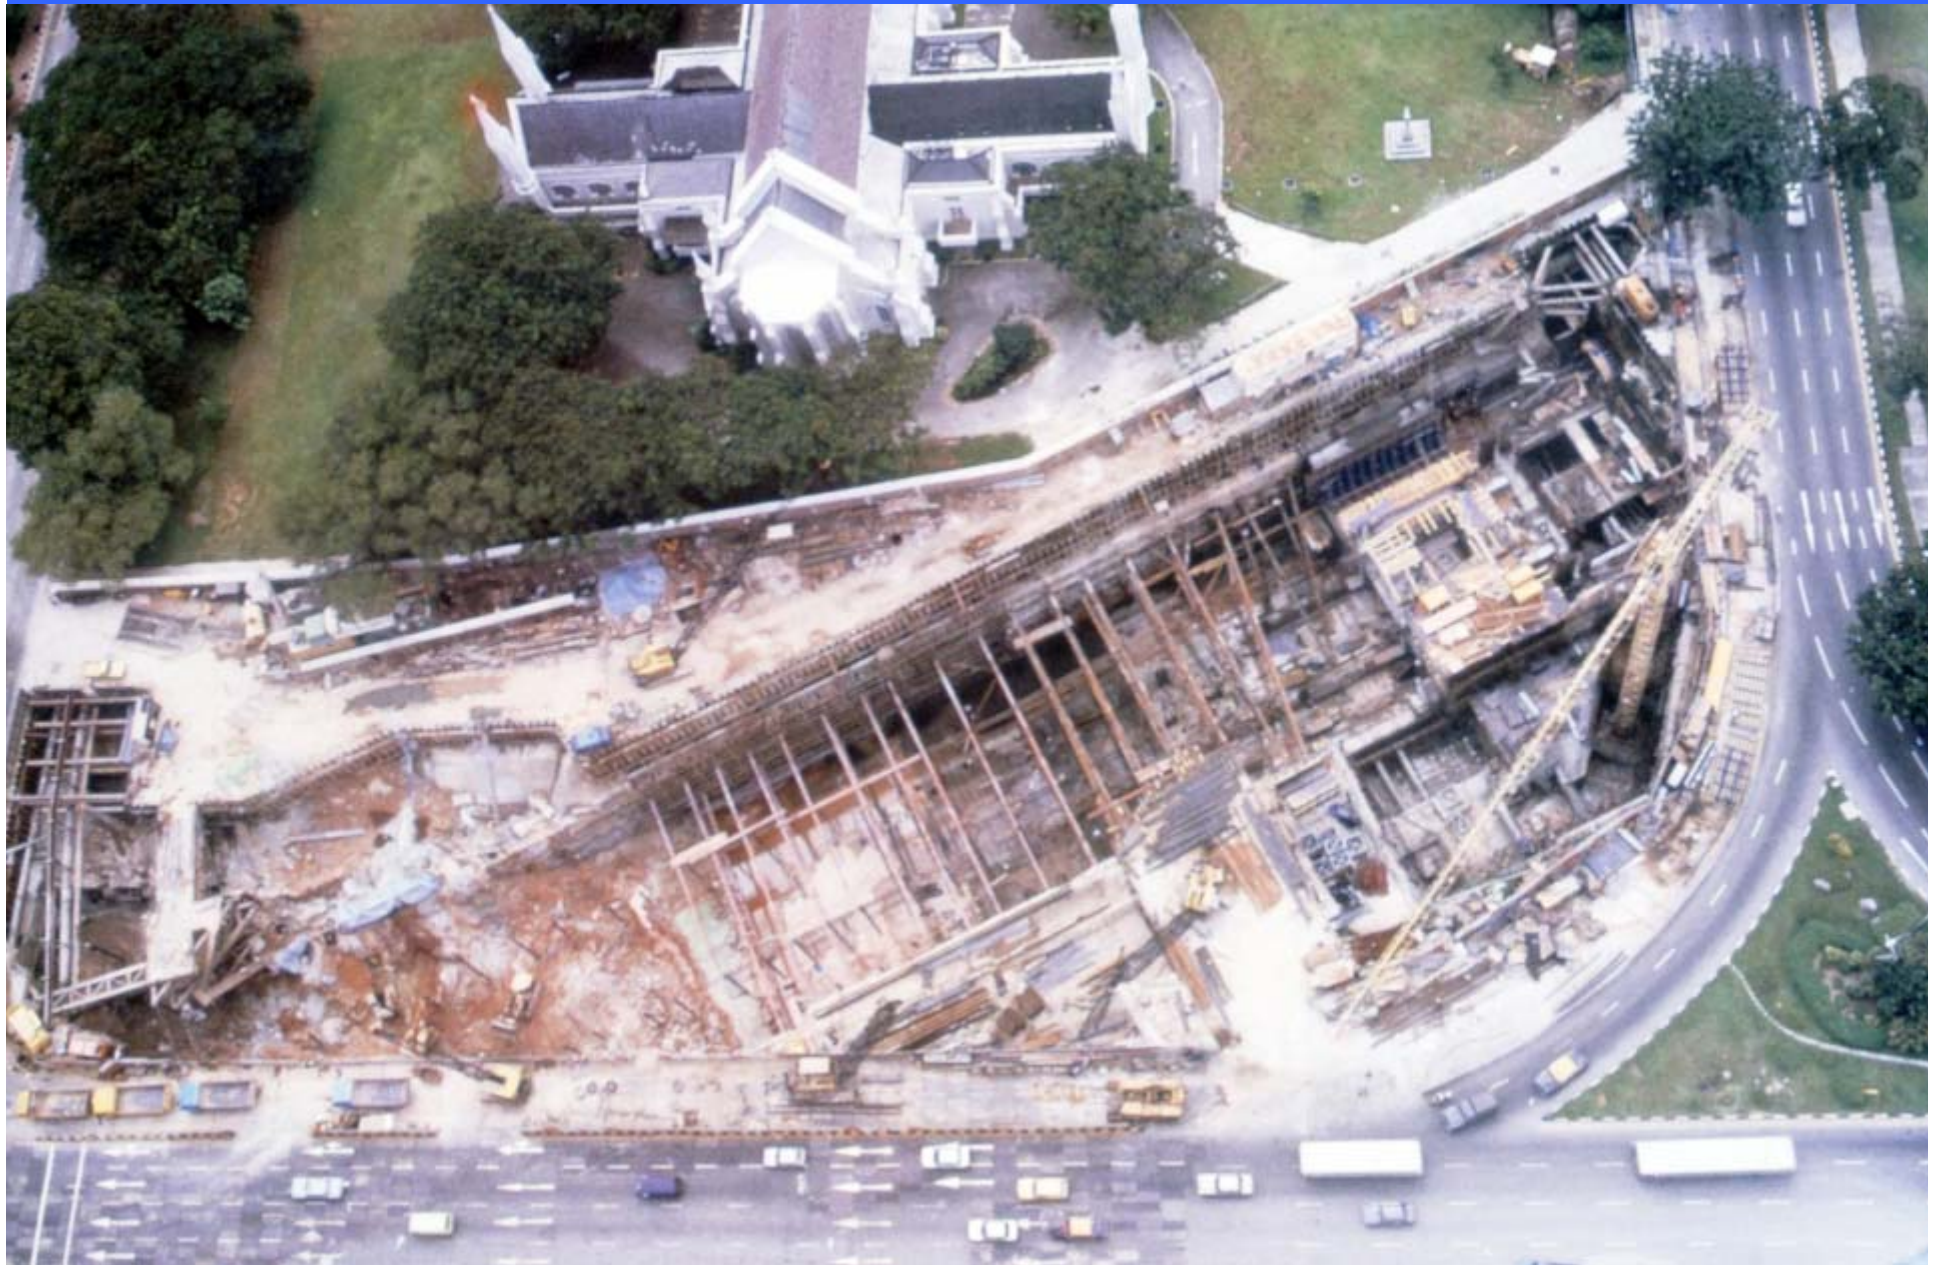
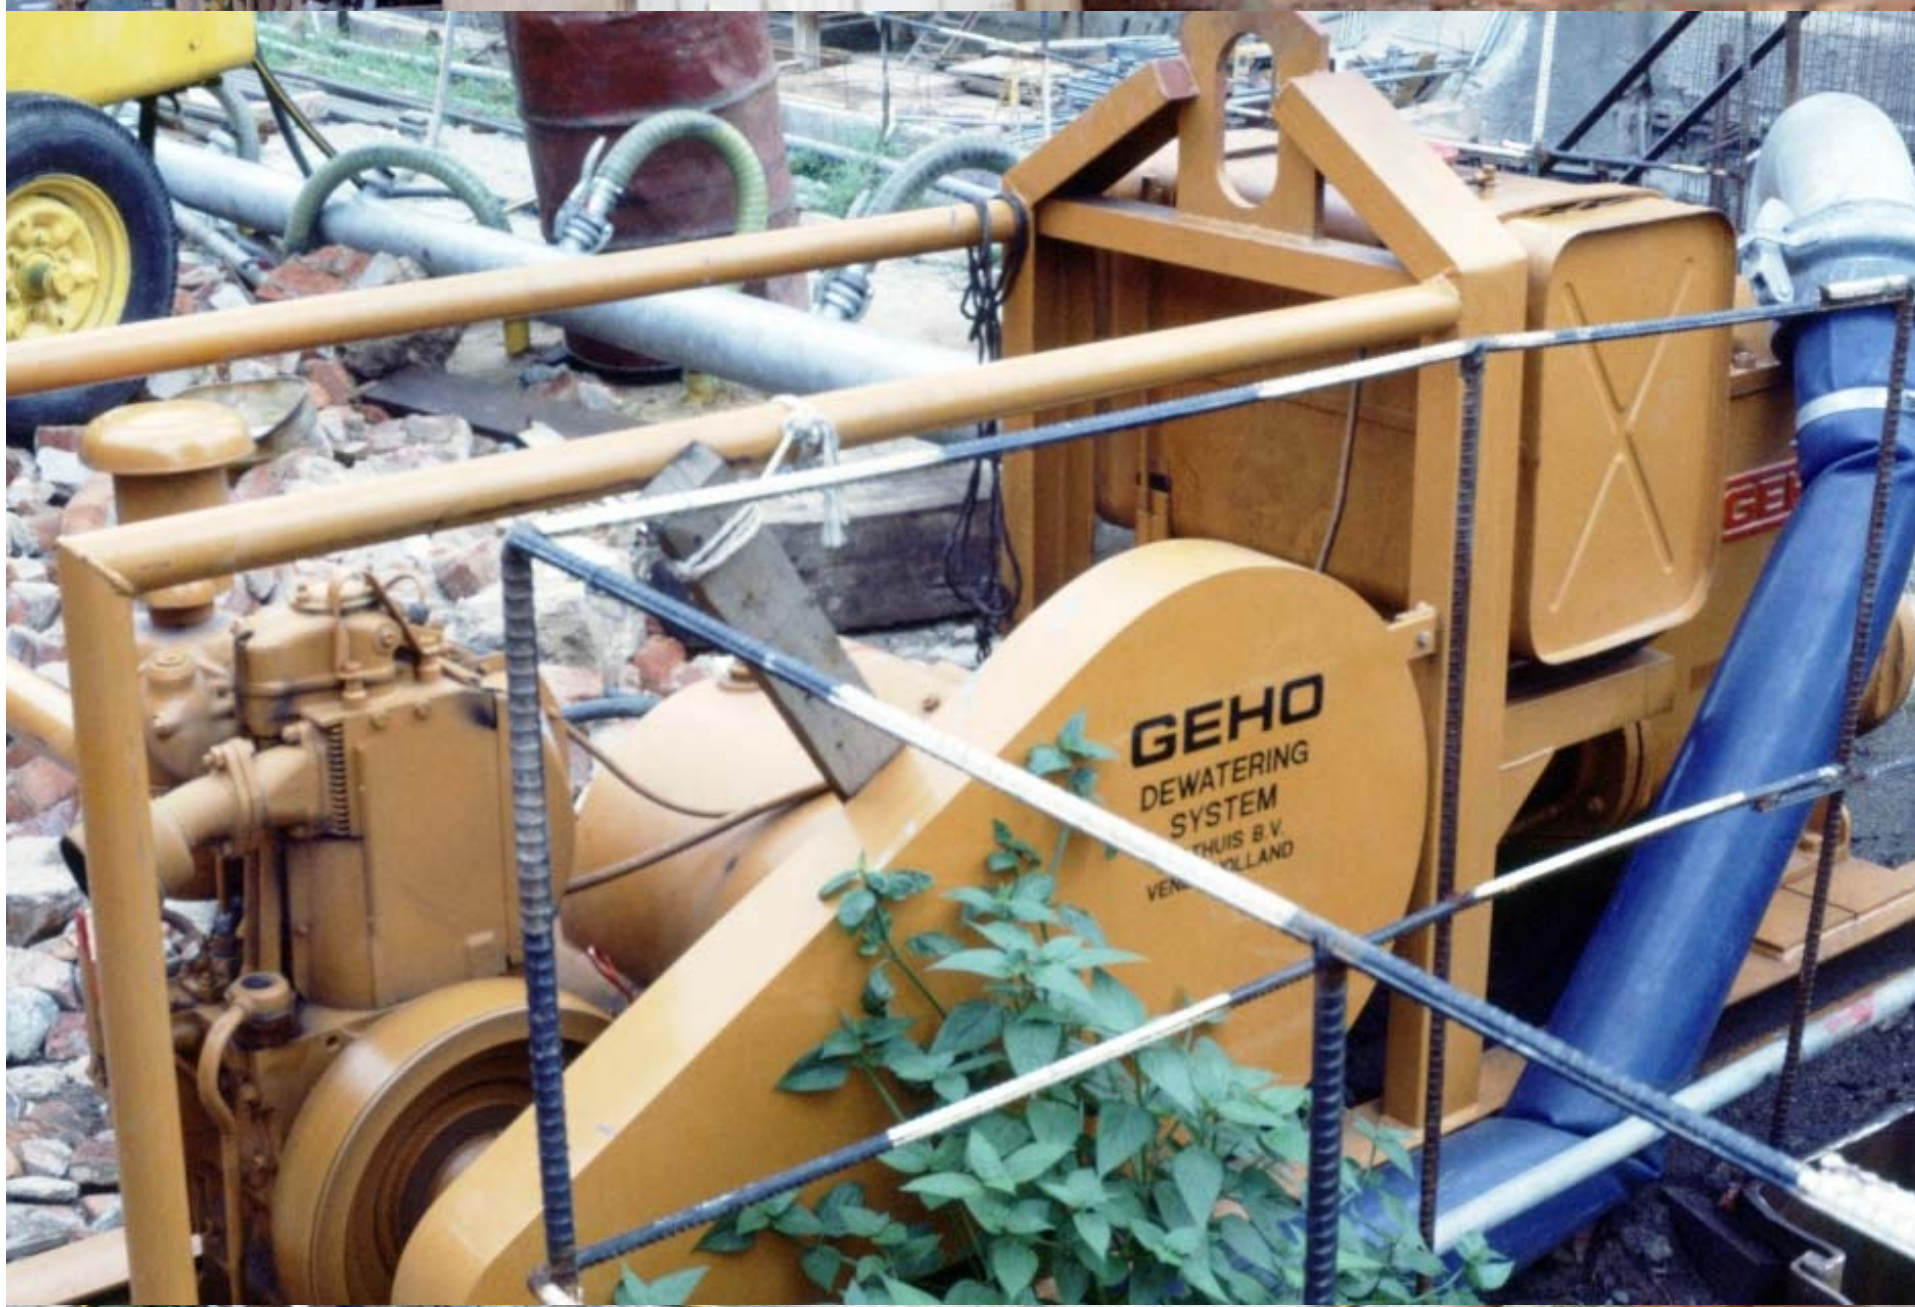
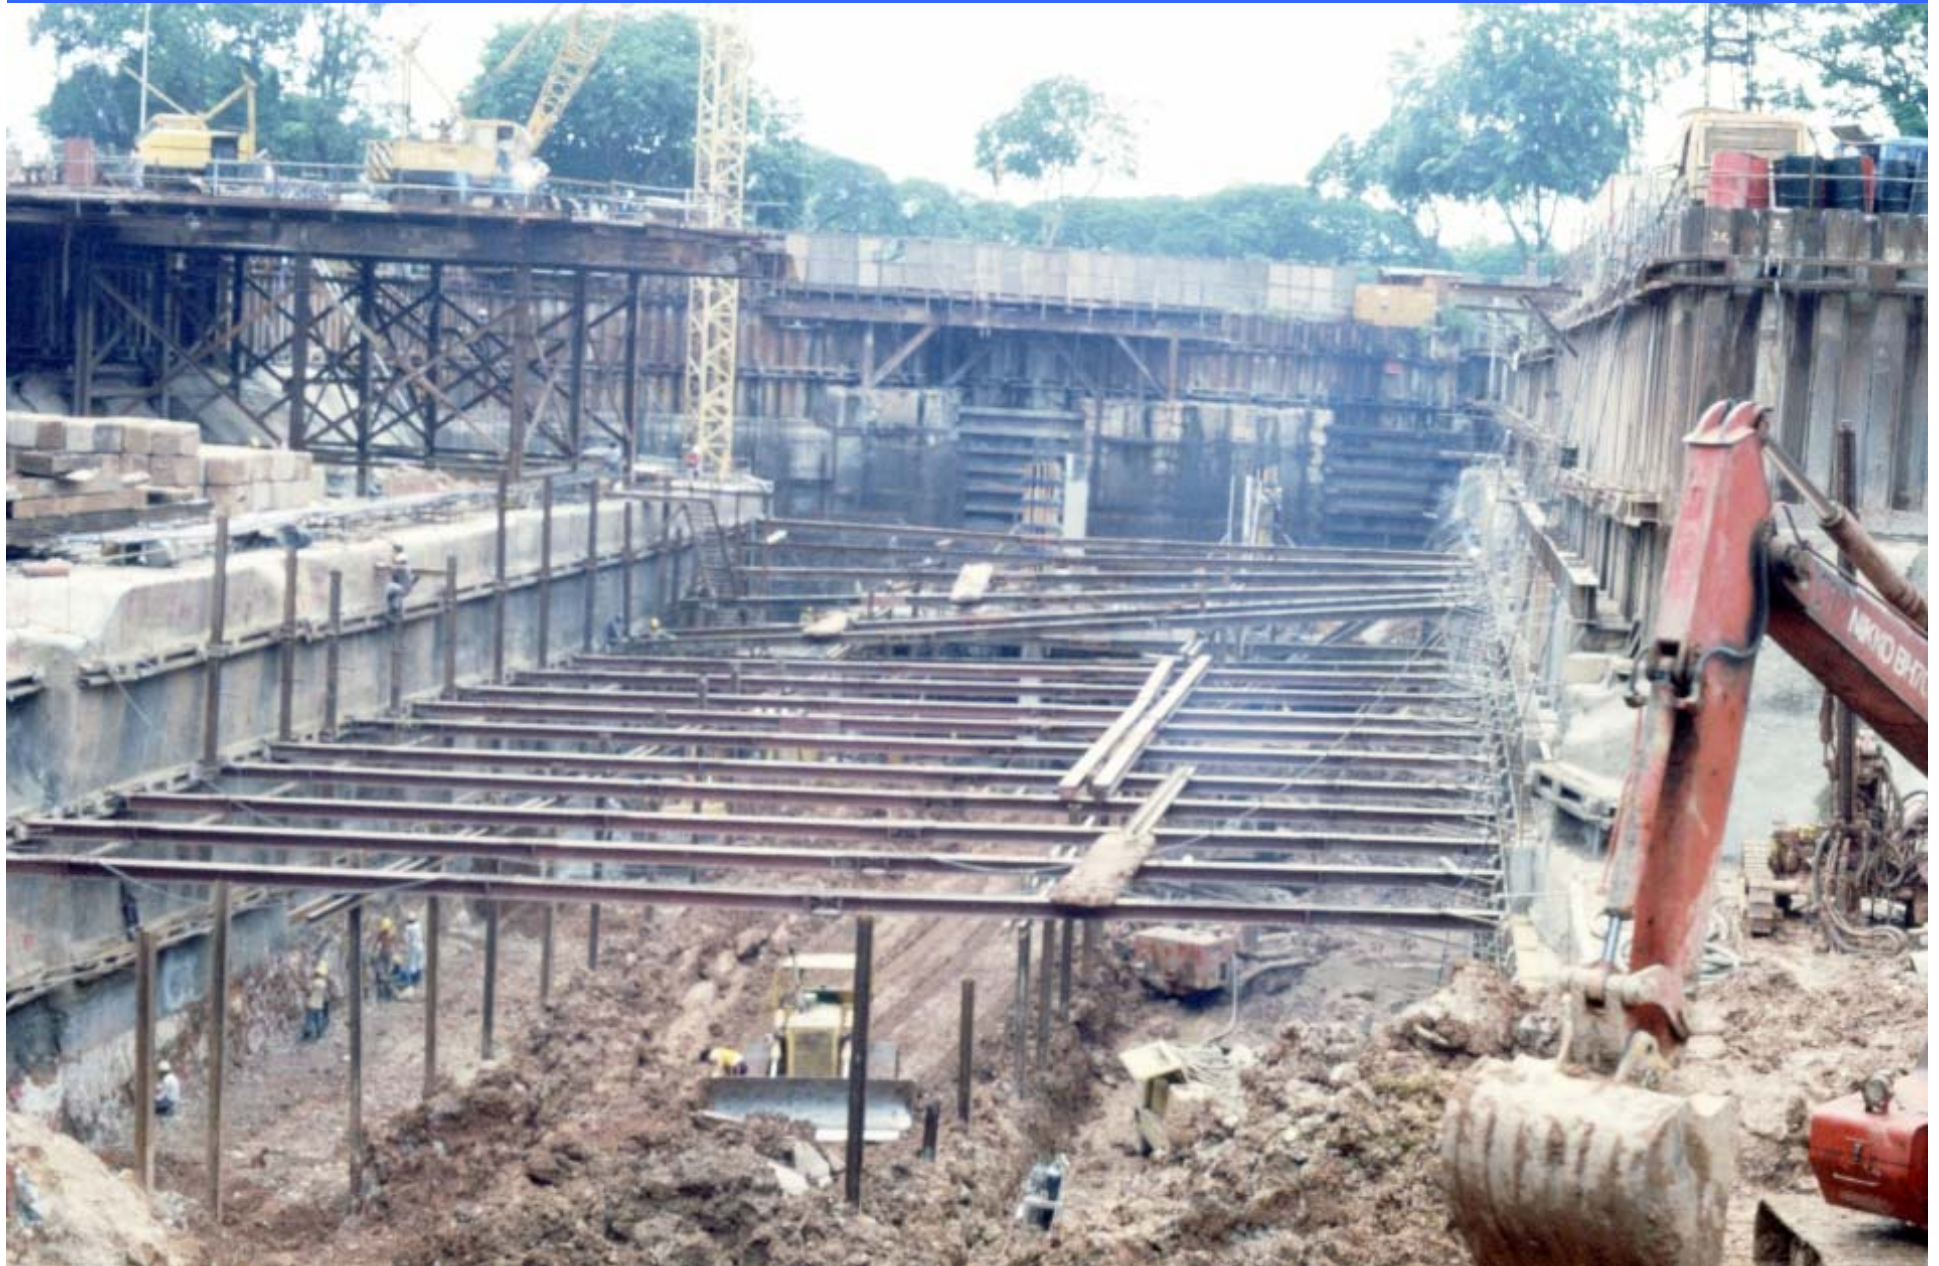
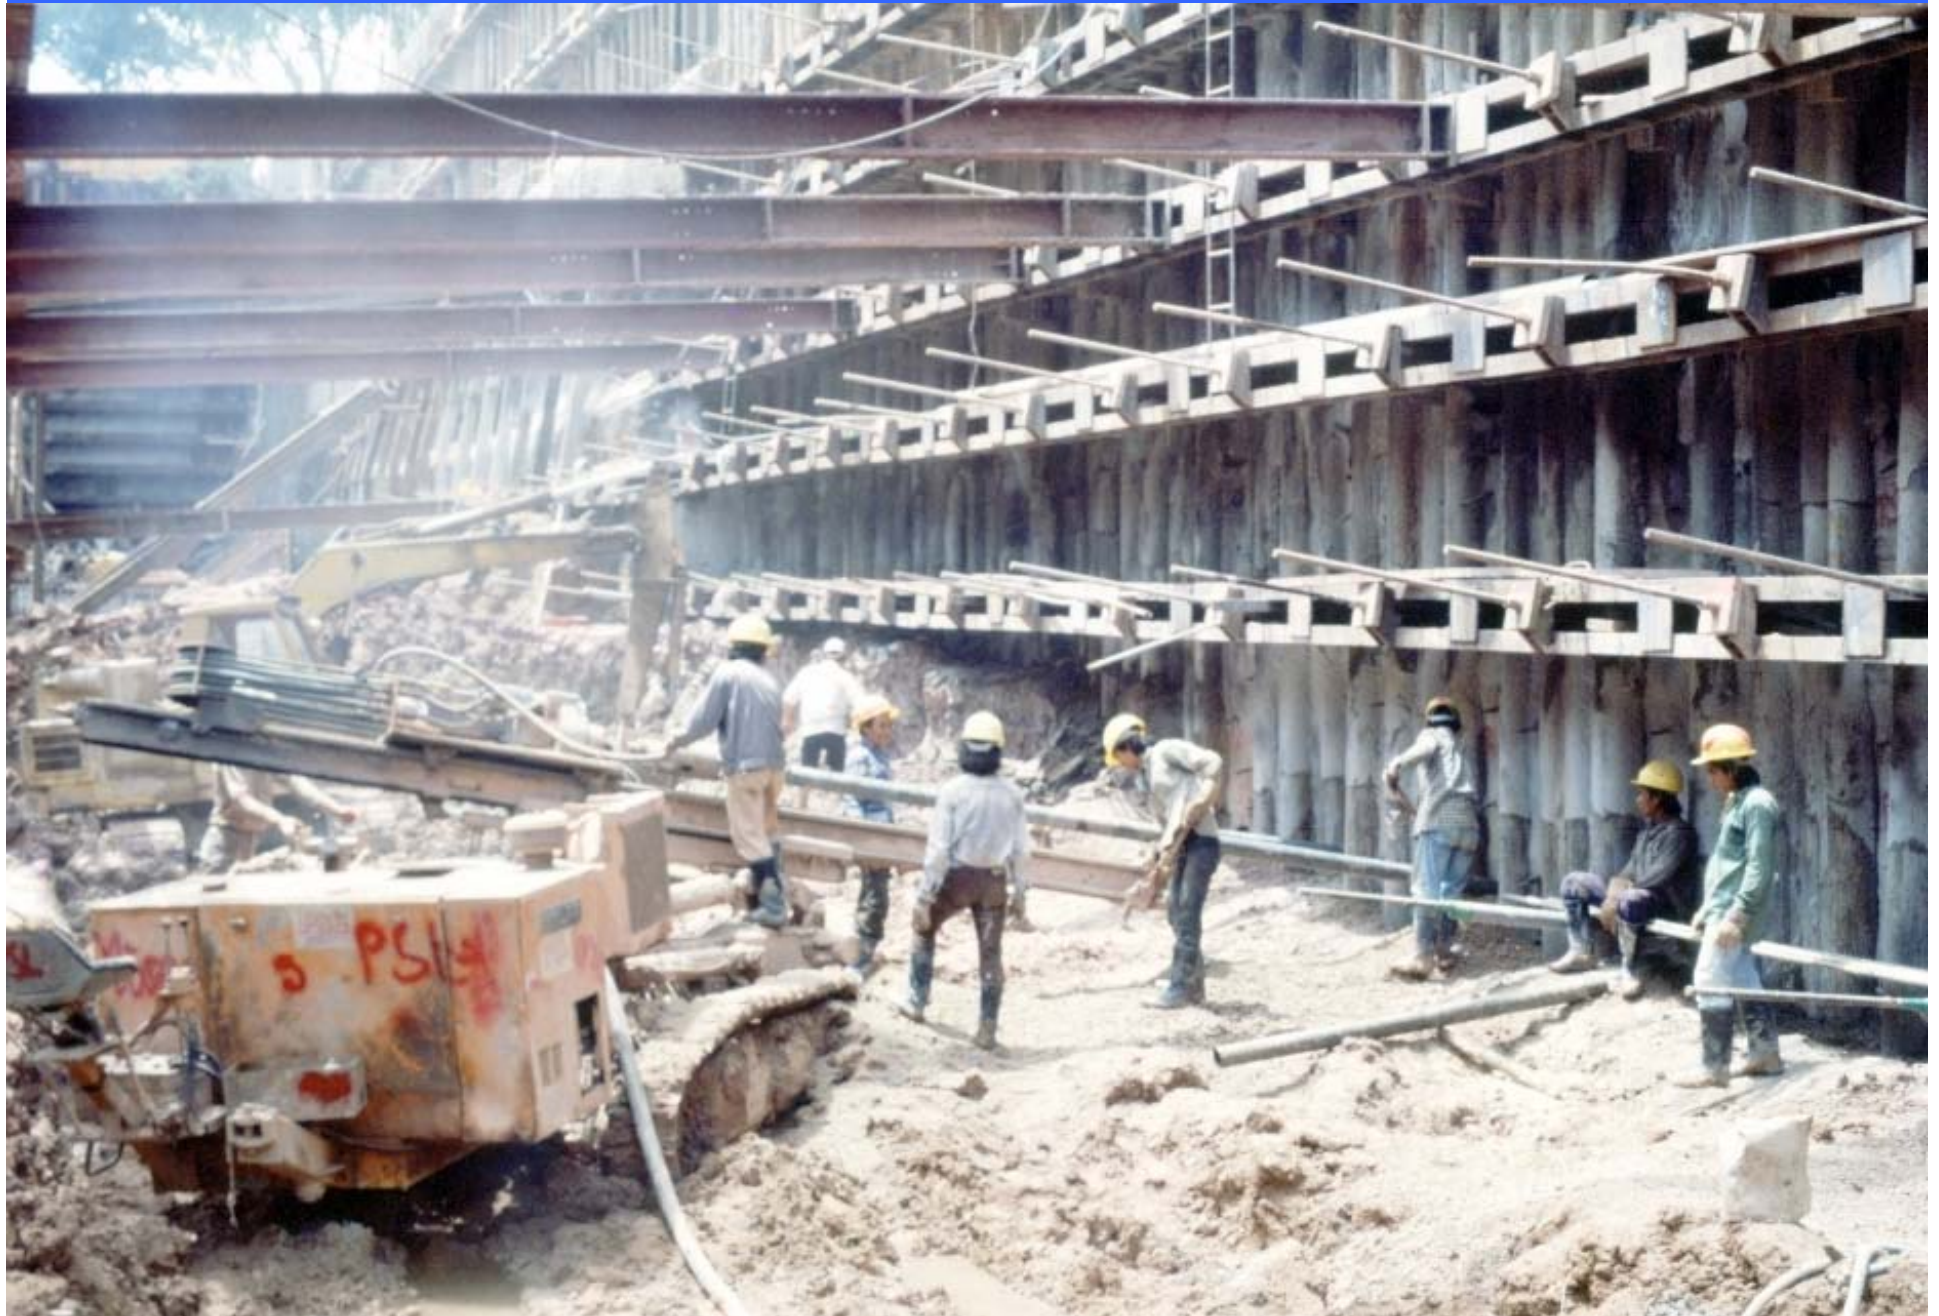
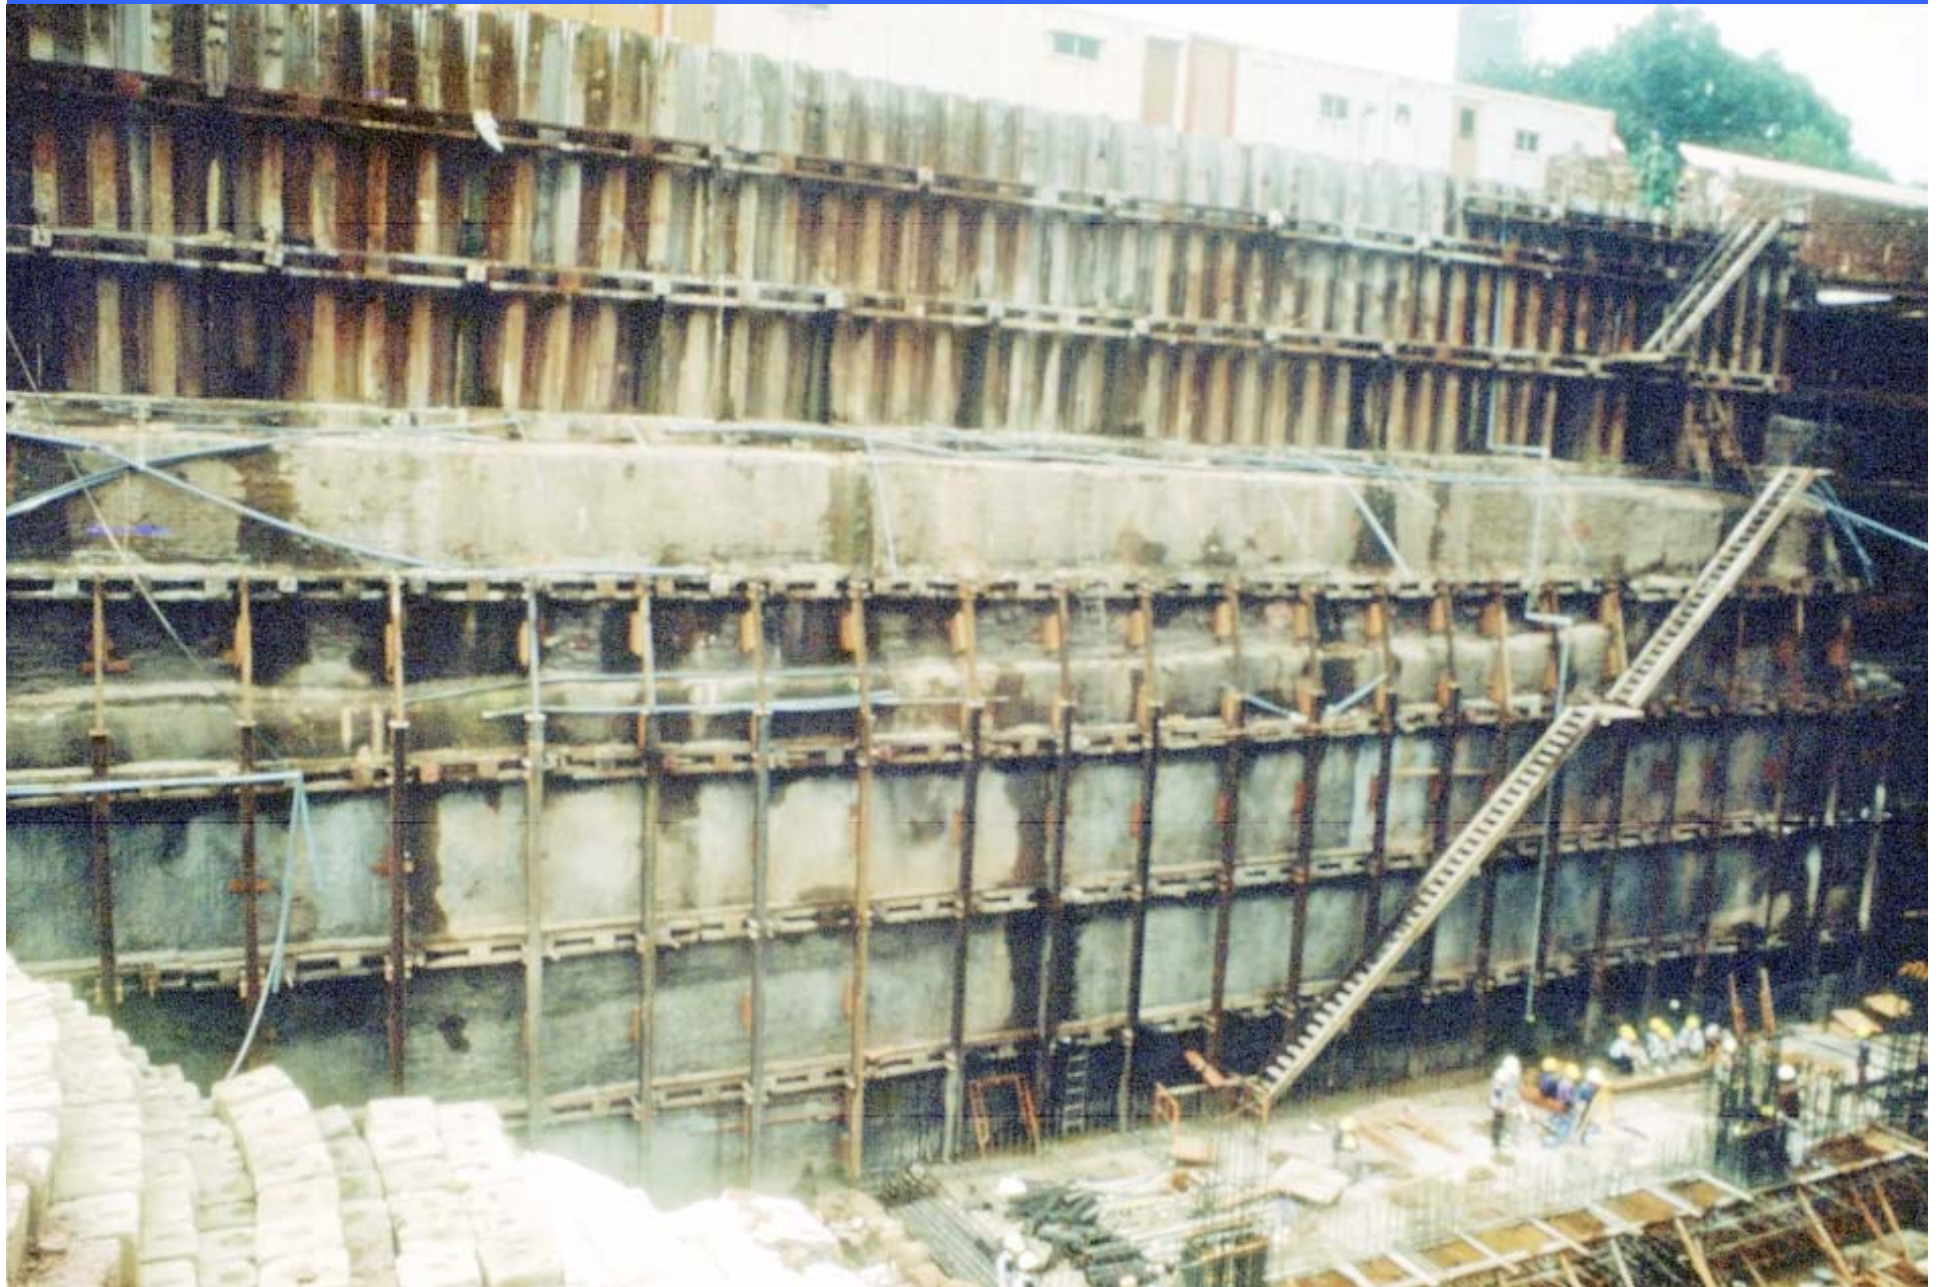
- **City Hall Station, Singapore MRT**
  - Two level soil profile
    - ◆ Anchored sheet piles at upper level
    - ◆ Anchored pads at lower level
  - Anchors failed on Whit Sunday 1985
  - Backfill to stabilise
  - Dewatering surface sands
  - Contiguous pile wall through backfill
  - Anchors with vertical and horizontal walings

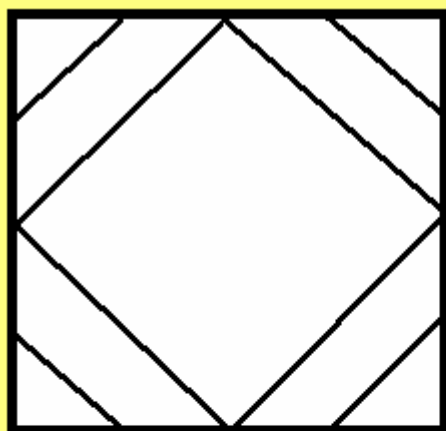
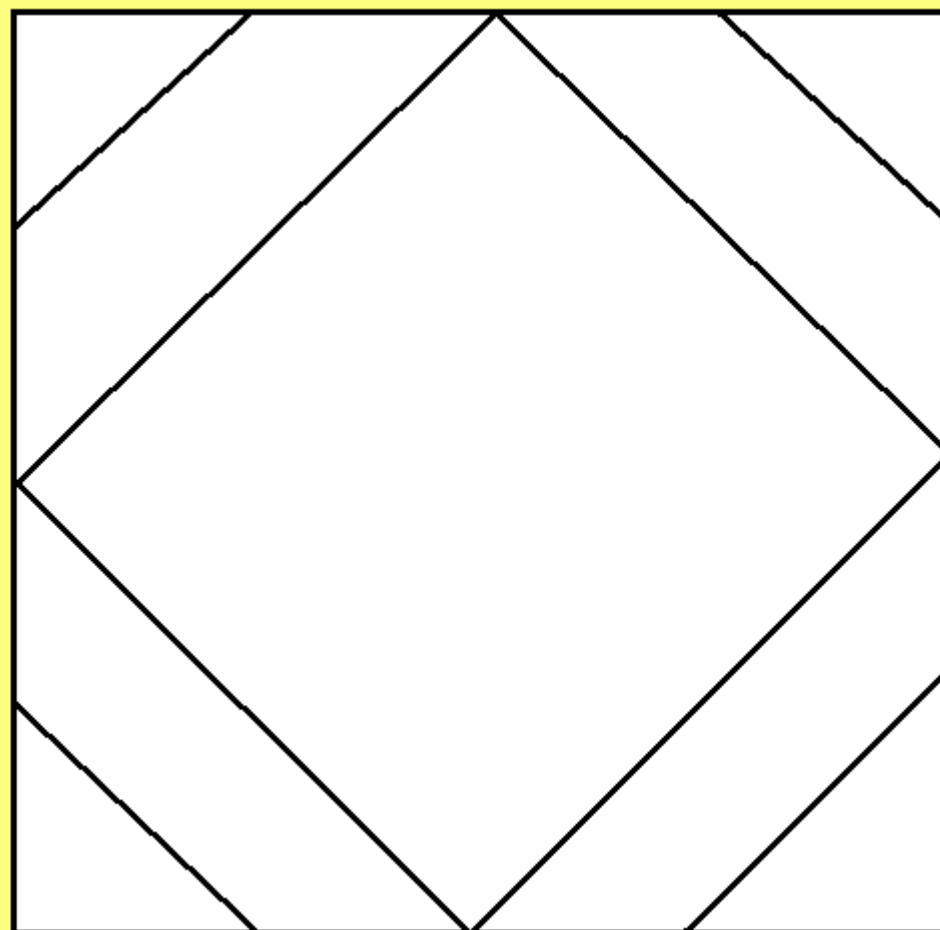
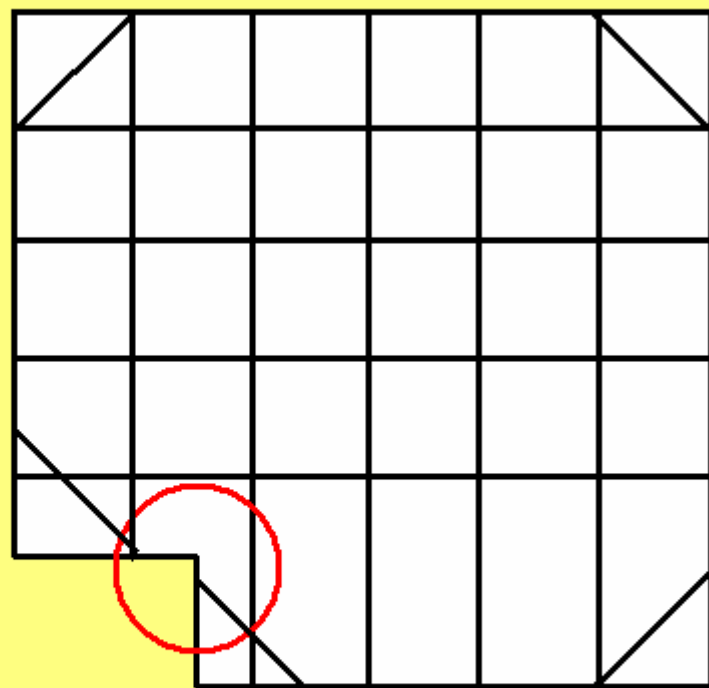
- **Failure of sheet piled cofferdam in Bangkok**
  - Extrapolation of strutting system from small rectangles to large excavation
  - Reentrant corners

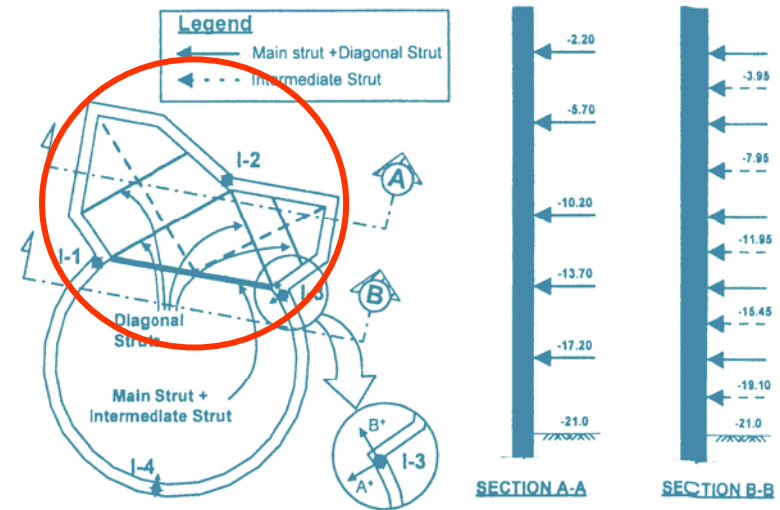
Figure 2. Temporary bracing system (Initial design)

- Inlet Pumping Station
- Collapse of diaphragm walled shaft on 17 August 1997
- Difficult, restricted site
- Circular PS shaft and “rectangular” inlet/bypass chamber
- Poor strut detail
- Poor strutting installation
- Lack of monitoring

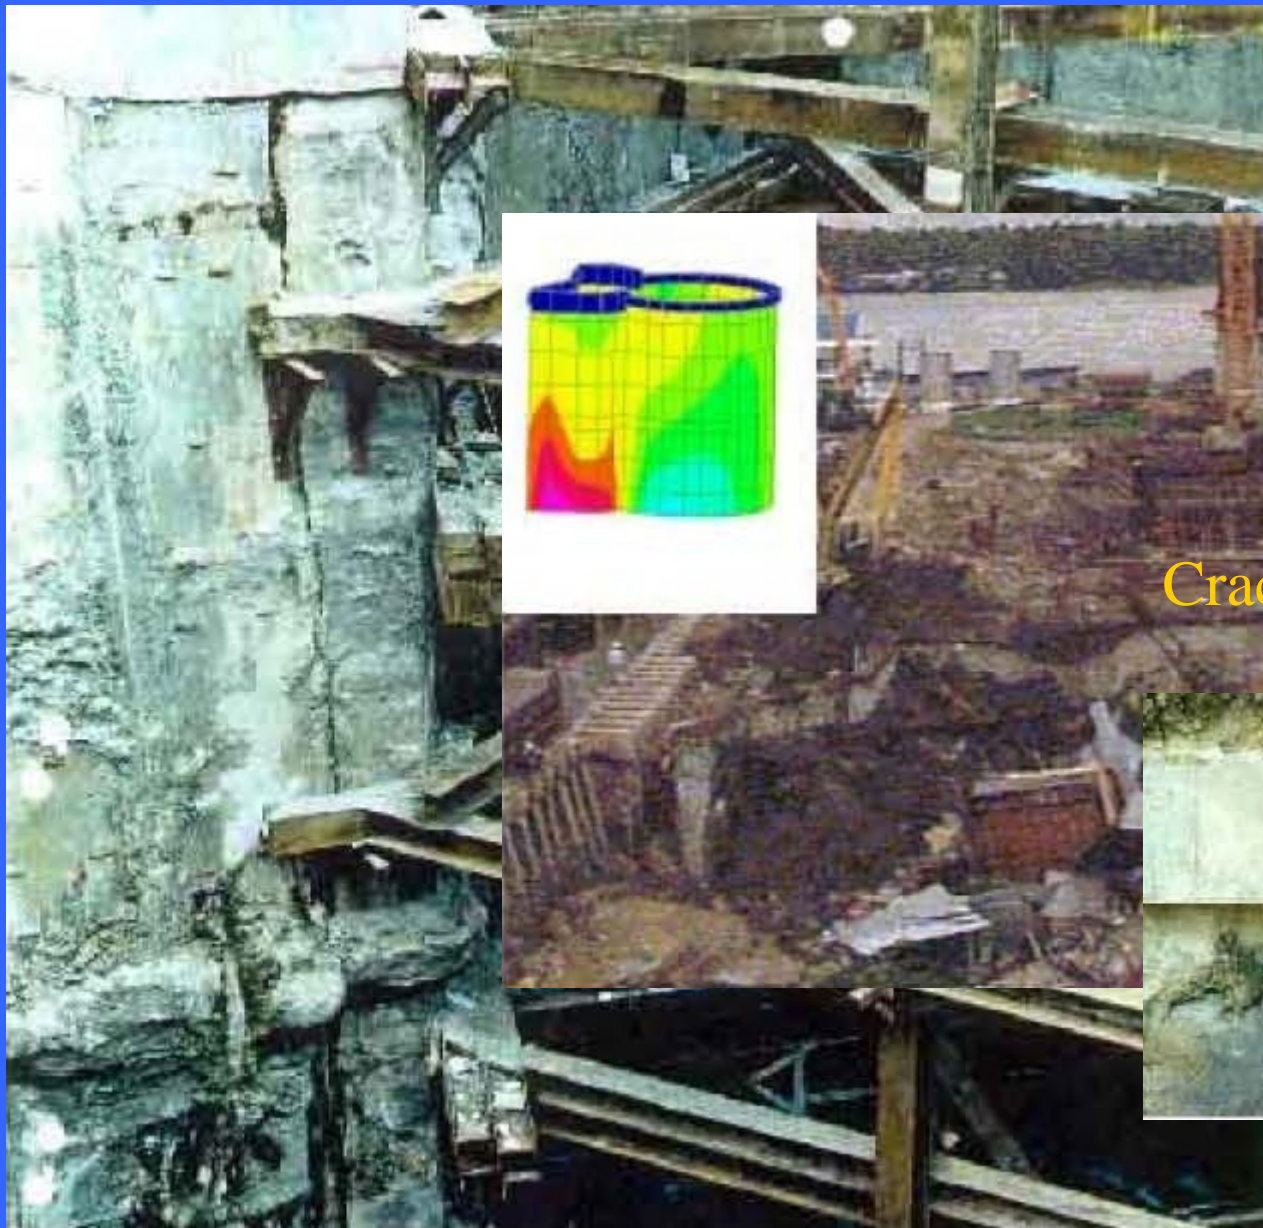
Cracks in capping beam
