# Deep excavations

## ■ Collapse at Lok Fu Station, HKMTRC

- Collapse of Nicoll Highway on 20<sup>th</sup> April 2004, caused by incident at MRT Circle Line Worksite
  - Contract 824 included
    - ◆ NCH Station, 3-level underground 327 m long
    - ◆ BLV Station, 3-level partly underground 246 m long
    - ◆ 800 m of twin bored tunnels
    - ◆ 2 km of cut-and-cover tunnels, mainly in soft marine clay

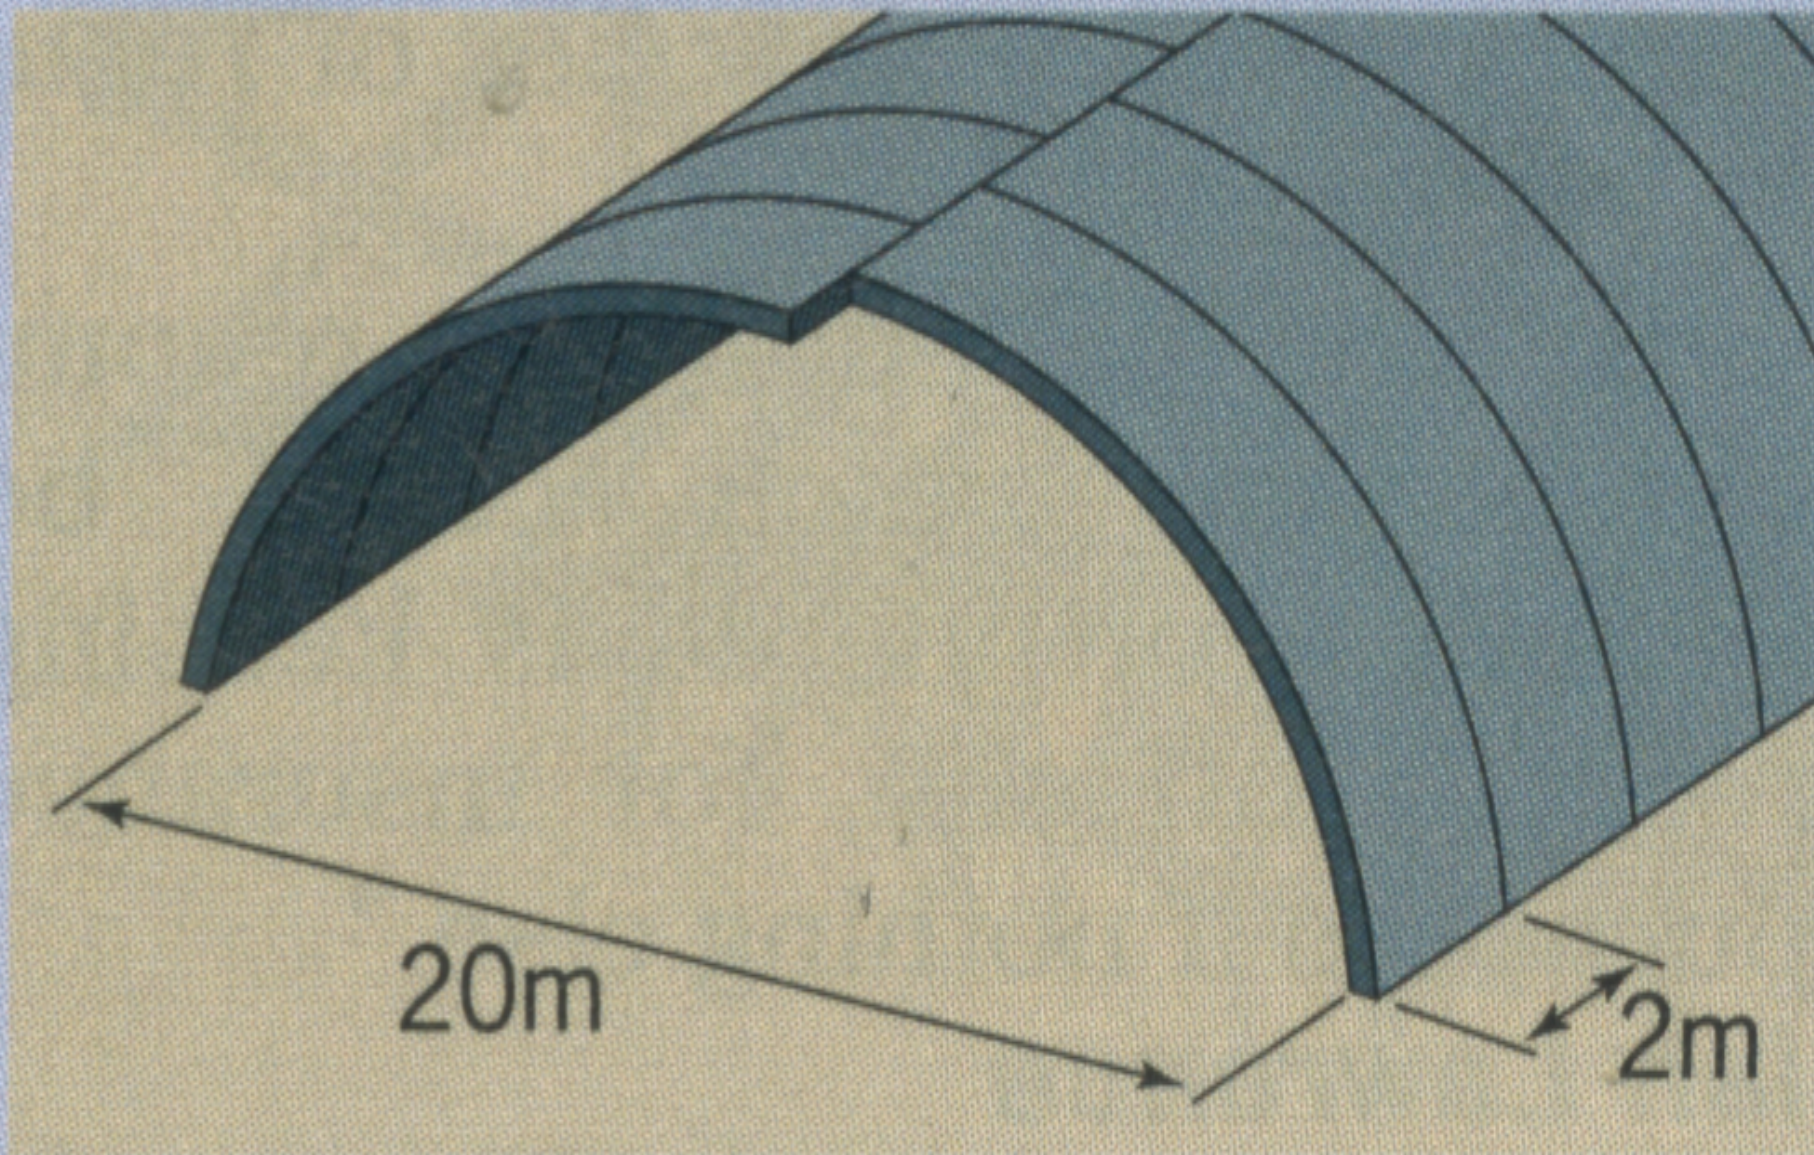
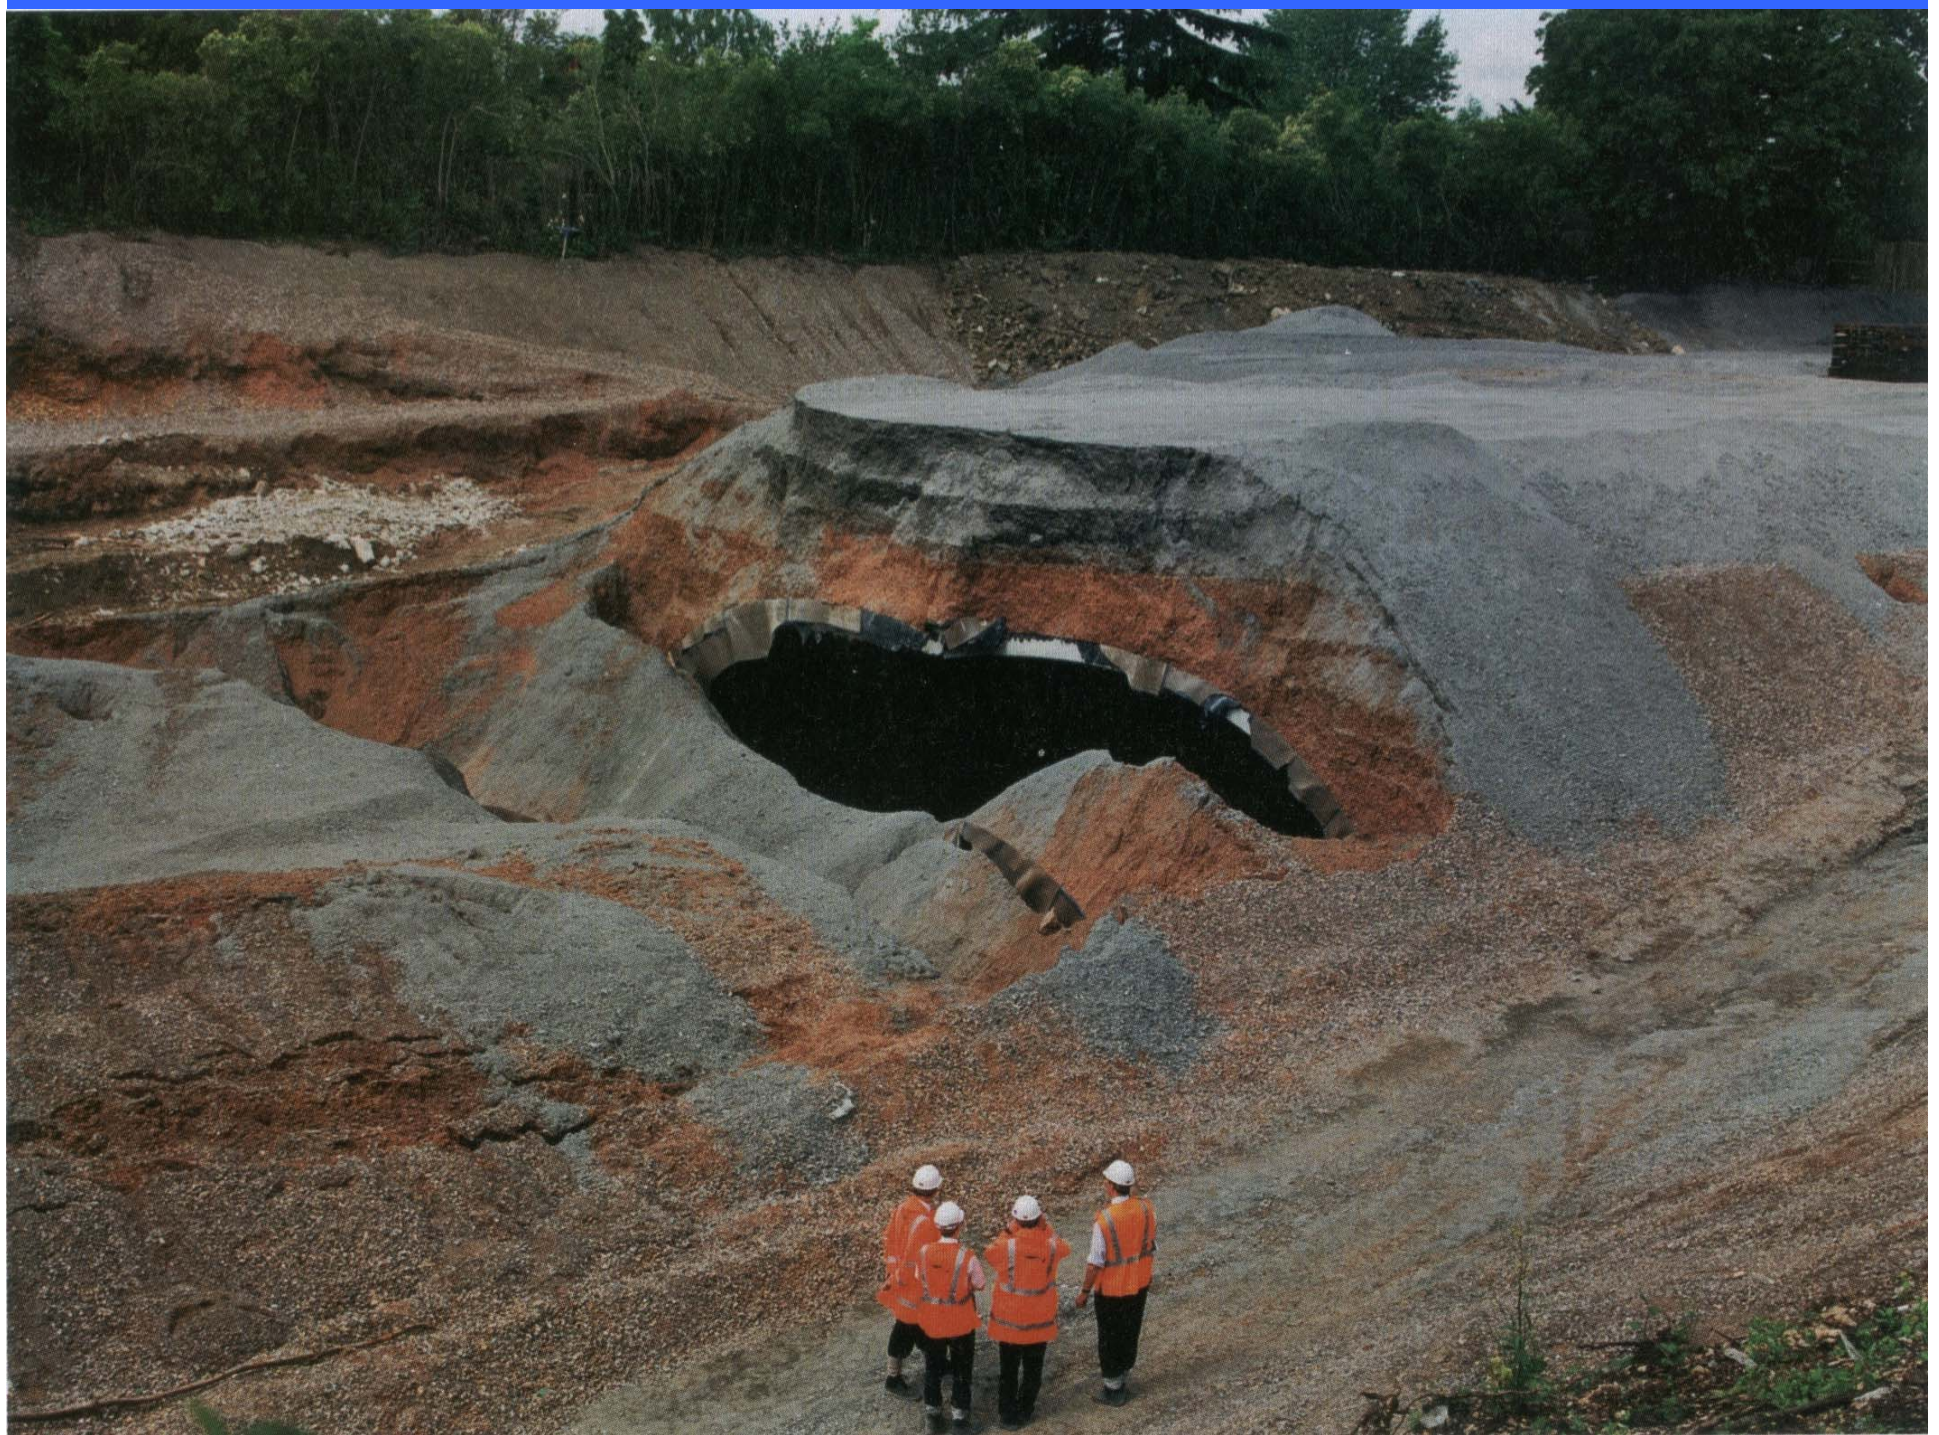
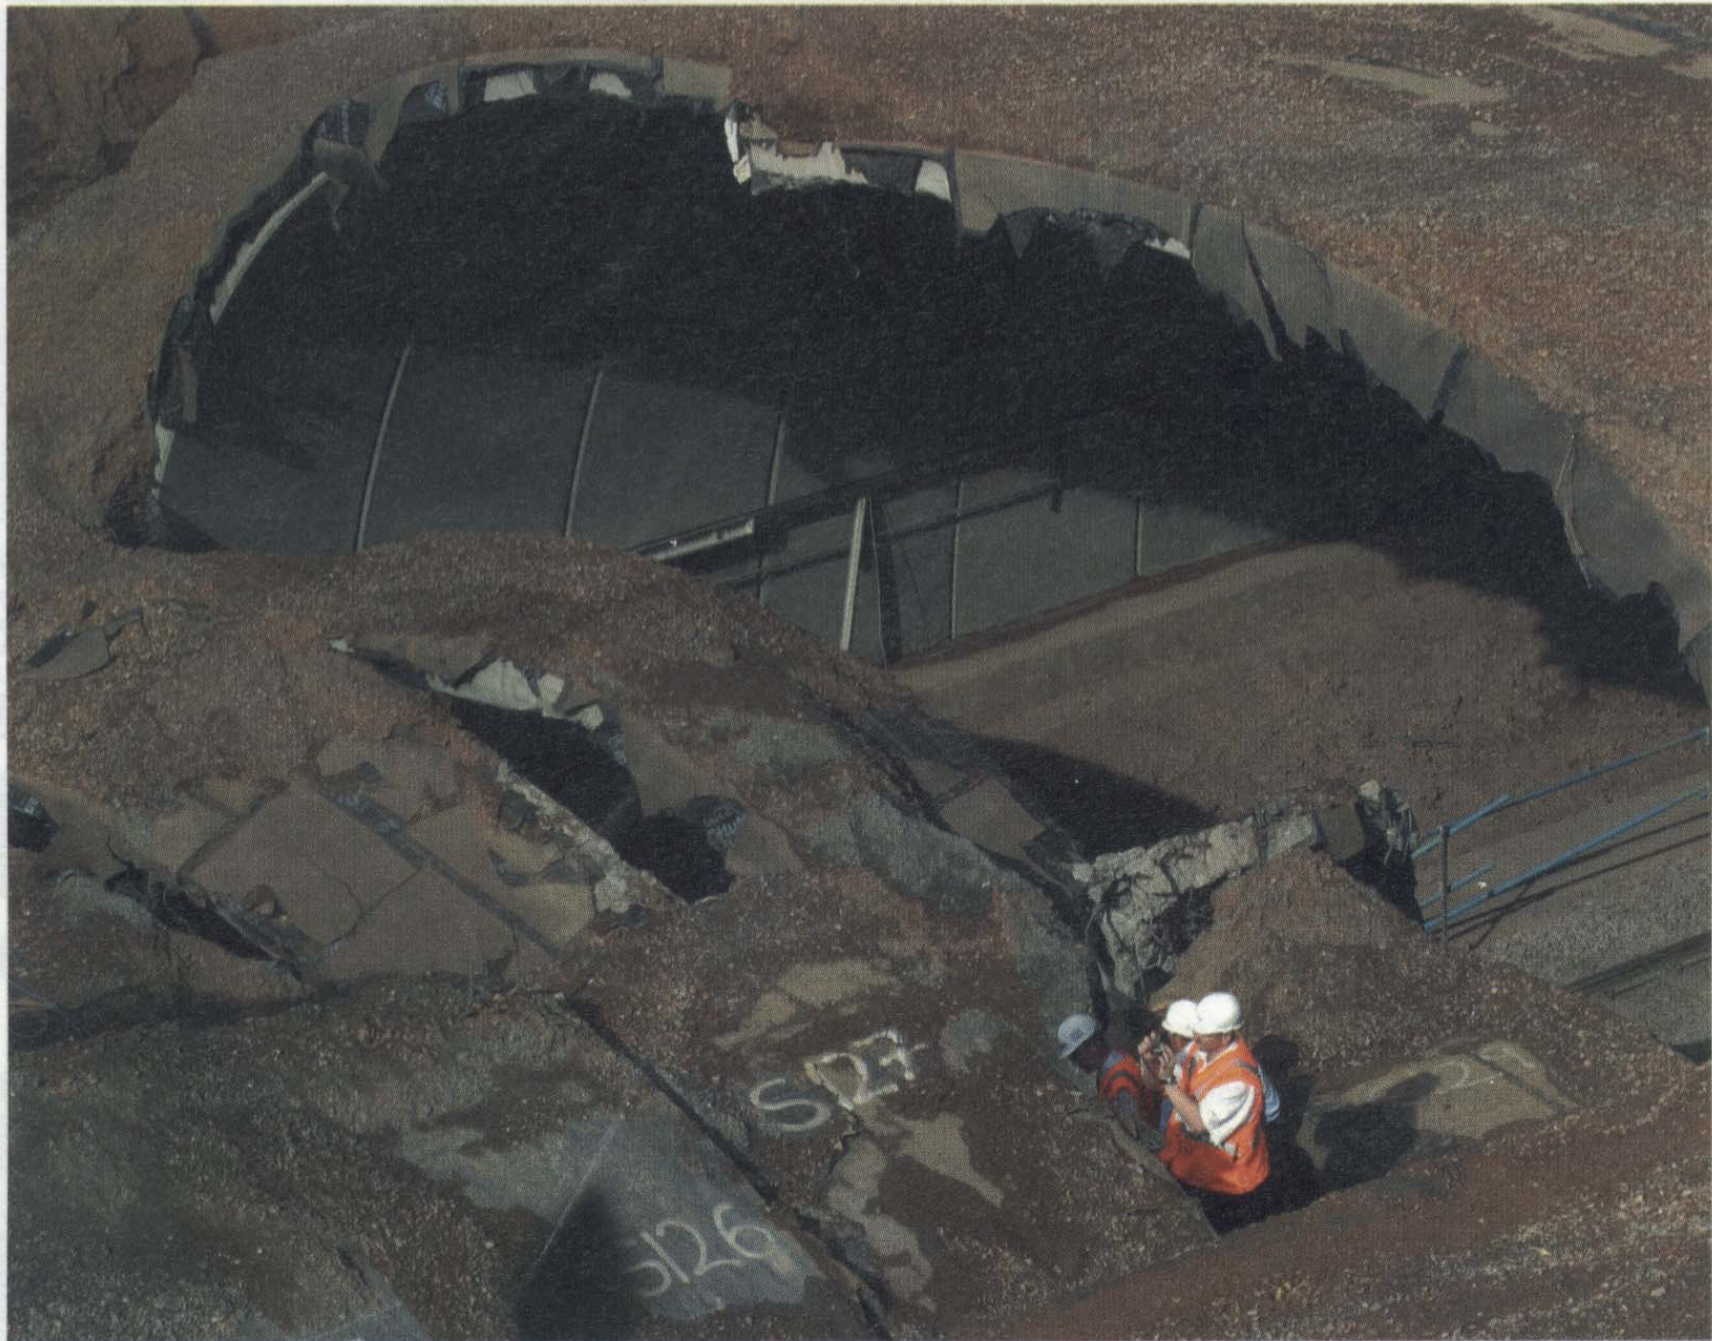
- **Collapse of cut and cover tunnel at Gerrards Cross, UK**
  - Existing railway line in cutting
  - Land being reclaimed for Tesco superstore
  - Precast “pinned” arches built on piled ground beams
  - Backfill over
  - Collapsed on 30 June 2005 at 7:30pm – no injuries

**The collapse happened because not enough fill had been placed to the sides of the tunnel before material was placed on the crown.**

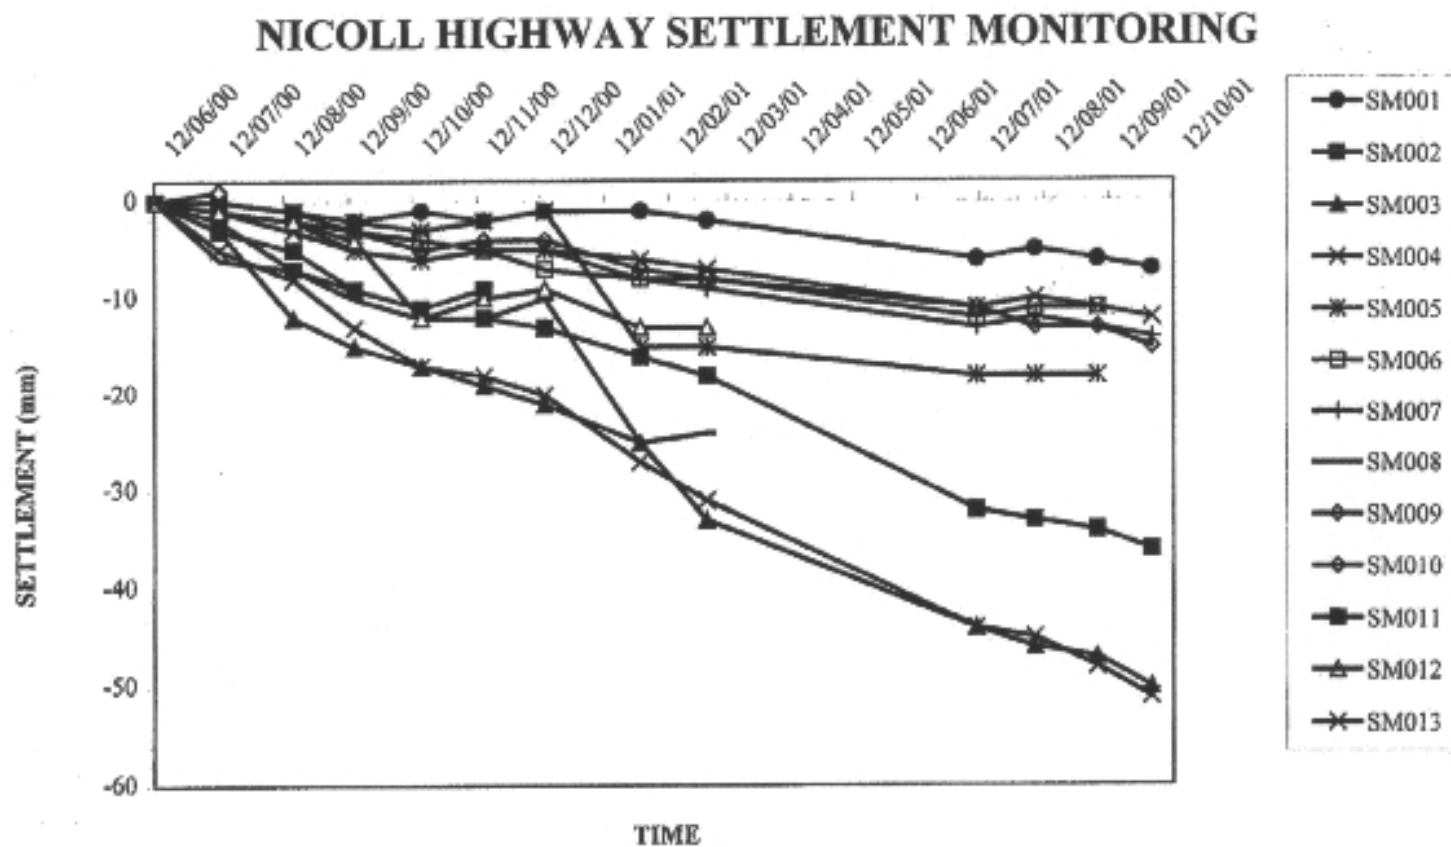
**Figure 2.13**

Settlement monitoring data in the C824 area from June 2000 to December 2001.

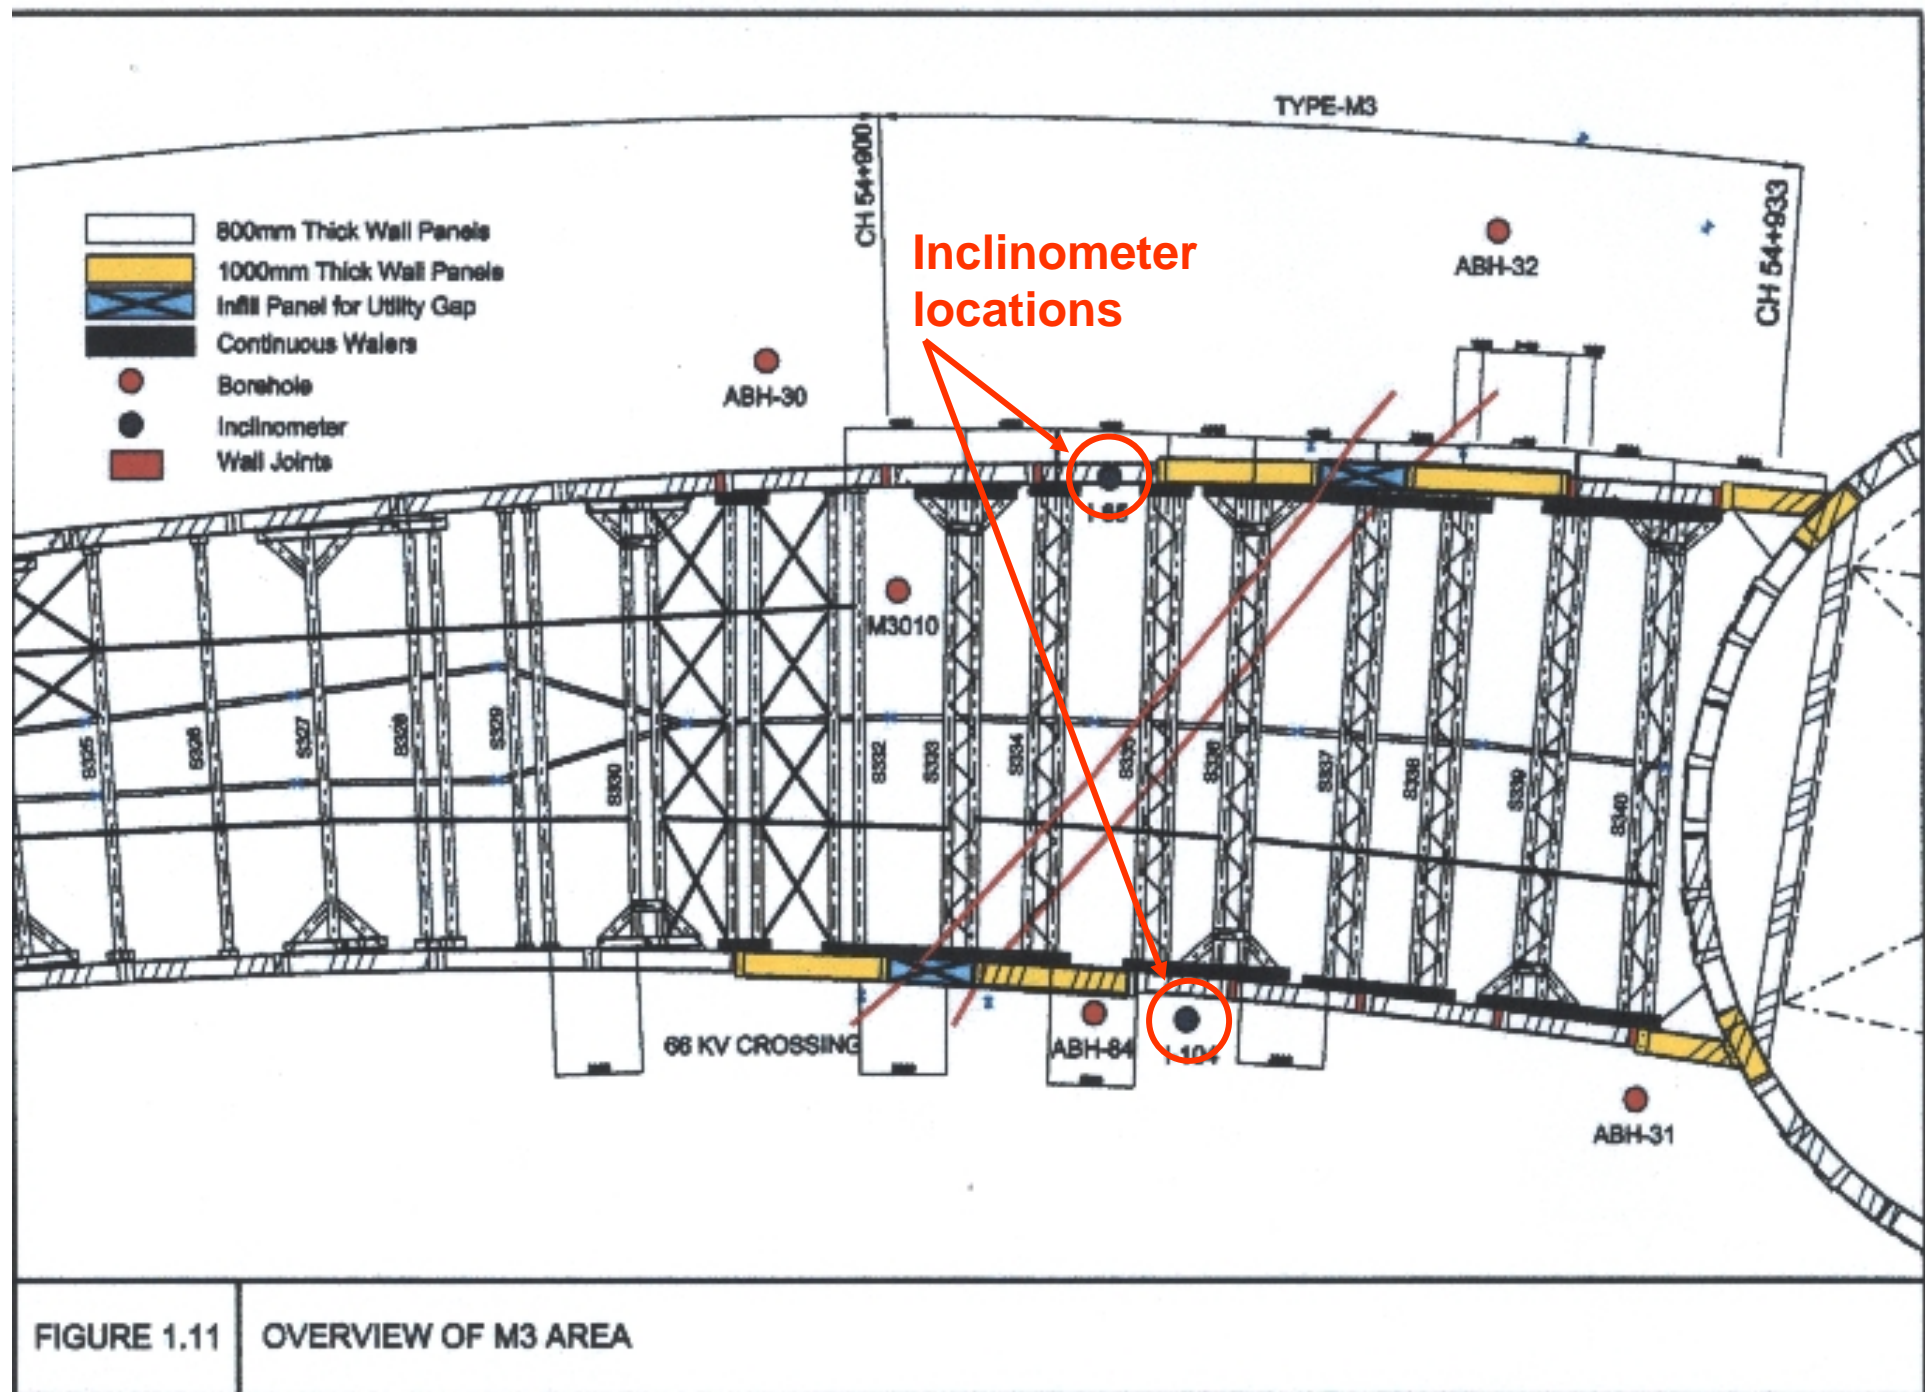
Circle Line C824  
Soil Inclinator (IS-104)

*(taken between the period between Oct 2003 to Apr 2004)*

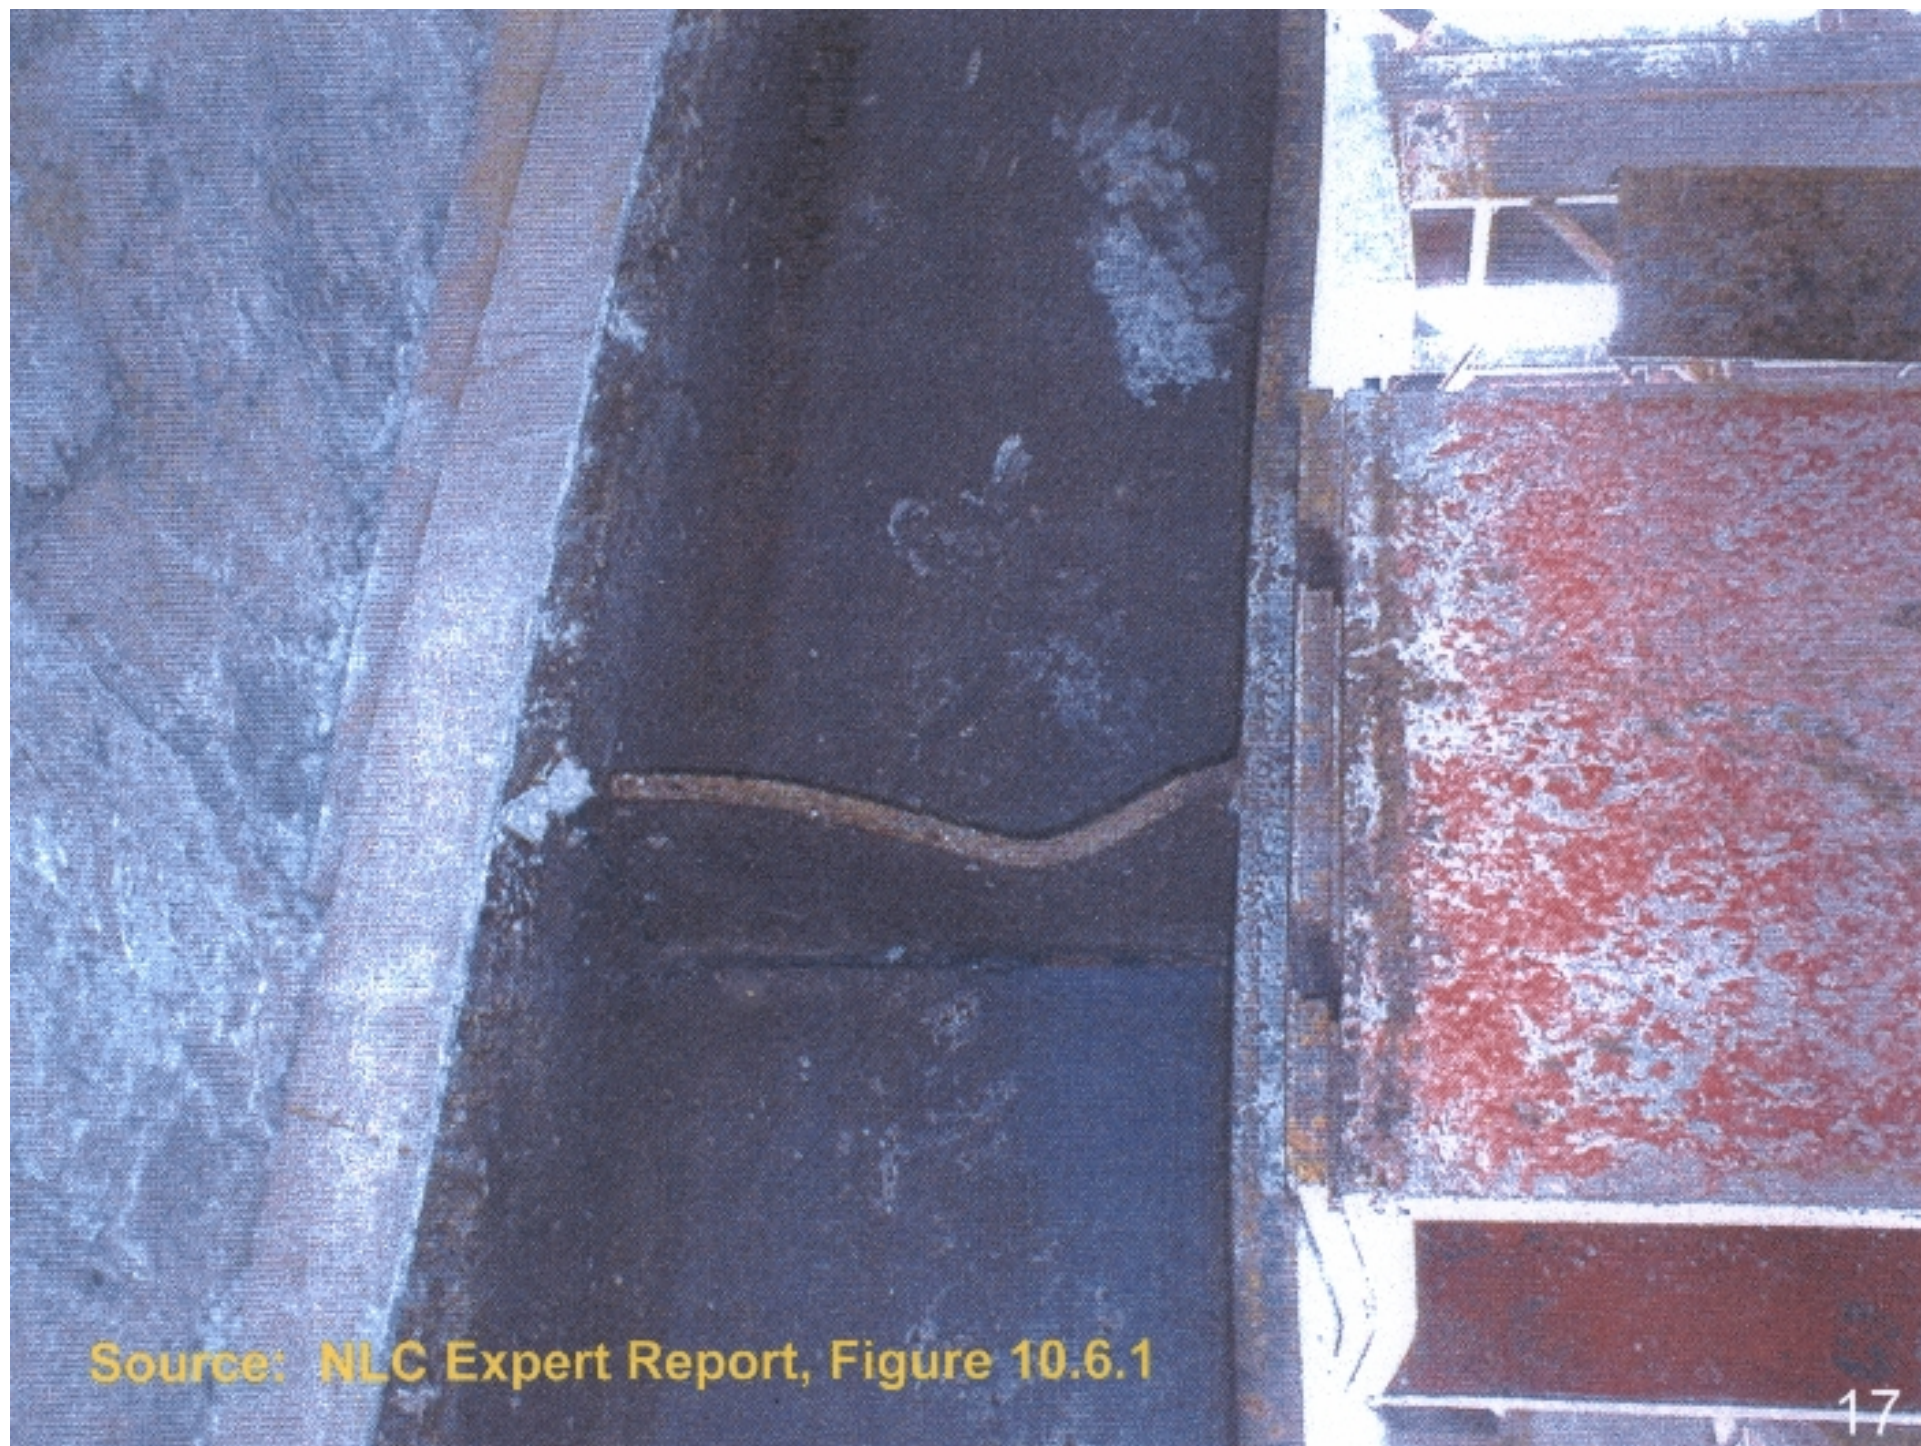
Source: NLC Expert Report, Figure 10.6.1

The Commission of Inquiry found two “root” causes:

- **Under-design of the diaphragm wall**
  - Related to FE analysis using Plaxis and failure to understand soil model
- **Under-design of the strut/waler connections at the 9<sup>th</sup> level**

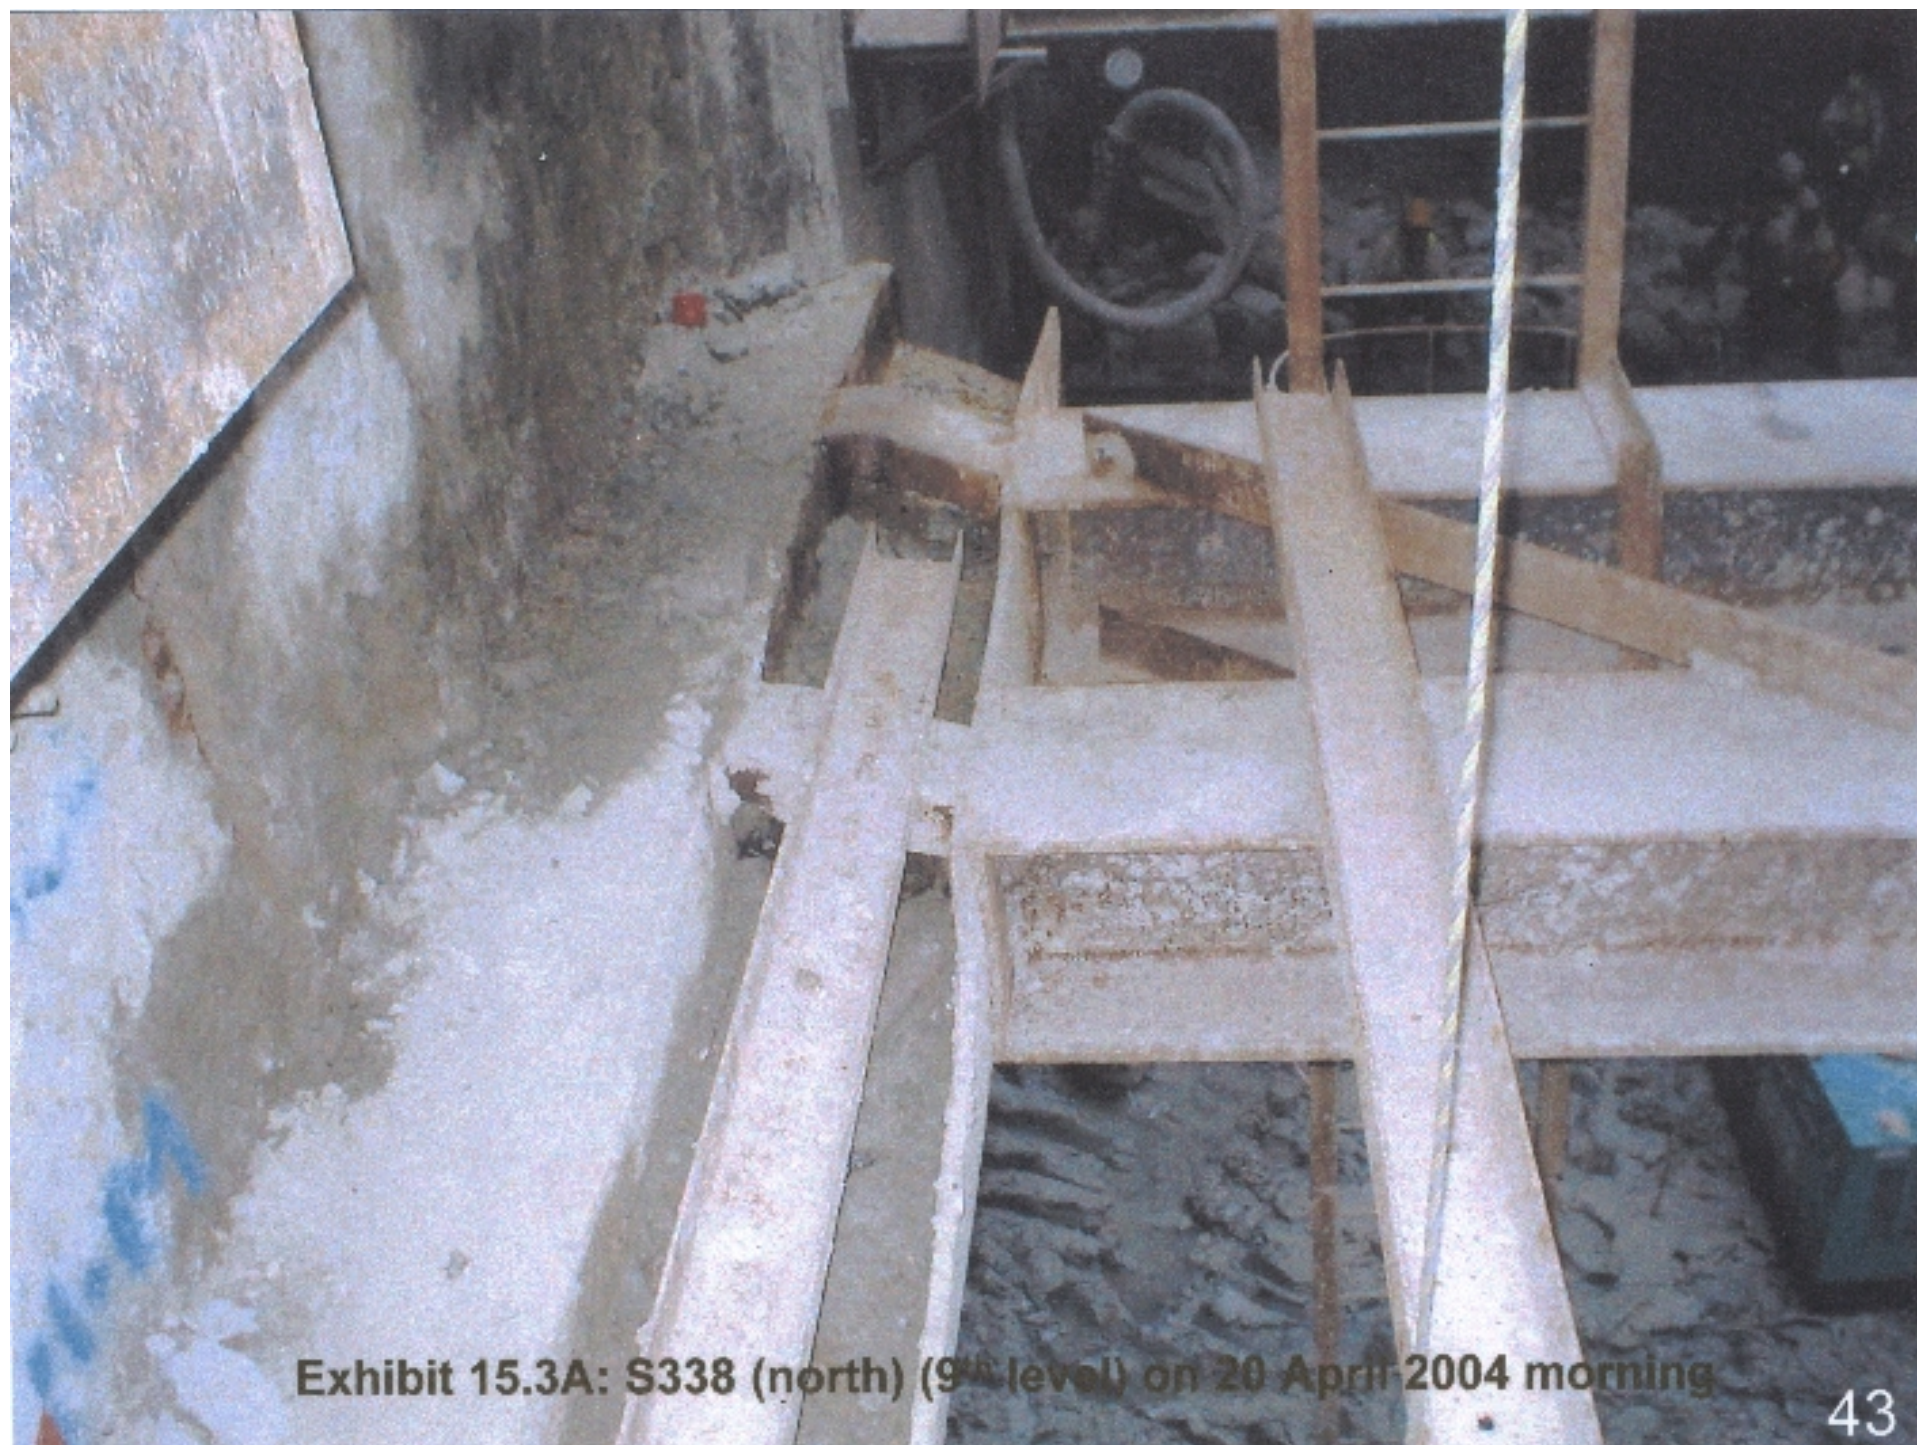
Exhibit 15.3A: S338 (north) (9<sup>th</sup> level) on 20 April 2004 morning

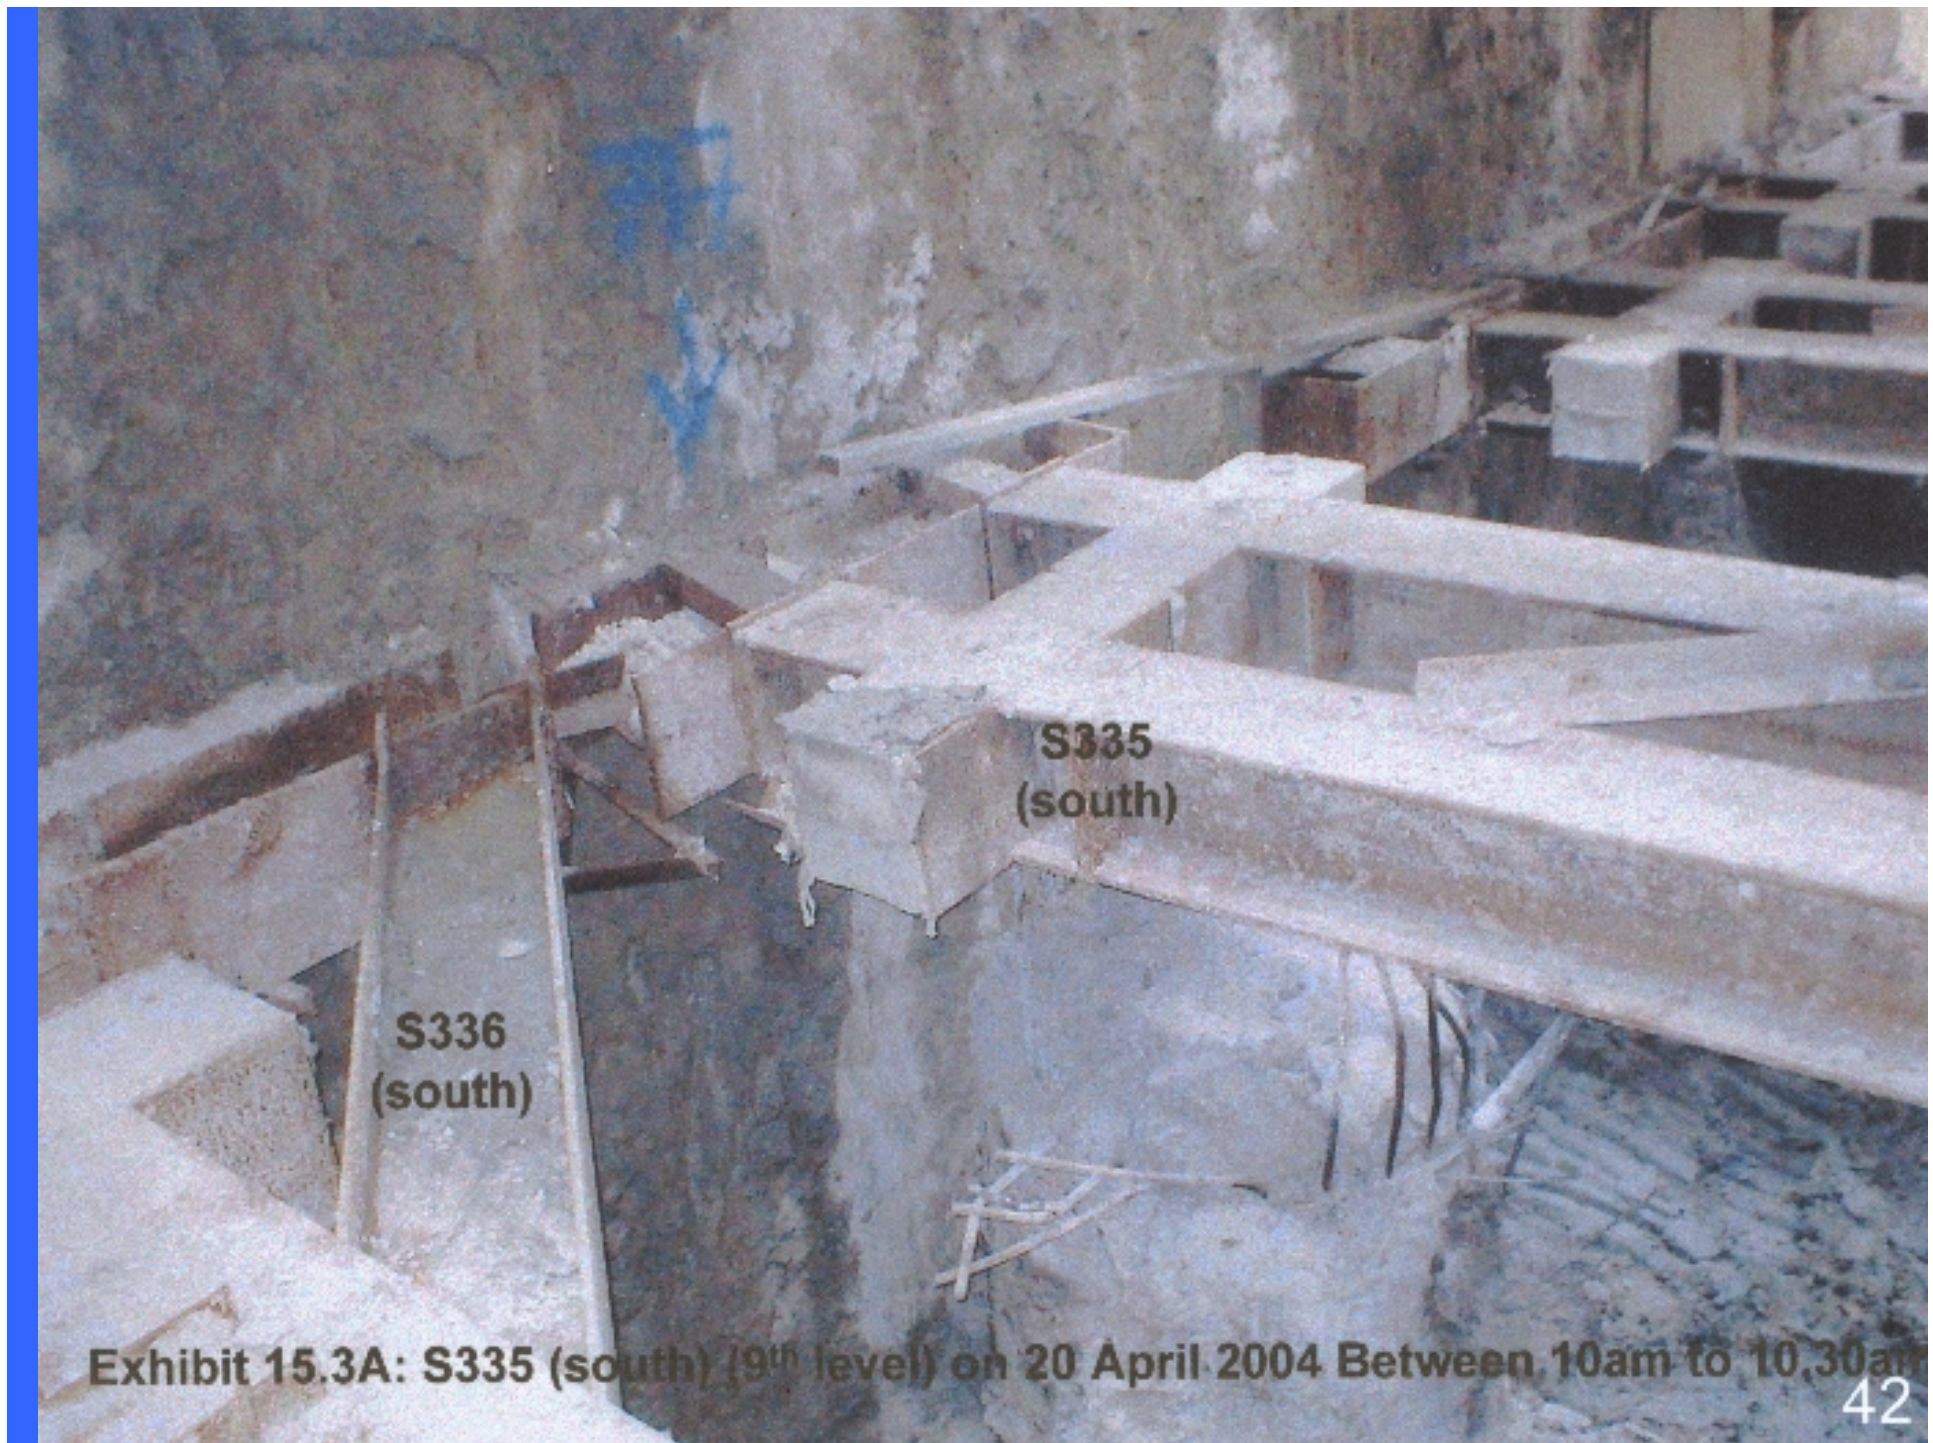
**Exhibit 15.3A: S335 (south) (9<sup>th</sup> level) on 20 April 2004 Between 10am to 10.30am**
