# Deflection Behaviour of GFRP Bar Reinforced Concrete Passive Bored Pile in Deep Excavation Construction

**ABSTRACT:** This paper describes the investigation of a glass fibre reinforced polymer bar (GFRP bar) as a replacement for a traditional steel bar reinforcement in bored concrete piles with specific application to deep excavation construction. These two concrete passive piles were cast and experiments were conducted with reference to soil excavation. Normally, the point load which is applied to the pile head is provided by static lateral load test equipment for determining the pile behaviour; however, these two piles suffered from changed earth pressure during excavation. The amount and location of horizontal movement was monitored along the pile length by an inclinometer system which contained a PVC tube and a readout probe. The deflection behaviours of GFRP piles during the installation of one concrete and two steel supports were provided. It is concluded that, based on the difference between the total accumulated deflection of each pile, the GFRP bar reinforced concrete piles can resist the lateral loading and can provide an alternative to traditionally reinforced concret

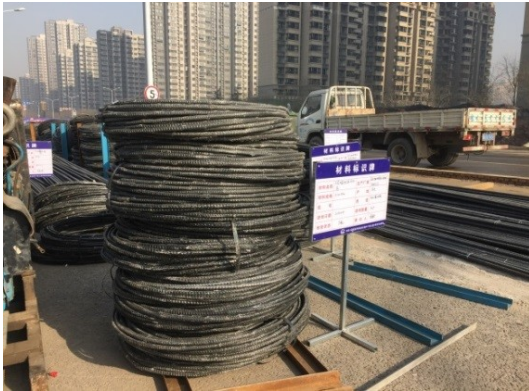
Figure 4 GFRP Stirrups of Piles

The manufacture process of GFRP bar reinforced concrete piles and steel bar reinforced concrete piles was driving holes, assembling reinforcement, and transferring into the holes and casting. The monitored piles which suffered from lateral loading were GFRP bar and steel bar reinforced concrete piles, respectively. These two bored piles were all designed to be 22m long with pile diameters of 700mm. The GFRP stirrups were 10mm in diameter with spacing of 150mm (Figure 4); the longitudinal reinforcement was 26 GFRP bars with diameters of 28mm (Figure 5). The ultimate tensile strength of the GFRP bar was over 500MPa and the designed grade of the concrete was C30. Based on the Chinese Concrete Code GB50010-2010, the cubic compression strength of C30 was 30MPa (dimensions of the cubic concrete sample are 150mm×150mm×150mm). The GFRP cage is assembled as shown in Figure 6.

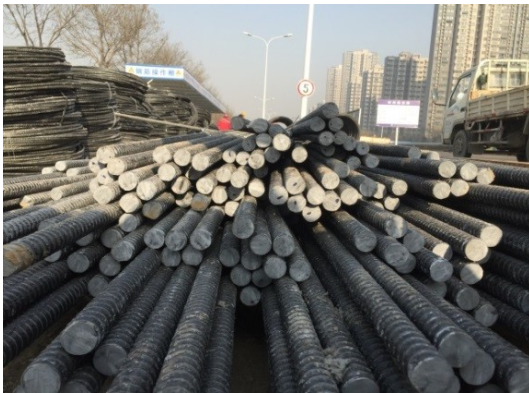
Figure 5 GFRP Reinforcements of Piles

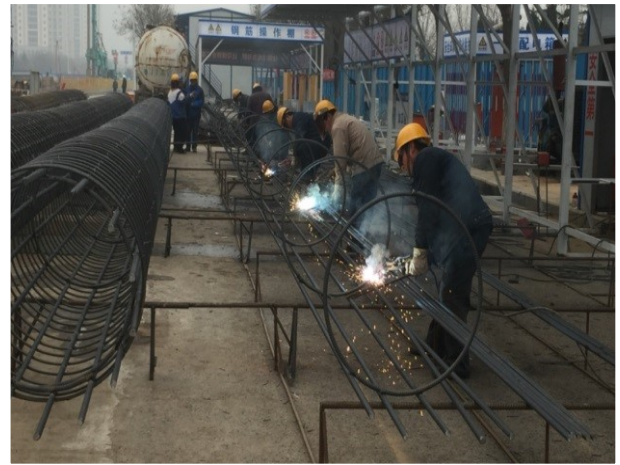
Figure 7 Assembled Steel Cage of Pile

The traditionally steel reinforced concrete pile was also made of C30 concrete, the stirrups were 16mm diameter HPB300 (Hot Rolled Plain Bar) bars with spacing of 150mm and the horizontal reinforcement was 26 HRB400 (Hot Rolled Ribbed Bar) bars with diameters of 28mm. The ultimate tensile strength of the concrete was 30MPa, and the yield strength of HPB300 and HRB400 were 300MPa and 400Mpa, respectively. The steel cages were welded and the finished steel cages can be seen on the left-hand side of Figure 7. The parameters of GFRP and steel reinforcement are summarized in Table 3.

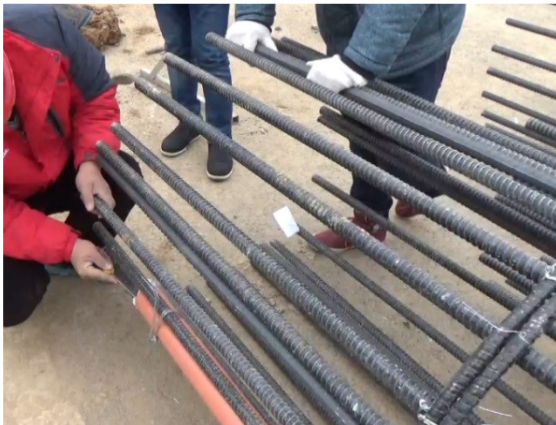
Figure 8 PVC Tube on GFRP Cage

The measurement system for determining the lateral deflection was plastic PVC tubes and a readout probe. The internal diameter of the PVC tube was 75mm with 4 grooves cut at 90 degree intervals. Figures 8 and 9 illustrate the installation of PVC tubes on GFRP cages and steel cages, respectively. The readout probe that fits into the grooves is shown in Figure 10.

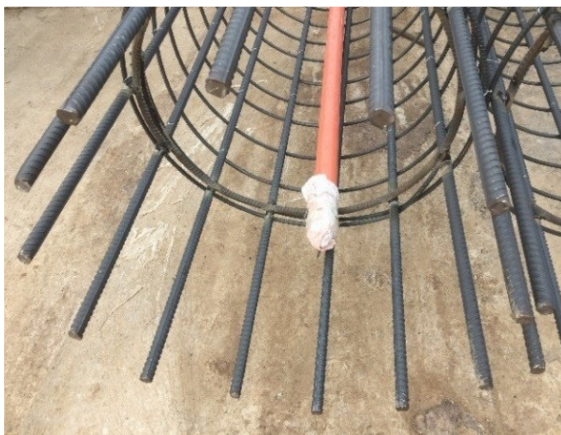
Figure 9 PVC Tube on Steel Cage

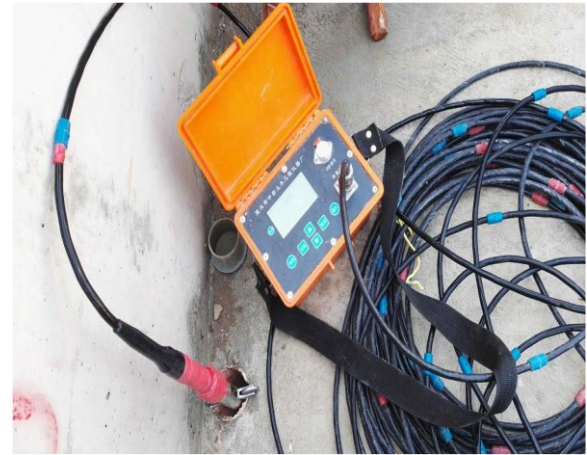
Figure 10 Readout Probe for Deflection Measurement of Pile

The amount and location of horizontal movement in a deep foundation can be determined through lowering down the readout probe into the bottom of PVC tube and pulling it upwards. During system installation, the top of the PVC was covered by a cap to avoid

The readout probe was firstly lowered down to the bottom of the PVC tube and lifted up 0.5m after recording the initial data of  $A_0$  (the data are labelled as  $A_1, A_2, A_3 \dots A_j$ ). Once reaching the pile head, the probe was rotated and lowered down again, and then pulled up again to record the data of  $B_{180}$ , which represents the data after the rotation of 180 degrees (the data are labelled as  $B_1, B_2, B_3 \dots B_j$ ).

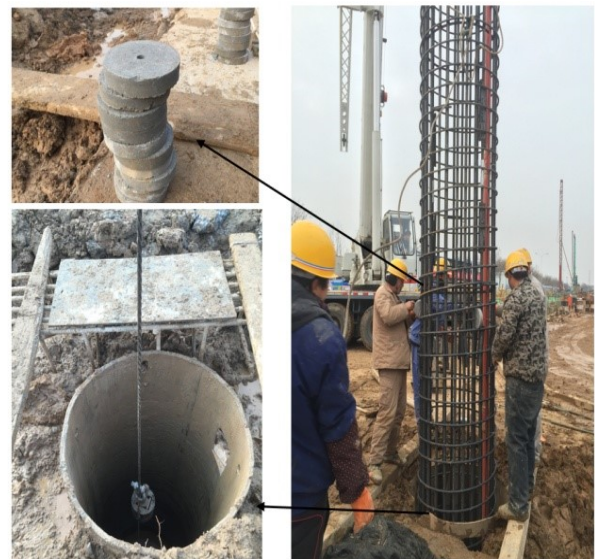
Figure 11 Installation of Steel Reinforced Concrete Pile

After the reinforcement cages were assembled and the PVC tubes were installed, the cages were then transferred to the required location. The cage of each pile was lifted by two cranes and was then transferred into the guide slot. In order to make sure the concrete cover met the requirements, concrete cushion blocks were used with spacing of 2m. Figure 11 shows the installation of the steel reinforced concrete bored passive pile. After the installation of the GFRP and steel reinforcements, the fresh concrete was poured into the holes.

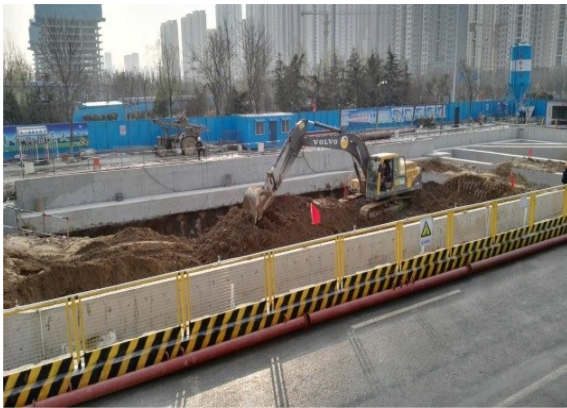
Figure 12 Excavation after First Concrete Support was installed

The concrete supports were cast before excavation. As shown in Figure 12, the excavator dug out soil after the concrete support was cured (cured date: 18-03-2016). It was believed that there was no lateral displacement of the pile at this stage since the earth pressure was relatively small during the first excavation. However, there were three excavators, which created extra pressure to push the pile head outside the excavation site.

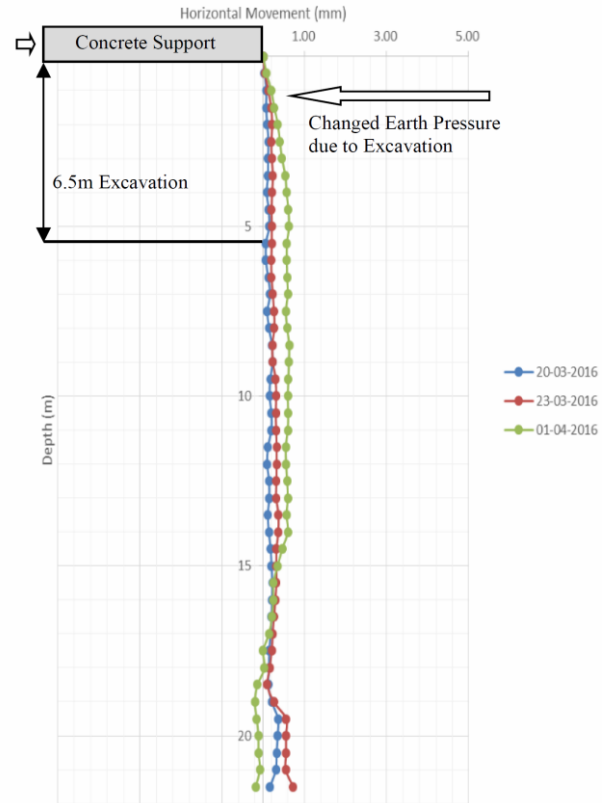
Figure 13 Deflection of CFRP Pile at the beginning of Excavation

Under the assumption of 0 movements of the pile head, the accumulated displacement values were overestimated by calculation especially from the pile bottom. As shown in Figure 13, the data shows that, during the five days of excavation from 18-03-2016 to 23-03-2016, lateral deflection was detected within +0.4mm from the pile head (error due to equipment or effect by the excavators), and the accumulated lateral deflection was +0.73mm at the bottom of pile, which is calculated by adding error values from the pile top.

As the excavation kept going, the earth pressure started to increase, which meant that the data could be captured by the equipment accurately. As shown in Figure 13, after 01-04-2016, the recorded data could be trusted because negative value occurred, which represented that the earth pressure had pushed the pile to the excavation pit.

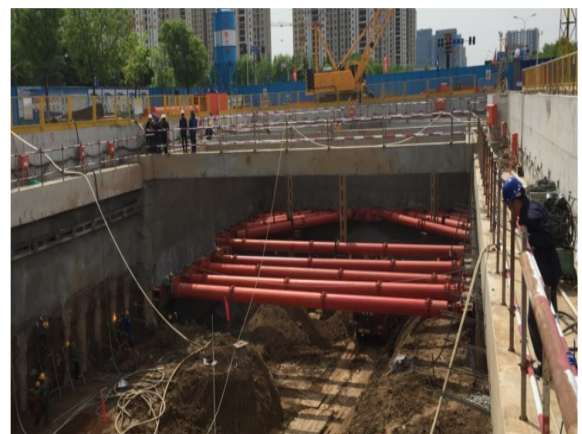
Figure 14 First Steel Support Applications

The first and second steel supports were installed on 22-04-2016 and 27-05-2016, respectively as shown in Figures 14 and 15. After these three supports were installed, the deflection behaviours of the GFRP reinforced concrete pile were recorded as shown in Figure 16 (a) with labels a, b, and c representing the collected data after installation of the three types of supports. As demonstrated in Figure 16 (b), during 26 days of continuous data collection, the horizontal movement remained stable.

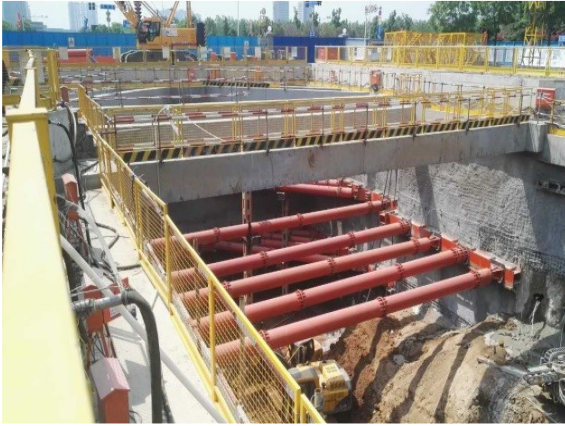
Figure 15 Second Steel Support Applications

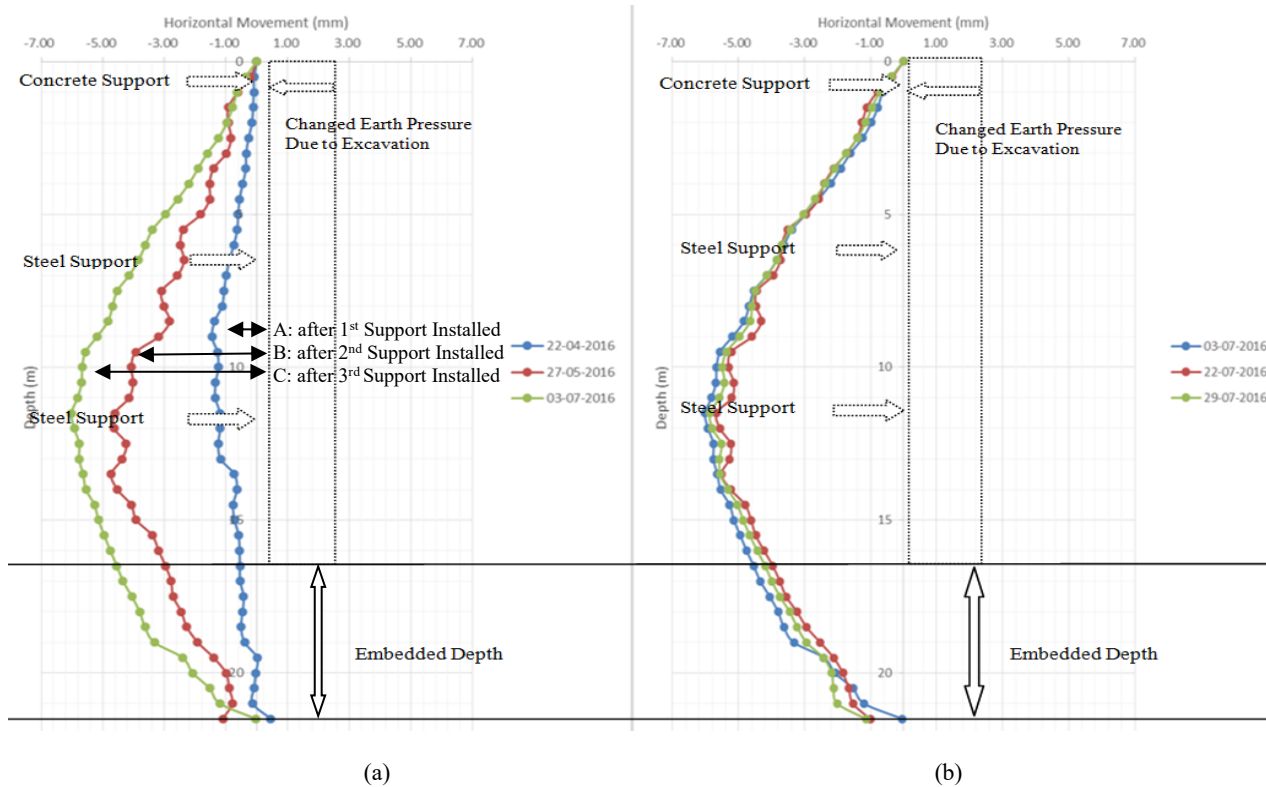
Figure 16 (a) Lateral Deflection of GFRP Pile during 3 Stages; (b) Total Horizontal Deflection of FRP Pile

Through analysis of the data obtained from the inclinometer (Figure 16, (a)), it was detected that lateral deflection of FRP reinforced concrete pile was increasing as excavation depth was

increasing. It was detected that the maximum horizontal deflection was -1.5mm at the depth of 13m when the second support was installed (the first steel support). After the first and second steel supports were installed, the maximum deflections were discovered at the depth of 12.5m and 13m, with values of -4.7mm and -5.8mm, respectively. Additionally, after the last steel support was installed, the data collection kept going on. The deflection became stable after 03-07-2016 (Figure 15(b)). It was also detected that the horizontal movement of the pile toe was stable at the value of -1.1mm, which led to the heave in the excavation pit (also discovered by total station). This phenomenon proves the correct assumption of 0 movement from the pile head.

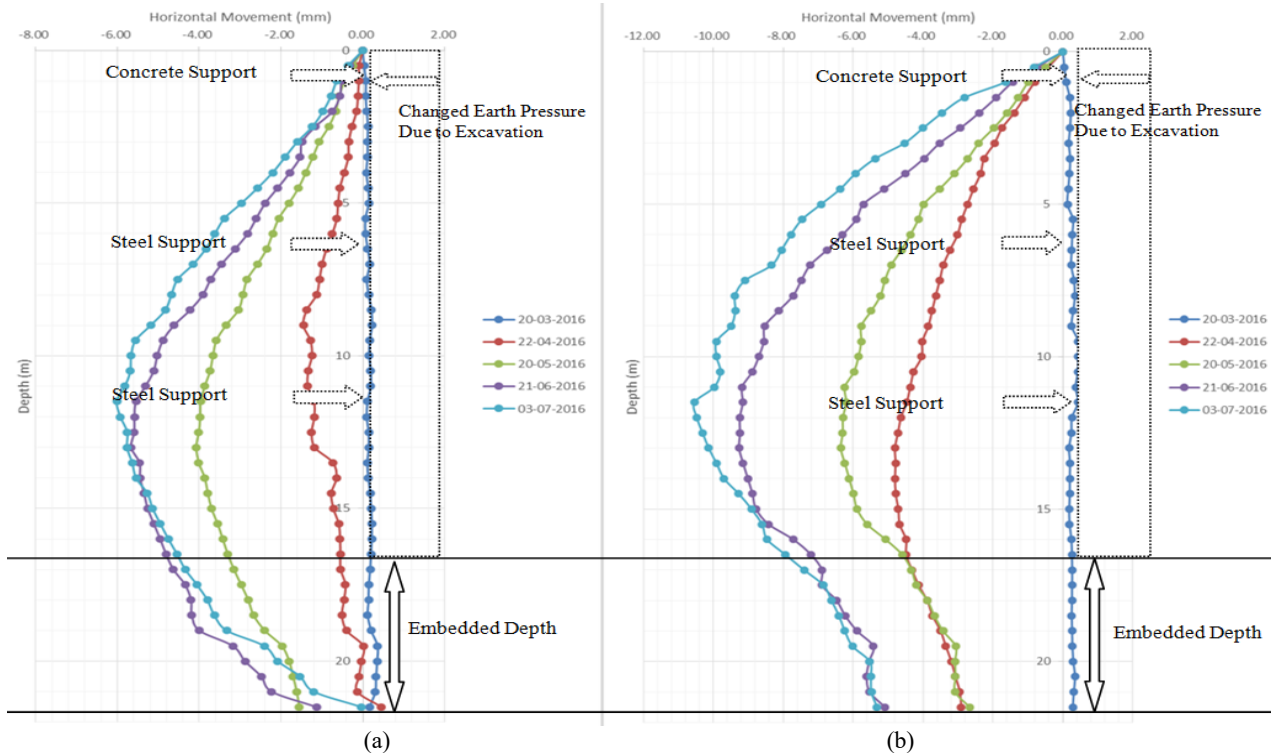
Figure 17 Deflection of GFRP Bar (a) and Steel Bar (b) Reinforced Concrete Bored Piles

Simultaneously, the steel reinforced concrete pile was also monitored. After approximately 15 weeks of monitoring, the lateral deflection data of the traditional steel reinforced concrete pile obtained from the inclinometer system demonstrated that, after the concrete support and two steel supports were installed, the maximum lateral deflections were -4.70mm (at the depth of 12.5m), -7.95mm (at the depth of 12.5m) and -10.56mm (at the depth of 12.5m), respectively as shown in Figure 17. Comparatively, the deflection behaviour of these two piles is summarized in Table 4.

Analysis of the lateral displacement diagrams of the piles evidences that the deflection is increasing along the pile length with no turning point. It can then be concluded that the concrete and steel supports made little contribution and the project is, therefore, over-designed. Lateral deflection tests between GFRP reinforced concrete piles and steel reinforced concrete piles were conducted and the installation procedure of piles was provided. The GFRP composite pile demonstrated maximum lateral deflection of -6.02mm at the depth of -10.56m and the maximum lateral deflection of steel reinforced concrete bored pile was -9.02mm at the depth of 13.5m.
