ERT-Based Leakage Tracing for Dam Safety and its Potential Sliding Surface

ABSTRACT: Electrical resistivity tomography (ERT) has been efficiently applied to geological investigation, mining exploration, groundwater probing, and pollution prevention for years. In this paper, the on-site investigation was required to inspect the possible groundwater leakage through an earth dam during either its full-level storage period or empty storage period. A potential seepage belt could gradually develop along the residual permeable sandy/gravelly layer, an old abandoned river channel. A downhole ERT-based brine tracing technique was conducted on the slopes nearby a spillway and a dam levee widening. The brine seepage flow observation could rapidly reflect the possible direction and path of leakage flow developed in an earth dam in few hours. Monitoring the ERT distribution variations can effectively identify the leakage spatial path, accumulation zone, and its potential sliding surface on dam slopes.

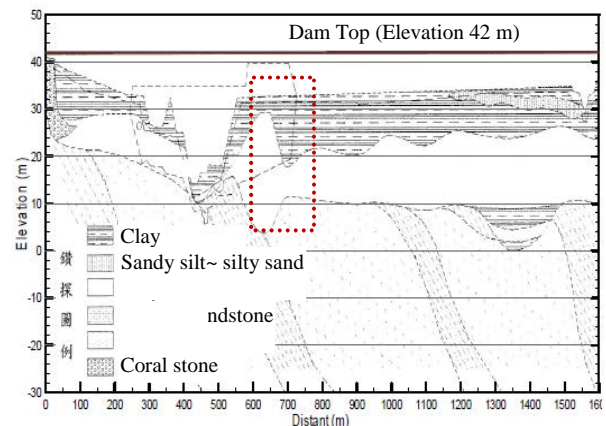
Figure 3 Geological profile along the dam mass (after Sinotech, 2010)

The geological conditions along the earth dam is plotted in Figure 3. The clay core dam overlays a 10~20-m thick silty sand layer which overlaps a monocline consisting of overlaid pervious muddy sandstone and silty mudstone. The black dashed line also indicates the concrete core zone.

An ERT investigation line is chosen at distances of 0k+603 m~0k+783 m at the downstream side along the dam top, the most possible leakage position (Figures 2 and 3). The total investigation length is 180 meters. The inspection is conducted at both the high-level storage and low-level storage periods. The on-site images in the reservoir show that the water level and waters coverage have significant changes (Figure 4). If one carries out the ERT survey along the dam at the different storage levels, such variations on water head could likely lead to amplify the leakage effect on resistivity distribution and probably help investigators identify the leakage zone at the downstream side of the dam.

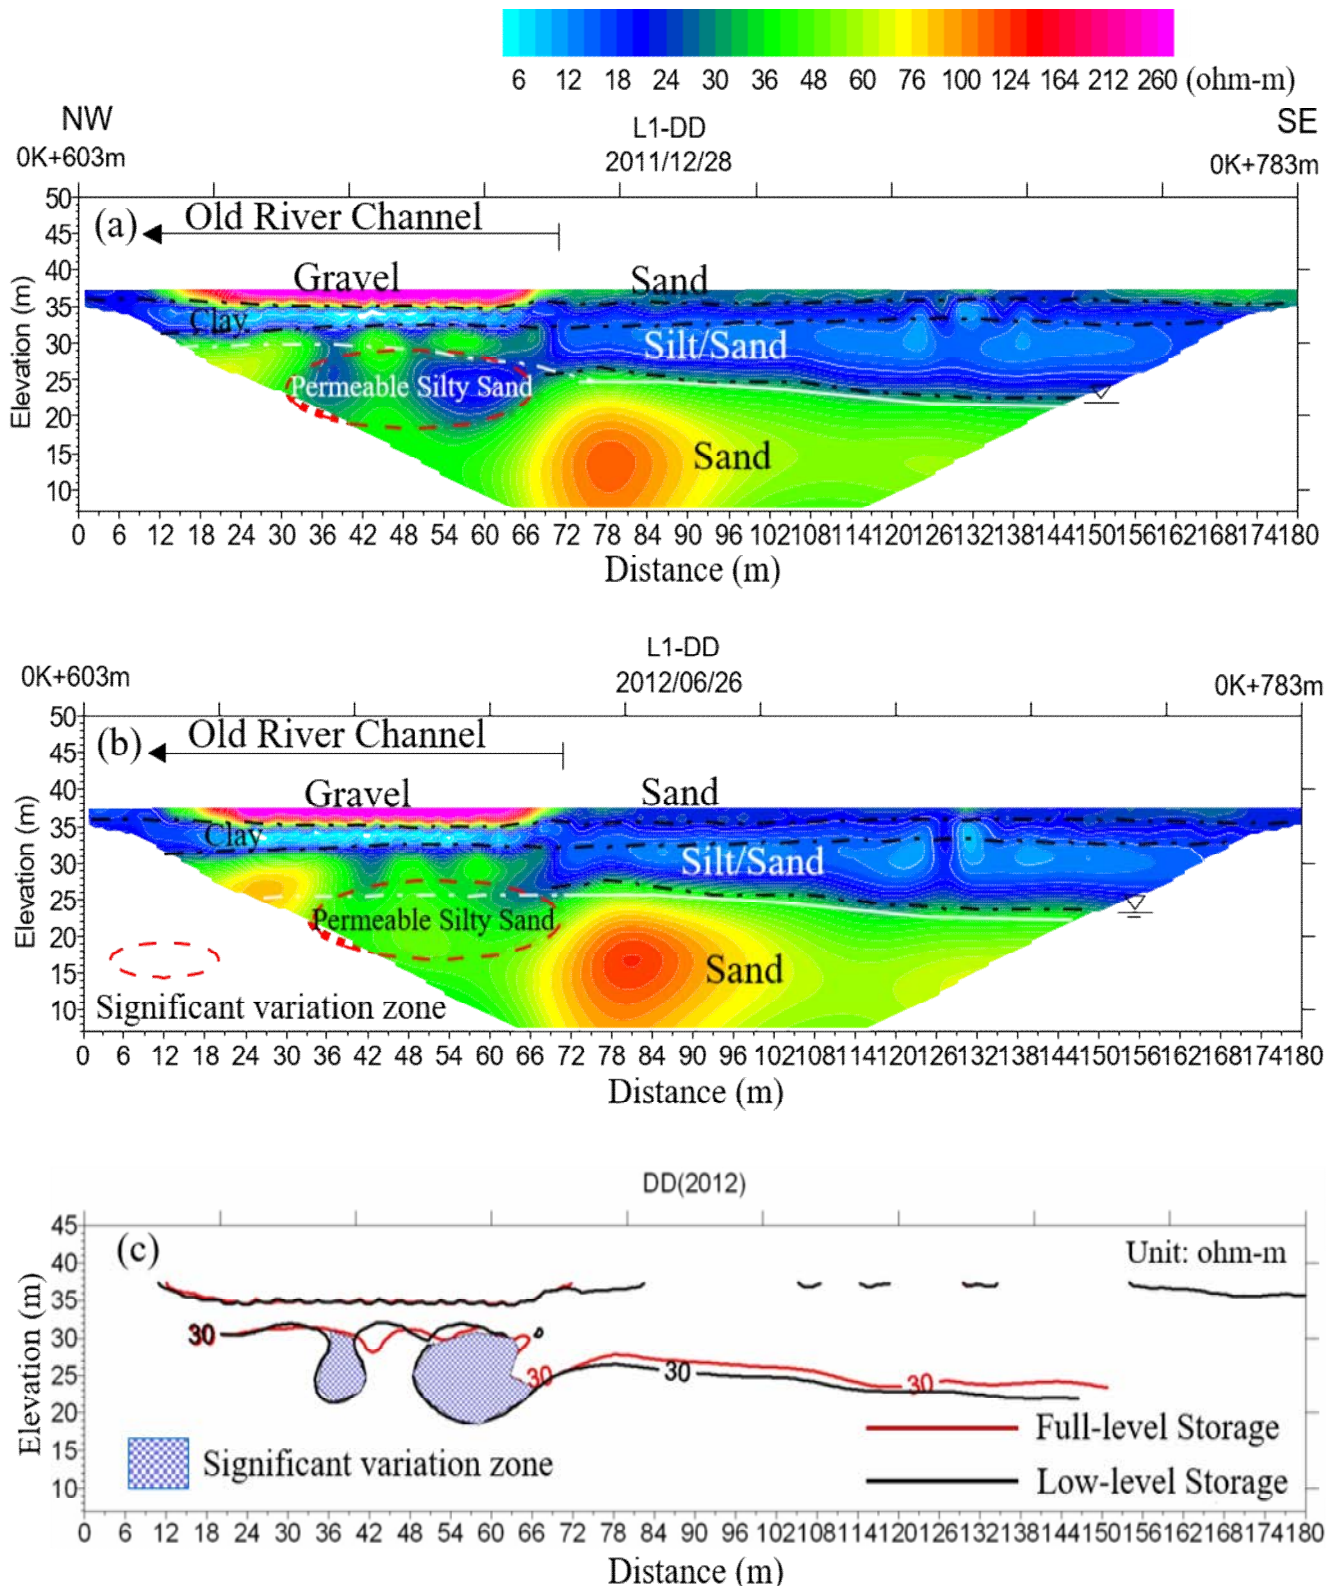
Figure 5 Electrical resistivity tomography images: (a). Full-level storage period; (b). low-level storage period; (c). resistivity variations

Figures 5(a) and 5(b) indicate the ERT inspection outcomes during the full-level and low-level storage periods, respectively. The estimated geological layers and groundwater table are labelled with black and white dashed lines, respectively. The relatively high resistivity contour zones, corresponding to the pink, red, orange, yellow, or green zones, indicate the sand or gravel layers. The relatively low resistivity contour zones, corresponding to the blue

and grey shades, represent the silty sand and clay layers. The significant resistivity variation zone is found at the measurement positions of 30~70 m as shown in Figure 5(c). This pervious silty sand layer could be reasonably inferred as the potential leakage zone. In addition, an old landform sketch before the dam construction reveals that the meandering zone of the old river channel right overlaps this leakage zone.

1. Under the different reservoir levels, a high water-level storage in a dam provides a higher water head as a more intensive surcharge source. Significant variations on the resistivity space distribution are feasibly measured for tracing aberration leakage position on the dam mass.

2. The pervious silty sand is reasonably identified as the potential leakage section, which is located at the old river channel when constructing an earth dam. The previous river meandering causes deeper disturbance on the silty sand feature.

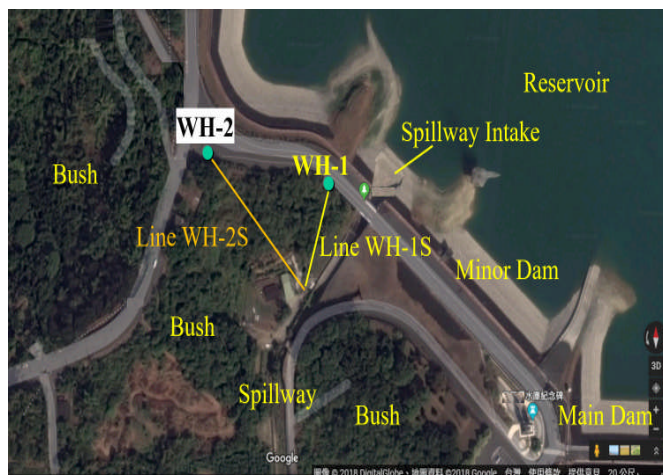
Figure 6 Top view photo of reservoir and dam (modified from Google Map)

Its accessory concrete spillway is located at the west minor dam as shown in Figure 6. Unfortunately, shallow sliding is frequently reported all the way around the spillway (NCTU, 2005). Figure 7 shows on-site slope failure images and temporary repair with plastic canvases preventing from more surface erosion. The shallow surface sliding removes more than 2-m deep top soils right beside the spillway culvert walls. The soil lose also spreads to the substrate soils under the spillway. Lack of substrate support leads to severe cracking on the spillway bottom. Substrate refill and retrofitting construction on the channel bottom are conducted for recovering the original function of the spillway.

In order to know the possible sliding surface, the ERT-based brine tracing technique is introduced to this manner. Two borehole positions and two ERT investigation lines are also plotted in Figure 6. The borehole positions, including WH-1 and WH-2, are set at the dam-top roadside grass. A 56-m long ERT survey Line WH-1S is extended downward from borehole WH-1 and measures the sliding mass conditions directly (see Figures 6 and 7). Another 70-m long ERT survey Line WH-2S is extended downward from borehole WH-2 along the dam slope surface covered with bush and grass. Such an investigation pattern can not only provide the detailed geological information from the borehole samples but also transfer these two empty boreholes into the brine injection pipes for following ERT tracing.

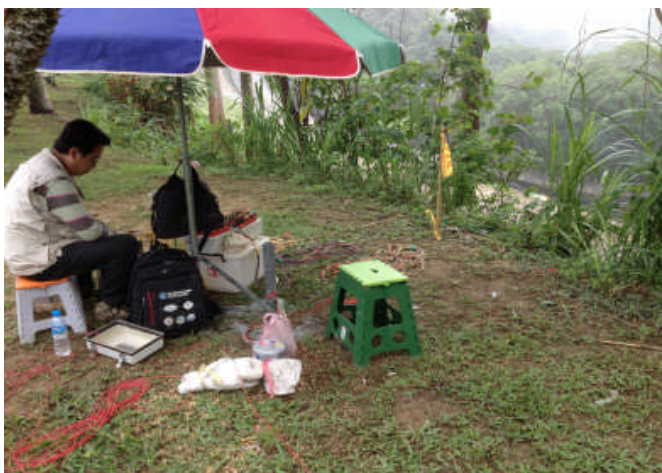
Figure 10 ERT-based brine tracing conducted at borehole WH-1

Figure 10 shows the ERT-based brine tracing technique image at borehole WH-1. The brine water is continuously infused into the dam mass through the borehole PVC pipe from water tanks. The ERT instrument records the resistivity images before brine infusion and traces the resistivity variation images up to 840 minutes.

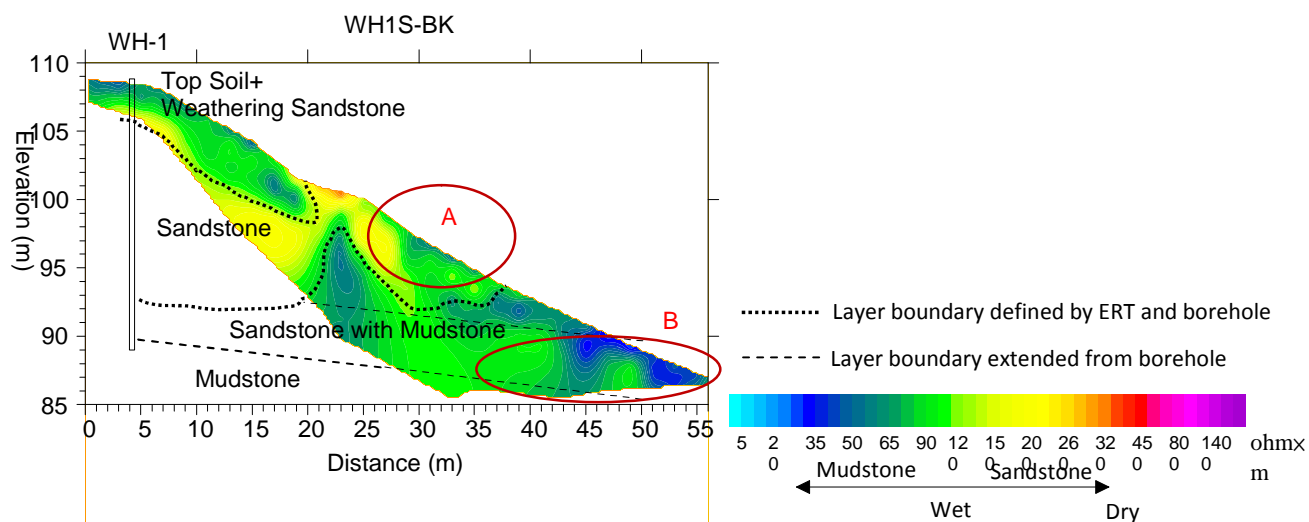
Figure 11 indicates the resistivity background image measured along survey Line WH-1S. The dotted and dashed lines represent the layer boundaries defined by both ERT and borehole sampling and borehole sampling only, respectively. The ERT background image consists with the findings at borehole WH-1. The top soil and weathering sandstone layers correspond to the light blue and green zones, scattering from the ground surface to depths of 3~5 m. The yellow, light green, and orange zones could indicate the sandstone, which overlays the sandstone with mudstone, a relatively low resistivity value zone.

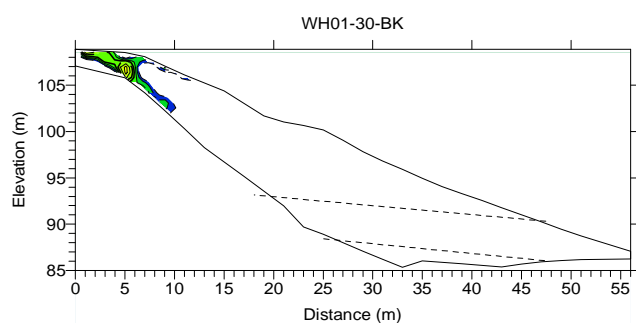
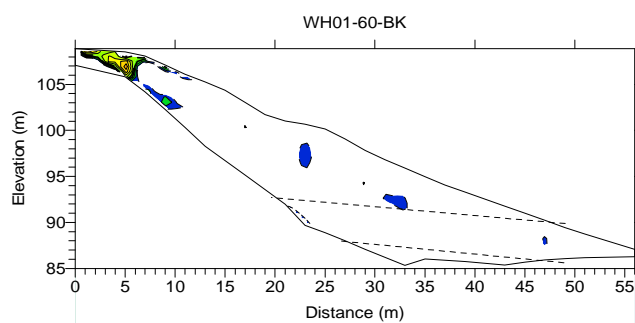
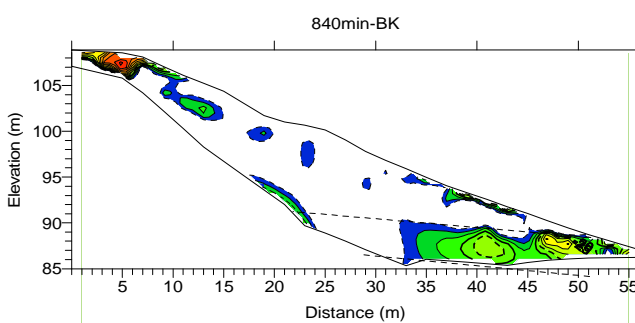
Figure 12 ERT-based seepage brine tracing image along investigation Line WH-1S (variation more than -5% only)

Figure 12 represents the resistivity variation images (more than -5%) along survey Line WH-1S up to 840 minutes. The resistivity variations for brine tracing measure the resistivity differences between the background and the influence from brine transmission at specific moment. Infusing brine water could lead to the decrease of resistivity values in the dam slope when it seeps through more pervious layers. At the first 60 minutes, the intensive variations occur at the depths of 2 m on the dam slope around the injection borehole WH-1. Up to 240 minutes, the brine seepage flows downward along the permeable sandstone layer. A significant brine accumulation zone, marked as A, steeply seats upon a relatively impervious layer. In future, this would possibly develop as a potential sliding surface, about 3~5 meters deep, around the middle part of the dam slope when extreme rain occurs. After 14 hours, the brine water moves downward to the slope toe, labelled as B. This could be another potential sliding surface.

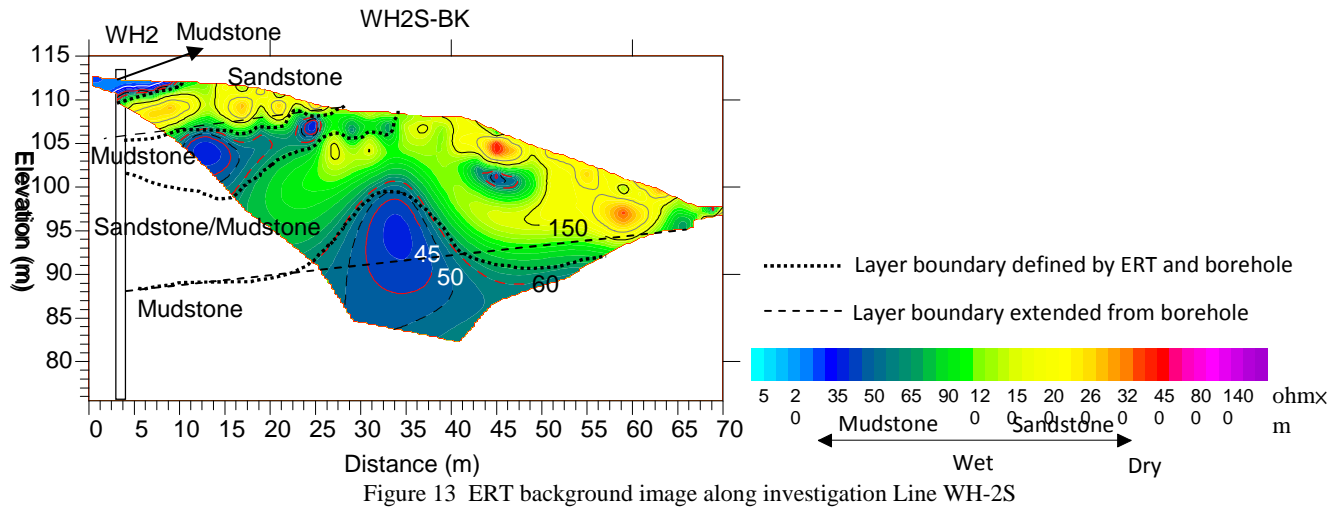
Figure 13 shows the resistivity background image measured along survey Line WH-2S. The dotted and dashed lines also represent the layer boundaries defined by both ERT and borehole sampling and borehole sampling only, respectively. The ERT background image also consists with the findings at borehole WH-2. The extremely low resistivity mudstone layer lays over the relatively high resistivity sandstone layer, corresponding to the yellow zones. Another mudstone layer overlays the sandstone interlayered with mudstone, which covers over a mudstone layer.

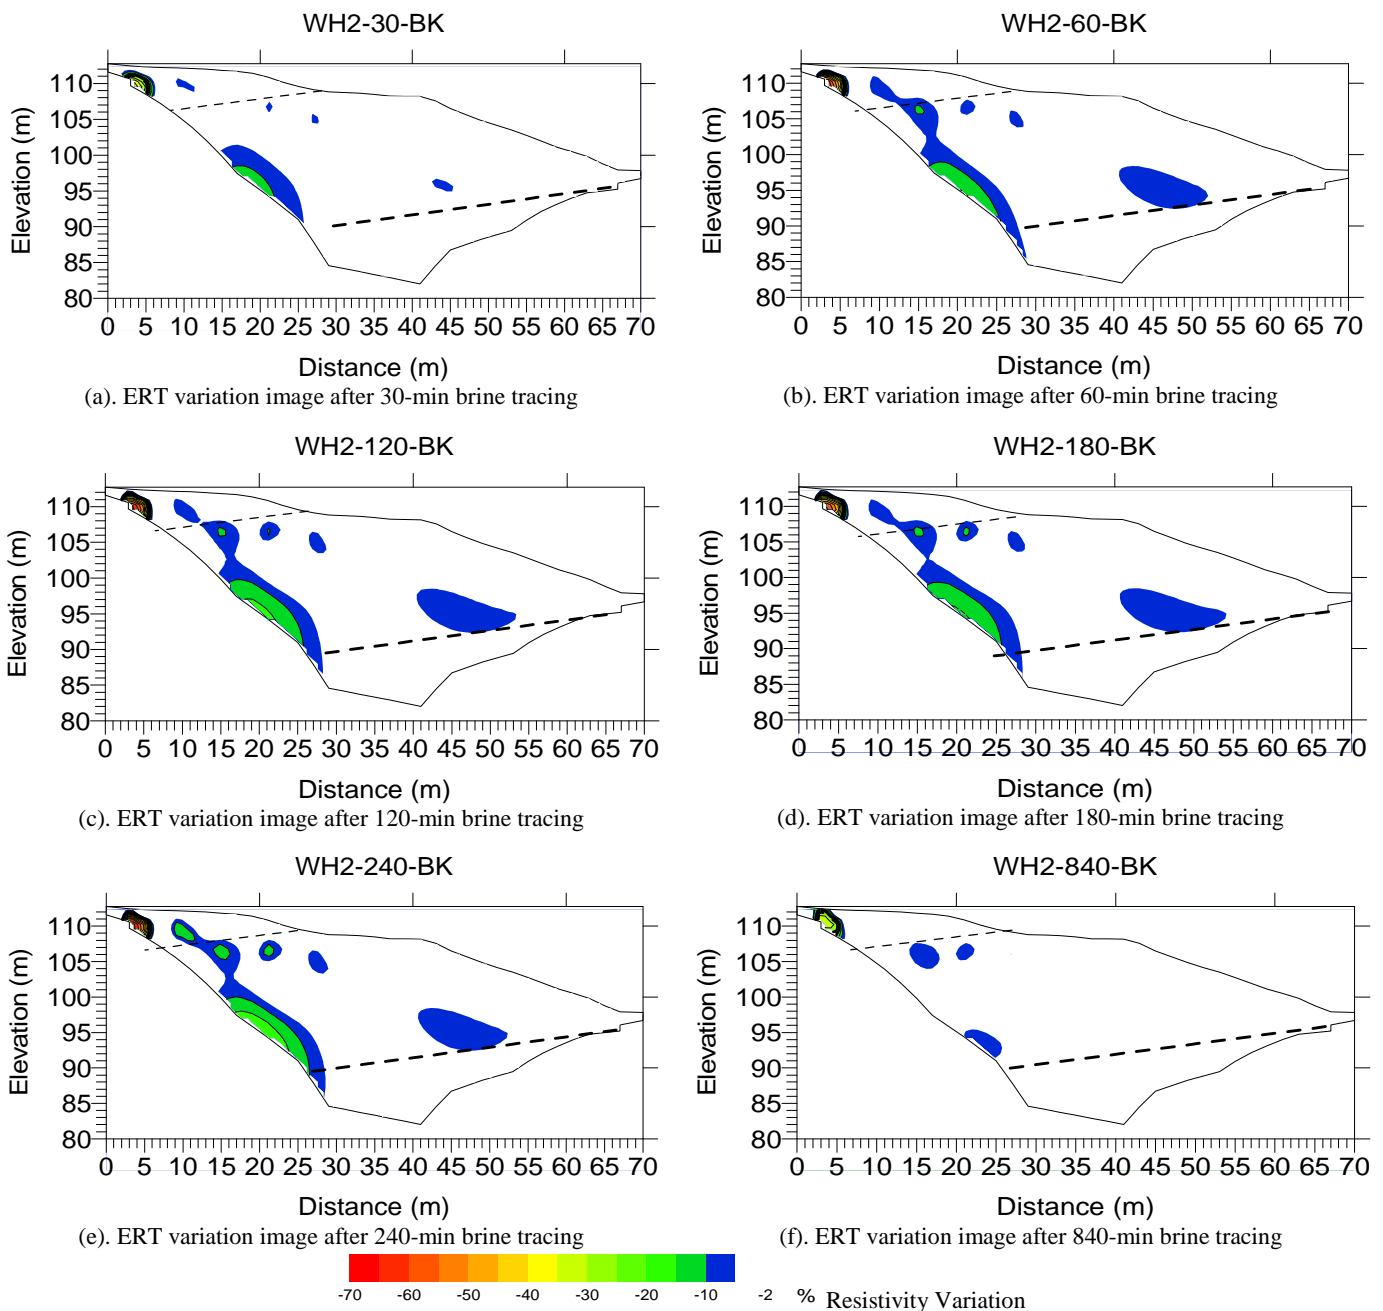
Figure 14 ERT-based seepage brine tracing image along investigation Line WH-2S (variation more than -5% only)

Figure 14 presents the resistivity variation images (more than -5%) along survey Line WH-2S up to 840 minutes. The resistivity variations for brine tracing indicate the resistivity differences between the background and the influence from brine transmission at specific moment. Within the first 240 minutes, the relatively high variations (-20% maximum) occur at the sandstone and mudstone interlayer, around at the elevations of 85~100 m and measurement positions of 15~30 m. As the infusion time increases, the resistivity variation range expands outward, but limited. However, when stopping injecting brine water into the dam mass (14 hours later), the expansion phenomenon on the resistivity variation image stops and vanishes synchronously. This possibly reveals that the brine water or groundwater is affected with near-borehole diffusion only. The coverage on resistivity variation depends upon continuous brine infusion. There is no significant direction or accumulation zone on the seepage or groundwater flow along investigation Line WH-2S installed on the dam slope. In fact, the dam slope is covered with broomy bushes and grass. There is no significant scour or sliding scars along survey Line WH-2S.

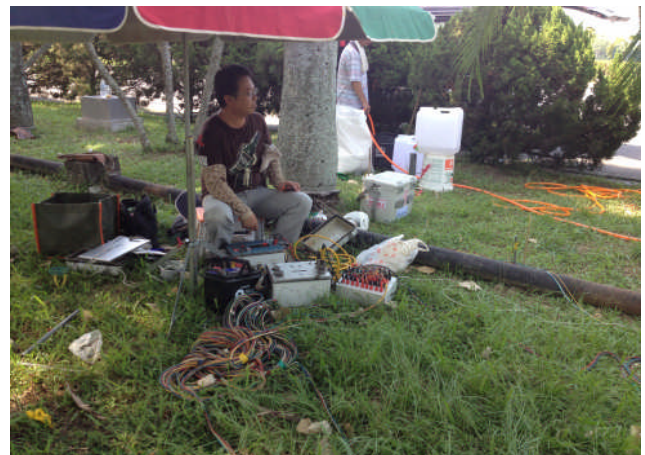
Figure 17 ERT-based brine tracing conducted at borehole WH-3

Figure 17 shows the on-site ERT-based brine tracing technique image at borehole WH-3. The brine water is continuously infused into the dam mass from the borehole pipe with water tanks. The ERT instrument records the resistivity images before brine infusion and traces the resistivity variation images for 400 minutes.

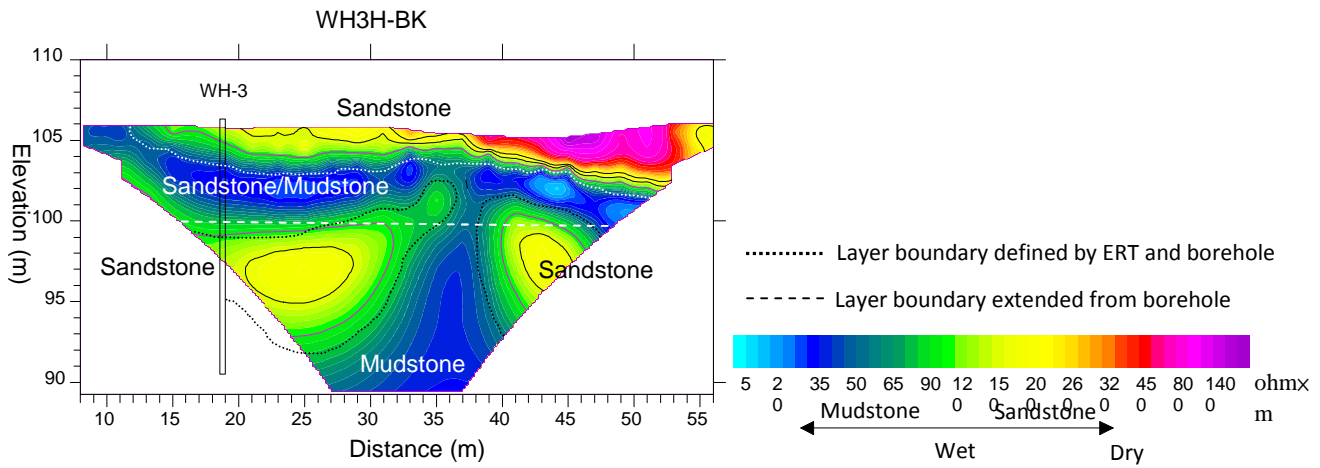
Figures 18 and 19 present the resistivity background and variation images, respectively, along Line WH-3H. The dotted and dashed lines represent the layer boundaries defined by both ERT and borehole sampling and borehole sampling only, respectively. The background image consists with the findings at borehole WH-3. Two loose sandstone layers correspond to the pink, red, orange, or yellow zones, scattering surface to depths of 2~3 m and depths of 6~13 m. In-between, the relatively low resistivity belt indicates the sandstone interlayered with mudstone. The resistivity variations for brine tracing measure the image difference between the background and brine infusing at specific moment (Figure 19). The resulting variations are still not significant after 300-min tracing. This indicates that the main seepage does not transmit along the horizontal direction, i.e., parallel to the dam levee top road.

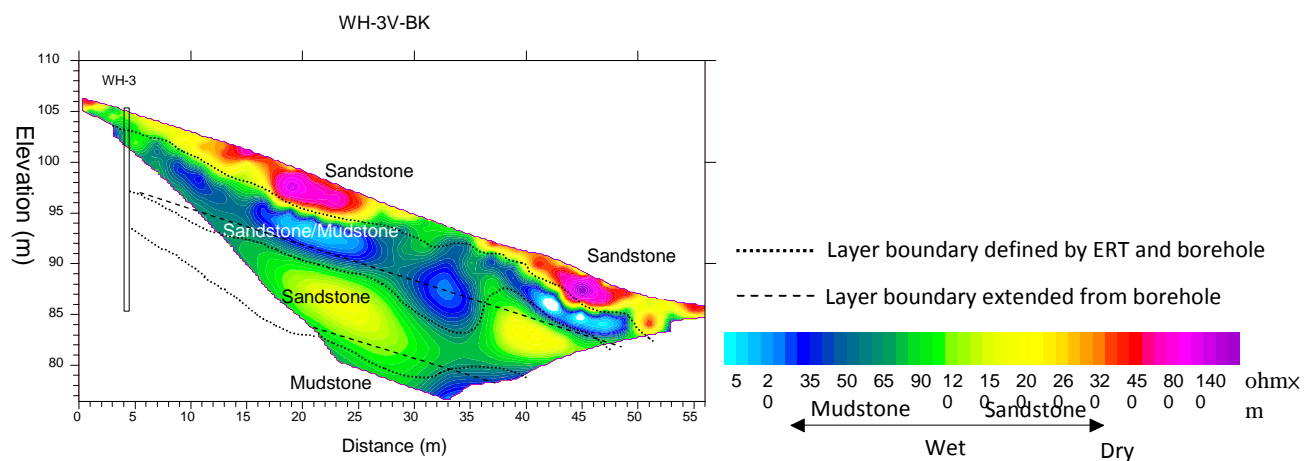
Figures 20 and 21 also show the background and variation resistivity images, respectively, along survey Line WH-3V. The dotted and dashed lines represent the layer boundaries defined by both ERT and borehole sampling and borehole sampling only, respectively. The background image also consists with the findings at borehole WH-3. Similarly, two loose sandstone layers correspond to the pink, red, orange, or yellow zones, scattering surface to depths of 2~5 m and depths of 8~16 m, which overlays on mudstone. In-between, the relatively low resistivity belt indicates the sandstone interlayered with mudstone. The resistivity variations for brine tracing measure the image difference between the background and brine infusing at specific moment (Figure 21). In Figure 21, significant variation zones are identified on the pervious sandstone layer. The seepage moves downward to the slope toe in the SE-NW direction. The resistivity variations only exist within the pervious sandstone layer and no significant resistivity aberration is found in two mudstone layers as the infusion time increases. This indicates that the seepage or groundwater belongs to inter-stratum water flow and is almost sealed within two relatively impervious mudstone layers in this investigation coverage.
