# Liquefaction Problems in the 21<sup>st</sup> Century

Ikuo Towhata<sup>1</sup>

**ABSTRACT:** This paper concerns liquefaction problems that were not solved in the 20<sup>th</sup> Century. Most of the problems lie in inexpensive structures and existing structures that were out of scope in the past. Efforts are going on to overcome the problems in spite of the imbalance of the required cost and the financial capacity. Seismic performance design is one of the future directions but there are again problems to tackle. It is stressed that qualification of the properties and lands are important because people can recognize the lying hazards and can prepare for the future safety.

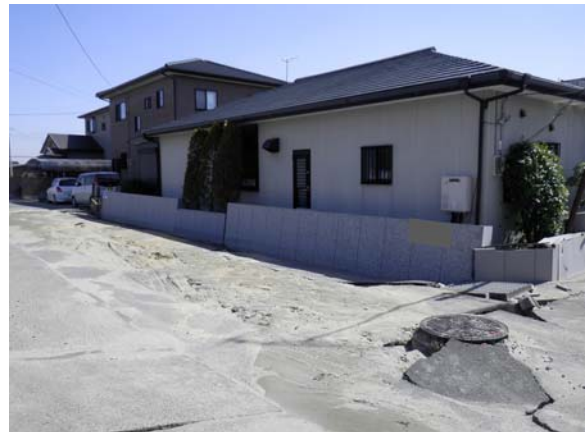
Photo 1 Liquefaction damage of house

The technologies to mitigate liquefaction disasters were developed in the 20th Century for the safety of such important infrastructures as harbors, bridge foundations, energy facilities, dams and big buildings among others. Because those important structures were constructed by public sectors and big industries that were able to provide sufficient funding, the established mitigation technologies were rather expensive, although they are reliable as verified by many earthquake events. As a consequence, those infrastructures that cannot afford the high cost of liquefaction mitigation are left unprotected today. Examples of those “poor” structures are residential house foundations, embedded lifelines and river levees (Photos 1 to 3 taken after the 2011 gigantic earthquake in east Japan).

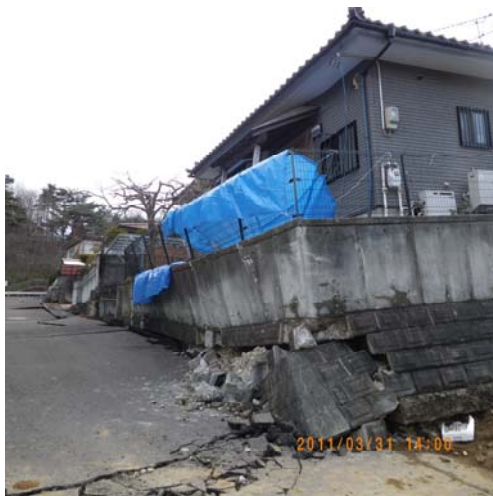
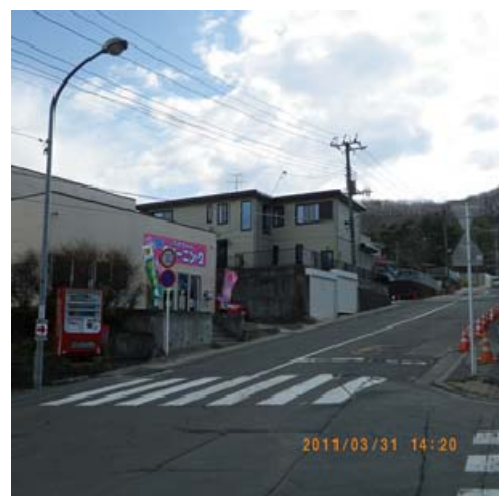
(a) In earth-filled former valley

(b) In cut parts

Photo 8 Failure of residential land during the 2011 earthquake

The 2011 earthquake demonstrated two types of earthquake problems in people's houses. Photo 8 indicates failure of residential fill that led to the total demolition of an overlying house. Because this residential area was constructed in a hilly area by cutting high places and filling valleys, there occurred a significant difference in seismic performance among places and only the filled parts experienced fatal damages during the earthquake. The problem from the people's viewpoint is that customers are not aware of the seismic risk of land that they are going to purchase and are shocked to see the consequence after a big earthquake. It is unfortunate that efforts of seismic experts to disseminate knowledge have not been efficient to date. Photo 1 illustrated liquefaction-induced damage of a house that was essentially subsidence and tilting while no significant structural damage happened. The significant subsidence led to breakage of embedded lifelines that were connected from free field to the subsiding house foundation. Most of such liquefaction damage were reported in young sandy ground that was constructed by reclamation of former seas, lakes and river channels. The problem is that the residents were not aware of the liquefaction risk when they purchased the land despite that concerning rules and regulations state that land owners themselves are responsible for the risk. It is important that liquefaction technology has not paid or could not pay much attention to the safety of private properties, while much has been done to protect infrastructures from liquefaction problems. Another problem is that efforts to

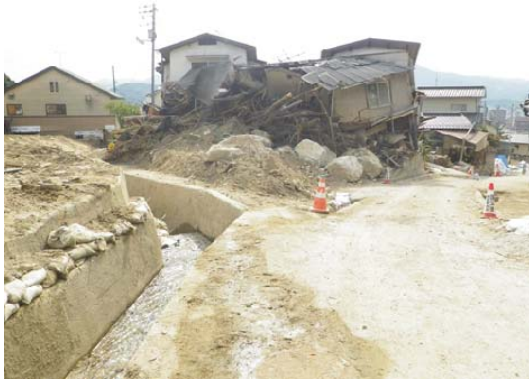
Photo 9 Consequence of debris flow caused by heavy rain (Hiroshima, 2014)

Earthquake is not the only one kind of natural disaster that produces a fatal damage to a private house. Photo 9 illustrates an area near Hiroshima where a heavy rain in August, 2014, caused debris flow in a residential area, destroyed many houses and killed 74 people during mid night. The problem was that a residential development took place on an alluvial fan that was formed by deposits of debris and that people did not pay attention to the risk of natural disasters. Similar to the aforementioned earthquake problems, it is very difficult to reduce the risk by reconstruction, soil improvement, relocation etc. after people have constructed houses and started living. Such a problem in existing structures is profoundly more difficult than that of new construction. Relocation requires people to purchase another land despite that their previous land and house are still under unfinished mortgage payment.

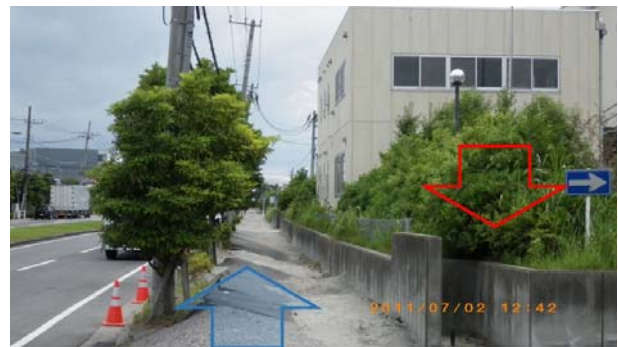
Photo 11 Uplift of public sidewalk as a consequence of liquefaction-induced subsidence of private building

In principle, soil improvement in a private residential land is a responsibility of house owners. However, the scale of house damage during the 2011 gigantic earthquake was extremely huge and the national government decided to provide a certain public aid to private properties, which is an integrated soil improvement package by which both public streets and private lands are worked on together. It was thought therein that the safety of streets and embedded lifelines against liquefaction is achieved by soil improvement not only under the public spaces but also in private lands; hence the public fund should be added to the personal money in order to improve private subsoil. Photo 11 shows a case in which liquefaction in a private land induced subsidence of the building and the subsided soil was pushed out to the public sidewalk where significant uplift happened. Note that pipelines are often embedded under sidewalk.
