# **Experimental Research at the Asian Institute of Technology 1990s**

## **Some Research Examples**

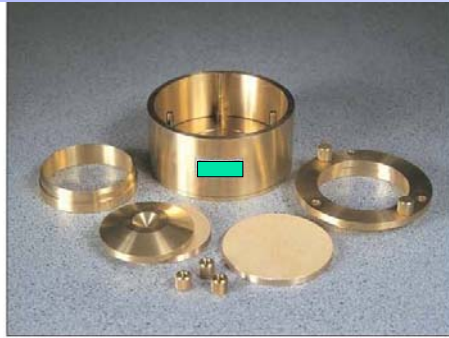
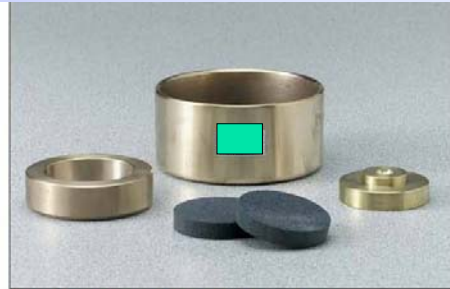
**Floating Ring Consolidometer**

Electrostatic design eliminates friction between soil

Poor  
Top  
Cap

Proper  
Top  
Cap

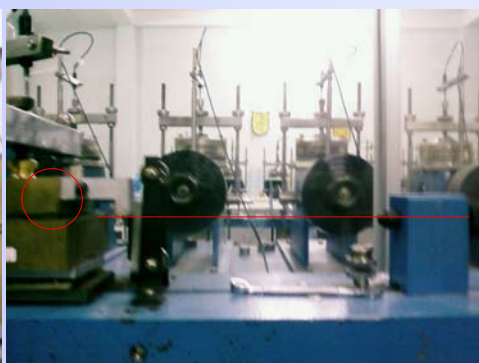
Poor Force  
Alignment

Proper Force  
Alignment

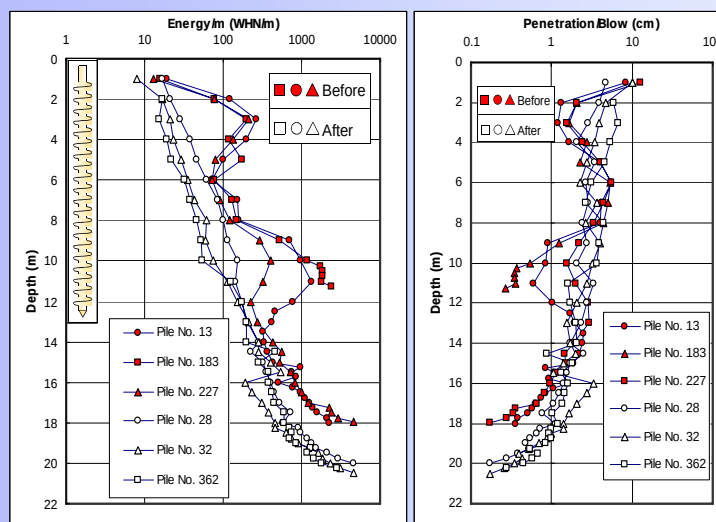
## Augering and Lower Energy Input
