Common Blind Spots in Ground Investigation, Design, Construction, Performance Monitoring and Feedbacks in Geotechnical Engineering: Shaw-Shong Liew, G&P Geotechnics Sdn Bhd, Kuala Lumpur, Malaysia

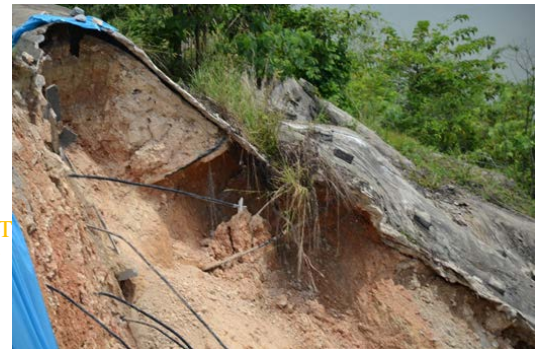
Case 3: Bridge Abutment Distresses due to Piled Embankment Failure

- The incompatibility of stiff bridge abutment and weak lateral pile support of piled embankment has attracted remarkable lateral load to structurally fail the vulnerable abutment piles and embankment piles. The settlement of temporary working platform shall not be overlooked in soft ground condition that potentially results in large free standing pile length and reduces the pile lateral resistance.
