Evaluation of the vulnerability of rock weathering based on monitoring using photogrammetry

D.H. Kim, I. Gratchev, E. Oh & A.S. Balasubramaniam

Griffith School of Engineering, Griffith University, Gold Coast, Australia

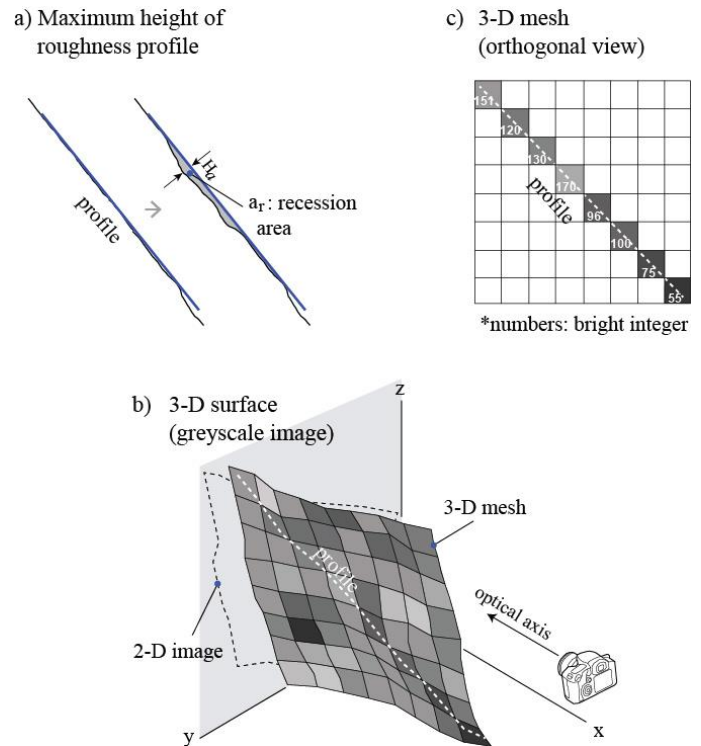
Figure 1. The use of a greyscale 3-D rock surface model to investigate surface recession by weathering

As a distinct advantage of 3-D images, extended meshes which cover all the areas of interest in orthogonal directions to the sections, can be obtained as shown in Fig. 1 (b) and (c). This enables an analysis of the integer values of pixels combined with

the 3-D roughness data. In this study, the changes of intensity values of greyscale 3D images are interpreted with the changes of asperity heights obtained from photogrammetric profiles. The results are used to estimate the recession areas during the time interval.

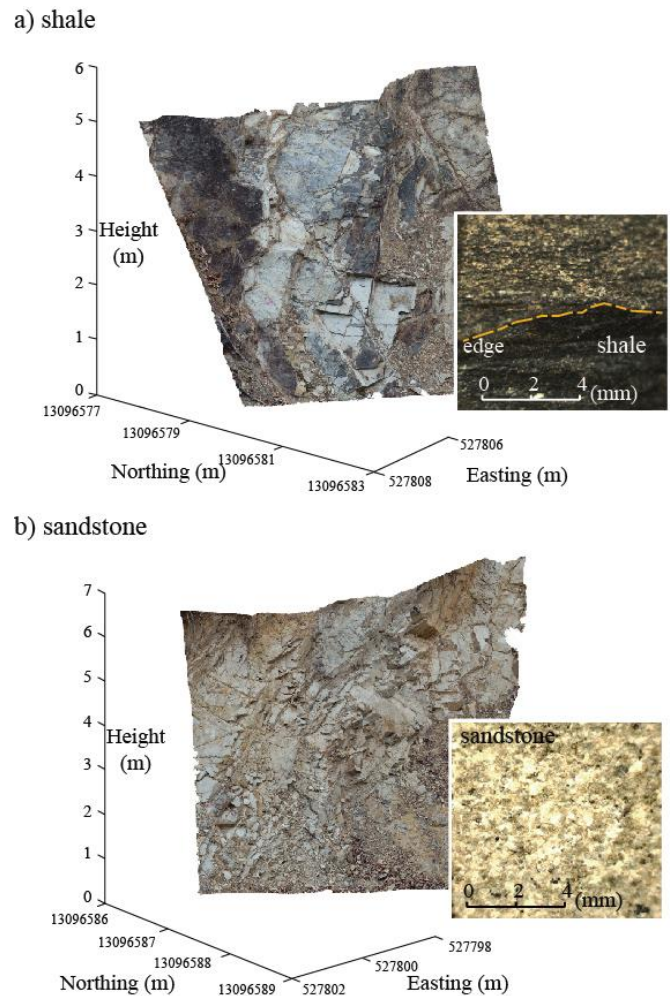
Figure 2. Photogrammetry 3D models of the study area and details of rock surface textures surveyed in 2012; Shale (a), Sandstone (b)

The study slope is located on the Gold Coast in Australia. The geological condition is composed of the alternate bedding structures of sandstone and shale in the Nerangleigh-Fernvale beds. The texture of the sandstone is medium to coarse grained and joint sets are frequently found from the slope surface. The texture of the shale is fine and has a laminated structure, and the orientations of the beddings are steeply inclined. The textures were observed using digital images taken by an 8 megapixel microscope camera from collected samples, as demonstrated in Fig. 2.

Sirovision (CSIRO, 2012) was used for the post-process of the photogrammetry surveys. Fig. 2 presents geo-referenced 3D models for both shale and sandstone areas of the models created in 2012. Two sections of both shale and sandstone were selected for a detailed investigation of roughness variation over two years. The selected areas were extracted from the both years’ 3D models. The dimensions of the selected areas and the density of the 3D image pixels are summarized in Table. 1. The 3D image pixel scale, which indicates the measurement scales and the extent of accuracy of image analysis varied in accordance with the locations of sample sections. However, the range of variation is negligible.

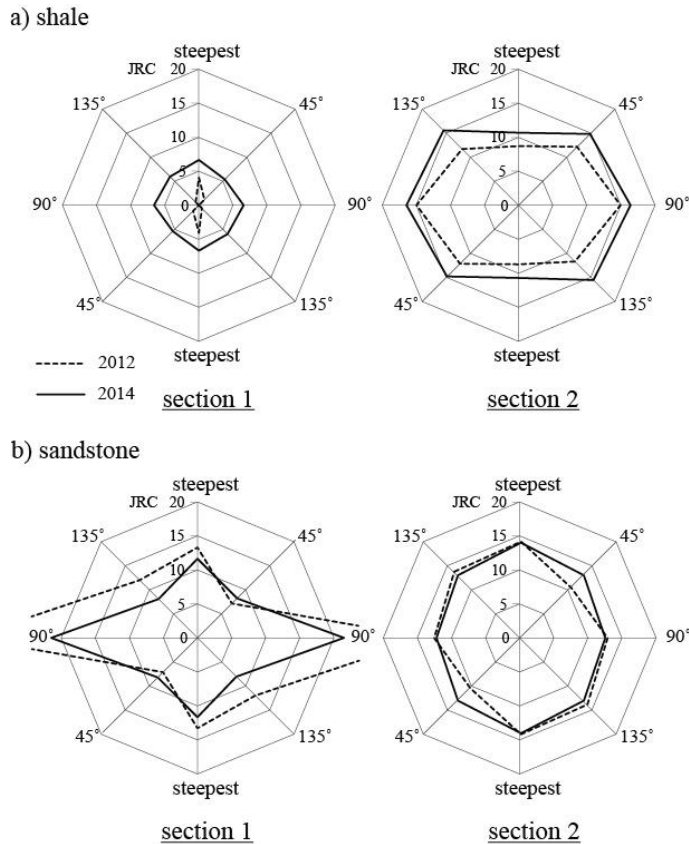
Figure 3. Alteration of photogrammetric JRC values in radial directions (0°, 45°, 90°, 135°) over the two year interval in the shale area (a) and sandstone area (b)

By comparing of the 3D images of 2012 and 2014, the sample areas were selected because they show noticeable changes on the exposed surfaces, especially on the periphery of exposed joints. Using the extracted 3D images of the selected sections, JRC values were then estimated for the sample areas in four radial directions (steepest, 45°, 90°, 135°). The variations of JRC values in the radial directions are presented in Fig. 3. The overall undulations of the

extracted profiles approximately simulated the locations of the loss of roughness and the positions of joint sets (see Fig. 4). The shapes of profile variations helped to detect the ranges for the correlation between the loss of height and the intensities of the greyscale images. The JRC values change over time according to the rock types. For example, for the given two year period, the JRC values for shale increased, as indicated in the graphs. Alternatively, in sandstone regions, the JRC values diminished slightly.

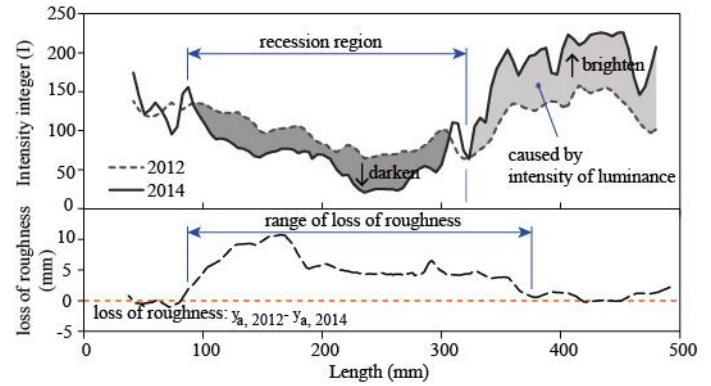
Figure 4. Changes of brightness integers (I) and the loss of roughness of the profile along the centre line of sandstone 2 section

The original RGB 3D images were converted to greyscale with 8 bit pixel depth to simplify the image data. Fig. 4 demonstrates the brightness integers and the variation of asperity heights at the same positions

along the profiles located in the centre lines extracted from the 3D models of the sandstone section 2. The variations of brightness integers (I) obtained from greyscale 3D images are correlated with the changes of asperity height. In the sandstone area, it is obvious that large variations of (I) values occurred at the same regions where the asperities are lost by weathering. Also, there is an extraneous increment range of (I) values caused by the different luminance between the photographing in 2012 and 2014. It can be also explained by the fact that there is no considerable roughness change in the range. In the shale area, however, it was observed that the ranges of brightness integers considerably varied by a discoloration along the exposed surface as a result of chemical weathering. Due to the various changes in colours, it was difficult to define the correlation between the roughness changes and the integers of greyscale images in the shale area. In addition, the difference of luminous intensity at the moment of photographing also disrupted the image analysis using the brightness integers.

This study also tried to detect the damaged area by weathering over the two year period. Using an image thresholding technique of MATLAB, the pixels of the greyscale images were filtered within the obtained guide ranges of (I) values from the profile analysis as described in Fig. 4. The obtained threshold images are demonstrated in Fig. 5. The percentages of the detected areas to the total areas were also calculated using the corresponding numbers of the pixels. The filtered areas of the sandstone are appeared to be reasonable as an indicator of the products of weathering as the ranges of brightness is relatively simple. As the sandstone in the study area is more vulnerable than the shales as shown by the results of slake durability tests, the recession areas were markedly increased (from 8.1% to 17.6%: section 1, from 8.6 % to 25.4 %: section 2). On the contrary, the recession areas analysed by using the guided integer range are inconsistently distributed on the surfaces of the shale. This result can be explained by the

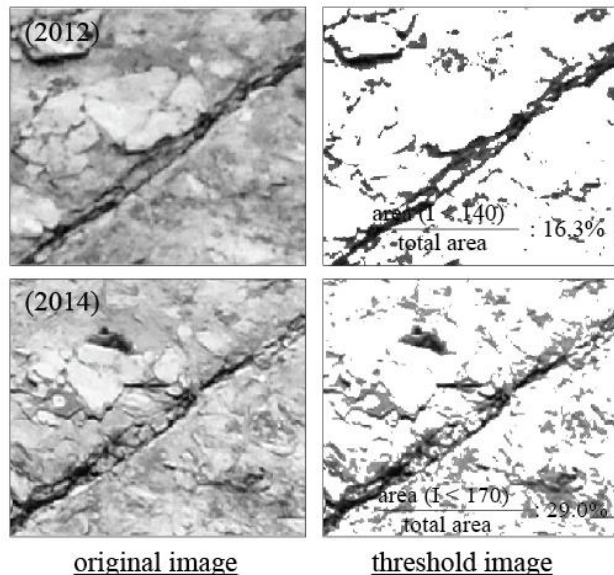
a) shale (section 2)

Figure 5. Original images of altered areas by weathering and detected areas by using MATLAB image analysis; for shale section 2 (a) and sandstone section 2 (b)

responses of chemical weathering along the laminations of the shale surface.
