Volcanic Cohesive Soil Behaviour under Static and Cyclic Loading

ABSTRACT: The objective of this study is to evaluate the behavior of reconstituted samples of a volcanic soil under static and cyclic loading using series of undrained static and cyclic test. The static test results show that at a low confining pressure, the soil exceeds contractive behavior followed by dilative behavior. This behavior indicates that the pore water pressure development is not higher than the soil shear strength. Otherwise, the soil shows contractive behavior. The cyclic test results show cyclic mobility behavior under an investigated cyclic stress ratio. In one hand, at low cyclic stress ratio, the shear strain increased slowly, and after a certain number of cyclic, it significantly increases. In another hand, the shear strain increases gradually at high cyclic stress ratio. These results indicate a contradictory behavior of the soil under different confining stress and cyclic stress ratio.

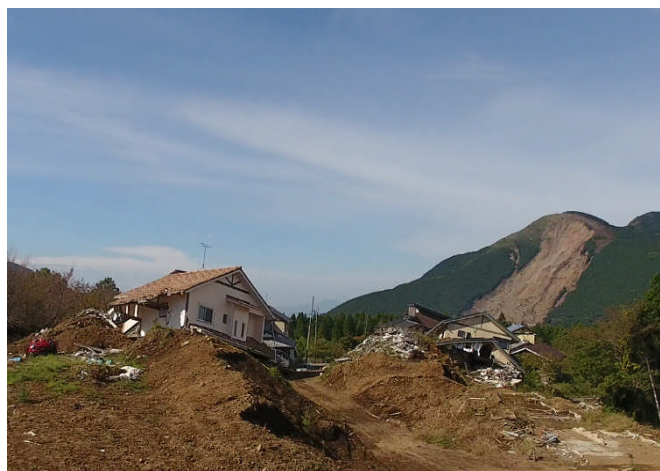
Figure 3 Swept away houses

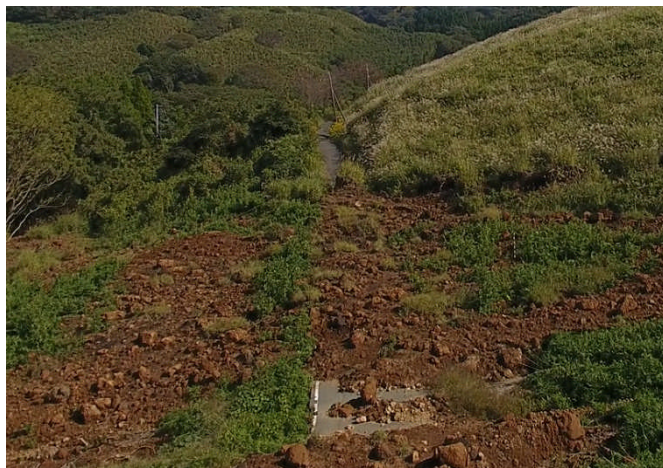
Figure 4 Damage to roads

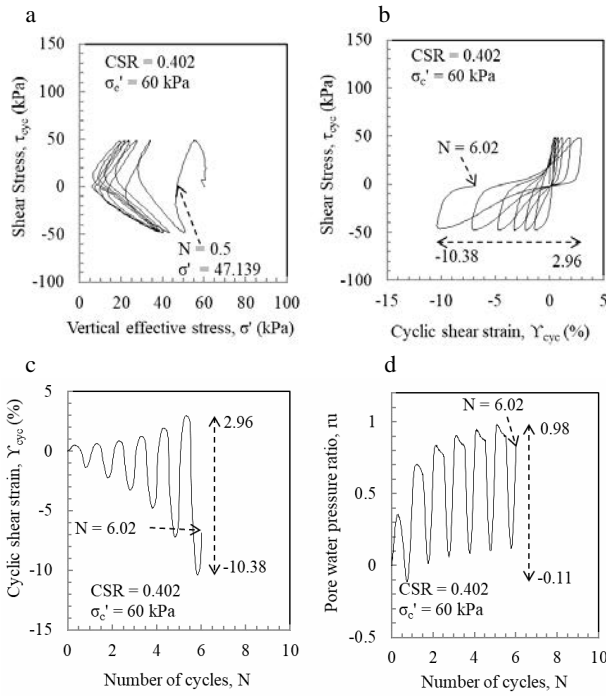
Figure 19 Soil response for CSR = 0.402: (a) effective stress path, (b) shear stress versus shear strain, (c) shear strain versus a number of cycles, and (d) pore water pressure ratio versus a number of cycles (Sumartini et al. 2018^a)

Figures 18 and 19 display the response of disturbed samples while Figures 20 and 21 show the response of undisturbed samples in the undrained cyclic triaxial test. The stress path trend of disturbed samples is similar to undisturbed sample although the disturbed sample appears faster in liquefying. The effective stress path of both samples indicates that the effective stress in undisturbed samples tends to decrease at a lower rate than in disturbed samples. The generation of excess pore water pressure for each cyclic load application is much faster for the disturbed samples compared to undisturbed samples. Therefore, it can be concluded that the deformation of the soil structure due to reconstituting process has a significant effect on the pore water pressure development. Thus, the disturbed samples appear to be more susceptible to liquefaction. The liquefaction susceptibility of disturbed samples and undisturbed samples are presented in Figure 22.

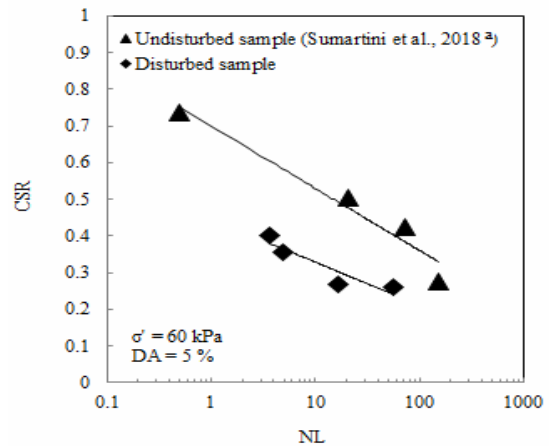
Figure 22 Liquefaction susceptibility of Orange soil: (a) undisturbed samples and (b) disturbed samples
