Geosynthetic Reinforced Road Structure as Fast Rehabilitation for a Typhoon Disaster

H. Hermina¹, Y. Jeff¹, and S. Henry¹
¹ ACE Geosynthetics, Taichung, Taiwan, R.O.C
E-mail: hermina.ho@geoace.com

Keywords: disaster recovery, geosynthetics reinforced structure, carbon emissions, green engineering

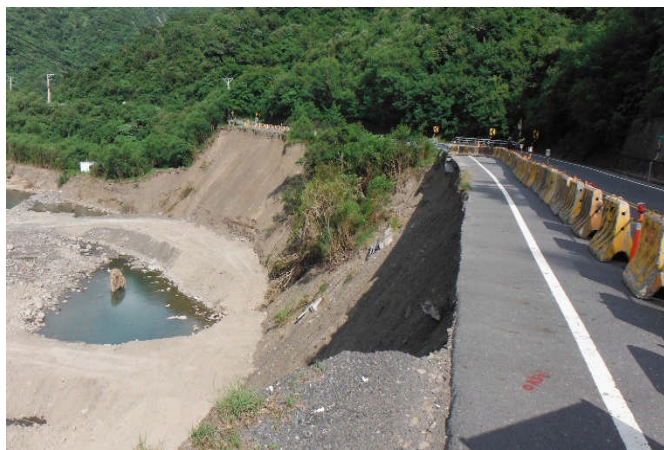
This paper presents a case study of slope rehabilitation project using a composite structure made of pile foundation, RC wall, and GRS. The case is located in the southern part of Taiwan, specifically in Pingtung County, Provincial Highway No. 9 470K+500, adjacent to Fenggang River. In 2013, Typhoon Kong-Rey was attacking Taiwan with heavy rainfall, in which the concentrated rainfall rise upon 250 to 300 mm within a single day (JTWC, 2013). Rapid change of precipitation rate caused a fluctuation in the adjacent river water level. The impact of high energy and high velocity in the river stream was an accelerated scouring of soil. Thus, a slope failure was occurred beneath Provincial Highway No. 9 (Figure 1).

Figure 1 Slope Failure below Highway Embankment

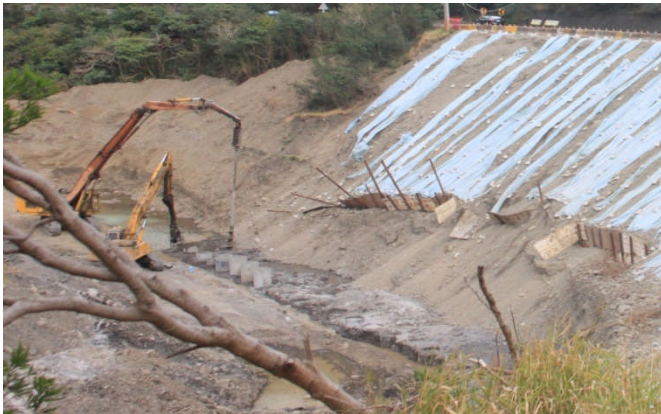
The foundation was set with double-row cased piles with a diameter of 1.2 meters (Figure 3). The outside piles were set at intervals of 2 meters in a row, and the interval of rear piles was set as 5 meters. The depth of each pile is about 10 m with an initial drill penetration of at least 2 meters into the rock sublayer. A total of 155 piles were installed to transfer the vertical load into metamorphic basement rock and improve the bearing capacity of the whole structure. Furthermore, a reduced influence of riverbed scouring was expected, and the sliding drive force raised by the earth pressure of slope was resisted.

Figure 3 The All-Casing Pile Installation

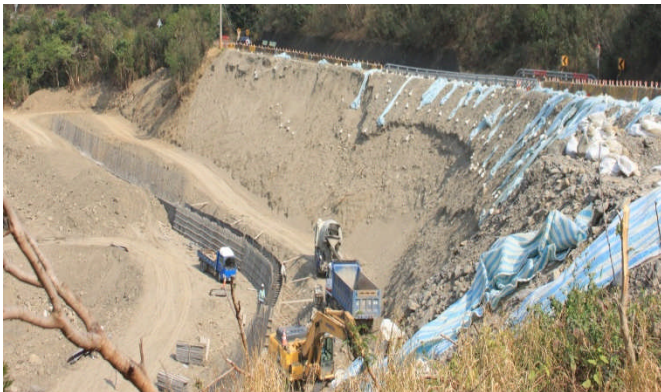
The semigravity RC retaining wall was constructed on the top of pile foundation and connected to the pile cap (Figure 4). Taking into account the highest water level, the wall high was raised up to 12 meters. The main function of the RC retaining wall is to prevent the main structure from being damaged by the impact of debris flow during typhoon season and resist the lateral earth pressure from the backfill.

Figure 4 Semigravity RC Retaining Wall Construction

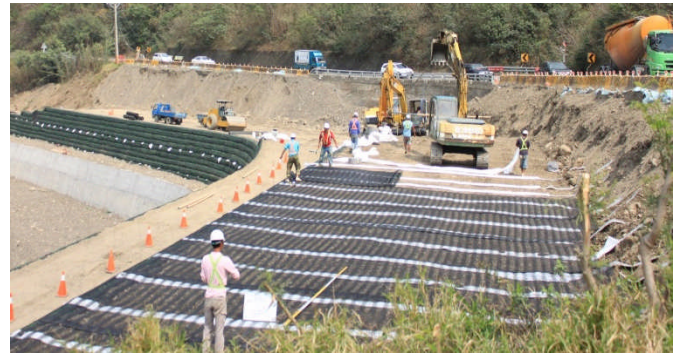
The upper structure above highest water level was constructed as a geogrid reinforced slope (Figure 5) to a certain height and then backfilled with soil to the level of road base. According to the safety stability analysis, the geogrid reinforced slope was considered to be divided into two stages. The lower stage used geogrid with an ultimate tensile strength of 240 kN/m and the upper stage utilized 160 kN/m separately. The embedded length of the geogrid for both stages is 10 meters. The backfilled material utilized the collapsed soil in the construction site and the dredged sand from the river. Besides the mechanically stabilized components, the design of drainage in the structure is greatly important as well, the drainage system composed of drainage board, non-woven geotextile and gravel, are placed into the structure to guide and drain the water

pressure inside the geogrid reinforced slope. The facing system of the GRS was piled up soil bags as the vegetation medium. Above the GRS, a soil slope with a gradient of 1:0.3 and 2 meter height was backfilled and compacted as the road base.

Figure 5 The Installation of GRS

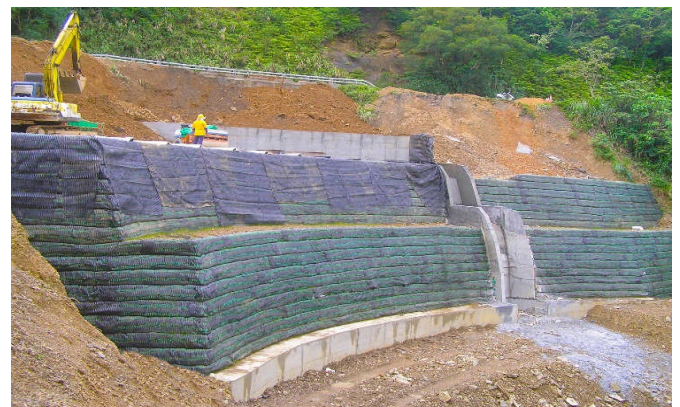
In order to discharge the water from heavy rain on the slope, the design of the drainage box culvert under the road surface was also carried out. The overflow from the road surface and upper slope can be collected by the drainage system and then transported into the adjacent river. In this structure, drainage system will prevent the cohesion-loss from the soil, which is caused by surface water infiltration (Figure 6).

Figure 6 Drainage System for Surface Erosion Measurement

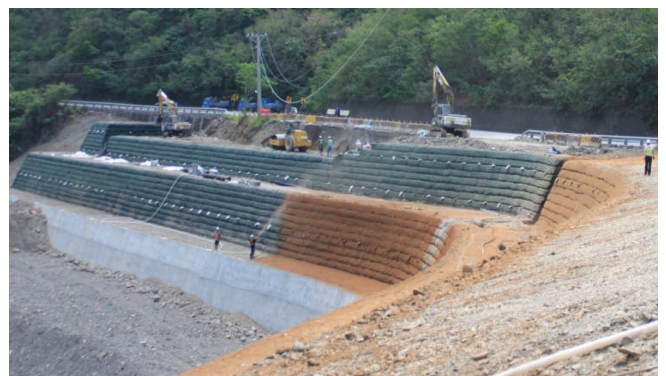
Hydroseeding, a plantation work using a mixture of seed and mulch, was performed after the completion of GRS installation (Figure 7). The main function of hydroseeding is to control the surface erosion using vegetation growth, while it also provides an aesthetical function to enhance the appearance of the whole GRS structure. Overall, hydroseeding has a beneficial impact on the environment aspect by lowering the carbon footprint from the construction work.

Figure 7 Hydroseeding

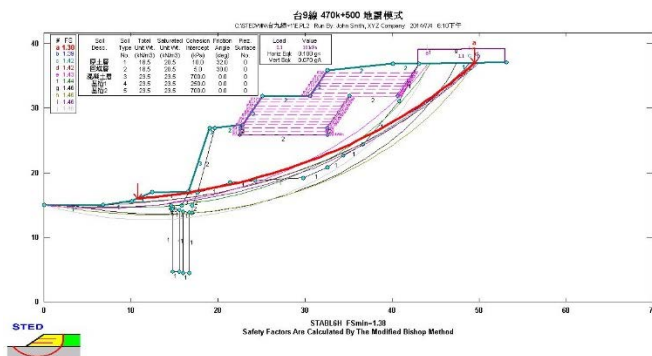
The overall structure was analyzed by commercial software STEDwin for global safety and stabilization under normal, rainstorm and earthquake conditions (Figure 8). The soil parameters for analysis were set as follows in Table 1 according to the geological report for the construction site. The analysis result demonstrates that the composite structure made of pile foundation, RC wall, and GRS is stable under normal, typhoon, and earthquake conditions. The achieved factor of safety for normal condition (FS_{normal}) is 1.63, typhoon condition ($FS_{Typhoon}$) is 1.27, and earthquake condition ($FS_{earthquake}$) is 1.38.

Figure 8. The Global Stabilization Analysis (Presenting Earthquake Model as an Example)

Parameters	In-situ soil	Backfill soil
γ (kN/m ³)	18.5	18.5
γ_{sat} (kN/m ³)	20.5	20.5
Cohesion, c (kPa)	10/5	5/3
General/ Storm		
Friction angle, ϕ (°)	32	30

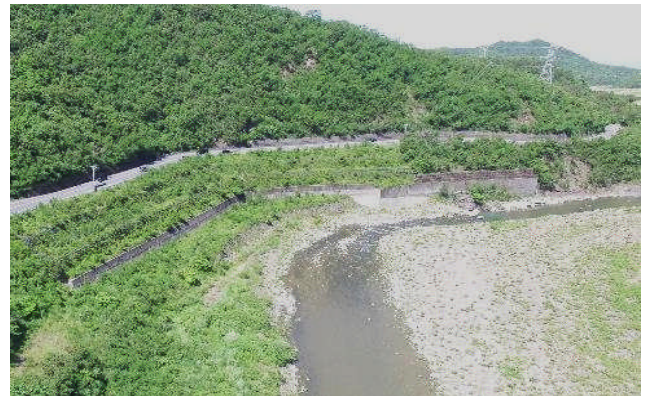
Since the structure was completed in 2014, it has been through several natural disasters, such as earthquake and typhoon. In recent years, the structure remains intact with no deformation is observed on the site (Figure 9). Therefore, it can be seen that the GRS is a green engineering method that combines rapid construction with ecological landscapes and carbon reduction. Certainly, although there are so many advantages of GRS, a geological limitation might be a concern. This paper presents a combination between GRS and traditional RC structure to deal with natural hazard, such as typhoon and earthquake. This kind of structure is completely suitable for a country like Taiwan, which has frequent natural disasters. Due to the many advantages of the composite construction method, this method has gradually been welcomed and favoured in Taiwan for disaster recovery process. This paper suggests a sustainable solution for disaster recovery engineering in countries with similar geological conditions to Taiwan.

Figure 9 GRS Structure Condition in 2018
