BORED PILE RETAINING WALL SOLUTIONS FOR EARTHQUAKE SLIP 6 AT OHAU POINT, KAIKOURA, NEW ZEALAND

ABSTRACT: The 14 November 2016 M_w 7.8 Kaikoura Earthquake triggered a number of landslips along the Kaikoura coastline. Ohau Point is located approximately 26 km north of Kaikoura and was the site of massive landslide which destroyed the road and rail transport corridors. This paper describes the bored pile retaining wall solutions that were developed as part of the North Canterbury Transport Infrastructure Recovery (NCTIR) earthquake recovery program of works for the New Zealand Transport Agency (NZTA) and KiwiRail. The subject site is named as NCTIR Site 6 and the subject bored pile retaining walls are named RTW 3.

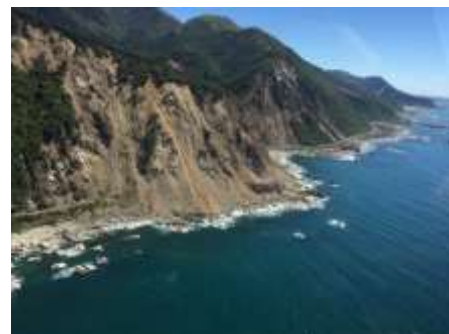
Figure 2-The Site 6 landslide a few days after the 14 November 2016 Earthquake

The major landslide which was located at the south side of Ohau Point was named as Slip 6 by NCTIR. The Slip 6 landslide material had a total volume of approximately 110,000 m³. Figure 2 shows the Slip 6 landslide a few days after the Kaikoura earthquake.

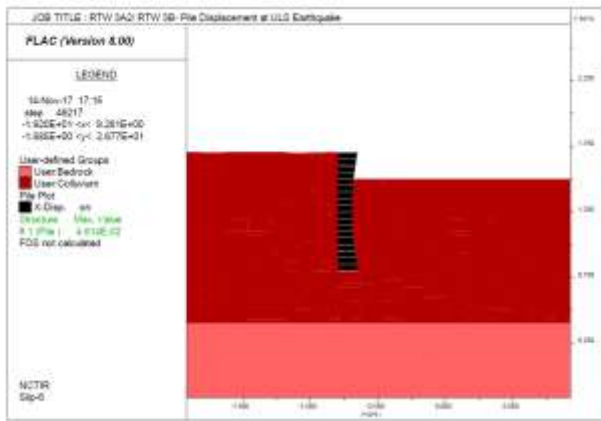
Figure 8- FLAC Model

The geotechnical stability and structural demands on the proposed retaining walls were analysed using the specialized software package FLAC version 8.00.448 and Mohr-Coulomb soil models. Figure 8 provides an example typical output from the FLAC Model, showing total wall displacements.

In the FLAC analysis, all the sections and their respective construction sequences were modelled as per the construction programme that was provided by the Delivery Team (Construction crew). Usually such program was driven by the need to have a temporary road and rail passage open as quickly as possible, with further work undertaken at a later date to achieve the permanent cross-sections and topographic profiles.

The structural demands such as bending moment, shear forces, deformations of the wall and settlement of the road and rail corridors were estimated by and inferred from the FLAC models. The results from these models was also used to optimize the spacing of the bored piles, pile size and propping systems such as anchors and concrete slabs. The slope stability in both static and seismic design cases also were analysed using the FLAC models and check make for ensure the design criteria.

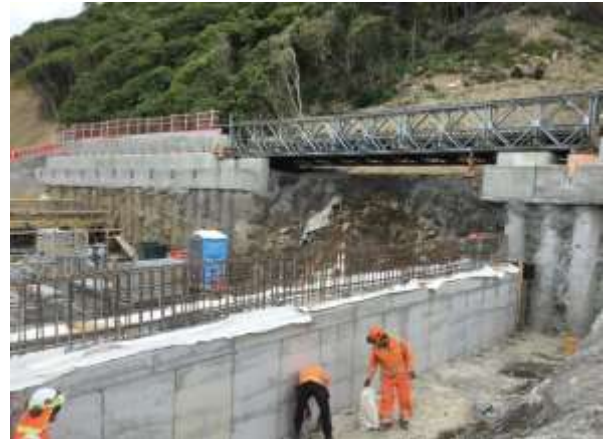
Figure 9- Bailey bridge installed above the bored pile retaining wall to enable traffic to pass safely, during the RTW 3 and debris flow bridge construction

- Complete all slope stabilisation works as appropriate, above the RTW 3 construction site.
- Construct temporarily bailey bridge crossings adjacent to RTW 3 (see figure 9)

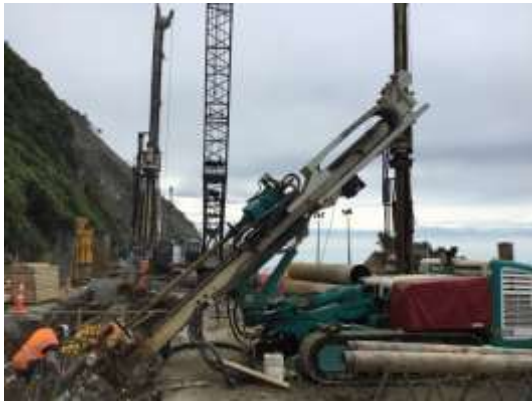
Figure 10-Bored pile construction (at RTW 3D1, an anchored section of RTW 3

- Construct bored pile - Provide a temporary casing to all pile excavations which extends 1.0 m minimum above the adjacent working platform surface (see figure 10).

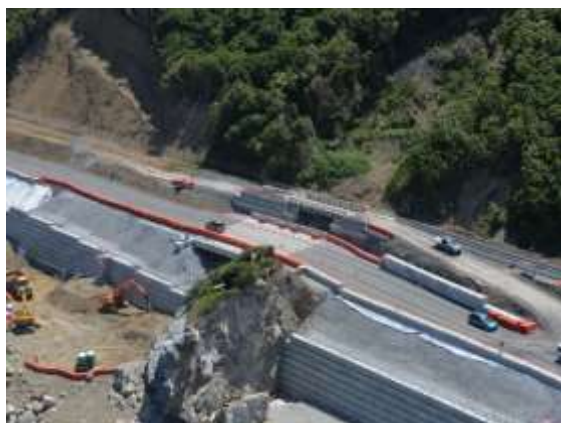
Figure 11-State Highway 1 opened after road debris flow bridge construction, the debris flow channel construction underway.
