Emergency Works and Landslide Remediation using Geosynthetics Reinforced Soil Structures – Recent Indonesian Case Studies

Deny¹, Matteo Lelli², Dinda Mutiara Savitri³

¹PT Maccaferri Indonesia, Indonesia

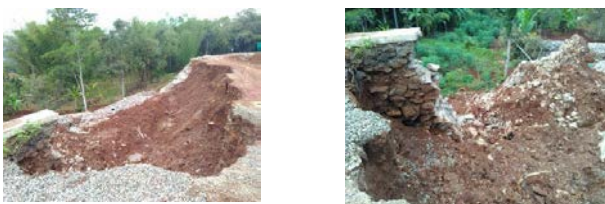
Leuwigoong Dam was built for irrigation purpose for citizens agricultural lands in Garut regency, West Java Province, Indonesia. As seen from figure below that the stone masonry at the access road along 45 meters collapsed on 24th November 2017. This incident happened after heavy and continuous rain the night before.

Figure 3 Site condition on 27th November 2017

This structure allegedly collapsed due to poor quality of back-filling compaction so that the run-off water from the rain can infiltrate inside the embankment. This also compounded by the poor drainage system on the retaining wall which not enough permeable to allow water flow from the backfill to outside the structure.

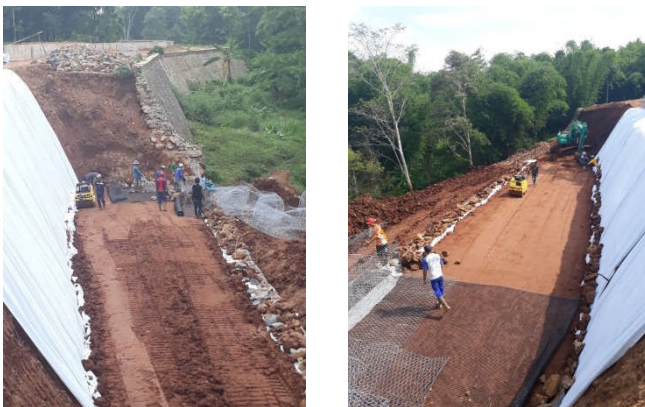
The backfilling soil was transported by trucks and unloaded with the help of heavy equipment. The use of heavyweight machinery close to the facing (within 1 m from the facing) as well as track vehicles in contact with geogrid reinforcement shall be avoided. Vibratory rollers of adequate dimensions was used in function of the filling material (as per ASTM D3282). Light vibration compactor has been used for the area close to the fascia to minimize any damage to the fascia units.

Figure 8 Installation of Terramesh and MacGrid as Reinforced Soil Structure

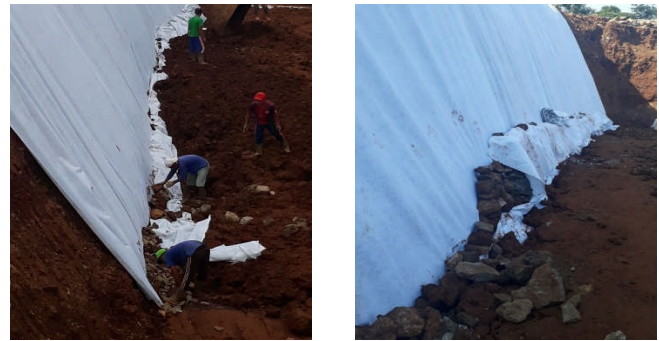
In addition, the internal drainage system inside the structure has been done by placing available permeable material, namely, rock or gravel. The thickness of the rock material is 30 cm and wrapped with geotextile as separator. And for the horizontal drainage applied by using drainage pipe with proper inclination to collect and channel the water out.

Figure 9 Installation of Gravel as a Drainage Material

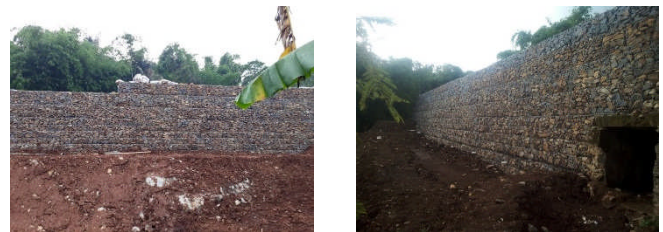
Figure 10 View of the Reinforced Soil Structure during construction (left) and almost completed (right)

The construction process is repeated until it reaches the designed height. The total construction time of this reinforced soil structure were completed in 6 weeks from January to February 2018 (see Figure 9).

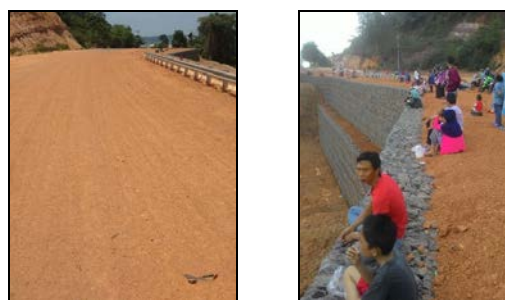
Figure 16 View of the Completed Access Road Remediation
