# State-of-the-Art of the Tunnel Maintenance in Taiwan and Challenges to Sustainable Development

**ABSTRACT:** Tunnel construction of Taiwan started early in late nineteenth century. Within 125 years, tunnel maintenance in Taiwan went through several stages. In early days, engineers meant tunnel excavation. Tunnel inspections, repairs and reinforcement were performed only when serious damage was observed. As the number of damaged tunnels increased, investigations of the most frequently recurring anomalies revealed that the degradation of tunnels in Taiwan was inevitable and usually occurred in an exceptionally short period. Frequent earthquakes, a high ground water level and poorly cemented rock masses provides a severe environment for engineering structures. Hence, to adapt more effectively to the environment, tunnel maintenance started to consider the entire life cycle of a tunnel. Recently proposed monitoring technologies and anomaly cause diagnosis methods of Taiwan have been demonstrated to be useful in supporting the sustainable operation of tunnels.

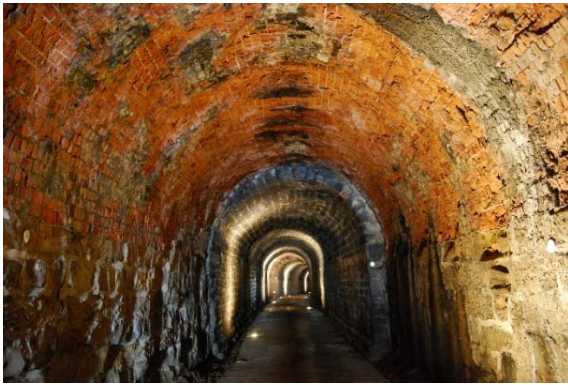
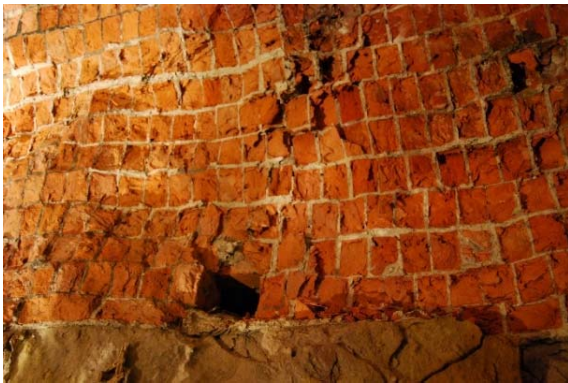
Figure 2 (a) Full view and (b) close-up of undulating surface of masonry lining in Shiqiling Tunnel

The Shiquiling tunnel was built in 1887-1890, and abandoned after only seven years of operation because the deep slope and sharp turns of tunnel alignment is unfavorable to railway. The tunnel is built by masonry bricks and stones in Keelung City (Figure 1). The masonry lining flaked off, leaving undulating surface and cracks parallel to tunnel rim (Figure 2). The continued flaking was first observed and treated in 1990, 100 years after the tunnel was completed. Chiu *et al.* (2014a) concluded that the high precipitation and rocks that are prone to weathering were responsible for the tunnel anomalies.

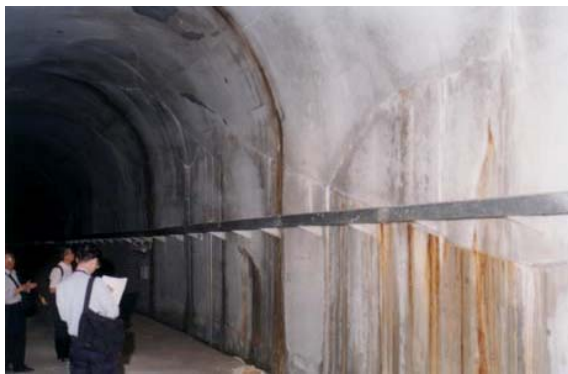
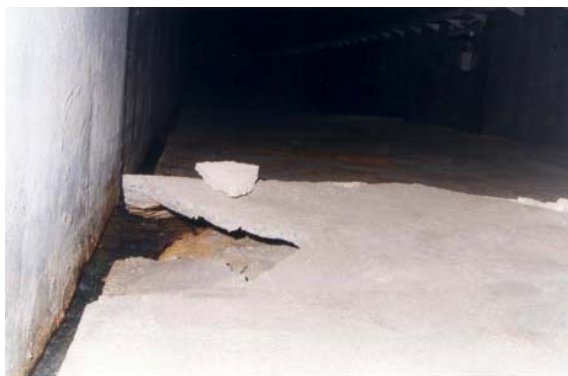
Figure 3 Anomalies in Sanyi Tunnel following Chi-Chi Earthquake in 1999; (a) inclined cracks and (b) invert heaving

The Chi-Chi earthquake with a Richter magnitude of 7.3 seriously damaged the Sanyi No.1 railway tunnel (Figure 1) in Miaoli County, which was approximately 58 km from the epicenter. Longitudinal cracks in tunnel roof and the spring line, circumferential cracks, inclined cracks (Figure 3a), invert heaving (Figure 3b) and spalling were all found in the tunnel. The earthquake damaged 53 other tunnels. Lining cracks, portal failure and lining spalling are the three most common anomalies in the damaged tunnels (Wang *et al.*, 2001).

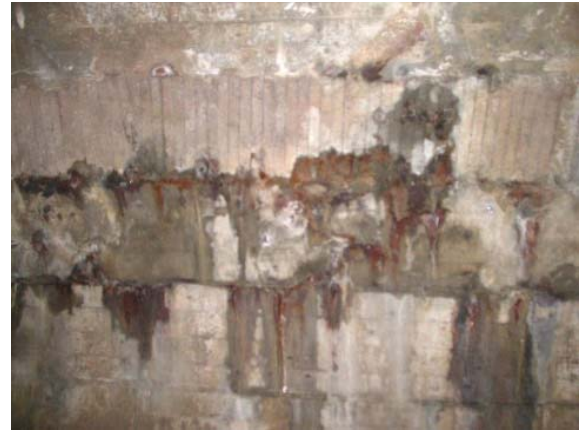
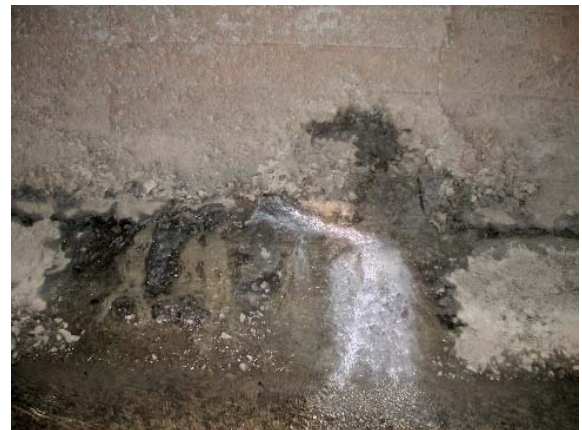
Figure 4 (a) Corroded rebar and (b) leaking water, at Wushanling Tunnel in 2004

Completed in 1920s, the Wushanling hydraulic tunnel in Tainan City (Figure 1) has been rehabilitated three times in the late 1950s, the early 1970s and the mid-2000s. None of these rehabilitations fully recover its design function and performance. Cracked lining and corroded rebar (Figure 4a) were found after the inspection in 2004. Surrounding rocks behind the tunnel lining are visible in some seriously cracked and spalling area. Along the displaced lining, water leaked (Figure 4b) and efflorescence occurred due to water abrasion. The Chia-Nan Irrigation Association is now planning to build a new Wushanling tunnel to ensure the water supply to Wushantou Reservoir.
