# Case Study – Soft Clay Site Characterization

Location = Saugus,  
Massachusetts

Deposit = thick  
deposit of Boston  
Blue Clay (BBC)

Design = replace  
existing bridge  
foundation → deep  
foundation

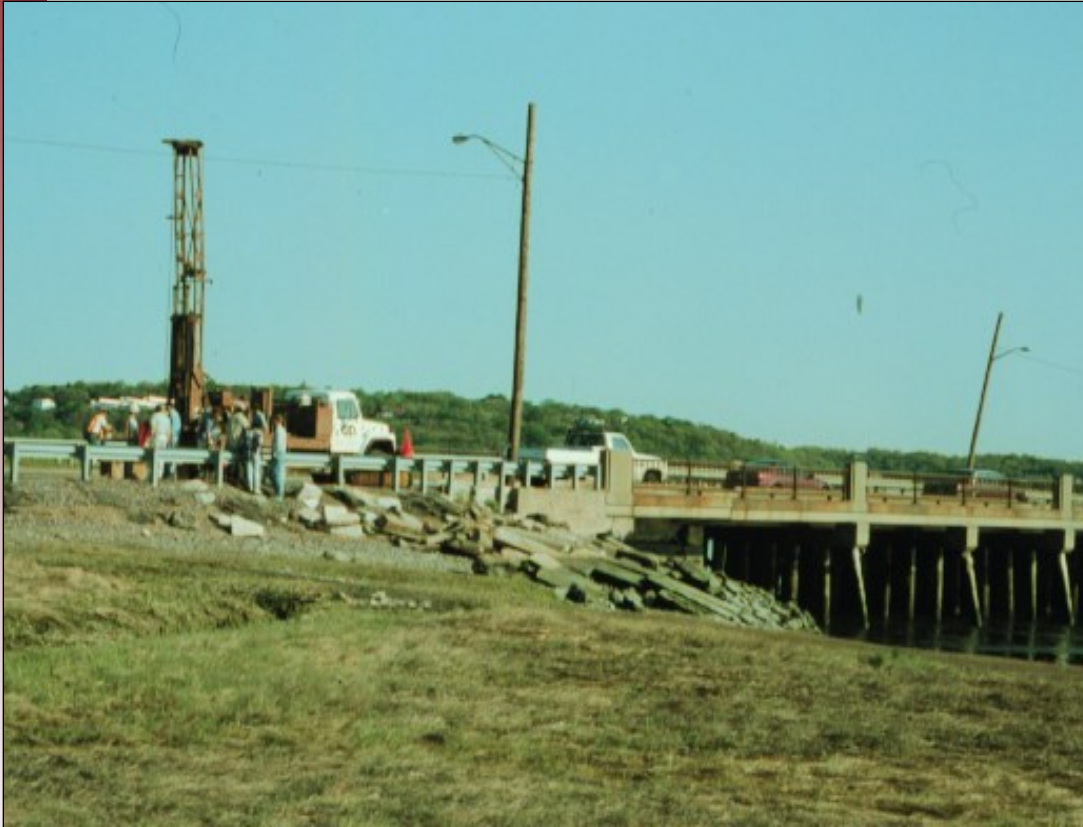
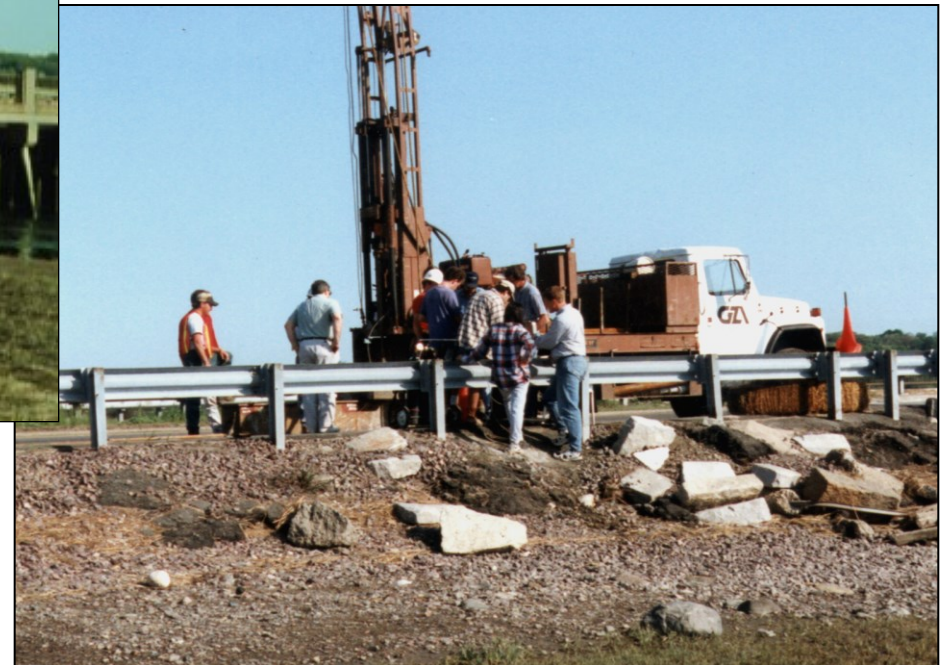
# Recommended CPTU Testing

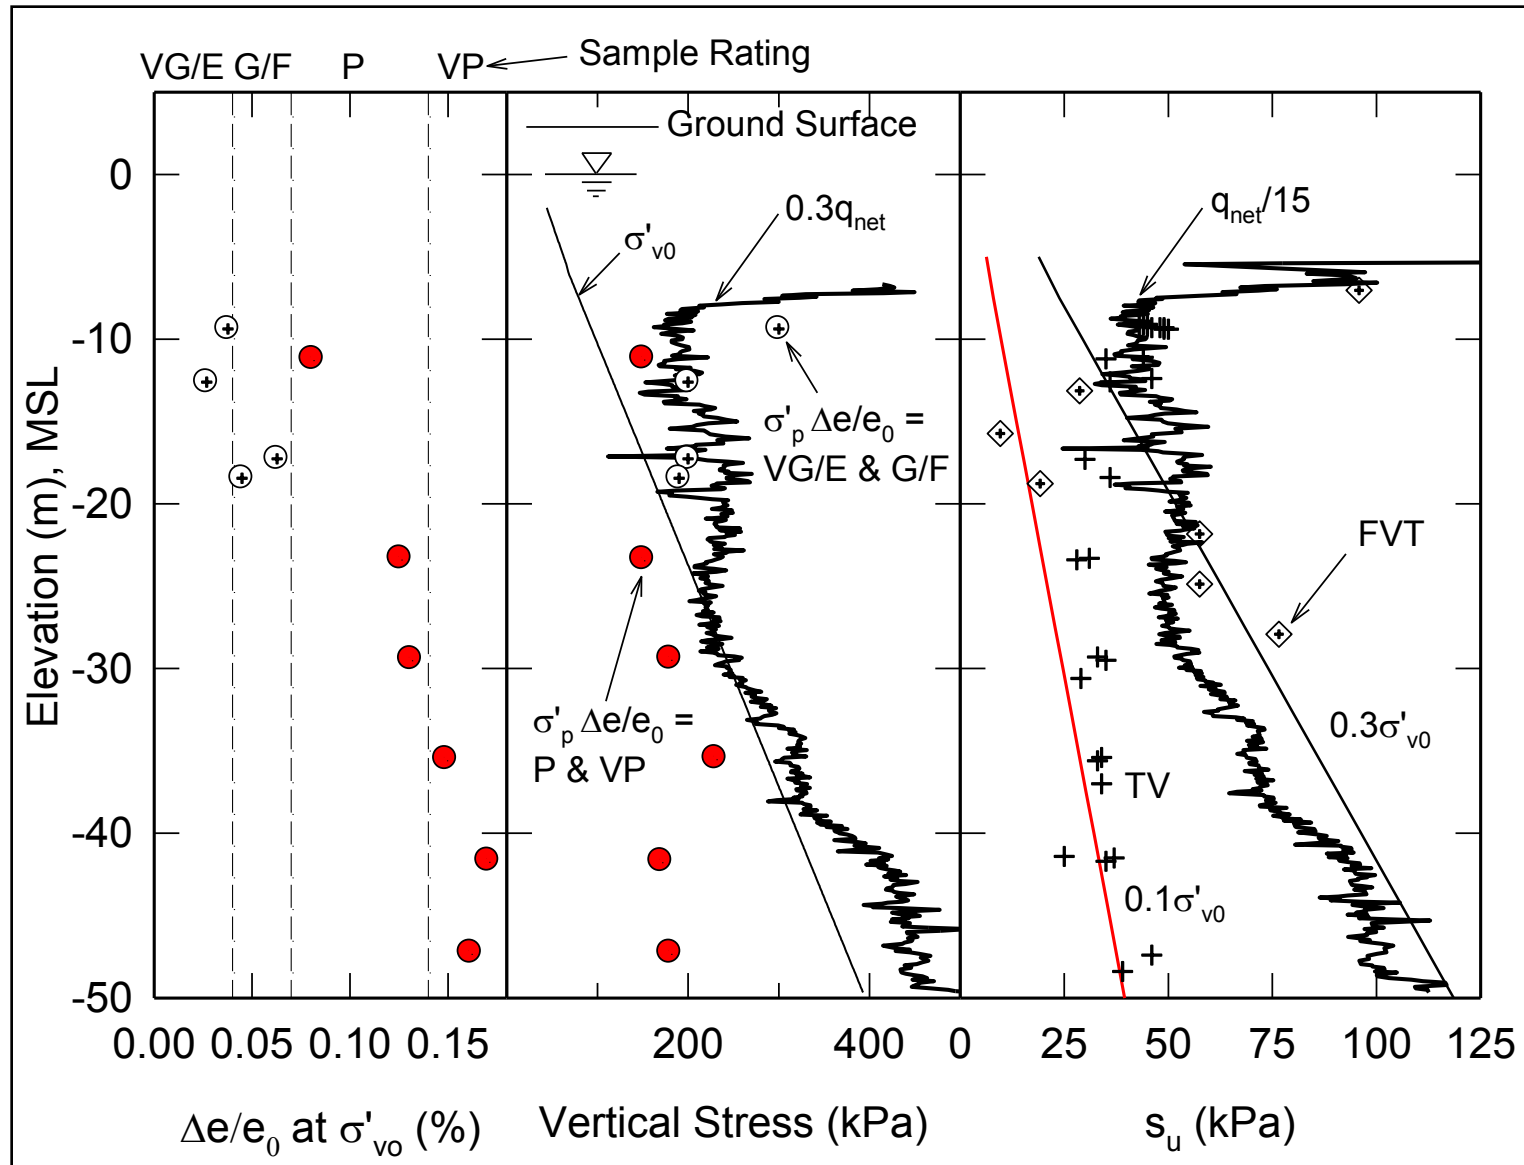
# Final Composite Profiles
