Case Histories of Failures in Geotechnical Engineering Practice

Richard Hwang

Case 1 – Human Error (Negligence)

Case 3 - Unforeseen Condition

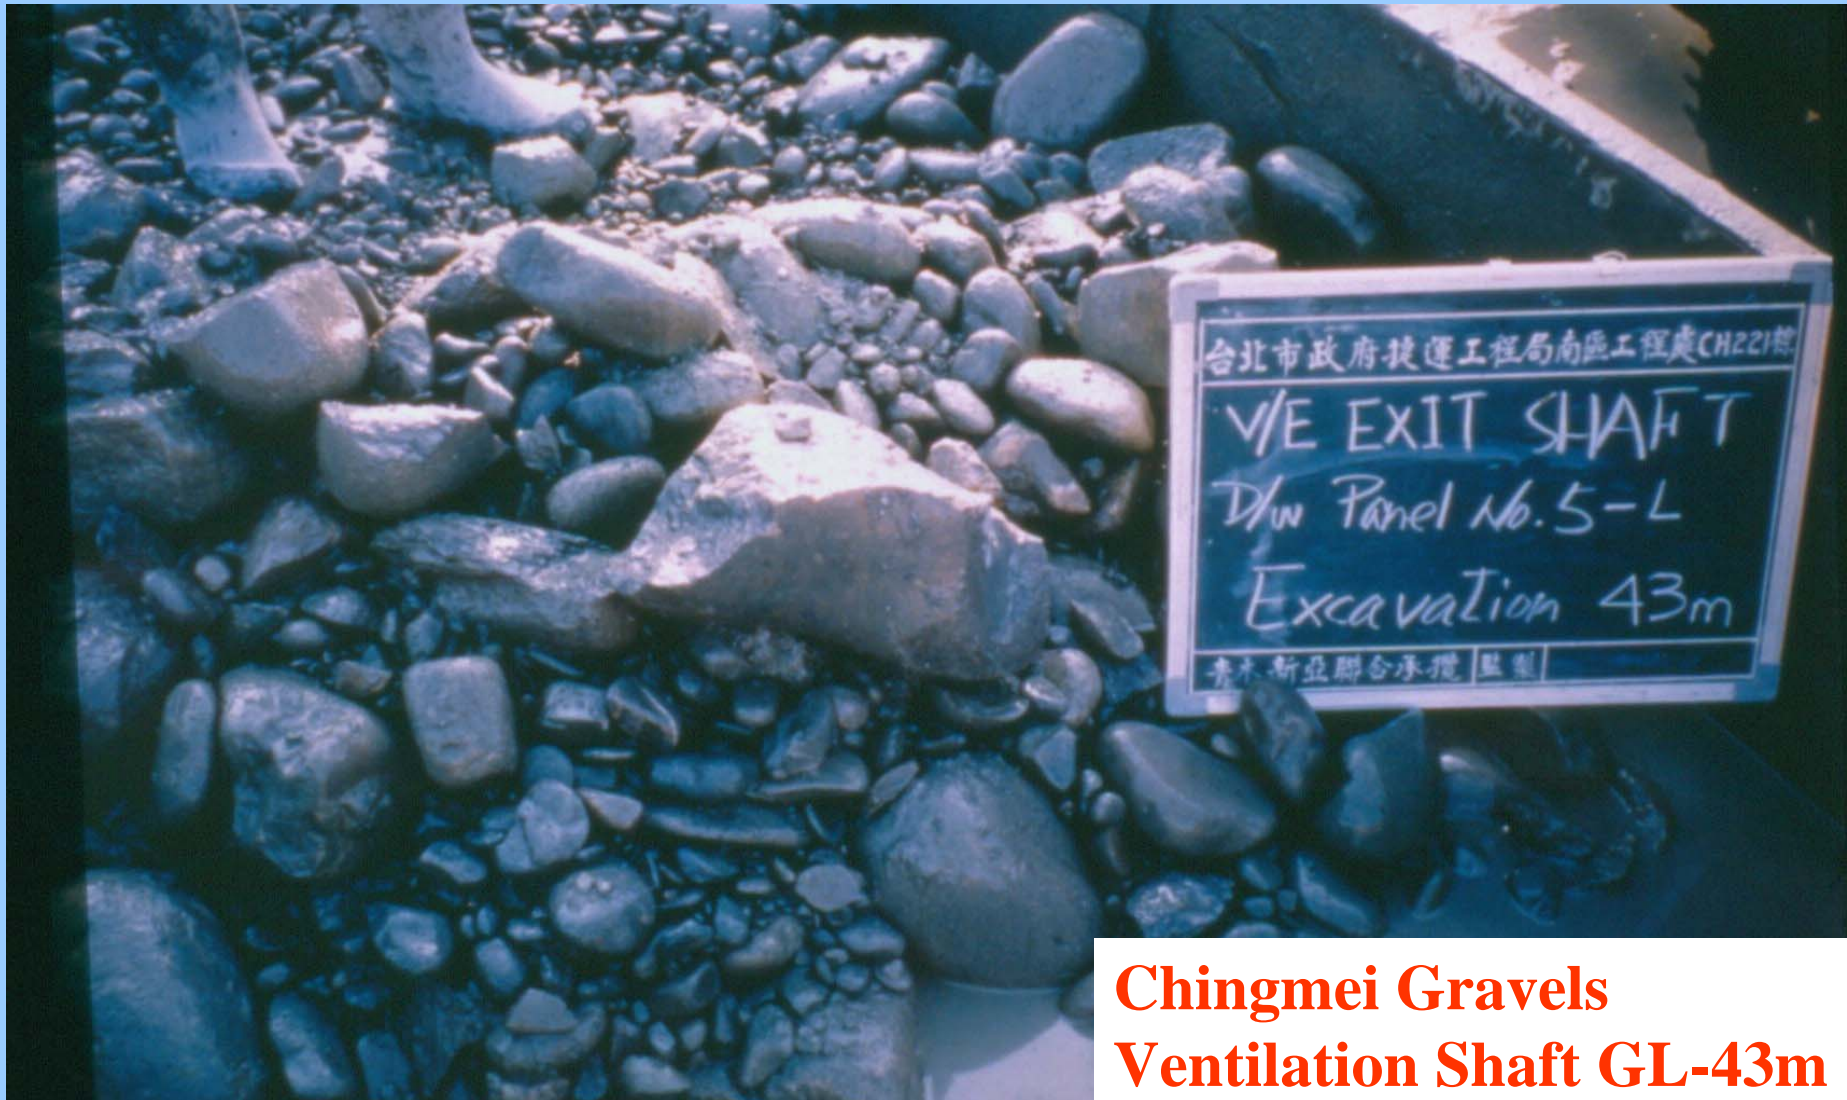
E-W Geological Profile of the Taipei Basin

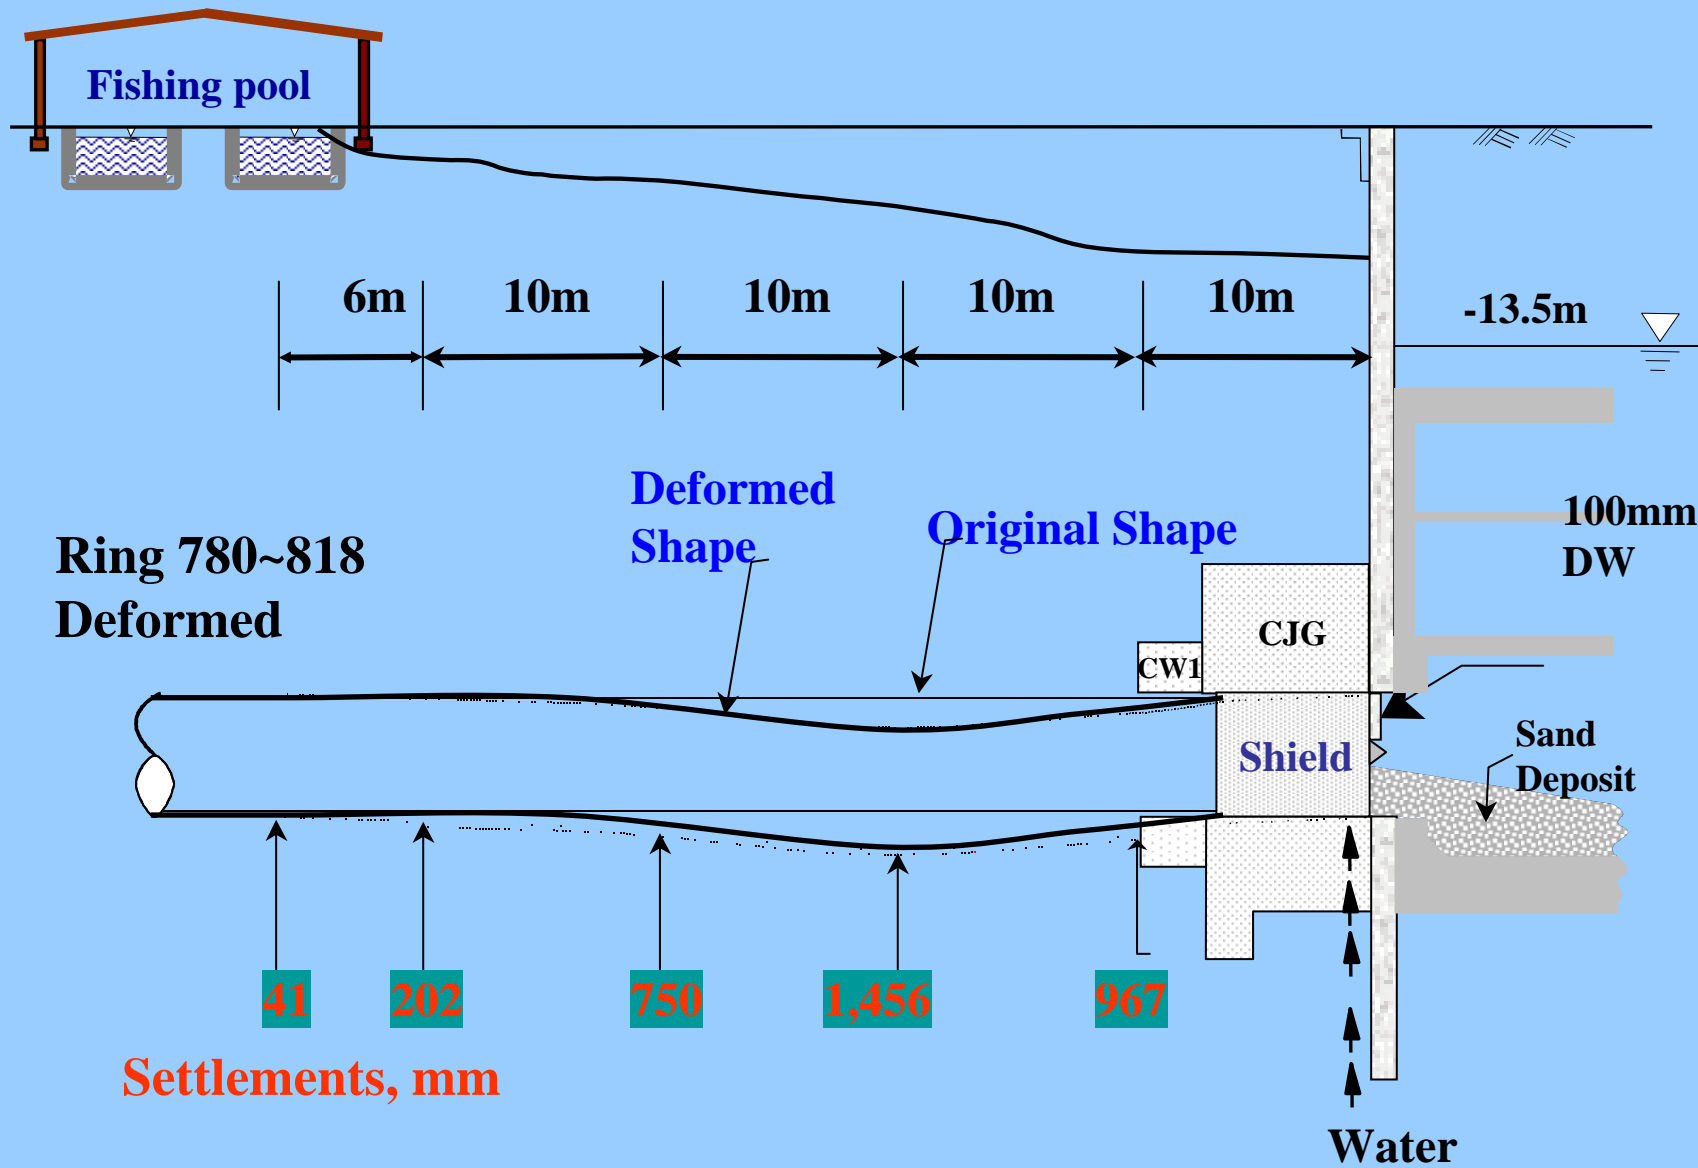
Settlement Profile
