Nicoll Highway Incident in singapore

20th April 2004

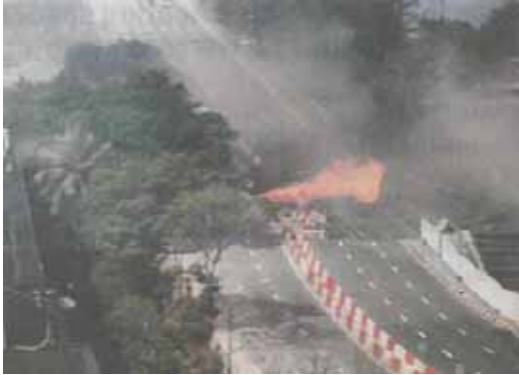
Picture of the collapse

Around 3:30 p.m. on 20 April 2004

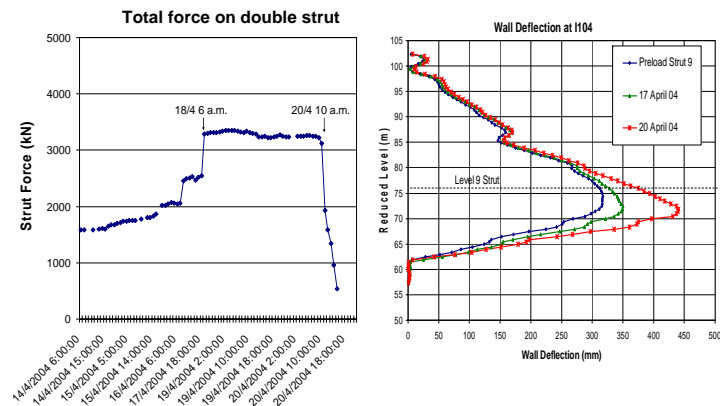
Strut Forces & Wall Rotation at S335 Level 9

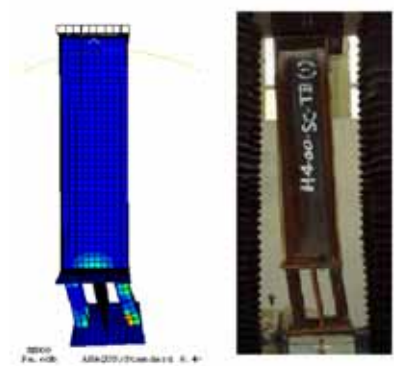
3-D Numerical Modeling
