# Challenges in Slope Engineering in Hong Kong

R. K. S. Chan

*Geotechnical Engineering Office, Civil Engineering and Development Department, Hong Kong  
raymondkschan@cedd.gov.hk*

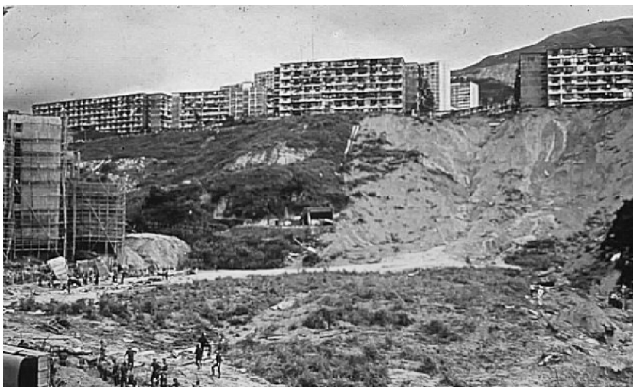
Fig. 1 1972 Sau Mau Ping landslide

In June 1972, a road embankment in a new public housing development failed (Fig. 1) and engulfed a temporary housing area. Seventy-one people died. A few hours later, a temporary excavation in the Mid-levels district on Hong Kong Island collapsed, bringing down the natural hillside above it (Fig. 2). The debris demolished a 13-storey building and killed 67 people.

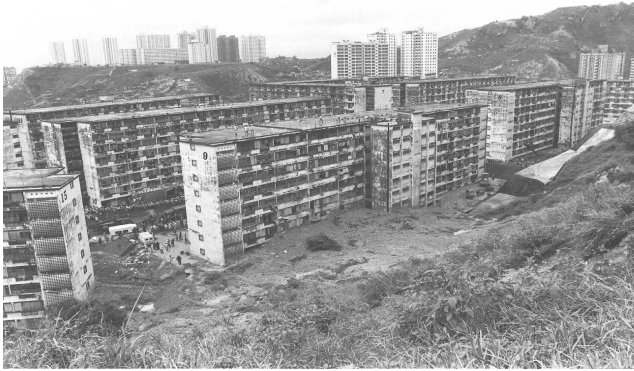
Fig. 3 1976 Sau Mau Ping landslide

In 1976, another road embankment in the same housing development of the 1972 failure again failed (Fig. 3), killing 18 people. The Government invited international geotechnical experts to review the landslide problem. One of the outcomes of the review was the setting up of the Geotechnical Control Office in 1977 (renamed as Geotechnical Engineering Office (GEO) in 1991, currently part of the Civil Engineering and Development Department of the Government of Hong Kong SAR), as a central body to regulate geotechnical engineering and slope safety in Hong Kong (Hong Kong Government, 1977).

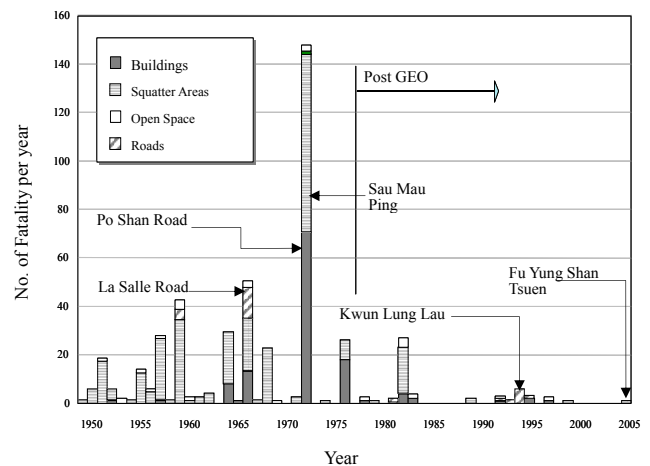
Fig. 6 Known landslide fatalities in Hong Kong

occurrence of multi-fatality landslides. The previously secondary impact of landslides, viz. temporary closure of roads and building evacuation, then became key issues. The public also demanded better environment, a more transparent government and enhanced information service. The GEO reacted positively to the new challenges by:

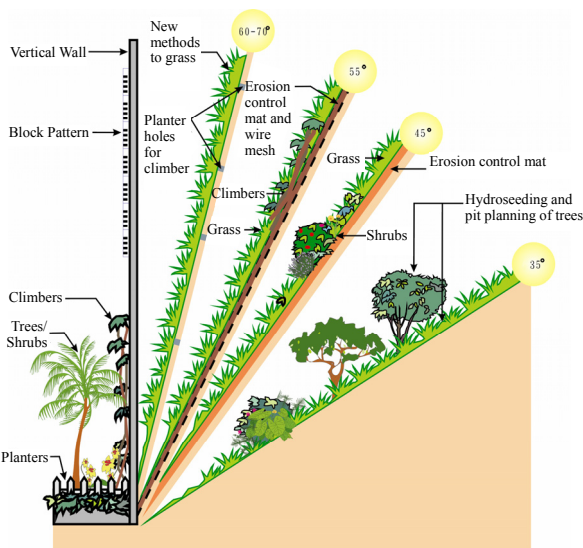
Fig. 7 Common methods of vegetating slopes

People want a slope to be safe as well as pleasant looking and environmental friendly. To meet this challenge, the GEO landscapes all the slopes that are upgraded under the LPM programme. New greening techniques are introduced (Fig. 7). The commonly used methods are provision of vegetation covers with the use of erosion control mats as needed, masonry block facing, ribbed or other patterned finishes, toe planters, colouring and planter holes, coupled with suitable retention of existing vegetation. More fancy techniques such as decorative artwork and artificial rock are occasionally used (Fig. 8). The enhancement in slope appearance has been made possible by promulgation of new technical guidelines (e.g. GEO Publication No 1/2000 (GEO, 2000)), sharing of experience amongst practitioners and getting specialist advice from landscape experts where needed (Chan, 2005).

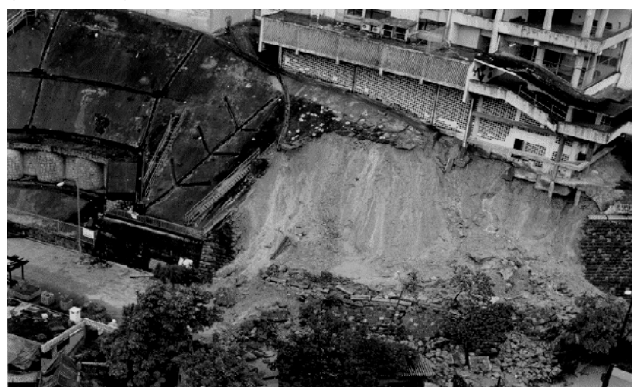
Fig. 11 1994 Kwun Lung Lau landslide

A landslide occurred adjacent to a footpath within the Kwun Lung Lau housing estate in Hong Kong on 23 July 1994 (Fig. 11). The landslide involved the collapse of a masonry wall more than 100 years old, that was likely to have been intended as a facing to a steep cut slope. It resulted in five fatalities and serious injuries to three other people. It was a 'surprise' and aroused great concern of the public, the legislators and the Administration. The GEO carried out a comprehensive investigation into the cause and mechanism of the landslide (GEO, 1994), and an international geotechnical expert was engaged to conduct an independent review of the investigation (GEO, 1994).

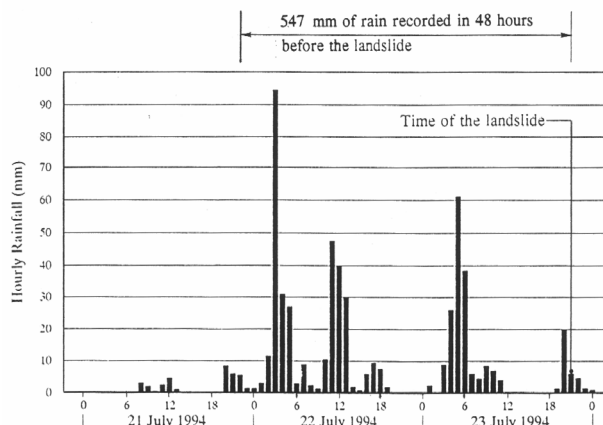
Fig. 12 Rainfall at Kwun Lung Lau at the time of landslide

The landslide occurred in the late evening at about 8:53 pm during heavy rainfall (Fig. 12). Many people walked along the footpath at that time. The landslide debris, about 1000 m<sup>3</sup> in

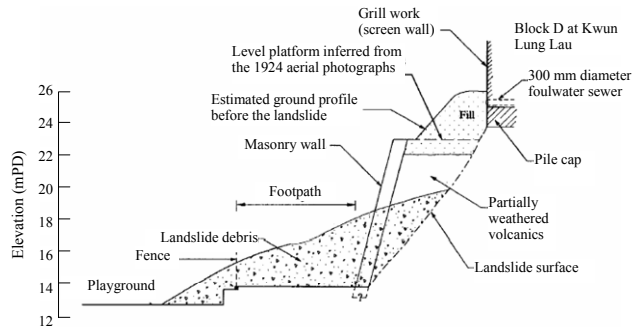
Fig. 13 Cross section of the ground that failed at Kwun Lung Lau

volume, buried the footpath and some passengers. The landslide scar measured 28 m wide and 14 m high, with an average depth of about 3 m. A cross section through the landslide site, showing the ground profiles before and after the failure, is given in Fig. 13. The geology of the landslide location comprised fill overlying partially weathered volcanics. The fill behind and above the wall was loose and generally very permeable.

It was known from old topographic maps that the wall was constructed some time before 1901. Additional fill was placed behind the wall between 1964 and 1969. Engineering analyses showed that, prior to the placement of the additional fill, the wall would not become unstable even if the retained soil became fully saturated. After placement of the fill, the stability of the wall relied on soil suction that was developed in the soil beneath the surface cover, and it would become unstable if the soil became saturated.

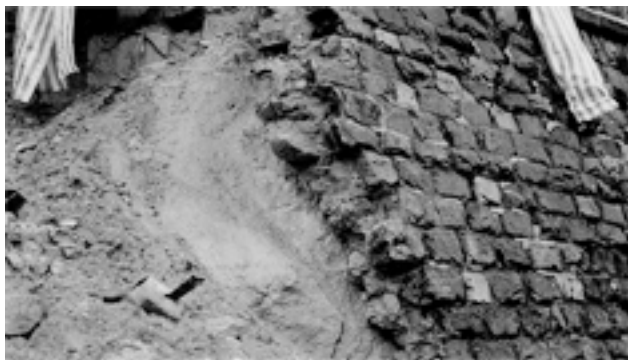
Fig. 14 Close view of the collapsed retaining wall

The masonry wall that failed was a pointed squared-rubble wall with stone ties and weepholes. This kind of wall was once commonly constructed in Hong Kong. The wall has a maximum height of 10.6 m. At the failure location, the wall was 700 mm to 800 mm thick, and was constructed against a cutting into the natural ground (Fig. 14). The wall had been inspected by a number of professional parties in the past. The wall was found to be in fair or good condition; no signs of distress were ever recorded.

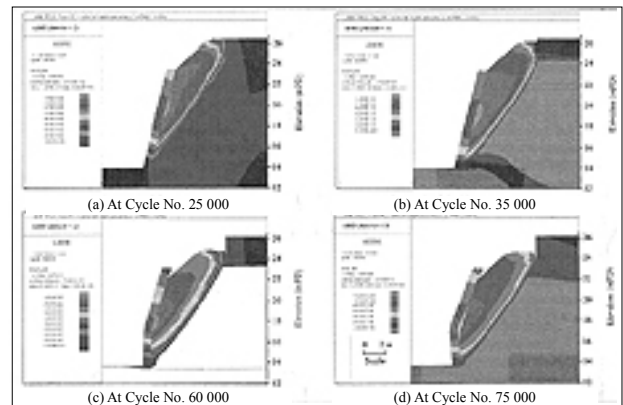
Fig. 15 Numerical modelling of the 1994 Kwun Lung Lau retaining wall failure

According to the accounts of witnesses, the masonry wall failed initially by bursting at about its mid-height. The brittle mode of failure of the slender wall was confirmed using numerical analysis. The analysis predicted that the wall would fail with a complex mechanism, involving a combination of bulging and overturning modes followed by sudden total collapse of the ground (Fig. 15).

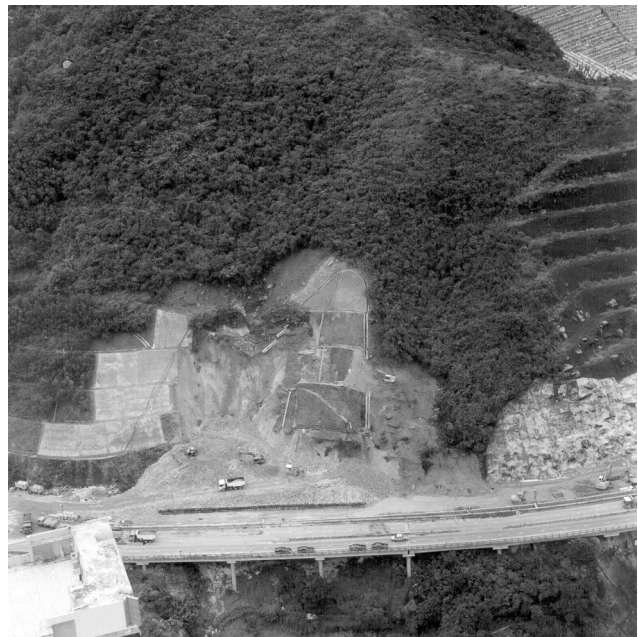
Fig. 16 1997 Ching Cheung Road landslide

In July and August 1997, a series of three landslides occurred on a roadside cut slope above Ching Cheung Road (Fig. 16), which is a major trunk road in the urban area. The last landslide event was the biggest. It occurred at 11:15 a.m. on 3 August 1997. The landslide debris completely blocked a 50 m section of the road and trapped a vehicle. The trunk road was subsequently closed for about one month until completion of temporary stabilization works to the slope.

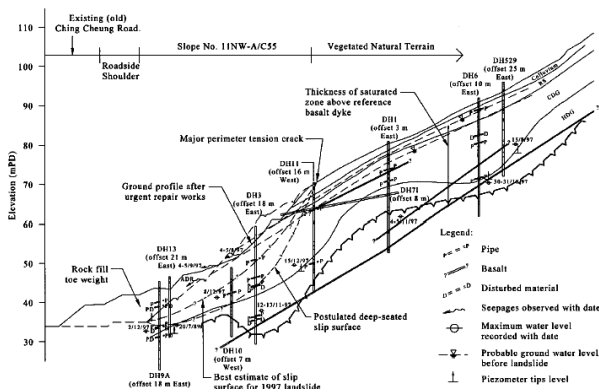
Fig. 17 Geological section of the landslide at Ching Cheung Road

The landslide scar measured about 20 m wide, 30 m high and up to 7 m deep. The failure volume was about 2000 m<sup>3</sup>. The geology of the ground was complex (Fig. 17). The dominant material in the slope was highly and completely decomposed medium- to fine-grained granite, with medium to closely spaced joints. Some basalt dykes up to 1.3 m thick intruded into the granite. The basalt dykes were occasionally weathered to clayey silt. The permeability of the dykes would be notably lower than that of the surrounding weathered granite and therefore the dykes probably acted as aquitards locally. Extensive natural erosion pipes, up to 250 mm in height, were also present throughout the weathered rock profile. The pipes were generally infilled with

quartz-rich fine silts and sands at the top, grading to fine gravels at the base.

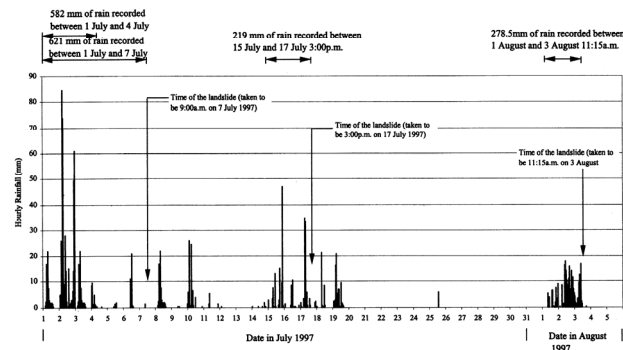
Fig. 18 Rainfall preceding the landslide at Ching Cheung Road

Previous landsliding would have caused local weakening of the weathered rock mass and contributed to the development of the natural pipe system in the slope. The 1997 landslides were triggered by adverse transient groundwater conditions which were developed following severe rainfall in early July 1997 (Fig. 18) and the previous months. The system of raking drains installed in 1972 was unable to prevent the critical groundwater pressures from developing, possibly due to deterioration and/or blockage of the drains prior to the slope failure. The slope, though having been cut back, became unstable when the groundwater level rose to the critical level.

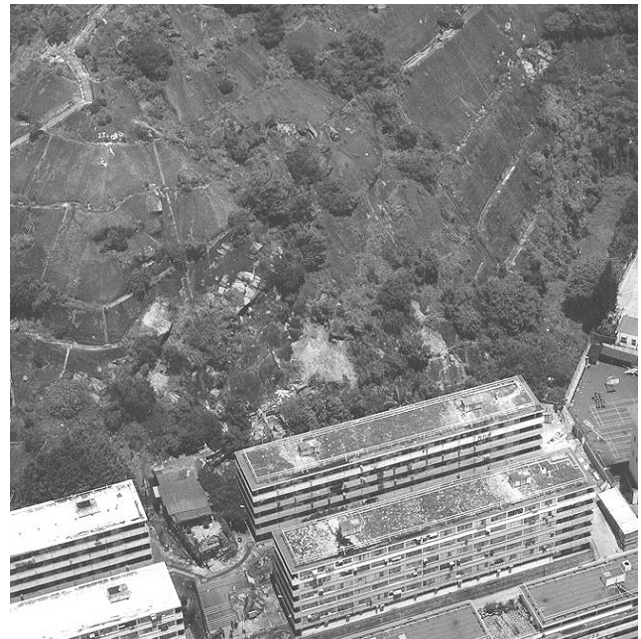
Fig. 19 1999 Shek Kip Mei landslide

On 25 August 1999, a landslide occurred at a cut slope behind some public housing blocks in Shek Kip Mei in the urban area of Hong Kong (Fig. 19). The landslide resulted in extensive cracking of the slope and localized detachment of soil mass. The volume of distressed material was about 2500 m<sup>3</sup>. Three housing blocks and a temple were permanently evacuated. More than 1000 people were affected. In the process of evacuation, an old woman who had lived in the housing estate for a long time committed suicide because of the worry on the move to new environment.

The slope affected was about 100 m long and has a maximum height of about 50 m. It comprised predominantly partially weathered medium-grained granite. Persistent sub-horizontal discontinuities were found. The discontinuities were generally infilled with polished, slickensided kaolin and manganese oxide deposits (Fig. 20). Pre-existing infilled tension cracks were noted at the soil surface below apparently intact chunam cover. These features indicated that slope movements had occurred in the past.

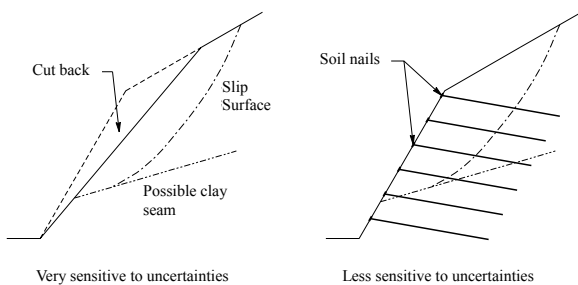
Fig. 21 Robustness of design scheme

Soil nailing is recognized as a robust scheme in that it is more resilient to local geological defects and unforeseen hydrogeological conditions and can effectively arrest instability due to the unforeseen conditions (Fig. 21). Nowadays, soil nailing is the most common type of stabilizing measures in Hong Kong. More than 200 man-made slopes are upgraded by means of soil nails each year.

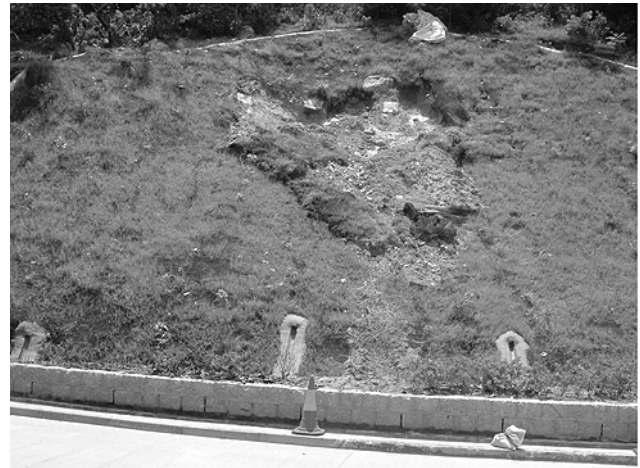
Fig. 22 Local failure at a soil-nailed slope

technology is not immune from technical problems. Minor surface failures did occur on a few vegetated slopes mostly in-between soil nail heads (Fig. 22). Large-scale failures had occurred in temporary soil-nailed slopes before soil nailing works were completed (Fig. 23). A common feature of these failures is the absence of soil nail heads. Construction problems were encountered occasionally, including hole collapse, excess grout loss, ground settlement and poor integrity of grout sleeve. These problems are generally associated with long soil nails (over 20 m in length). Practitioners had also raised questions on analysis method, soil-nail interaction, durability, quality control, etc.

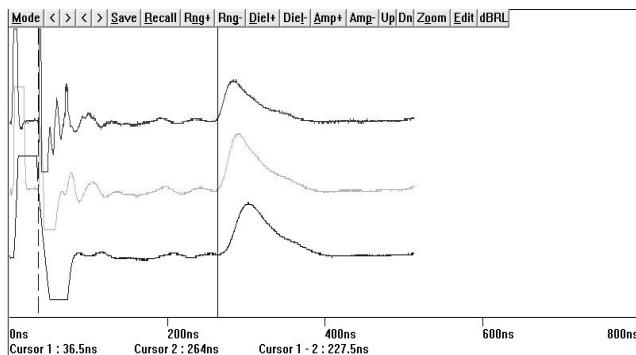
Fig. 24 Use of time domain reflectometry to determine the length of soil nail

- Development of reliable non-destructive technique for checking the integrity of installed soil nails, e.g. the use of time domain reflectometry (Fig. 24) (Cheung, 2005),

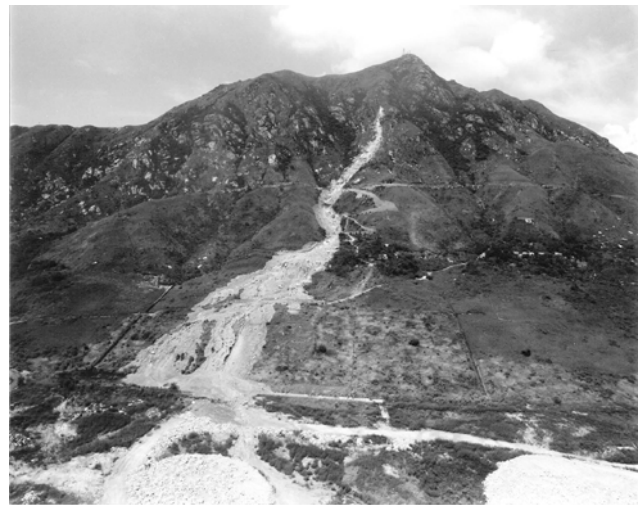
Fig. 25 Debris flow at Tsing Shan in 1990

In 1990, a large channelised debris flow occurred on the steep slopes of Tsing Shan in the northwestern part of Hong Kong (Fig. 25). The landslide had a source volume of about 2000 m<sup>3</sup>. After erosion and entrainment, the total volume of debris became 20,000 m<sup>3</sup>. The landslide had a runout distance of more than 1000 m. Up to 3 m of debris was deposited on a vacant site at the

foothill and there was fortunately no damage to life and properties (King, 2001).

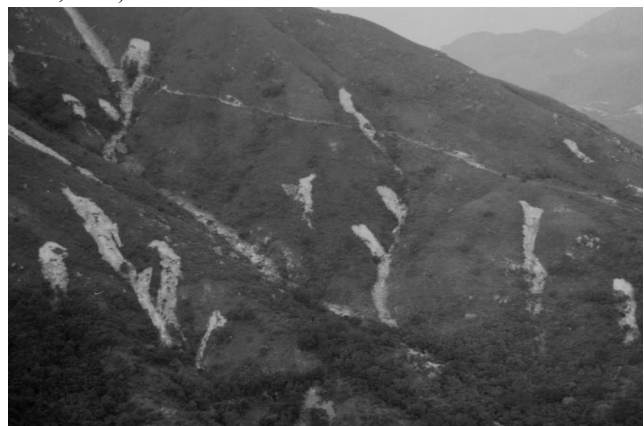
Fig. 26 Natural terrain landslides in Lantau in November 1993 rainstorm

In November 1993, over 700 mm of rain fell in 24 hours on parts of Lantau Island and resulted in more than 800 landslides on the natural terrain (Fig. 26). As development on Lantau Island was scarce, the landslides did not cause much concern (Wong & Lam, 1997).

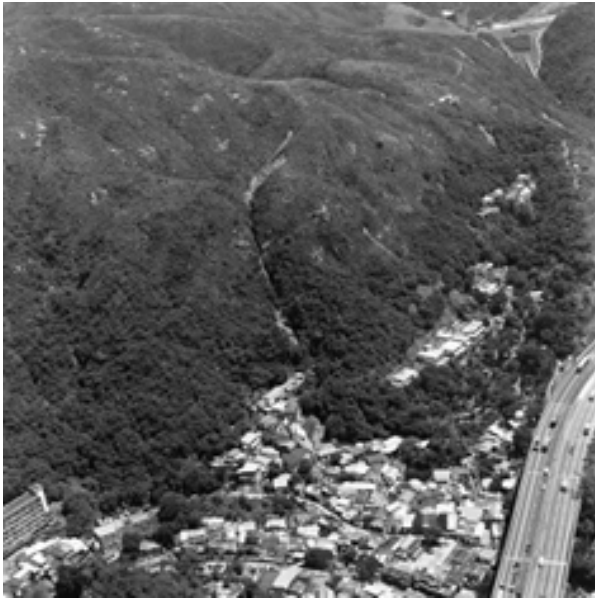
Fig. 27 Debris flow at Sham Tseng San Tsuen in 1999

On 23 August 1999, a channelised debris flow impacted on a number of squatter dwellings in Sham Tseng San Tsuen, which is situated at a foothill in the west of Kowloon (Fig. 27). The debris flow resulted in one fatality and several injuries. The debris flow was initiated from a landslide at the natural terrain. Approximately 500 m<sup>3</sup> of detached landslide debris entered a stream course and turned into the mobile channelised debris flow. The debris contained abundant boulders of size up to 1 m in a gravelly, silty sand matrix. The horizontal travel distance of the debris flow was about 270 m from the crest of the main landslide to the distal end of the debris (Fugro Maunsell Scott Wilson Joint Venture, 2005).

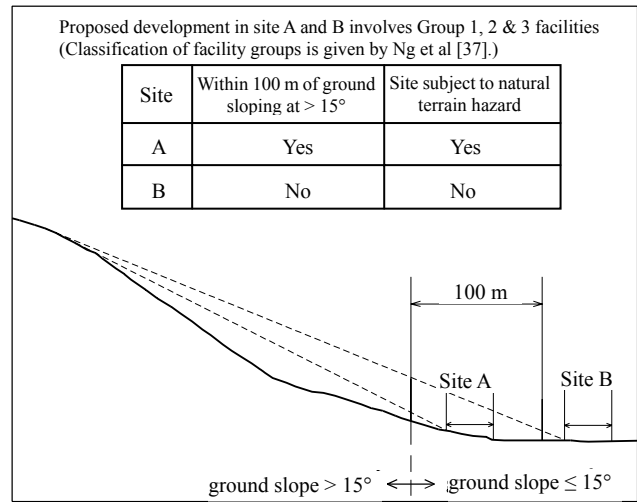
Fig. 28 Guidelines for screening of sites subject to natural terrain hazards

Hong Kong has established a set of simple and suitably conservative guidelines (Wong, 2004a), on the basis of runout distance of landslide debris, for initial screening purposes to assist planners, land administrators, project manager, etc. to review whether or not a given site may be subject to natural terrain landslide hazards (Figs. 28 & 29). Where a site is shown to be potentially affected by landslide hazards, more refined criteria are then used to examine whether the proposed development meet the ‘in-principle objection’ criterion (i.e. to relocate the proposed development or amend development layout), or the ‘alert criteria’ (i.e. to carry out natural terrain hazard study (NTHS) and the appropriate mitigation measures as part of the development).

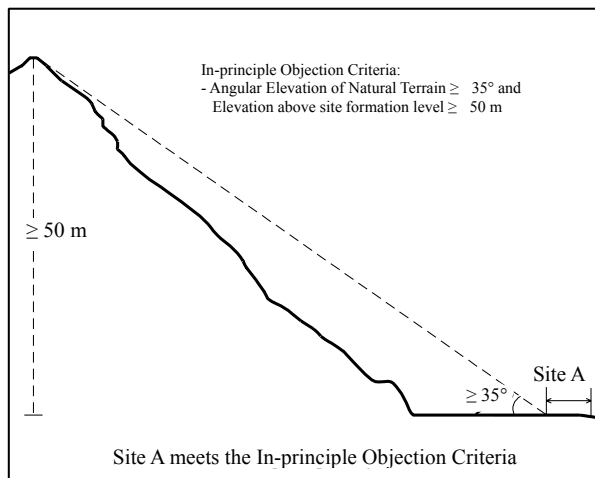
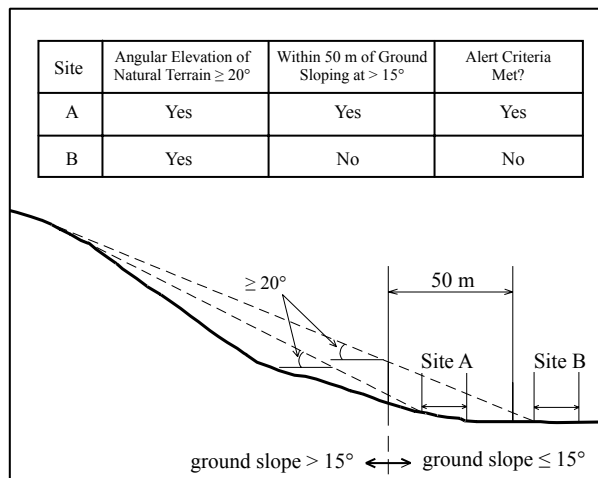
Fig. 29. Guidelines for follow up actions on sites subject to natural terrain hazards

(a) In-principle Objection Criteria (Relocation of site to be considered if criteria are met)

(b) Alert Criteria (Natural Terrain Hazard Study to be undertaken if criteria are met)

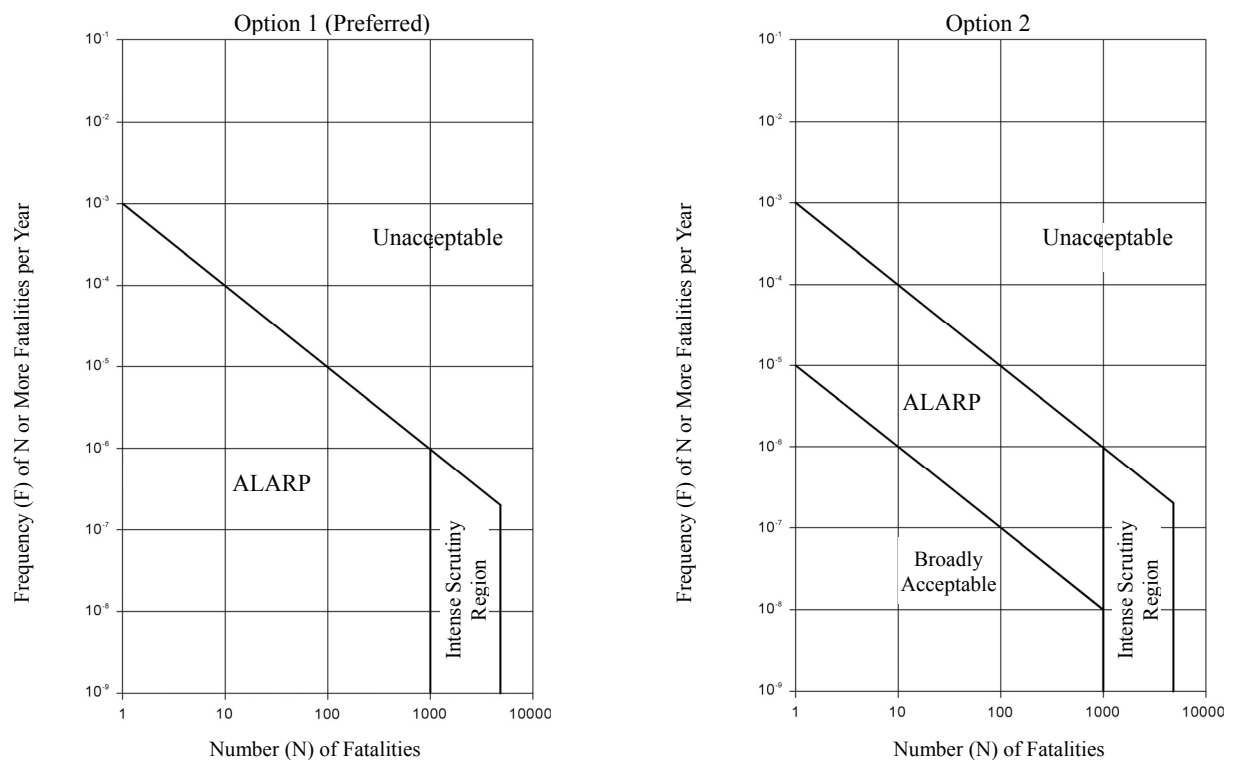
Fig. 30 Recommended societal risk criteria for landslides and boulder falls from natural terrain

The QRA approach entails detailed assessment of the probability and consequence of natural terrain hazards to a development site and determines any necessary mitigation measures. This approach provides a formalized methodology to gauge the relative importance of different parameters and the uncertainties associated with them, and to determine the acceptability of a calculated risk level by comparing it to established guidelines. Local risk acceptability guidelines for

landslides and boulder falls from natural terrain were developed (ERM, 1998) (Fig. 30).
