# Chapter 14

## Seismic Behavior of Slopes and Embankments

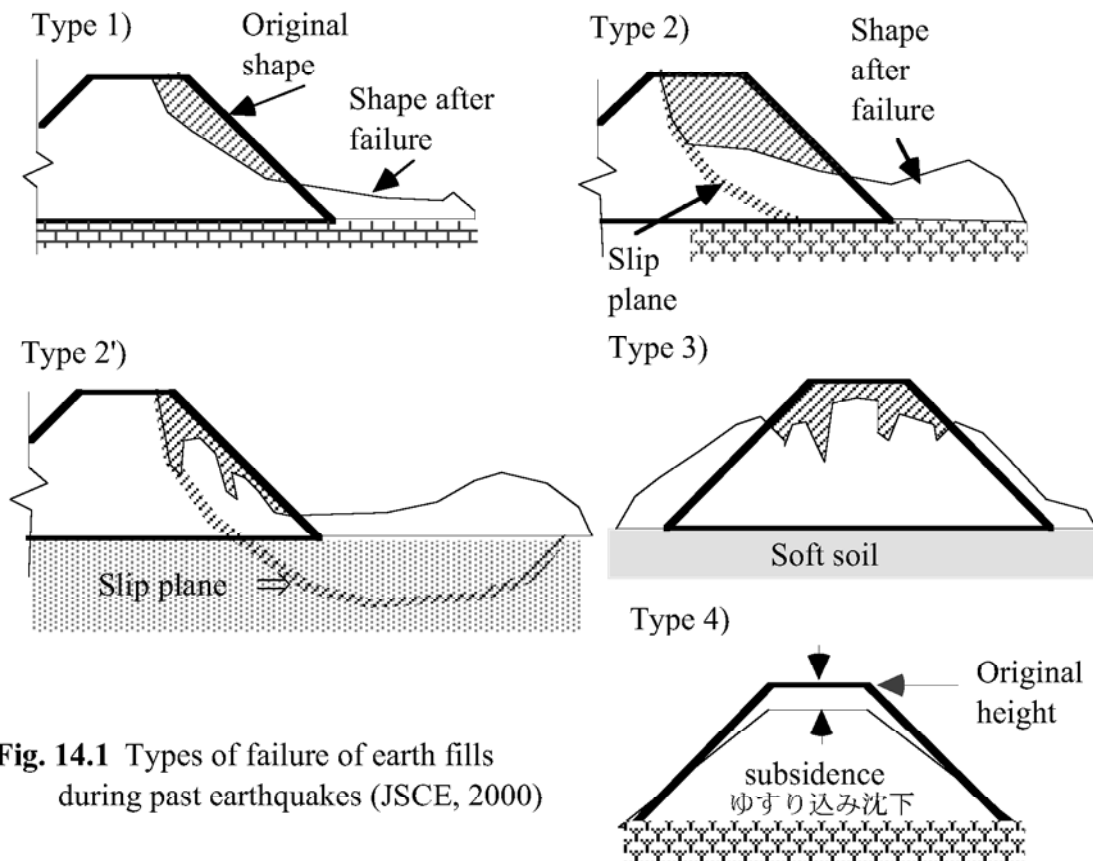
**Fig. 14.1** Types of failure of earth fills during past earthquakes (JSCE, 2000)

Figure 14.1 illustrates a variety of residual deformation of earth fills which were experienced during past earthquakes. They are classified as 1) shallow surface sliding of slope, 2) development of slip surface within the body of embankment, 2') development of slip surface reaching the soft foundation soil, 3) slumping, and 4) densification. Another type of damage of fill is the one caused by fault action. A river-dike fill resting directly upon a fault was deformed as shown in Fig. 14.2 (Wufeng 霧峰 in Taiwan). This dike was quickly repaired as shown in Fig. 14.3.

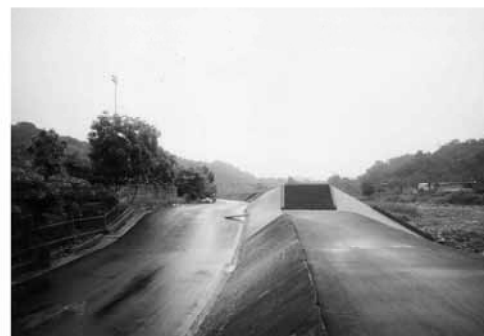
**Fig. 14.3** Repaired shape of dike in Wufeng

The quick restoration in Fig. 14.3 makes an important point that the restoration of earth structure is much easier and quick than that of steel or concrete structures. This issue will play an important role in the discussion on allowable seismic displacement in the performance-based design principle (Sect. 14.4 and Sect. 14.5).

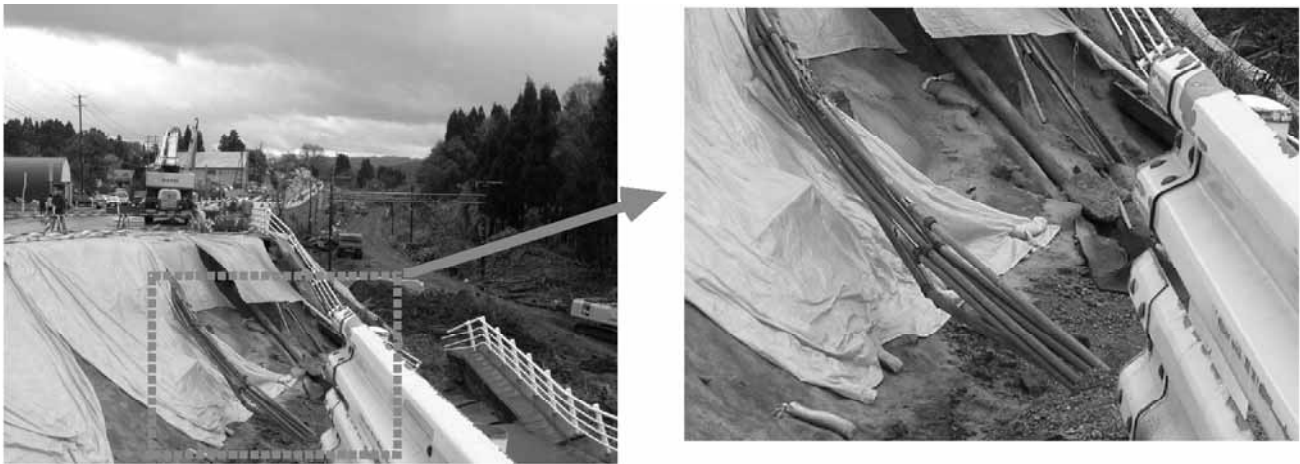
**Fig. 14.4** Effects of collapse of road embankment on embedded lifelines

Failure of an embankment may trigger additional problems. Fig. 14.4 shows a case of road embankment during the 2004 Niigata-Chuetsu earthquake (see Fig. 14.24 as well). The large displacement of a road fill destroyed many embedded pipelines. It is important that this site was situated upon a small valley, suggesting the potential instability of embankment upon such a small geology; see also Fig. 14.43.

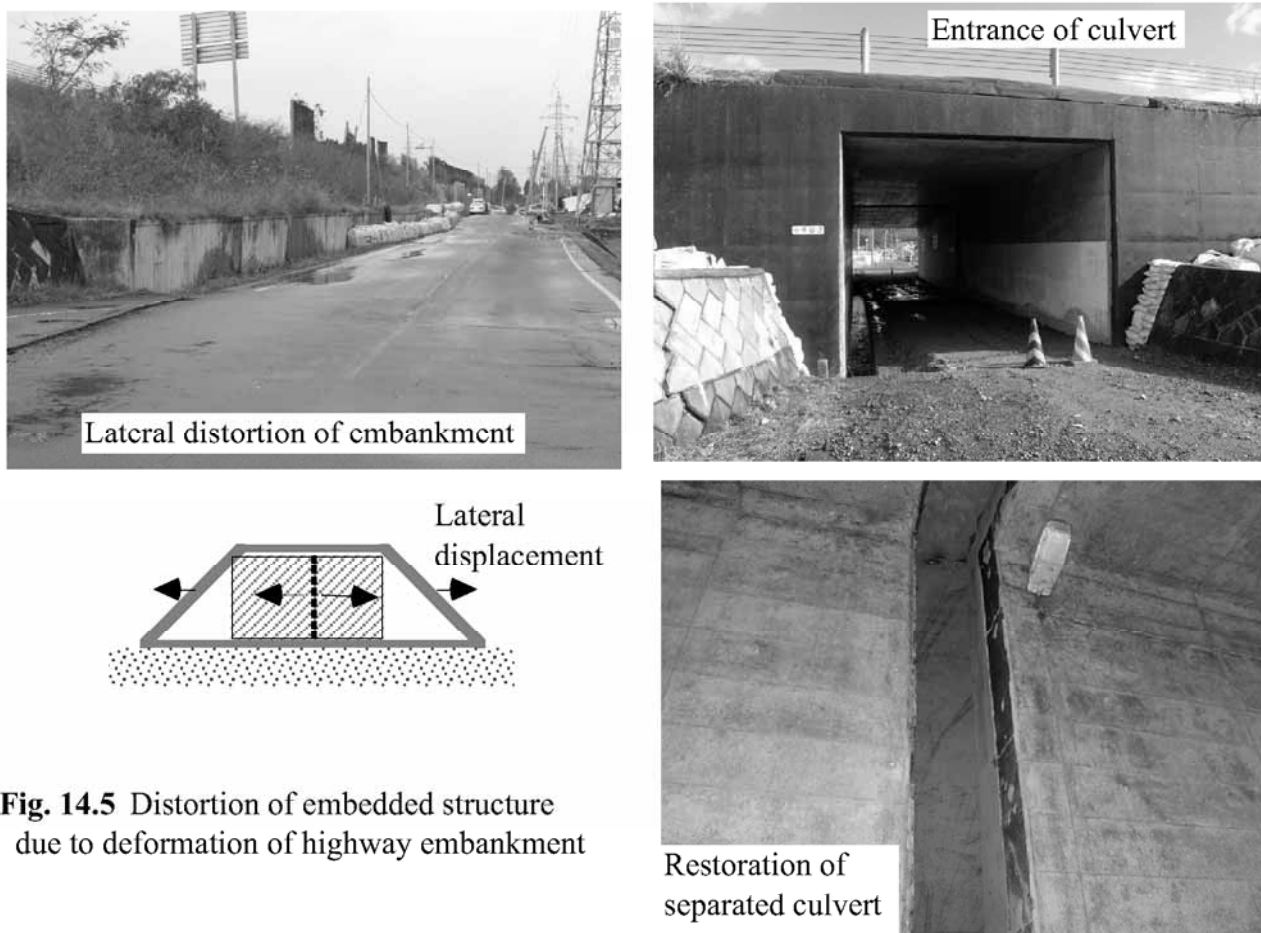
**Fig. 14.5** Distortion of embedded structure due to deformation of highway embankment

Another example is demonstrated in Fig. 14.5. A highway embankment deformed in the horizontal direction and an embedded underpass concrete structure (culvert) was separated into two pieces. The separation was restored by placing steel plates. Thus, the stability of an embankment has to be discussed from the viewpoint of interaction with embedded facilities.

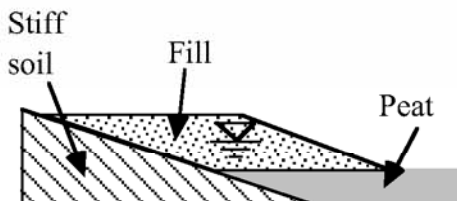
**Fig. 14.8** Mechanism of failure of Kayanuma fill

A deeper slip plane inside a fill (Type-2 and 2') can generate a more significant damage. Fig. 14.7 shows a damaged shape of a fill at Kayanuma site (茅沼) which was constructed upon a small stream facing a peaty marsh deposit; 1993 Kushiro-Oki earthquake. It is possible that ground water flowed into the fill in place of flowing into the stream, raising the ground water table in the fill and increasing the weight. The increased seismic inertia force was not resisted by the peaty soil at the bottom (Fig. 14.8). Thus, the fill collapsed. This fill was reconstructed after the quake to the exactly same shape and failed once more during the 1994 Hokkaido-Toho-Oki earthquake.

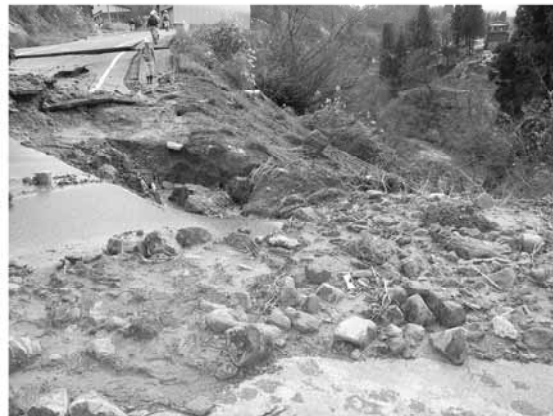
**Fig. 14.9** Failure of road embankment during the 2004 Niigata-Chuetsu earthquake

Figure 14.9 illustrates a failure of a road embankment during the 2004 Niigata-Chuetsu earthquake. Situated upon a small valley, the failed earth is overtopped by stream water. This failure was probably caused by a combination of two reasons, which are elevated water table in the fill as well as the weak stream deposit that was not fully removed during construction. Thus, an embankment constructed upon a stream (集水地形) needs special care such as drainage and reinforcement at the toe of a slope.

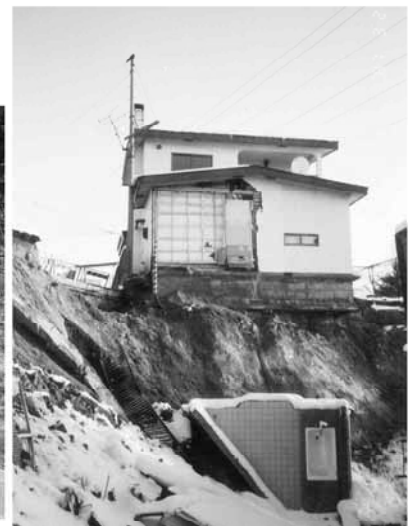
**Fig. 14.10** Slip failure of fill part in cut-and-fill area (Midoriga-oka in Kushiro)

Many land development projects in hilly areas employ cut-and-fill construction to achieve a level ground surface. The interface between cut and fill can form a slip plane. Figure 14.10 indicates a sliding failure of this kind. During the 1993 Kushiro-Oki earthquake, only the bathroom of this house, which was situated upon a fill fell down, while the remaining part of the same house was intact.

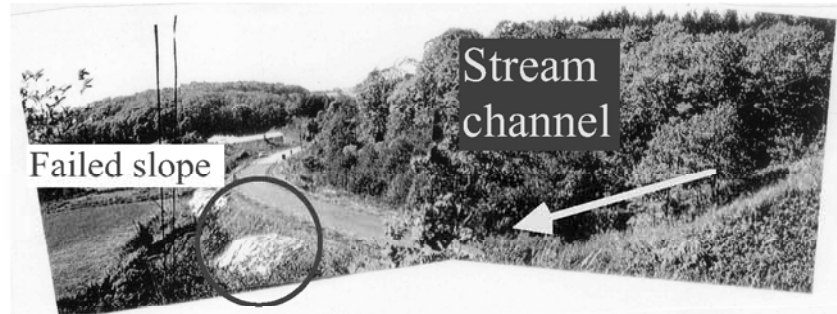
**Fig. 14.6** Surface sliding of road embankment at Nakachambetsu site in 1994

Figure 14.6 manifests a development of a shallow slip plane (Type-1 failure in Sect. 14.1). Placed upon a small stream channel, this fill failed during the 1994 Hokkaido-Toho-Oki earthquake.

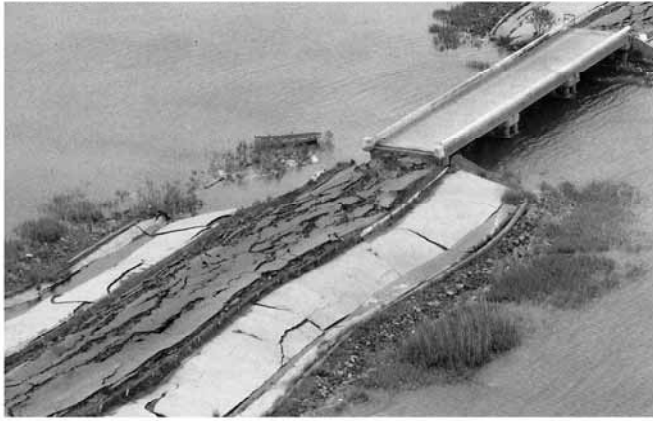
**Fig. 14.11** Slump failure of road embankment due to subsoil liquefaction (Akita Sakigake Newspaper)

Slumping (Type 3 in Sect. 14.1) is another important kind of failure of an embankment. The 1983 Nihonkai-Chubu earthquake caused liquefaction in subsoil under Gomyoko Bridge (五明光橋) site on the western side of Hachiro-gata (八郎潟) Lake. Figure 14.11 shows that slumping of the fill resting upon soft lake deposit produced many cracks at the surface pavement. These longitudinal cracks suggest that the fill spread laterally. Figure 14.12 demonstrates an example failure of a road embankment at Chiebunnai Bridge (智恵文内橋) during the 1994 Hokkaido-Toho-Oki earthquake. This fill was constructed on a deposit of a small stream. Thus, an embankment resting upon soft soil deposit is vulnerable to earthquake-induced failure.

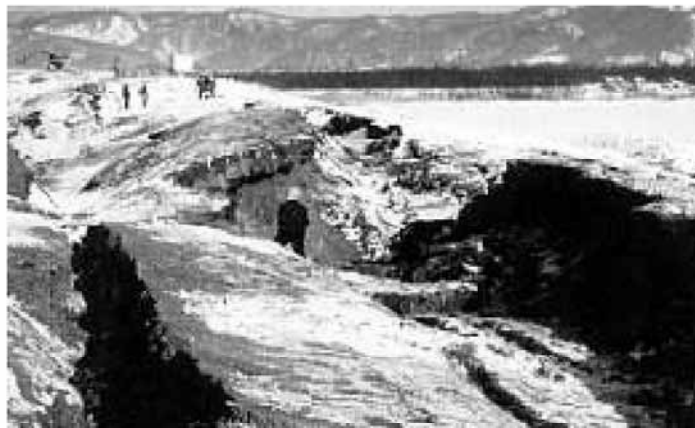
**Fig. 14.13** Damaged shape of Tokachi riverdike in 1993 (Ministry of Construction)

Figure 14.13 illustrates a damaged shape of the Tokachi river dike (十勝川堤防) during the 1993 Kushiro-Oki earthquake. Note that the center of the dike subsided more than the lateral slopes. Since an evidence of liquefaction (sand boil) was found here although the foundation soil was unliquefiable peat, the source of liquefaction was discussed. Sasaki (1998) stated that the original sandy body of the dike subsided into peat, expanded in its volume (loosening) and became liquefiable. For more details, refer to Sect. 17.4. Since this site took five months to repair, the conventional philosophy of quick repair before flooding comes did not function. Hence, a need of seismic resistance of important river dikes was recognized for the first time. Figure 14.14 shows a classical record of Nagara River dike which was destroyed by the 1891 Nobi earthquake. The longitudinal cracks suggest the tensile deformation of the dike in the lateral direction (Type 3 in Fig. 14.1). See in this figure the falling of railway bridge (Kansai Line) as well. It is very important that the stability of foundation soil significantly affects the stability of an overlying embankment. Figure 14.15 illustrates a case of Chan Dam in Gujarat Province of India which was destroyed by an earthquake in 2001. Although the dam body was compacted in accordance with the regulation, not much attention was paid to the natural deposit under the dam body. The subsoil liquefied when earthquake occurred, and its large distortion destroyed the dam body. It is interesting that the heaving at the end of the distortion zone was visible at the time of the author's site visit.

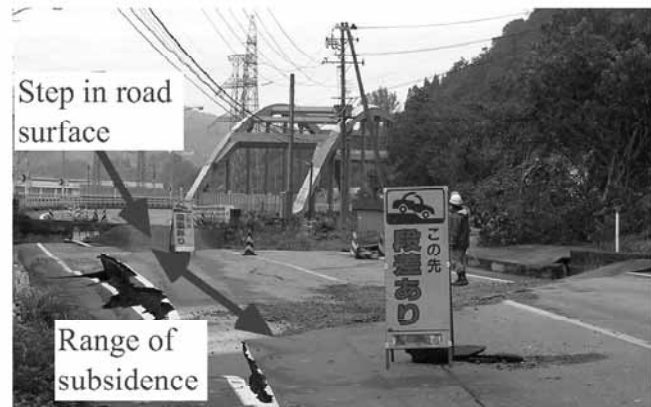
**Fig. 14.16** Bridge out of service due to subsidence of approach embankment (Minami Yamabe Bridge of Ojiya City, 2004 Niigata-Chuetsu earthquake)

Densification of road embankment due to strong shaking results in subsidence. If this occurs near an abutment of a bridge, the road transportation is stopped (Fig. 14.16) and even an emergency traffic is prevented. Thus, although the main body of a bridge is of good seismic design, its function is stopped by the soil part.

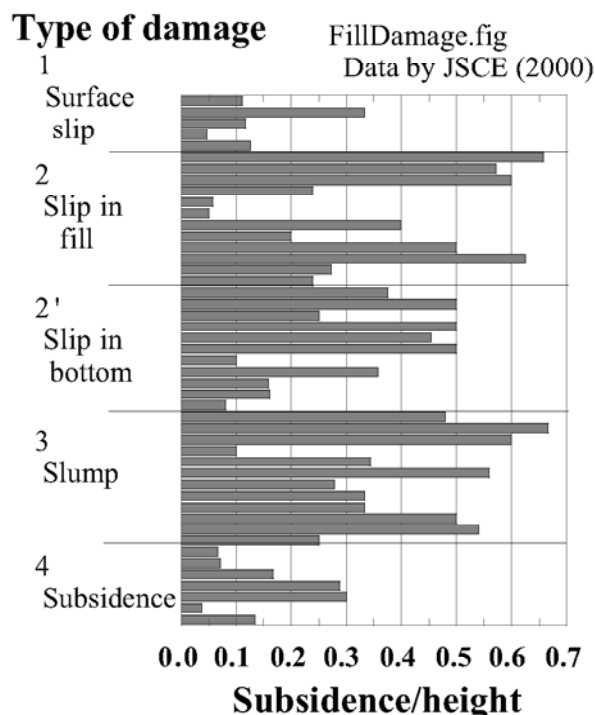
**Fig. 14.17** Subsidence/height ratio of damaged fills (JSCE, 2000)

Figure 14.17 illustrates the ratio of subsidence/height in each case. It is shown therein that Type 2 (slip plane) and Type 3 (slumping) can generate larger subsidence/height ratio than other types. It is interesting that the maximum subsidence / height ratio is less than 0.7 which is consistent with the finding from river dike damage (Fig. 17.36).

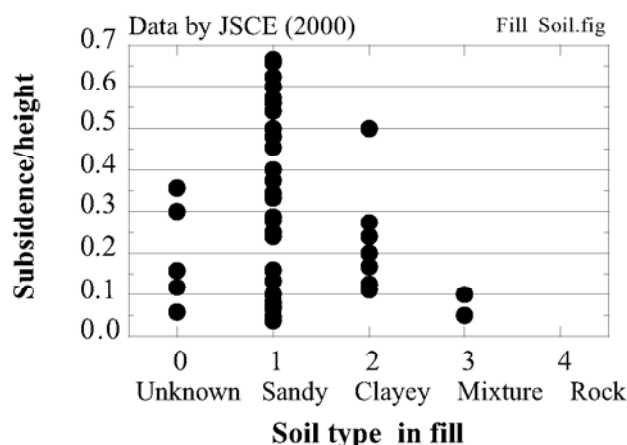
**Fig. 14.18** Effects of soil type in embankment on extent of subsidence (JSCE, 2000)

Figure 14.18 illustrates the magnitude of subsidence (subsidence/height ratio) changing with the type of soil in the embankment. It is found that sandy fill material can induce significant subsidence. Furthermore, Fig. 14.19 examines the effects of soil type in foundation on the extent of subsidence. Again, sandy foundation can cause large subsidence. These findings are probably related to excess pore water pressure development and consequent liquefaction either in fill or in foundation. It is important in Fig. 14.19 that clayey (or peaty) foundation soil might generate significant subsidence as well.

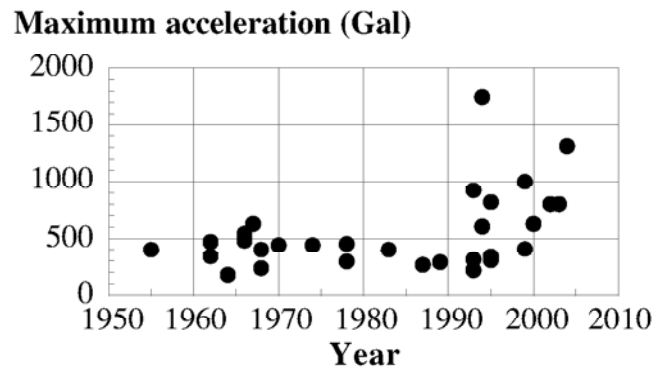
**Fig. 14.20** Variation of maximum acceleration in recent earthquakes

and should be greater than unity. The seismic load in (14.1) is related to the expected intensity of earthquake. Figure 14.20 illustrates the variation of maximum acceleration which has been recorded during earthquakes. It is noteworthy that the intensity of acceleration increased suddenly after 1990. For examples, see the 1993 Kushiro record in Fig. 6.23 and the 1994 Tarzana record in Fig. 6.25. This situation led to the increased intensity of design earthquakes and the magnitude of seismic load in (14.1).

Figure 14.20 does not mean that the seismic activity of the earth planet changed after 1990. Actually, since earthquake observation network was installed in many countries, the probability of obtaining very strong motions increased.

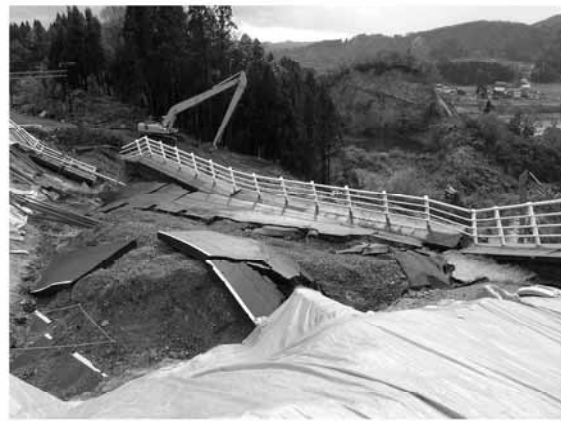
**Fig. 14.24** Significant subsidence of road embankment resting on small valley topography caused by 2004 Niigata-Chuetsu earthquake

Quick restoration and construction are important and unique feature of geotechnical structures. The total collapse of a road embankment in Fig. 14.24 appears to be too significant to be allowed. The seismic stability of this part of road embankment was bad because it was placed many decades ago on soft valley deposits. From the viewpoint of oil pipeline and communication lifelines which were embedded in this embankment, this collapse was certainly not allowable. From the viewpoint of road, in contrast, this case may still be allowable. Fig. 14.25 shows the reason; a detour road was constructed next to this collapsed fill within a few days after the quake. Hence, the road traffic was not stopped for many days.

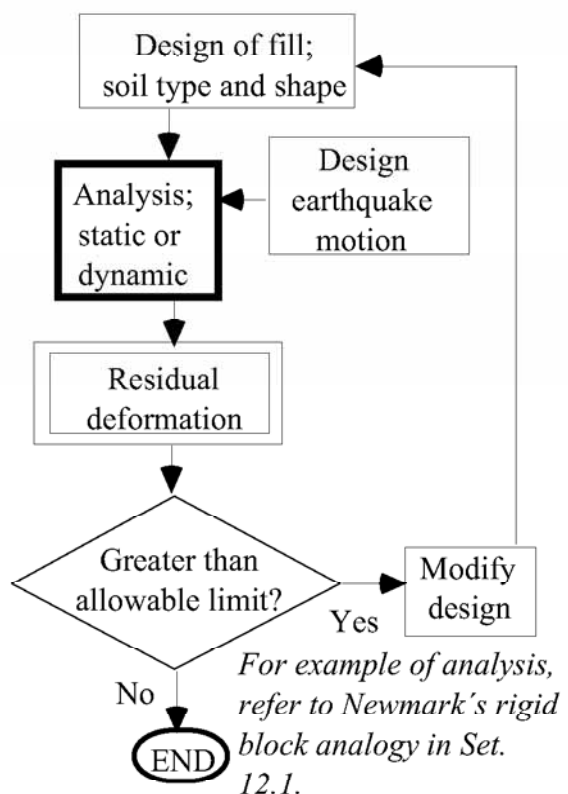
**Fig. 14.26** Flow of seismic design based on allowable deformation

The future principle in seismic design will allow the factor of safety to be less than unity and maintain the residual deformation within an allowable extent (Fig. 14.26). Since the seismic load is not of a static nature as (14.1) hypothesizes, its effect lasts for a short time (Sect. 5.12), and does not cause an infinite magnitude of deformation even if the factor of safety is less than unity.

at the end of the earthquake is compared with a prescribed allowable value. If the calculated value is greater than the allowable limit, the original design has to be modified. Figure 14.24 illustrates a conceptual flow of this principle. This new principle and the conventional one based on the static seismic coefficient and the factor of safety are compared in Table 14.1.

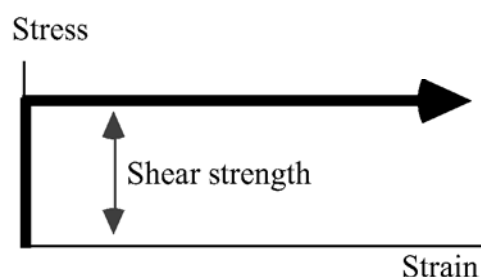
**Fig. 14.27** Rigid perfectly plastic model of soil

2. In this respect, the Newmark's rigid block analogy (Sect. 12.1; Newmark, 1965) is one of the good choices because it assumes a very simple, rigid, perfectly plastic constitutive relationship (Fig. 14.27). It should be borne in mind, however, that the determination of appropriate strength parameters (drained, undrained, static, or dynamic) is still disputable. Furthermore, the Newmark method is not appropriate when deformation of soil is less than failure strain because the method assumes the development of failure mechanism (rigid and perfectly plastic behavior). Liquefaction-induced large deformation is out of scope as well, because liquefaction-induced displacement is a consequence of large strain in place of shear failure mechanism (slip plane) as Newmark assumed.

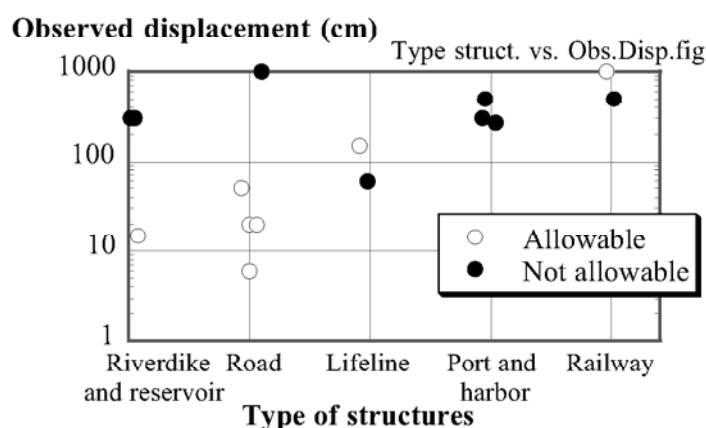
Fig. 14.29 Relationship between magnitude of displacement and people's attitude

The next question was asked to whether or not the people allow the geotechnical damage that they experienced. Figure 14.29 plots the observed displacement values by using two different symbols depending on whether the displacement is allowed or not. Here, "to allow" means to consider the results of the quake as what should be restored without need for seismic reinforcement. Conversely, "not to allow" means that measures should have been taken in order to mitigate the damage prior to the quake.

Moreover, the displacement in this section is the biggest one in each structure whether it is vertical or horizontal. Figure 14.29 gives a simple idea that displacement greater than 200 cm is not allowed, although the 1000-cm displacement of a railway embankment was considered allowable.

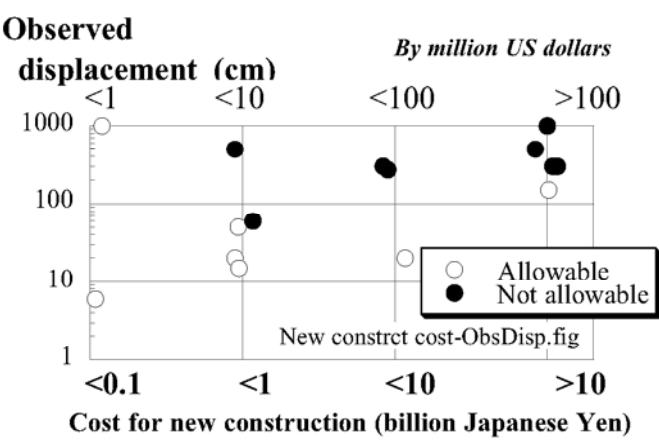
**Fig. 14.30** Relationship between observed displacement and cost for restoration

Costs for restoration and reconstruction do not affect the idea on allowability as shown in Fig. 14.30. This is consistent with the opinions shown in Table 14.2.

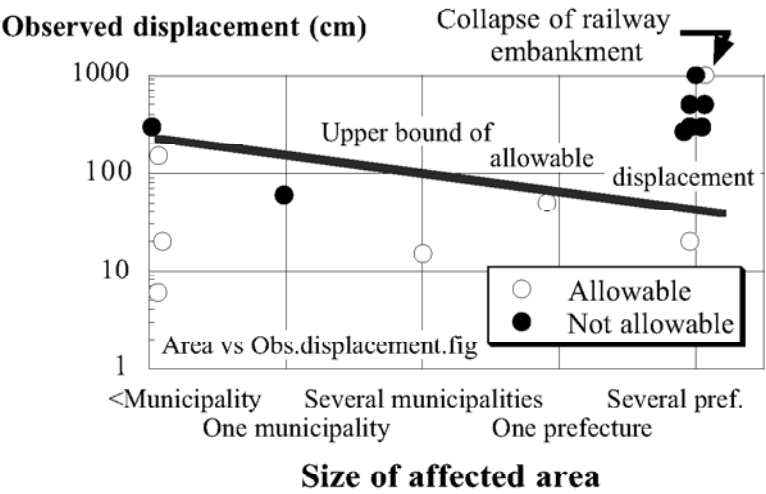
**Fig. 14.32** Relationship between size of affected area and observed displacement

The second component of the negative effects to the public lies in the size of the affected public. The effects to the whole nation are certainly more significant than those to a small village. In this regard, the present study inquired people about “the size of the affected area” as the simplest parameter that was easy to answer, although the size of the affected population or the size of the affected economy are more suitable for further studies. To make the answering even easier, the inquired people were requested to answer in terms of the municipal units. In Fig. 14.32, one municipality stands for a city, for example, with a population of tens of thousand to a few million. As for the prefecture, it is a good instruction to state that Japan has 47 prefectures in total. It appears reasonable to state that less extent of displacement is allowed when the affected area is greater.

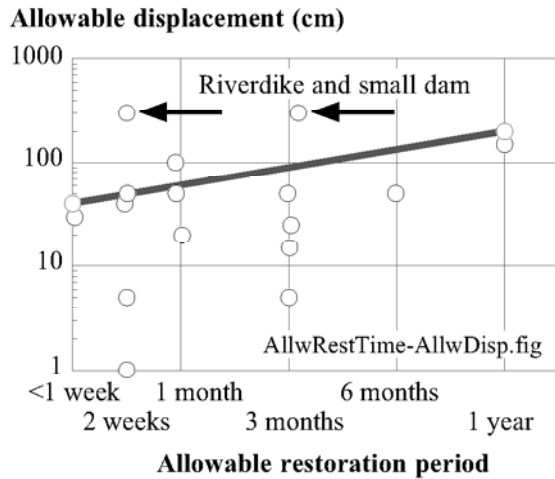
**Fig. 14.33** Relationship between allowable restoration time and allowable displacement

First, Fig. 14.33 shows the relationship between the allowable restoration time and the allowable displacement. When those people allowed longer restoration time probably due to very strong shaking or reduced importance, the greater residual displacement is allowed. Second, the upper bound in Fig. 14.34 illustrates that the allowable restoration time becomes shorter when the affected area (affected population

and economy) becomes larger. This certainly implies that important structures have to be restored more quickly. Further note in these figures that the idea of allowable displacement is significantly variable, suggesting that direct decision on the magnitude of allowable displacement is not an easy task; if 30 cm is allowed, why 35 cm is not allowed?

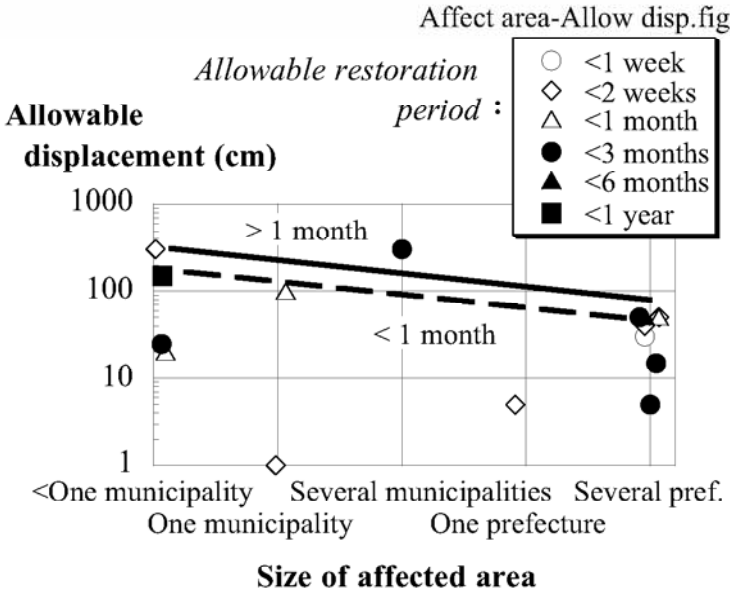
**Fig. 14.35** Relationship between allowable displacement and size of affected area in terms of allowable restoration time

To make the idea more realistic, Fig. 14.35 summarizes the opinions in Figs. 14.33 and 14.34. It is therein proposed to first decide the size of the affected area. It is a single village if a small bridge is the target structure. Conversely, the whole nation is the affected area if a nation’s No.1 highway is the target. This decision seems easy. The second decision is then made of the allowable restoration time: only a few days or several months, etc. This decision is easier than that on allowable displacement. Based on these two decisions, the magnitude of the allowable displacement is determined by this figure.

According to Fig. 14.35, a structure which affects several prefectures is an important structure. Hence, smaller displacement is allowed. However, when a design earthquake is a very rare one whose recurrence period is hundreds of years, a longer restoration period should be allowed. Then the allowable displacement should be increased to some extent. Once the allowable displacement is thus determined, design and prediction of displacement are made. Thus there are three important components in performance-based seismic design of geotechnical structures which are

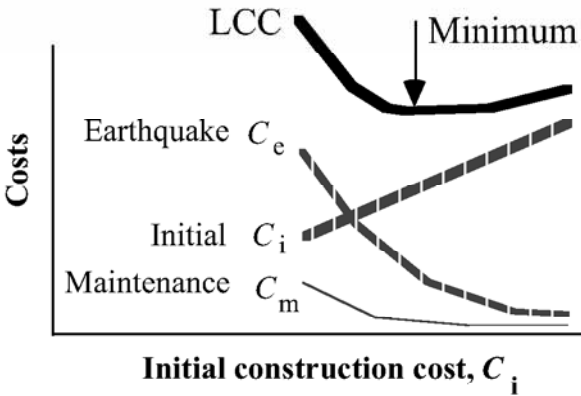
**Fig. 14.36** Conceptual illustration of minimization of life cycle cost (*LCC*)

from  $k = 1$  to  $N$ . This cost is calculated by using the probability of damage,  $P_k$ , and the induced cost,  $C_{e,k}$ , in the respective year. It is expected that the initial construction at a reasonable cost (not too expensive but not too cheap) can keep the maintenance and disaster costs at reasonably low levels and the entire LCC would be minimized (optimization); see Fig. 14.36.

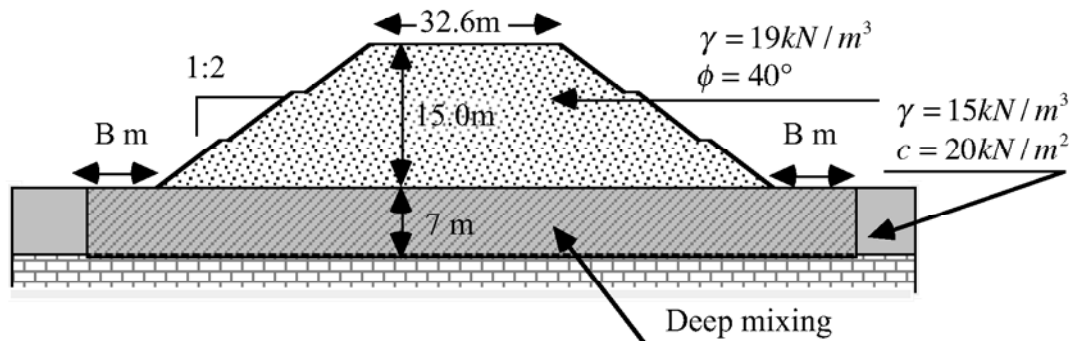
**Fig. 14.37** Cross section of expressway embankment with soft subsoil (Ishihara et al. 2007)

An example calculation of LCC was conducted on an expressway embankment (Ishihara et al. 2007). Figure 14.37 shows a cross section of an embankment studied which is underlain by very soft clay. It is possible upon a strong earthquake, therefore, that a shear failure mechanism is activated through the embankment and the soft subsoil, resulting in subsidence of the road pavement and cars may crash into it. Consequently, passengers in those cars are killed in such an accident. Moreover, the restoration of the expressway takes time, and the function of the expressway stops for a long time, thus causing economic loss in regional and even national economy. During the period of restoration, many vehicles come into local small roads and the number of traffic accidents may increase.

The present study employed deep mixing (mixing clay with cement; Sect. 26.13) of clay as a mitigation of soft clay. The size of deep mixing and the ratio of improved soil mass were variables. For definition of the size of deep mixing ( $B$ ), see Fig. 14.37. The types of cost which were included in the LCC calculation are as what follows:

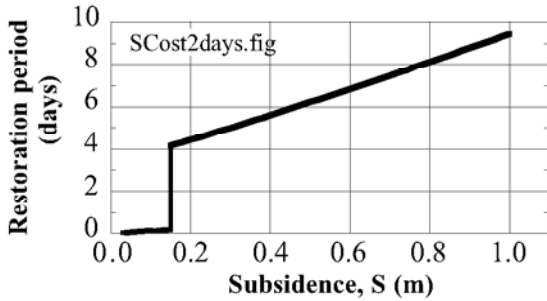
**Fig. 14.39** Number of days for restoration

By referring to many practices in both public and private sectors, the number of days needed for restoration was determined (Fig. 14.39). The restoration time is totally different for  $S$  greater than or smaller than 15 cm because of different types of restoration. On the basis of this  $S$ , the costs were determined as second-order functions of  $S$ . See Fig. 14.40 for details.

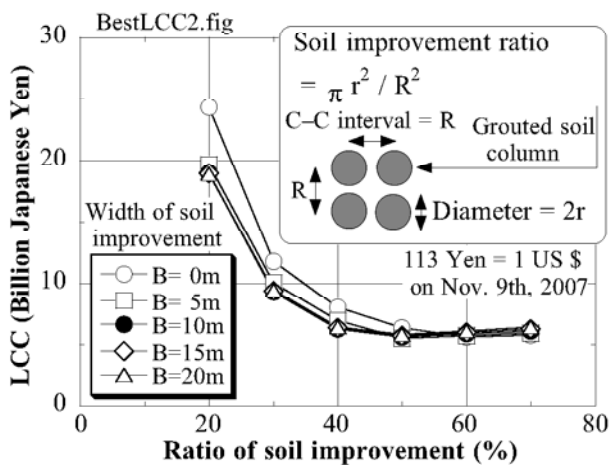
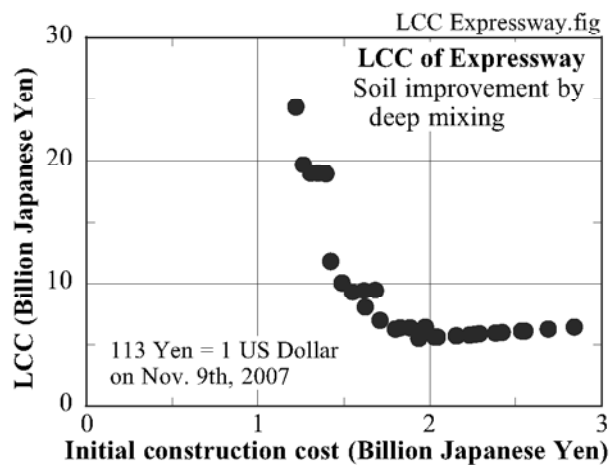
**Fig. 14.42** Minimum LCC of expressway embankment

(a) Variation of LCC with extent of soil improvement      (b) Change of LCC with initial construction cost

Table 14.6 compares details of the road embankment designed either by a conventional approach (seismic factor of safety = 1.12) or the LCC approach (mean factor of safety = 1.58, but varying probabilistically). Although the latter requires more initial construction cost, the overall cost in its life cycle is smaller.

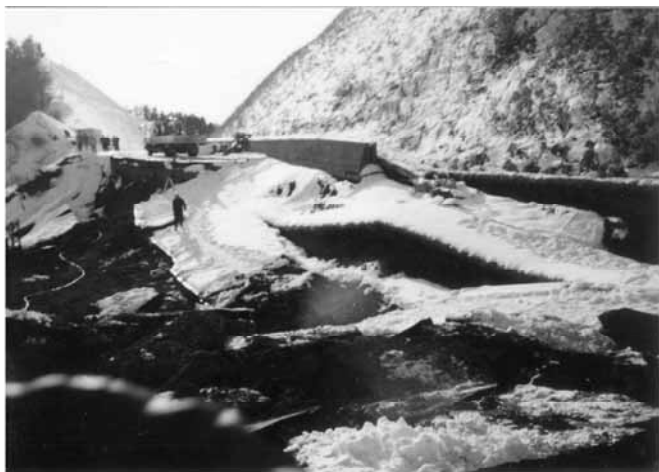
**Fig. 14.43** Failed shape of Itoizawa road embankment in 1993

The 1993 Kushiro-Oki earthquake triggered a failure of an important road embankment at Itoizawa site (糸魚沢) between Akkeshi (厚岸) and Nemuro (根室) in Hokkaido. This road was situated along the foot of hills which faced a marsh (swamp) of soft stream deposit. Figure 14.43 indicates the failed shape of the road embankment. This failure occurred at a place where the road crossed the exit of a small stream into the marsh (Fig. 14.44). Thus, an embankment resting on soft soil collected much water from a valley behind and failed easily upon shaking. The slope stability of the embankment had been improved before the quake by placing berms (腹付け盛土) on left and right sides of Fig. 14.45) at the bottom of the fill. This was however insufficient on the embankment resting on softer subsoil.

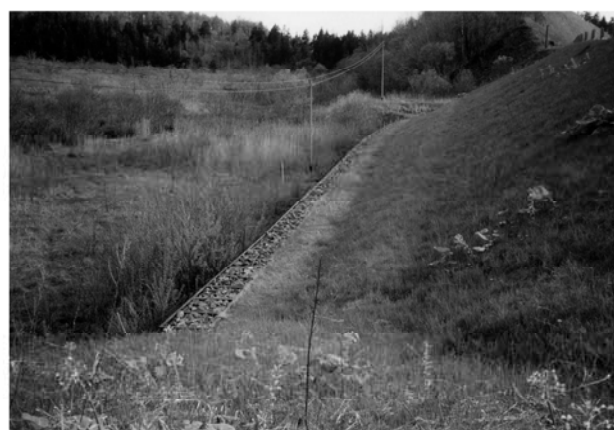
**Fig. 14.46** Repaired toe of road embankment in Itoizawa (photo by T. Honda)

The damaged fill was restored by constructing reinforced earth fill (soil with geogrids, plastic sheets, geotextiles, etc) while installing more water drainage pipes and replacing the base soft soil by gravels. Gravel gabions were placed at the toe of the slope for better shear strength and drainage (Fig. 14.46). Note that the slope toe is the place where stress concentrates and shear strain becomes greater than in other part of the fill. Together with the effects of drainage from inside the new embankment, consequently, no damage occurred here upon the 1994 Hokkaido-Toho-Oki earthquake.
