# Chapter 15

## Landslides

## 15.1 Earthquake-Induced Landslides

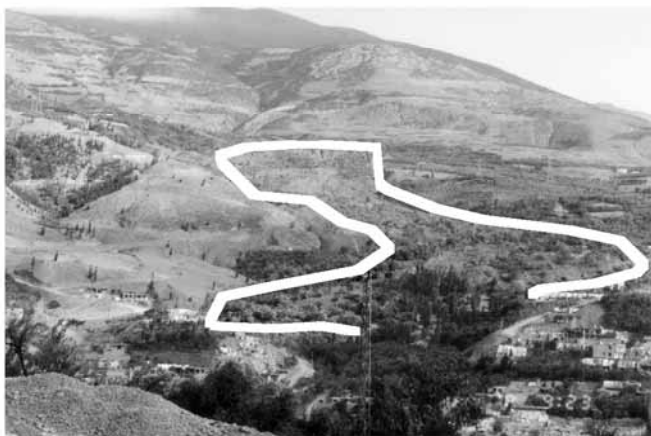
Figure 15.1 shows an overall view of a large landslide which occurred near Galdian village during the 1990 Manjil earthquake ( $M = 7.3$ ) in Iran (Ishihara et al. 1992). The soil type in the slip plane was clayey as indicated by the exposed slip plane (Fig. 15.2). Some part of the sliding soil was mixed with water and formed a mud flow (Fig. 15.3). It is not uncommon that sliding mass is significantly fluidized and reaches an unexpectedly long distance.

**Fig. 15.1** Galdian landslide in Iran during the 1990 Manjil earthquake

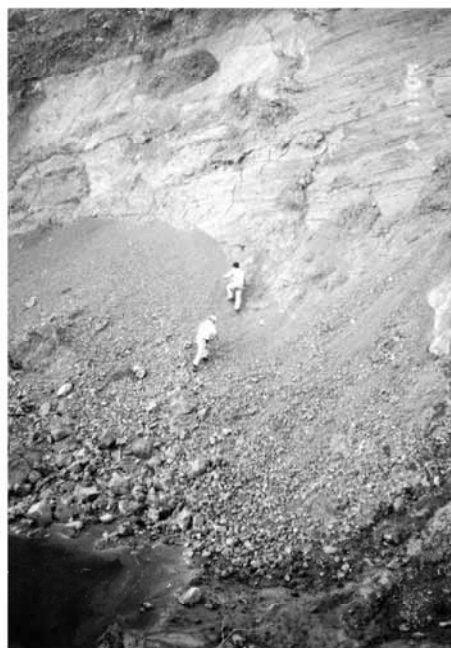
**Fig. 15.2** Exposed slip plane in Galdian landslide

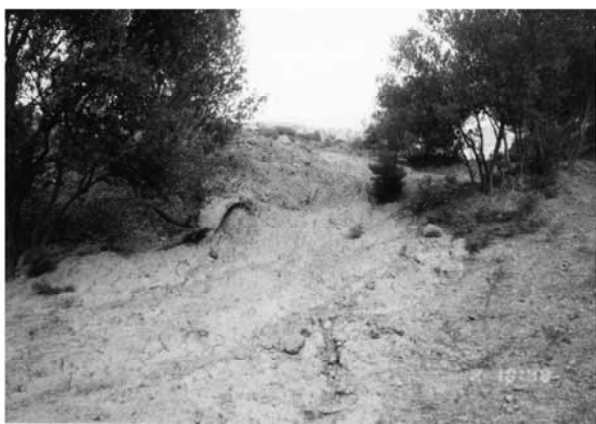
**Fig. 15.3** Deposit of fluidized material near landslide in Fig. 15.1

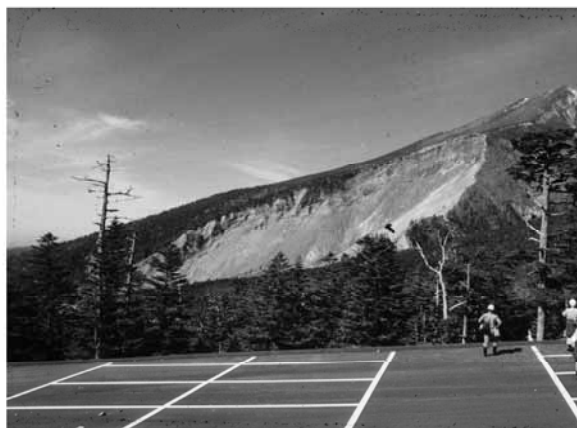
**Fig. 15.4** Seismic collapse of Mt. Ontake  
(photo by Prof. K. Ishihara)

Figure 15.4 shows the collapse in a slope Mt. Ontake during the 1984 Nagano-ken Seibu earthquake. Being a volcano, the body of this mountain was made of debris with water. Thus, it collapsed easily upon shaking, got fluidized, and flowed downstream along a valley. Note further that volcanic slopes are subjected to nonseismic failures as well which are induced by slope steepening due to magma intrusion and hydrothermal excess pore water pressure caused by magma intrusion (Voight and Elsworth, 1997).

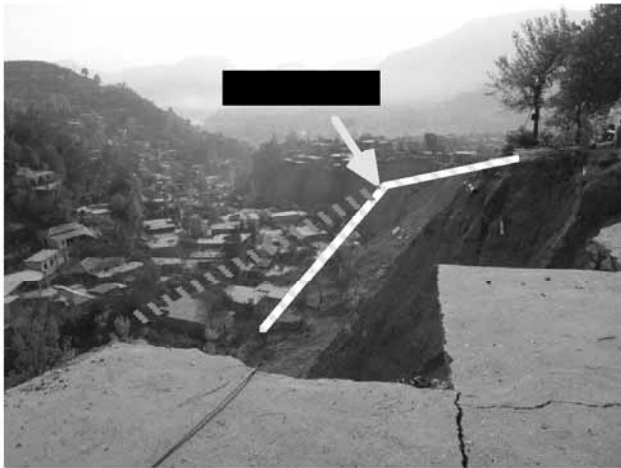
It is interesting that the risk of fluidization depends on moisture content of soil. Figure 15.5 indicates a slope failure in the town of Muzaffarabad which was triggered by an earthquake in 2005 that hit North Kashmir of Pakistan. It is important that the soil of the collapsed slope did not travel laterally and many

houses in the small valley were not affected by the soil flow. It seems that this fortunate situation was produced by the dry state of soil. Since the earthquake occurred in dry season (early October), there was not much water in the slope. There is water in subsoil, however, if water is supplied from leaking canal, pipeline, irrigation channel, or reservoir.

**Fig. 15.5** Collapse of dry slope in Muzaffarabad, Pakistan

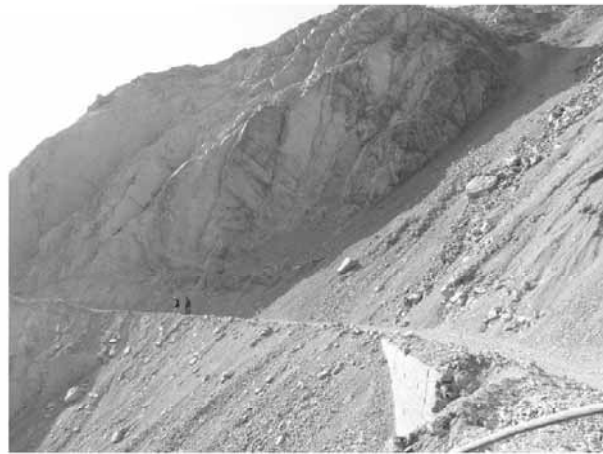
The 2005 earthquake in Pakistan showed several interesting features of seismic slope failure. Figure 15.6 demonstrates an example which occurred to the north of Muzaffarabad. The surface of limestone slope was significantly weathered due to temperature change and heavy sunshine, in particular, because of the lack of vegetation and repeated wetting and drying together with freezing in winter. The state of weathering is evidenced in detail by Fig. 15.7.

**Fig. 15.6** Surface failure of weathered limestone slope near Muzaffarabad, Pakistan, in 2005

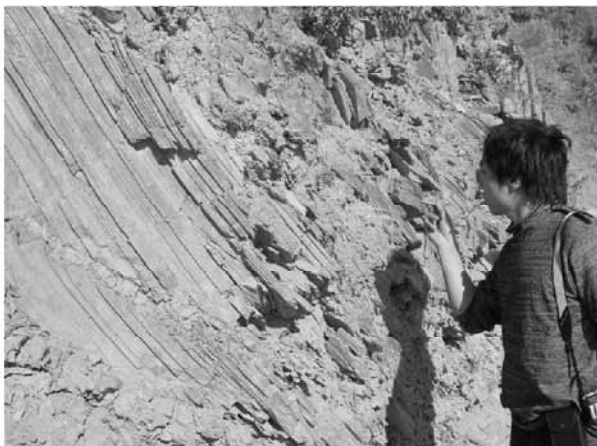
**Fig. 15.7** Weathered rock surface in Pakistan, 2005

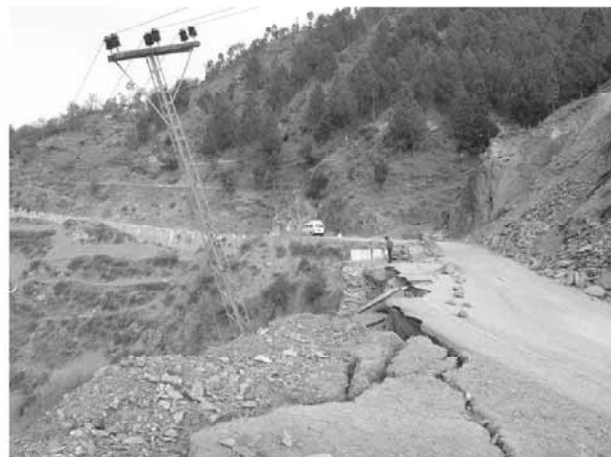
**Fig. 15.8** Collapse of slope surface and road shoulder near Barakot of Pakistan

Failure of surface material may not be so significant in volume as those in Figs. 15.1 and 15.4. It is, however, able to stop local transportation if the fallen debris close a mountain road. Figure 15.6 is an example. The time needed to open the road again is shorter than the case of failure of road embankments (Figs. 14.12, 14.43 and 15.8), because removal of fallen debris is much easier than reconstruction of a fill. Modern construction of highway tries to make a short cut by crossing valleys by means of embankments and bridges. Consequently, a failure of embankment seriously affects the operation of transportation. Conversely, such roads located along slope surface are constructed by cutting slopes and are more stable during earthquakes, although such roads are curved and not good for high-speed transportation.

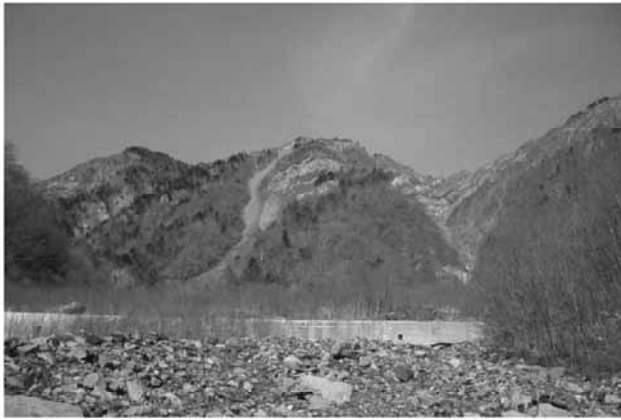
Ohya slide (大谷崩れ, Fig. 15.9) in Shizuoka Prefecture, Japan, is said to have been caused by the 1707 Hoei (宝永) gigantic earthquake. Since then, the destabilized slope (Fig. 15.10) has been producing

**Fig. 15.9** Ohya slide in Shizuoka

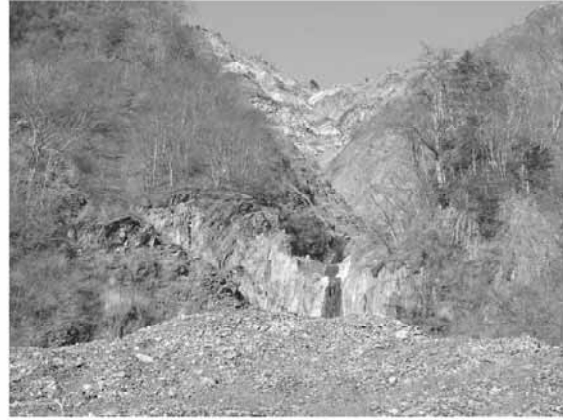
**Fig. 15.10** Unstable mountain slope

debris flow at heavy rainfall frequently (Imaizumi et al. 2005). Consequently, the bed of the Abe River (安倍川) is filled with cobbles and stones, rising continuously due to sediments (Fig. 15.11). To mitigate this situation, many erosion control dams have been constructed (Fig. 15.12). However, the problem has not yet been solved. Effort is also made to plant trees in the unstable slope (Fig. 15.13). It is noteworthy that decreased discharge of sediment from rivers into the sea has recently resulted in erosion of beaches, making coastal structures less unstable than before. The same problem is found in downstream area of rivers as well where the foundation of bridges is scoured.

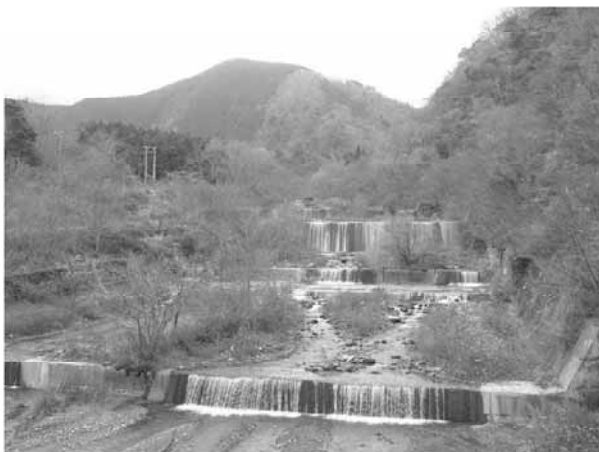
**Fig. 15.12** Erosion control dams in Abe river channel

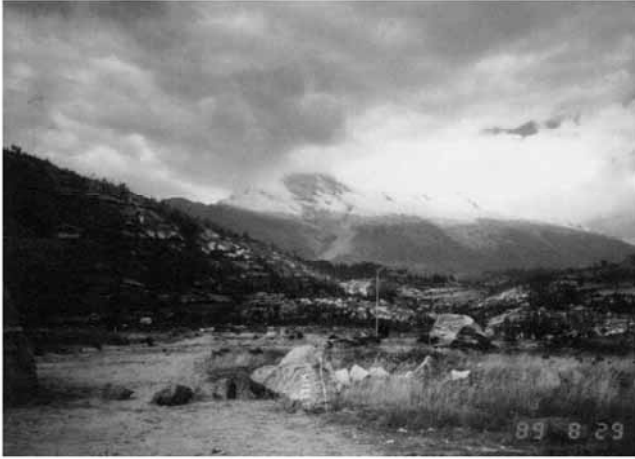
An earthquake-induced collapse of Snowy Huascarán Mountain (Nevados Huascarán; Fig. 15.14) in Peru in 1970 was characterized by debris which was fluidized when the falling rock and ice were mixed with water and stream deposits. A debris flow thus developed flowed over a small hill and buried the whole city of Yungay, killing over 30,000 people. Figure 15.15 shows the city prior to the disaster; the hill and Mt. Huascarán are seen behind. This debris flow traveled hundreds of kilometers along the channel of Río Santa to finally reach the Pacific Ocean. The total volume of this debris avalanche is assessed to be 50 million m<sup>3</sup> (Plafker et al. 1971). The soil deposit at the ruins of Yungay includes much amount of fines (Fig. 15.16), suggesting that original rocky material was ground into small particles.

**Fig. 15.14** Slope of Huascarán Mountain (in August, 1989)

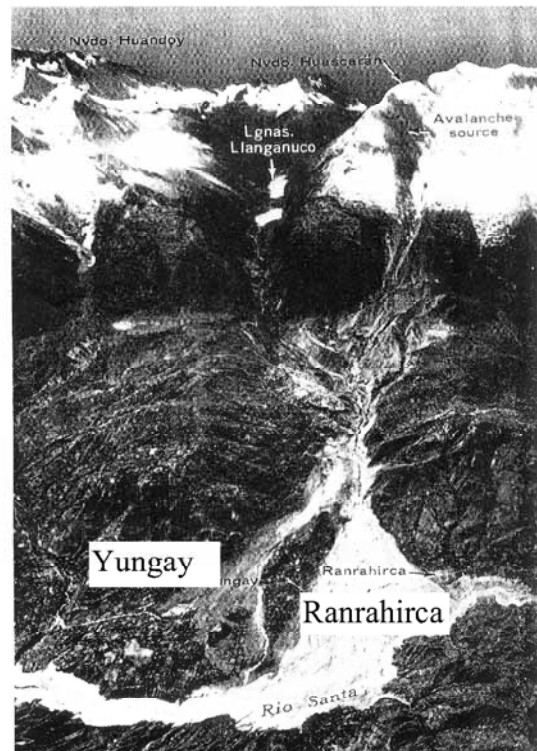
**Fig. 15.17** Aerial view of Yungay-Ranrahirca area (Town names were added to original photograph by Plafker et al. 1971)

Figure 15.17 shows the aerial view of the concerned area. The town of Ranrahirca was attacked in 1960 by another flow, while Yungay was protected by a hill. This experience gave the Yungay residents a wrong idea that their town was well protected from such a geohazard. This idea did not work in 1970

when another flow had a greater size.

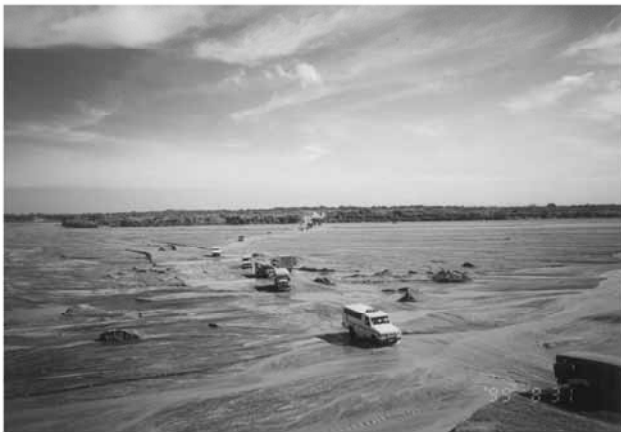
**Fig. 15.20** River bed filled with flooding of lahar from Pinatubo Volcano, the Philippines

After this tragedy, the city of Yungay was reconstructed at a safer place. Relocation is the best solution for avoiding natural disasters. It has to be borne in mind, however, that relocated people have to survive by finding new source of income. It is not good that they have to rely on governmental aids forever. Farmers need new agricultural land and fishermen need to go to the sea. This requirement is not always satisfied in relocation programs. Figure 15.18 and 15.19 show a life-aid activity by NGO (Non Governmental Organization) for those who were evacuated from home villages after eruption of Pinatubo volcano and resultant lahar flow (flooding of rain water with volcanic ash deposit); Figs. 15.20 and 15.21 in the Philippines.

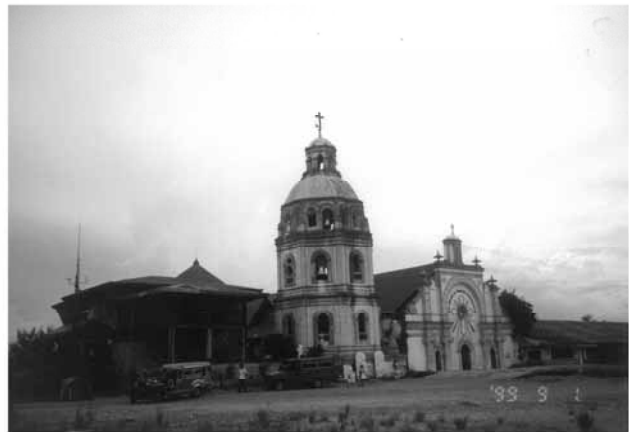
**Fig. 15.21** Church which was 50% buried by lahar after Pinatubo eruption in the Philippines

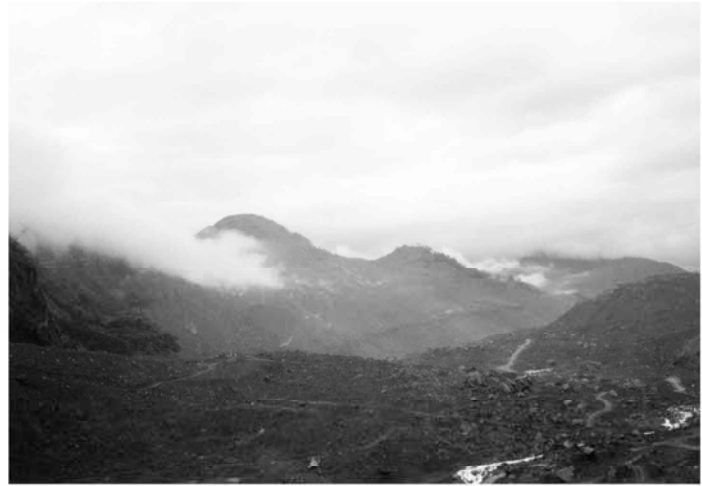
**Fig. 15.22** Overall view of Tsaoling landslide

Figure 15.22 illustrates the overall view of the Tsaoling (草嶺) slide which included the total volume of sliding mass greater than 100 million  $m^3$ . Of 4 km in width, this amount of sliding mass appears to be one of the greatest seismically induced landslides in the twentieth century. Similar to other landslides during the same earthquake, the Tsaoling slide occurred in an interbedded slope of shale and mud stone. Figure 15.23 shows the slip plane which was seen after the quake (December, 1999). It is important that this slide had developed failure two times during the past earthquakes; the first one in 1862 and the second in 1941 (Fig. 15.24). Another big sliding occurred due to rainfall in

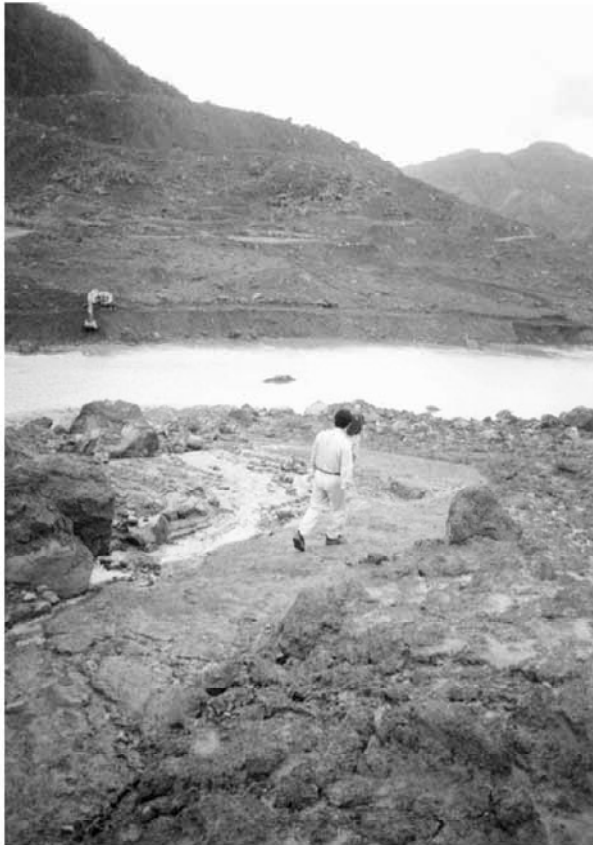
**Fig. 15.23** Slip plane after the 1999 quake

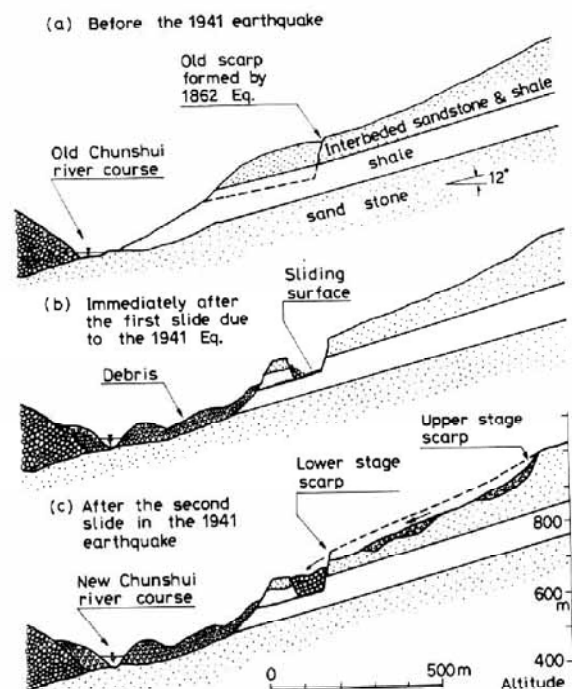
**Fig. 15.24** Repeated instability of Tsaoling slope (Ishihara, 1985)

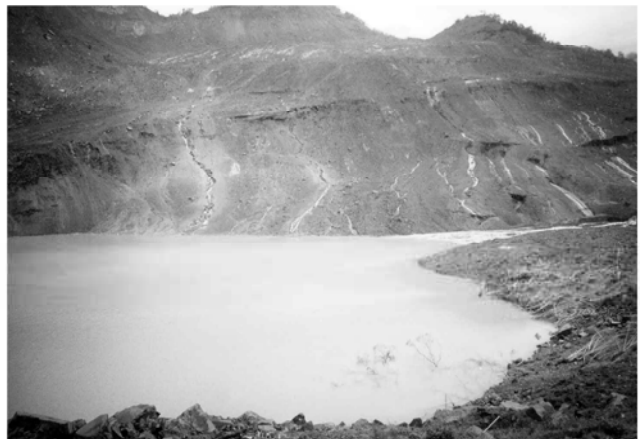
**Fig. 15.25** Natural dam after 1999 event

A big landslide often generates a natural dam. In 1999, the dam lake in Fig. 15.25 was produced. If the natural dam body is narrow, its erosion during high water level and a possible failure may lead to flooding and debris flow. Tabata et al. (2002) made a statistic analysis on landslide-induced natural dams in Japan. The size (length of dam in the direction of river channel) and depth information in Figs. 15.26 and 15.27 may be useful. Noteworthy is that most natural dams in the past failed due to overtopping of water, which led to erosion, and the number of failures due to piping of seepage water (seepage of water removing debris from the body of dam) is small (Fig. 15.28).

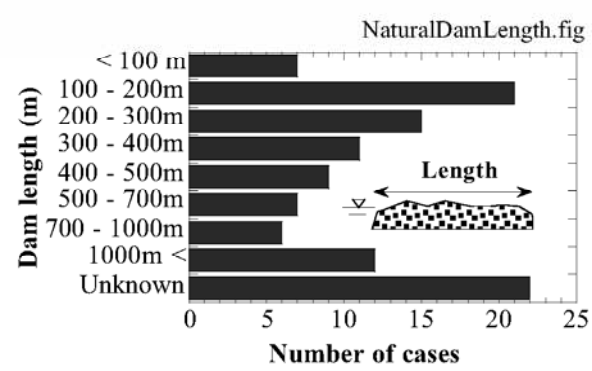
**Fig. 15.26** Statistics on length of natural dam in the direction of river channel (after Tabata et al. 2002)

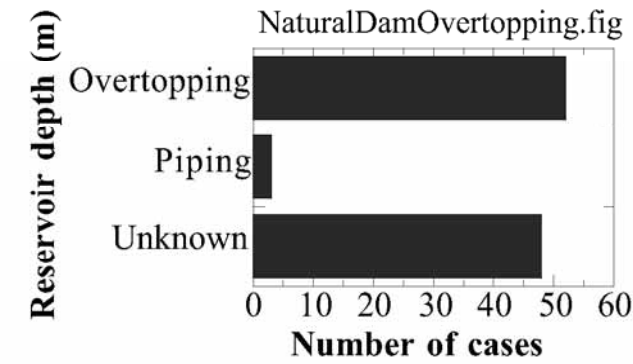
**Fig. 15.28** Statistics on cause of failure of natural dams (after Tabata et al. 2002)

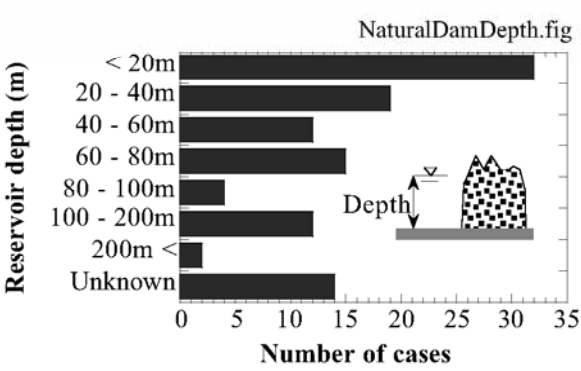
**Fig. 15.27** Statistics on depth of reservoir dam produced by natural dam (after Tabata et al. 2002)

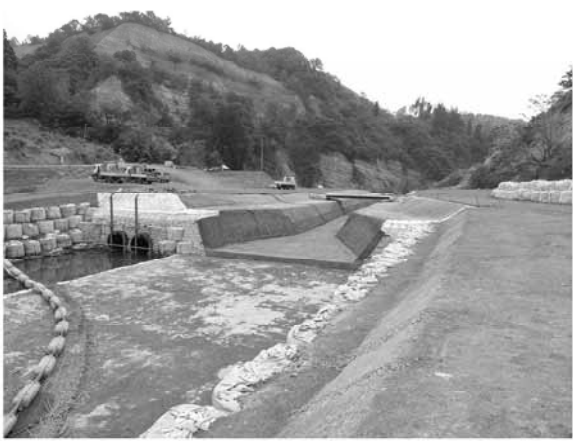
Figure 15.29 demonstrates a water channel which was excavated across a natural dam (Terano natural dam, 2004 Niigata-Chuetsu earthquake).

**Fig. 15.29** Water drainage channel in Terano natural dam in Niigata

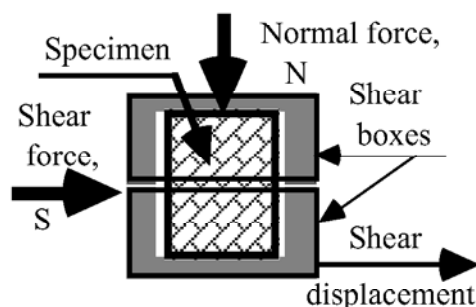
Sampling, laboratory shear tests, and stability analyses were performed to understand the Tsaoiling landslide triggered by the 1999 Chi-Chi earthquake of Taiwan. Samples were collected from the slip plane (Fig. 15.23) and debris deposits. Figure 15.24 showed the stratification of local geology which is parallel to the slope. Attention was therefore focused on the possibility of a weak layer and a weak interface between two different rocks. The problem was that the slope had already collapsed, making sampling of weak intact materials impossible. It was decided consequently to collect samples from debris deposits of broken rocks as well as the remaining slickenside slip plane (Fig. 15.23). Shear tests were carried out at CRIEPI (Central Research Institute of Electric Power Industry) by using its direct shear device, see Fig. 15.30. When the lower shear box moves laterally, shear failure of a rock specimen occurred along a small spacing between two rigid boxes.

Fig. 15.30 Illustration of direct shear test

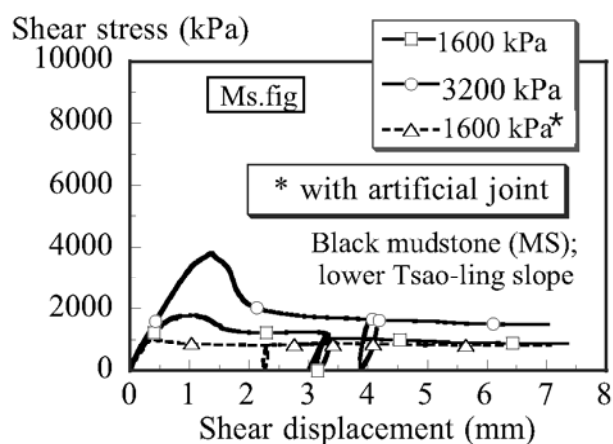
Fig. 15.31 Shear stress vs. shear displacement relationship of Tsaoiling black mud stone

Figure 15.31 presents the drained direct shear results of black mud stone specimens collected from the slip plane. Two intact specimens under different confining pressures developed peak strengths which were then followed by softening and a state of residual strength (constant stress level). Cracking and shear failure occurred at and after the peak strength. One cycle of unloading and reloading in the residual state did not develop a peak strength again because the specimen with cracks had already lost the peak strength. Effects of existing cracks were considered significant in the slope failure in 1999 because the earthquakes in 1862 and 1941 not only caused slope failure but also probably produced cracks in the remaining part which failed in 1999. In this respect, a third test was run by combining two separate rock specimens with a smooth interface in between. The dashed curve in Fig. 15.31 indicates that there is no peak strength and that the residual strength is more or less similar to that of an intact specimen under the same pressure of 1600 kPa. Thus, the residual strength stands for the strength of cracks and weak interfaces.

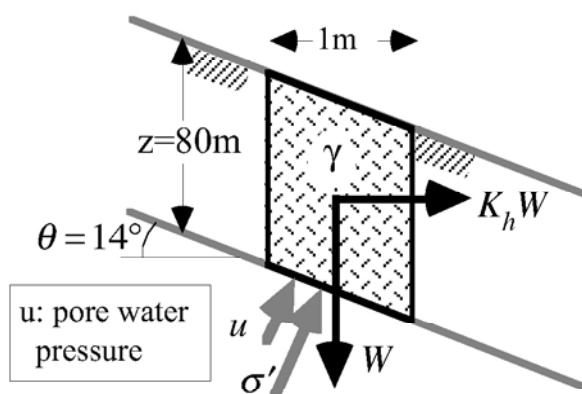
Fig. 15.32 Idea of quasistatic stability analysis

A pseudostatic stability analysis was conducted by using the idea of an infinite slope subjected to static lateral force (Fig. 15.32). The seismic coefficient,  $K_h = 0.305$ , was obtained by substituting  $A_{max} = 748 \text{ Gal}$  at a nearby CHY028 station (8 km from Tsaoiling, Seismology Center of Central Weather Bureau) in an empirical formula (Sect. 12.3):

$$K_h = \sqrt[3]{A_{\max}/g/3}. \quad (15.1)$$

For the residual strength,  $c = 417$  kPa and  $\phi = 19.4^\circ$  were used. The derived safety factors were 1.01 for the peak strength and 0.73 for the residual strength.

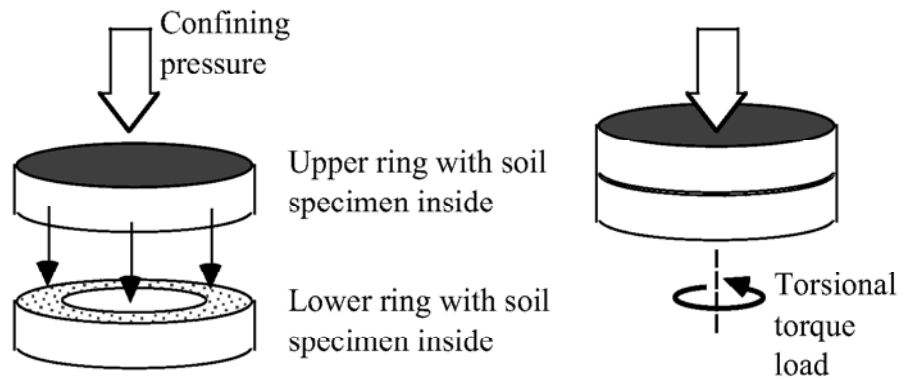
The role of sliding surface liquefaction has been studied experimentally by using a ring shear device. This device houses a hollow cylindrical soil specimen within upper and lower containers and applies torsional shear load. Since the specimen has a cylindrical shape, there is no limitation in shear displacement (Fig. 15.33). This feature is suitable in experimental reproduction of sliding surface mechanism in which slip displacement may be as large as tens of meters or more. Note that this device can measure shear displacement of a ring but cannot determine shear strain because strain is concentrated (localized) within a narrow sliding surface.

**Fig. 15.33** Illustration of ring shear test

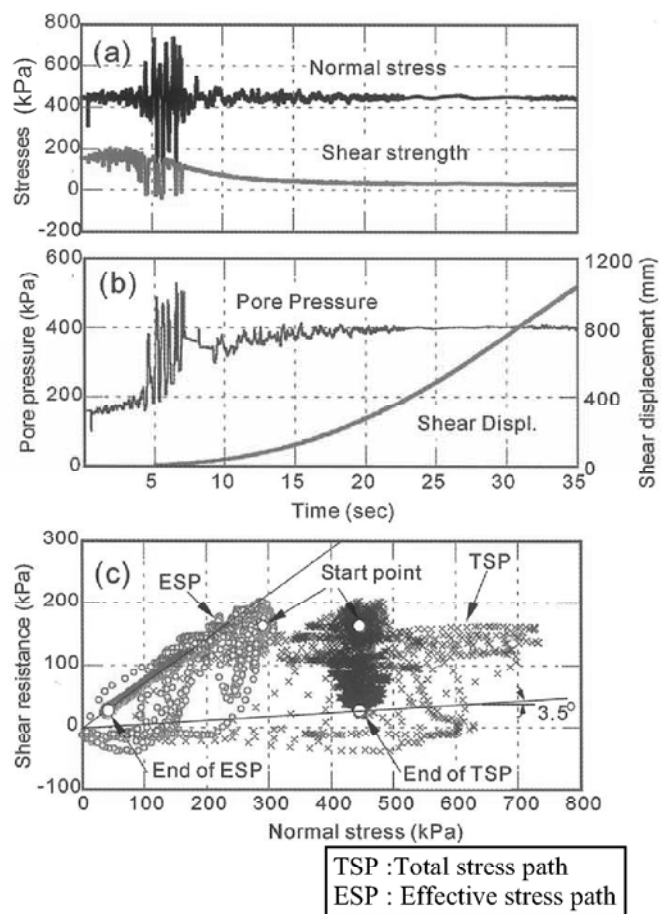
Figure 15.34 illustrates a typical test result in which the sliding displacement was induced in sand to be as large as 1,100 mm at a rate of about 50 mm/s. This rate corresponds to a real velocity of landslide mass. It is seen that cyclic loading of both shear and normal stresses increased the pore water pressure (Fig. 15.34b), and accordingly the shear strength decreased to a level of about 20 kPa (Fig. 15.34a). Since this strength was lower than the applied shear stress (vertical coordinate of Fig. 15.34c as well as the initial static shear stress of about 170 kPa), soil movement was accelerated and the displacement became as large as 1,100 mm. Note that the effective stress path (red symbols in Fig. 15.34c) shows that the stress path reached the failure line. Therefore, the development of large displacement is understandable. Nigawa landslide which was triggered

**Fig. 15.34** Experimental reproduction of sliding surface liquefaction by means of ring shear device (after Sassa et al., 2004)

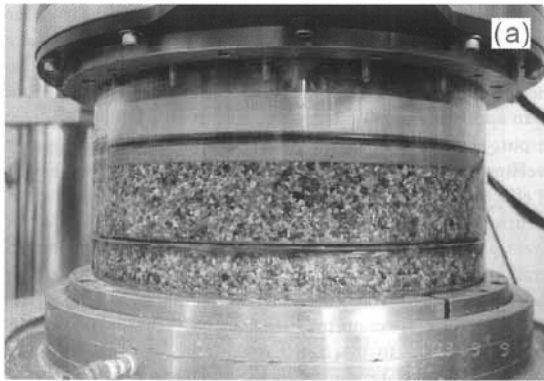
(a) Prior to undrained shear

Crushing of sand grains was verified by observing the soil behavior through a transparent side wall. In Fig. 15.35a, individual grains were visible prior to shear. Once shear displacement started, the initial high effective stress (300 kPa) caused crushing and lots of sand powders emerged within the specimen (Fig. 15.35b).

**Fig. 15.35** Ring shear test with visual observation of grain behavior (Sassa et al., 2004)

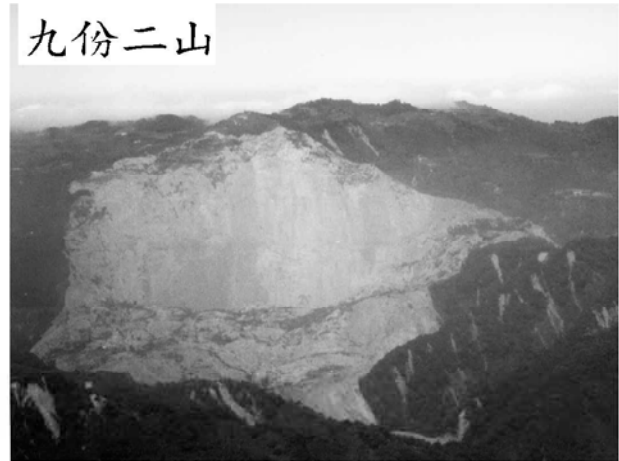
Among many landslides in Taiwan, 1999, the second most gigantic one, second to the Tzaoling (Sect. 15.3), was the one at Jiu-Feng-Er-Shan. Its view from a helicopter is shown in Fig. 15.36. The exposed layer of gray color is probably made of shale stone which formed a slip plane (Fig. 15.37), similar to the slide at Tsaoling. Figure 15.38 shows a plantation of betel palm trees (檳榔樹) near the top of this slide. It is interesting that the tree and its root were separated from the ground, suggesting that the tree jumped out of the ground due to strong (but probably less than 980 Gal) vertical acceleration. Residents near the top of this slide say that they heard a roaring and explosive sounds during the slide. They also saw the sky had pink color during shaking in midnight.

**Fig. 15.36** Aerial view of Jiu-Feng-Er-Shan landslide

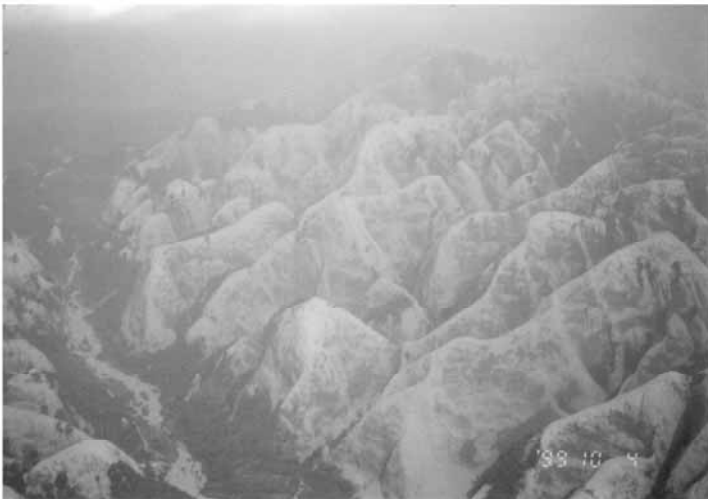
**Fig. 15.39** Appearance of 99 peaks after the quake  
(Sino Geotechnology Inc., 1999)

Ninety-nine peaks (九九峰) developed many surface slides as well and lost vegetation (Fig. 15.39). This mountain was made of gravelly sand and was vulnerable to earthquake-induced falling down of the material. Figure 15.40 indicates the gravelly material at the top of one of the failed slope.

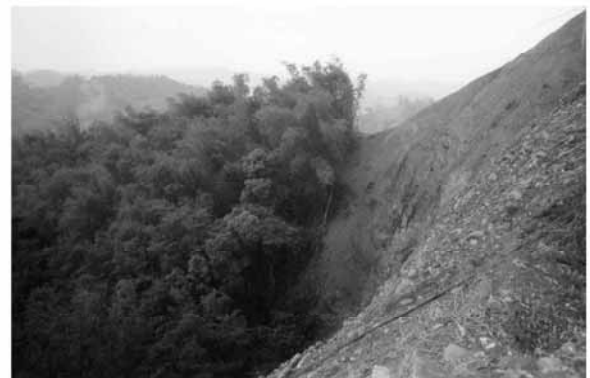
**Fig. 15.40** Gravelly material composing 99 peaks

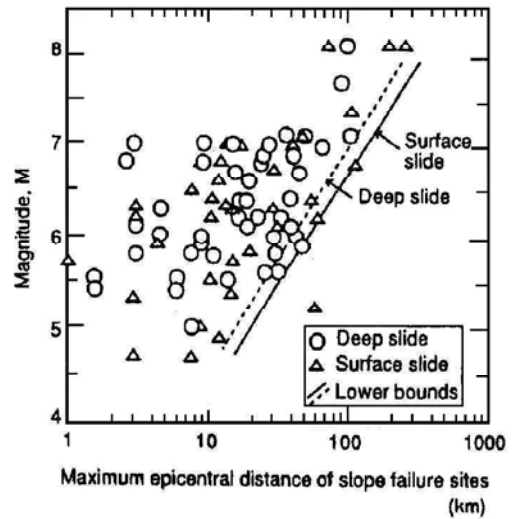
**Fig. 15.41** Maximum possible epicentral distance to failed slopes during past earthquakes (Yasuda, 1993)

Seismic failure of natural slopes is a significant problem to human societies. It is therefore desired to inspect the stability of slopes near human habitations as much as possible. The stability analysis has to take into account the expected intensity of earthquake motion, topography of the studied slope, and material properties of the rock/soil. This process requires a time-consuming site investigation, and, therefore, it is costly and unlikely to be practiced everywhere. To avoid complexity, Fig. 15.41 shows relationship between the earthquake magnitude and the maximum epicentral distance of failed slopes during past earthquakes. Beyond this distance, slope failure is unlikely. Although significantly simplified, it can do some help to risk assessment.

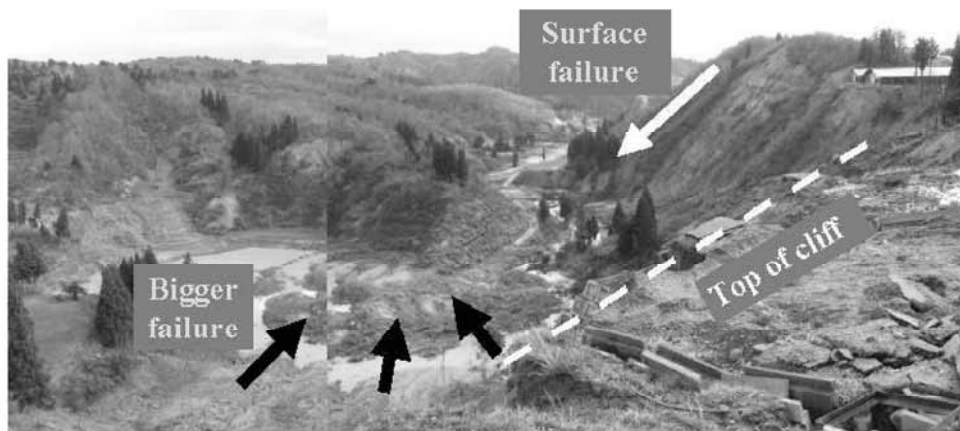
**Fig. 15.43** Different extents of lateral movement of debris due to different volumes at Naraki after 2004 Chuetsu earthquake

First, Fig. 15.44 plots the Kanagawa method’s point against the volume of landslide mass for many slope failures during the Chuetsu earthquake. Generally, there is a good consistency between the volume of landslide and the calculated point. There are, however, two slopes (Figs. 13.26 and 15.43) that received relatively low points in spite of their damage extent.

Figure 15.45 illustrates the method of testing. First, an air-dry soil sample was prepared in a conventional oedometer (consolidation testing device) by compacting with a hammer with a constant and specified energy. After loading under 20 kPa and allowing for creep deformation in a dry state, water was introduced into the sample quickly. This water submergence caused subsidence, and thereafter, some soils exhibited swelling. It is supposed in this study that swelling is caused by interaction of clay mineral and water and leads to loss of shear strength. Figure 15.46 shows the time history of volume change of three specimens which are those in Fig. 13.26 and Fig. 15.43 (both bigger and surface ones). It is therein seen that the extent of swelling varies with soil types; the surface material in Fig. 15.43 did not have swelling.

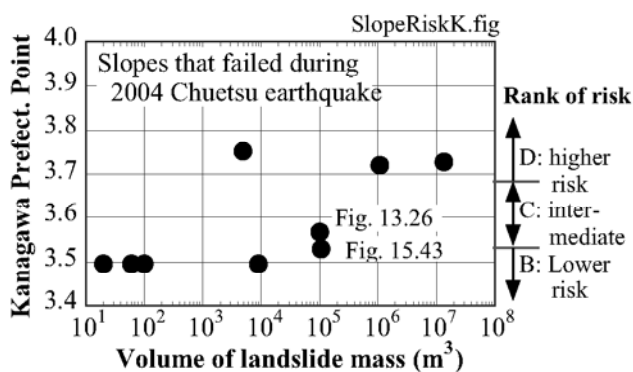
**Fig. 15.44** Assessment of seismic risk of slopes by Kanagawa Prefecture method

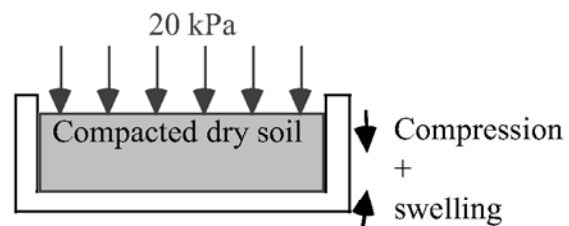
**Fig. 15.45** Method of swelling test

One of the shortcomings in the use of swelling is the long time needed for the test (Fig. 15.45). To avoid this, a correlation between swelling strain and plasticity index was plotted in Fig. 15.48. There is certainly some relationship between them, and probably the plasticity index can be used as an alternative parameter which does not require much time for testing.

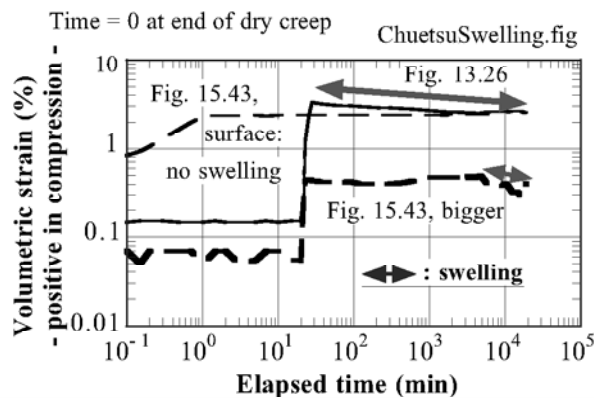
**Fig. 15.46** Example of swelling tests (volume change after water submergence)

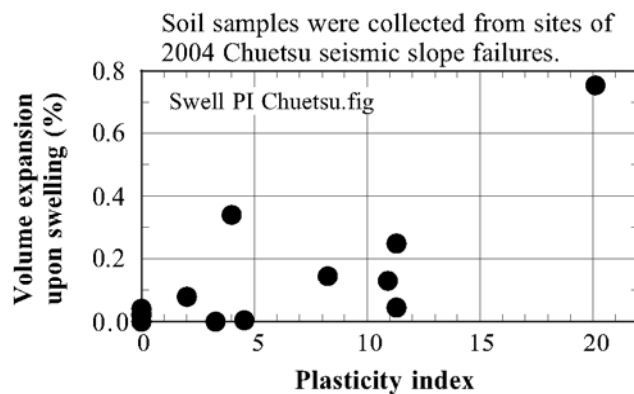
**Fig. 15.48** Correlation between plasticity index and swelling strain

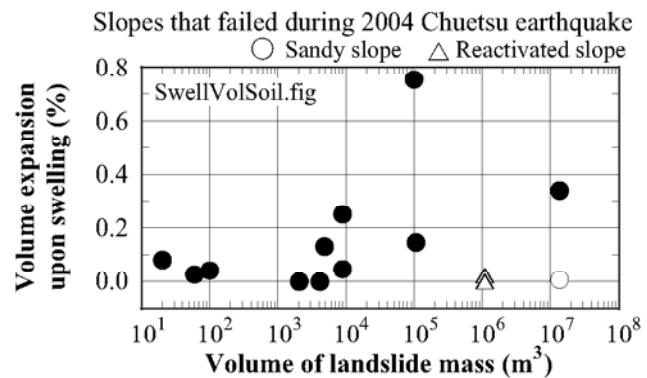
Figure 15.47 shows a positive correlation between the volume of landslide mass and the measured volumetric strain during swelling. There are, however, exceptional cases where the material was sandy or the landslide was a reactivation of an existing unstable mass. These cases do not affect the significance of the swelling strain in practice.

**Fig. 15.47** Relationship between volume of slope failure and extent of soil swelling

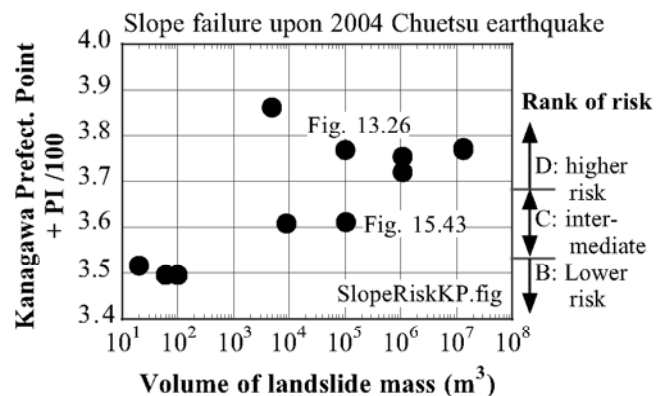
**Fig. 15.49** Revisal of seismic risk assessment of slopes by means of plasticity index

Figures 15.49 and 15.50 examine two types of revision of the original Kanagawa Prefecture method. The original points were modified by adding either (plasticity index)/100 or (swelling strain, %)/10. It may be seen that points for the cases of Figs. 13.26 and 15.43 were increased to more reasonable values. This is particularly significant in the case of Fig. 15.49 wherein the plasticity index was employed for improvement.

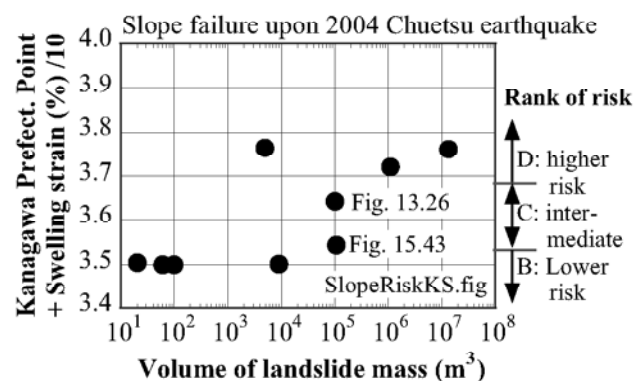
**Fig. 15.50** Revisal of seismic risk assessment of slopes by means of swelling strain

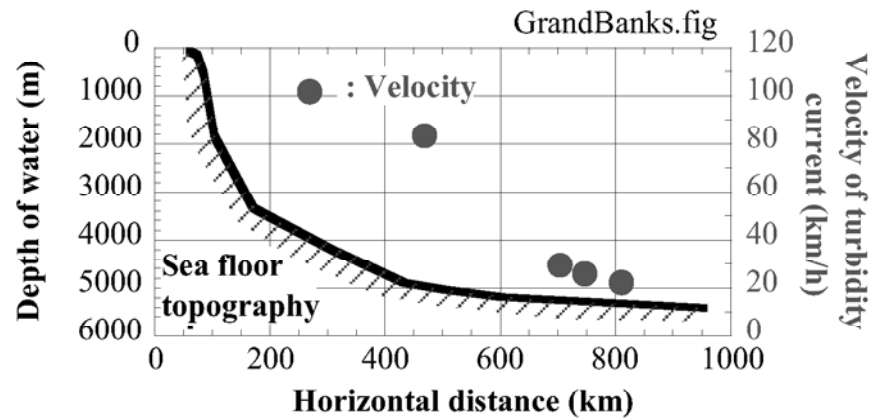
Heezen and Ewing (1952) stated that a sequential breakage of submarine telegraph cables immediately after the 1929 Grand Banks earthquake in the continental slope to the south of New Foundland was caused by a turbidity current of water and mud. Figure 15.51 by Heezen et al. (1954) indicates that the slope inclination was as small as 1/500 or less in the area of submarine cable breaks, while the velocity of the turbidity current was on average 20 knots (=39 km/h); the highest velocity probably exceeded 90 km/h. It is remarkable that the fluidized debris traveled more than 700 km over a very small inclination of sea bed. Note, however, that Hasegawa and Kanamori (1987) stated that the ground shaking which was recorded at the time of the sliding was not of an earthquake origin, but was the consequence of huge submarine sliding. If this is correct, one should understand that the Grand Banks Sliding was caused by nonseismic causes (Sect. 15.8).

**Fig. 15.51** Velocity of turbidity current after Grand Banks earthquake (drawn after Heezen et al., 1954)

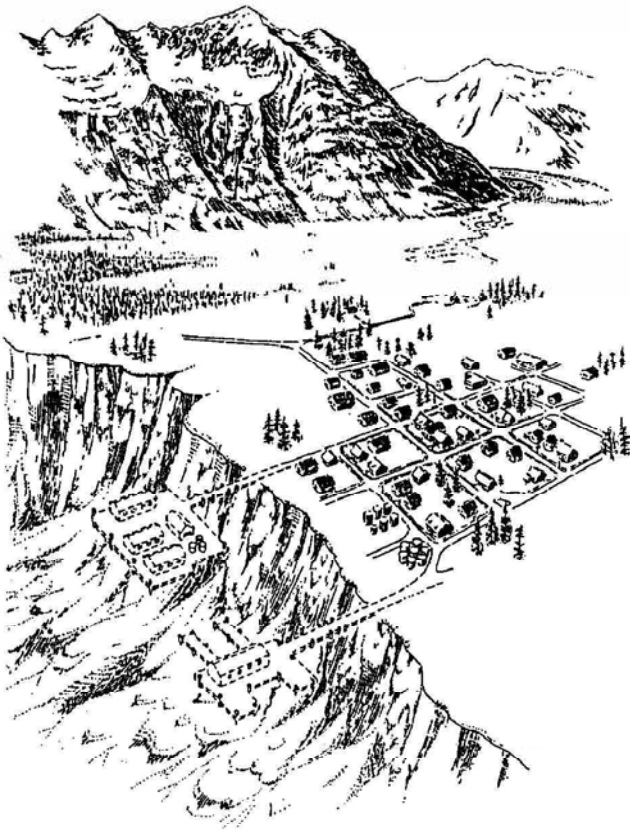
**Fig. 15.52** Conceptual sketch of Valdez submarine landslide (Drawn by David Laneville; after Coulter and Migliaccio, 1966)

A submarine landslide occurred in a gigantic scale at Valdez, Alaska, in March, 1964, when the great Alaska earthquake affected the area. Figure 15.52 illustrates the loss of sea slope, and the harbor facilities disappeared. The total volume of landslide was estimated to be around 100 million m<sup>3</sup> (Coulter and Migliaccio, 1966). Consequently, a large tsunami was produced and washed Valdez town. Figure 15.53 shows the aerial view of the present Valdez delta in 2002. The subsoil in this deltaic deposit consists of fine-grained cohesionless soil. This material was produced by scraping of mountain rock by glacier. Moreover, the small particle size

makes the velocity of grain sedimentation very slow in water, and therefore the density becomes low. When the gigantic earthquake occurred in Alaska in 1964, this submarine slope failed easily, most probably accompanied by development of excess pore water pressure. This feature of glacier deposit is similar to that of tailing material (Sect. 20.5).

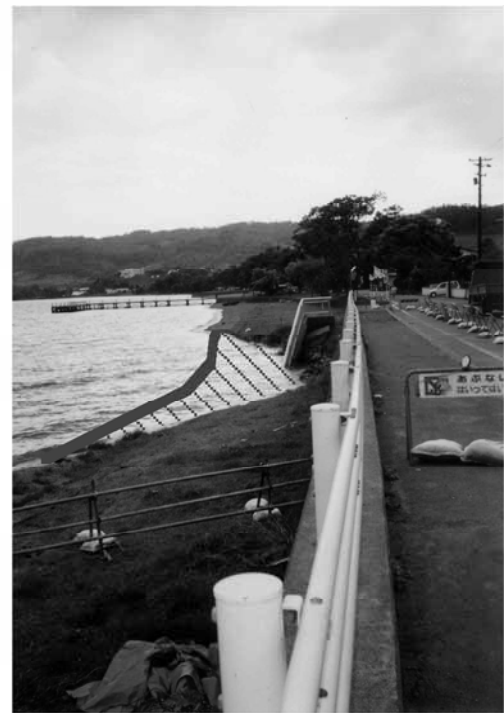
The body of a volcano is often affected by seismic motion. Figure 15.54 reveals an example in which a submerged wall of the Tohya (洞爺湖) caldera lake fell down at the time of the 1993 Hokkaido-Nansei-Oki earthquake and affected the shore line.

**Fig. 15.54** Earthquake-induced failure of caldera wall (Tohya Lake, 1993)

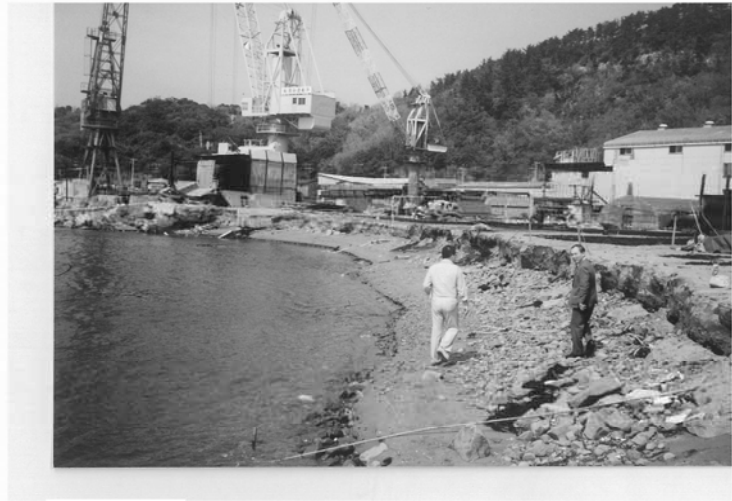
**Fig. 15.56** Small submarine landslide and missing beach due to rapid sedimentation (Naruto, Japan)

1. *Rapid sedimentation*: This is a major problem at mouths of big rivers where the rate of sedimentation is very rapid. Although the shear stress increases quickly together with sedimentation, the effective stress and shear strength take time for development due to delayed consolidation. Thus, the factor of safety decreases with time and minor impacts such as wave action or small earthquake suddenly trigger the total failure. An oil production platform was destroyed by this mechanism off the Mississippi River mouth (Sterling and Strohbeck, 1973). More detailed study is going on off the Fraser River delta, Canada (McKenna et al. 1992; Chillarige et al. 1997). Figure 15.56 is a small example of submarine landslide which was triggered by rapid sedimentation of sand in the sea bed off this beach.

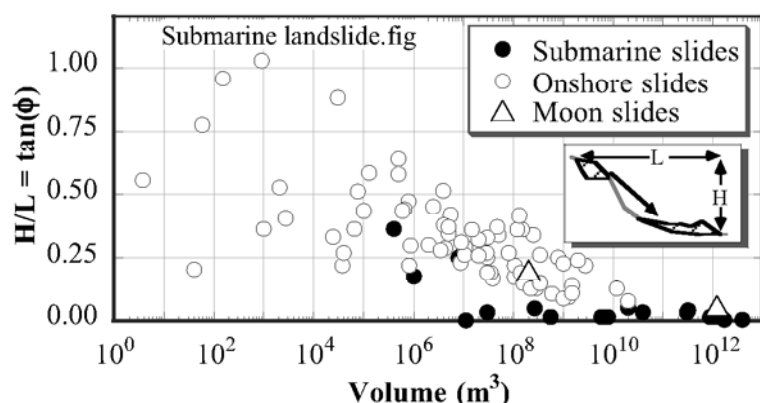
**Fig. 15.57** Apparent frictional coefficient of landslides; subaerial and submarine

Figure 15.57 suggests that typically  $H/L = \tan 30^\circ \approx 0.6$  for the cases of smaller debris volume which often occurs. This information is frequently used for assessment of area which is vulnerable to potential risk of landslide (hazard mapping). Note, however, that there are cases where  $H/L$  is very small possibly due to high water content and development of excess pore water pressure in the soil mass. It is empirically known, furthermore, that debris flow in volcanic slopes (Fig. 15.4 for example) has smaller  $H/L$  and greater travel distance than other onshore events (Siebert, 1984); compare Fig. 15.58 with Fig. 15.57.

A risk assessment of seismic slope failure requires evaluation of not only the factor of safety but also the travel distance of failed debris (Fig. 15.57). The latter issue certainly needs understanding of soil behavior in the course of rapid sliding movement. A unique idea on mechanism of long-traveling landslide was proposed by Sassa et al. (2004). This idea supposes that grains are crushed extensively in a thin layer (slip plane) during slope failure. Consequently, the granular structure of soil loses its capability to bear the overburden (loss of effective stress) and excess pore water pressure develops. This mechanism is called sliding surface liquefaction. This idea may also be applicable to a fault action if a fault is filled with soil.

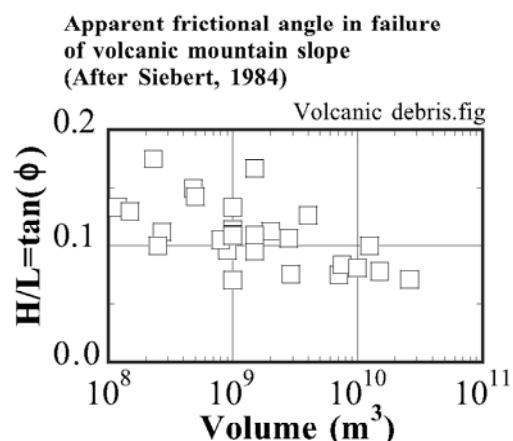
**Fig. 15.58** Apparent frictional coefficient in failure of volcanic mountains (data by Siebert, 1984)

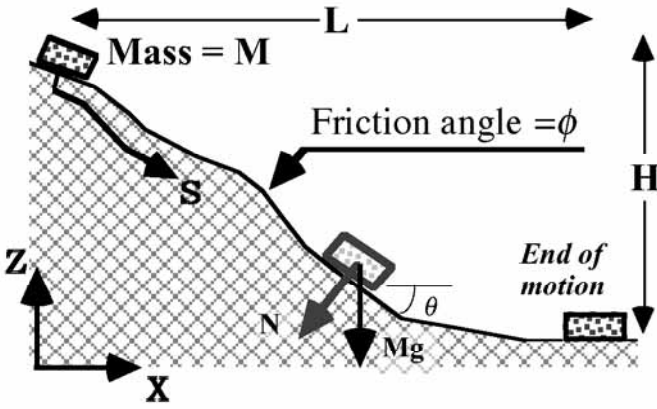
where  $s$  is the location of the moving mass measured along the slope surface (Fig. 15.59).

**Fig. 15.59** Motion of mass along slope surface      **Fig. 15.60** Changed flow direction of debris at bottom of slope (rainfall-induced slope failure in Shikoku, Japan, in 2004)

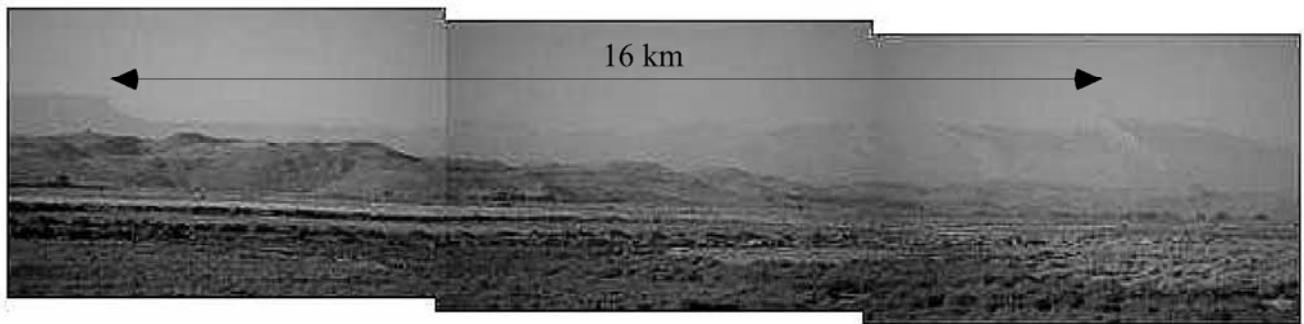
Figure 15.61 demonstrates the biggest onshore landslide that can be seen today (Harrison and Falcon, 1938). The width and the length of this Seimareh, Iran, landslide are 16 km and 5 km, respectively, while the thickness of the failed rock mass is 300 m (Fig. 15.62). Thus, the total volume of the debris was around 24 billion  $m^3$ . A  $C_{14}$  dating (Watson and Wright, 1969) by using sediment of a lake in this area suggests that this landslide occurred 10,000 years ago. Since the annual precipitation is very low (500–600 mm/year; van Zeist and Bottema, 1977), erosion is not significant and it is possible to see the slip plane (Fig. 15.63). This slide was probably caused by erosion by river at the foot of the slope (Oberlander, 1965). It is however possible that the unstable slope was finally destroyed by shaking. As Fig. 15.57 implied, this huge volume of debris makes H/L value very small; the travel distance was as long as 20 km which is evidenced by the debris deposit which is still visible today (Fig. 15.64).

**Fig. 15.61** Total view of Seimareh landslide seen from nearby town of Pol-e-Doghtar

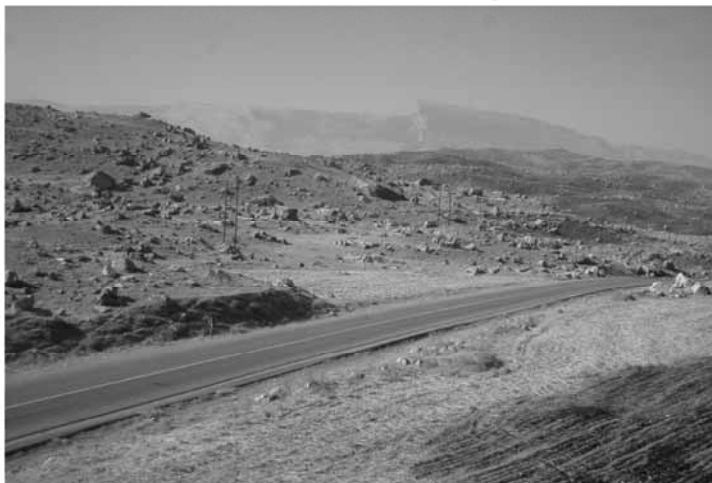
**Fig. 15.64** Debris deposit of Seimareh landslide
