# Geo-disasters in Japan in the Context of Climate Change

**ABSTRACT:** Japan is an area affected strongly by land surface upheaval and by climate change instability. Background evidence of increasing and magnifying geo-disasters includes the following: (i) frequent and extremely severe torrential rainfall; (ii) high and increasing frequency of strong earthquakes (5+ and 6- as the Japan Meteorological Agency seismic intensity scale); and (iii) typhoons with magnified damage effects. Based on a review of that information stated above, an attempt has been made to overview the present situation and future trends of geo-disasters in the context of climate change and to present possible adaptive measures against disasters. Particularly, emphasis is assigned to the importance of the combined effects of plural events, which increases the probability of extreme events, sometimes triggering devastating consequences. Adaptive measures against climate change-associated geo-disasters are presented by classification into software and hardware. Special emphasis is devoted to the availability of information and communication technology (ICT) and information, communication and robot technology (I

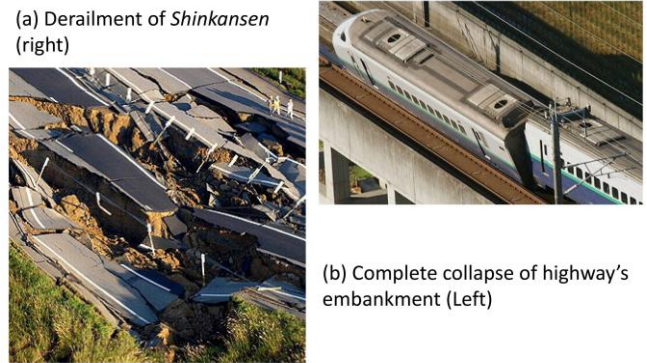
Photo 1 Damage to a railway and a highway

Extensive slope failure damage occurred in Niigata in 2004 because a great earthquake with magnitude 6.8 followed by long-term rainfall of longer than one month is counted as a typical compound geo-disaster. As shown in Photo 1, this disaster induced the collapse of highways and derailment of the *Shinkansen*, its first such accident, completely leading to slope failure at around 4000 locations. Many slope failures are caused mainly by the following:

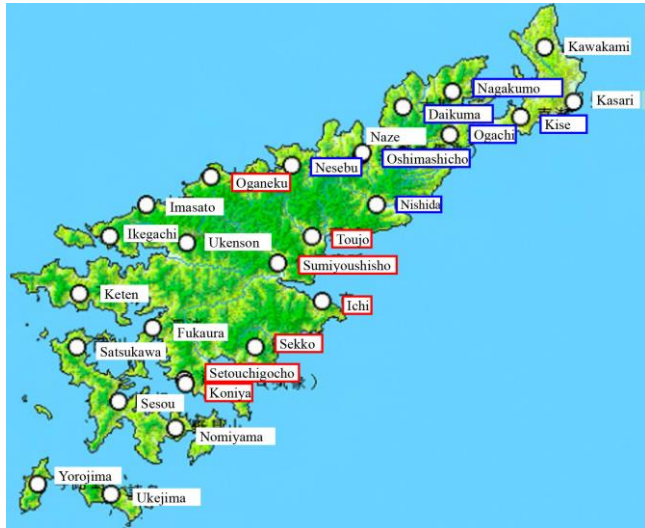
(a) Observation locations and boundary line of rainfall patterns

(b) Sediment disasters and boundary line of rainfall patterns (Kagoshima prefectural government, 2015)

Figure 14 Rainfall pattern and sediment disasters as determined from measurements and investigations.

Subsequently, Araki and Ishii (2015) noticed that there was a boundary line that can be used to divide single-peak and the dual-peak patterns, as shown in Figure 14. They also found that cliff failure and debris flows were respectively predominant in the northeast and in the southwest of the peninsula, which implies that precipitation with the single-peak pattern is associated with debris flow and precipitation with the dual-peak pattern is associated with landslides and cliff failure. However, they concluded that this tendency had nothing to do with the geological situation and that sediment disasters occurred only at the surface parts of slopes.

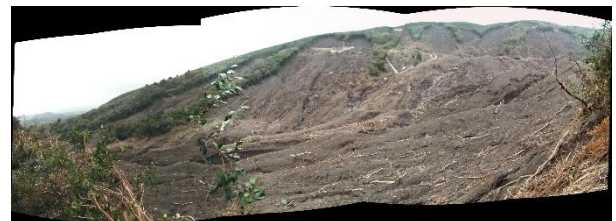
Photo 2 Slope failure and damage (November 9, 2013)

Sediment transportation from debris flow is shown in Photo 2 with slope failure. Slope failures led to debris flow, which is closely correlated to the single-peak precipitation pattern as found for the sediment disaster in the Amami Ohshima. Some similarities are apparent for Amami Ohshima and Izu Ohshima sediment disasters:

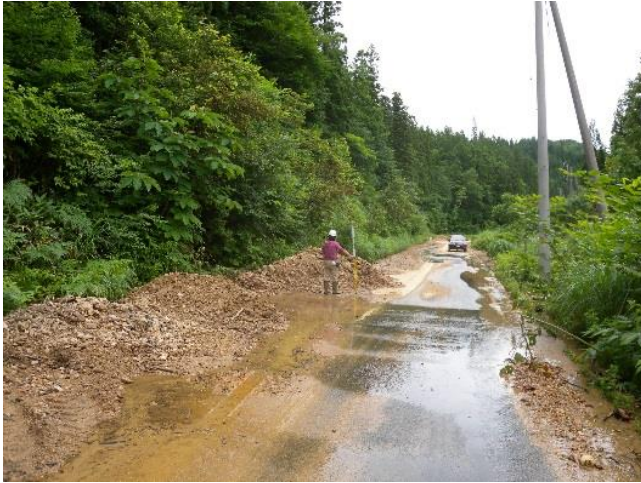
Photo 3 Sediments transported by slope failure

Particularly near the Oizawa Observatory where the largest amount of rainfall (212 mm/day) observed since the start of recorded observations in 1979. Frequent slope failure caused the disruption of roads and subsequently led to the isolation of numerous locations in town and villages, as shown in Photo 3. This was one reason preventing transportation of water resources to residents.

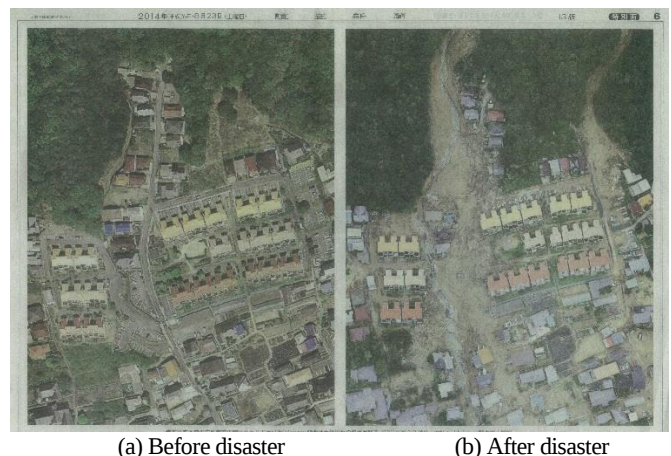
(a) Before disaster

(b) After disaster

Figure 18 Damaged site (Asa-minami district in Hiroshima city (Yomiuri shimbun, 2014))

Unexpected and locally torrential rainfall struck the mountainous slopes leading to production of debris flows that severely damaged the residences at the foot of mountains (Figure 18).

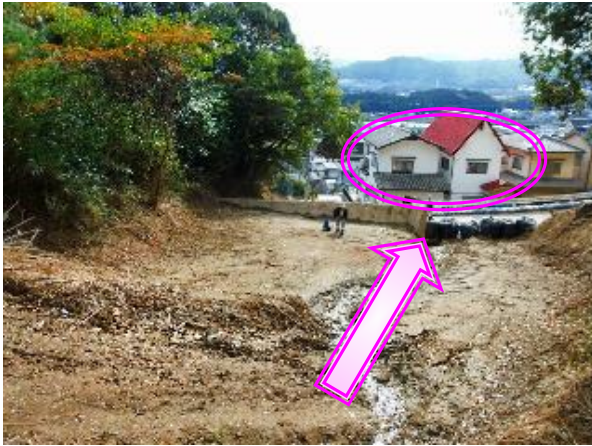
Photo 4 Relation between mountain stream outlet and residences in debris flow in Hiroshima

Photo 4 is a scene from the mountain stream outlet to residences in the Asa-minami district, showing that both are very close. This evidence shows that residents have no choice but to live close to the dangerous area for their convenience. A typical scene of damaged residences is shown in Photo 5.

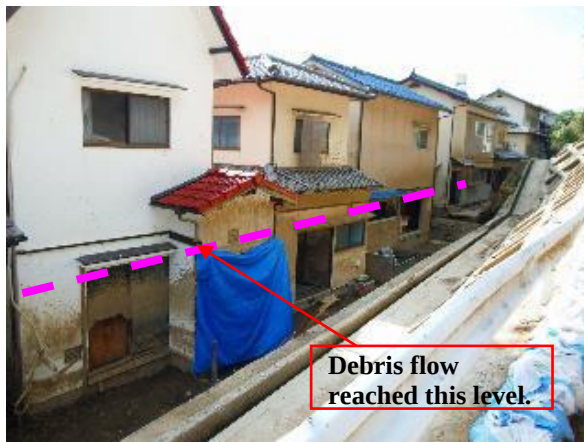
Photo 5 Damaged residences in debris flow in Hiroshima

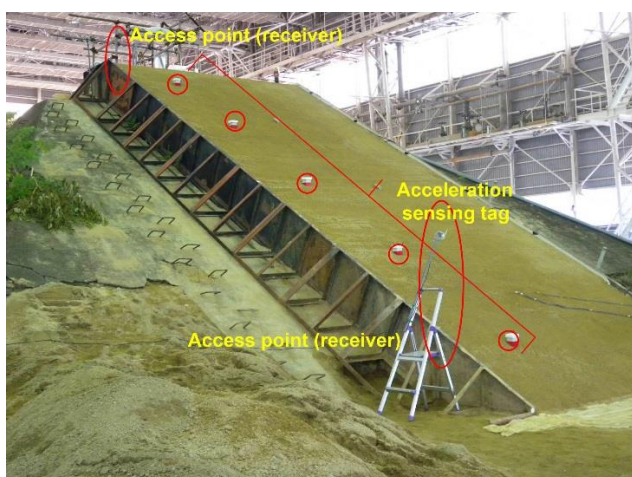
Figure 23 Outline of model tests on slope failure caused by rainfall

Large-scale model tests for slope failure caused by rainfall were conducted at the National Research Institute for Earth Science and Disaster Prevention (NIED) (Dairaku et al., 2014). Figure 23 shows a slope outline with 30 degrees for a gradient, which consists of masa soil with initial water content of around 7.9%. Masa soils used for the model tests closely resemble soils constituting debris flow that occurred in Hiroshima in August 2014. To ascertain how variation of acceleration in sloping ground with intensity of rainfall is correlated with slope failure, sensing IC-tags called MEMS were installed as shown in Figure 24 together with equipment to measure variations of volume moisture content.
