# Climate Change Impacts in a Large-Scale Erosion Coast of Hai Hau District, Vietnam and the Adaptation

**ABSTRACT:** Among the effects of global warming, sea level rise (SLR) and severe typhoons pose the greatest threat to the stability of human settlements along coastlines. Therefore, countermeasures must be developed to mitigate the influences of strong typhoons and persistent SLR for coastal protection. This study assesses climate change impacts on coastal erosion, especially in two projected SLR scenarios of RCP2.6 and RCP8.5. The results show that SLR and severe typhoons lead to the increase of coastal erosion, beach lowering and scour. Moreover, as in projected SLR scenarios, average waves in high tide can cause severe soil erosion at inner slopes and lead to dyke failure by 2060. SLR also increases pore water pressure and causes larger wave attacks on the seadykes making them more unstable in typhoons and storm surges. The paper highlights the need for additional geotechnical engineering measures to protect the coast of Hai Hau district against SLR and severe typhoons. Among the alternatives available for countering these threats, applying soil stabilization and soil impro

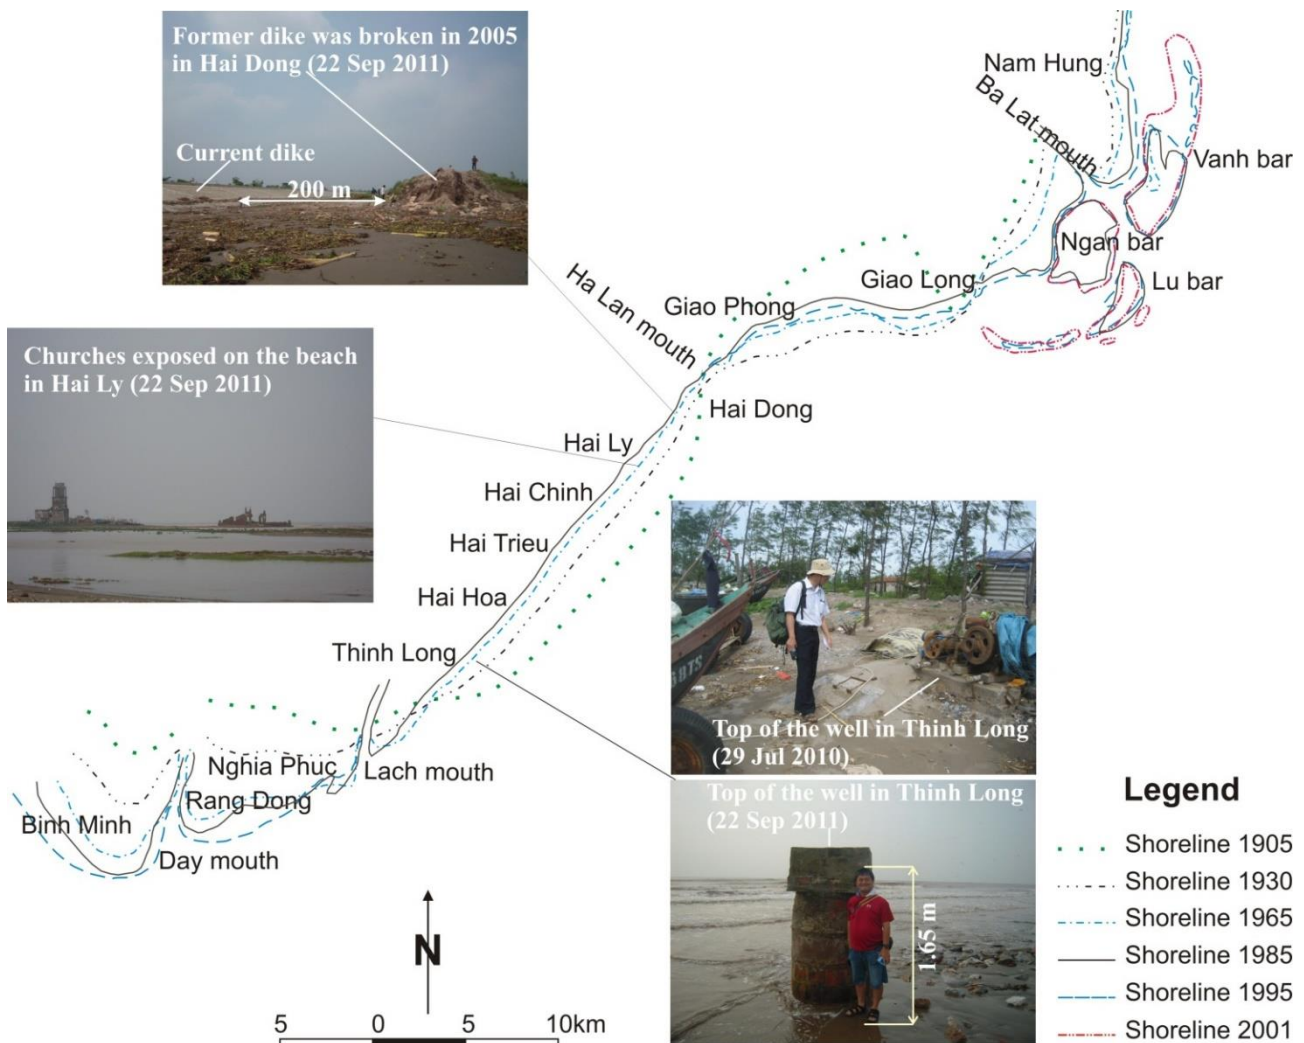
Figure 2 Coastal erosion in the Hai Hau coast (shorelines taken from Duc et al. 2012)

The summarized results from above mentioned scientific papers (Figure 2) show that the most severe erosion is on the coast of five coastal communes (Hai Dong, Hai Ly, Hai Chinh, Hai Trieu, and Hai Hoa) and Thinh Long town. The coastal erosion in Hai Hau was

Currently, the shoreline in Hai Dong has been accreted. However, the erosion continues to increase in other segments. The most severe erosion segment is now shifting to the southwest. The erosion is very significant on the coast of Thinh Long town. The shoreline was retreating up to 40-50 m/y from 2003 to 2005 (Duc et al. 2012). Beach relief in the south part of Thinh Long town was lowered by approximately 1.7 m in the period from July 2010 to September 2011 (Figure 2).

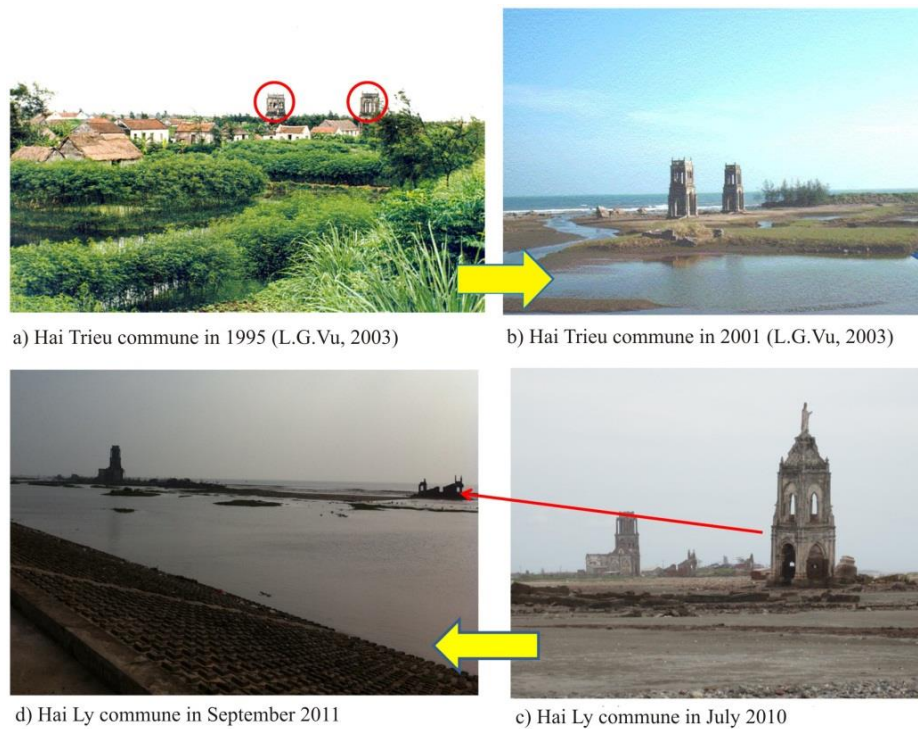
Figure 3 History of erosion process in the Hai Hau coast

Because of the severe retreat, coastal dyke collapse has occurred frequently, about once every 7–10 yr. (Cong et al. 2009), as depicted in Figure 3. The figure shows that using old churches as symbolic

monuments might illustrate the destruction caused by the progressive retreat of the Hai Hau coast. Unfortunately, the remaining symbolic churches finally collapsed in 2010.

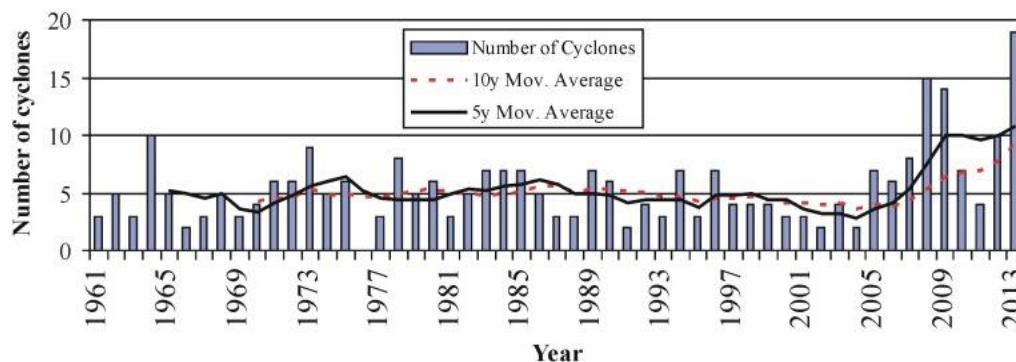
Figure 4 Number of tropical cyclones landed on Vietnamese coast (1961–2013) (Data source: Website of Vietnam National Center for Meteorology and Hydrology)

Tropical cyclones are a common climatic event in northern Vietnam. The so-called typhoon season often starts in June and ends in October. Approximately 13% of all tropical cyclones strike the northern coast. The most recent data for the annual number of tropical cyclones, as released on the website of National Centre for Meteorology and Hydrology ([www.thoitienguyhiem.net](http://www.thoitienguyhiem.net)) (Figure 4) show no clear trend in the number of cyclones between the 1960s

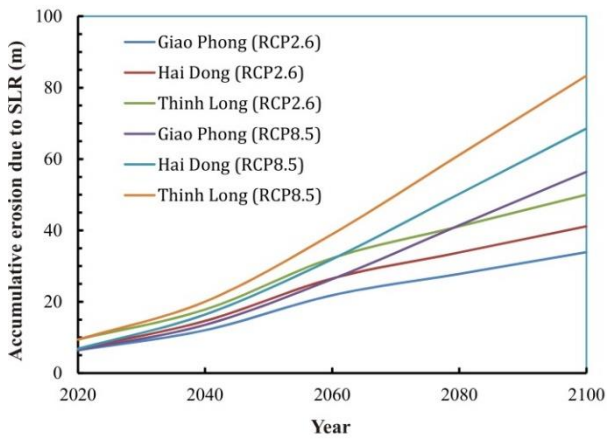
Figure 5 Erosion in Hai Hau coast due to SLR of RCP2.6 and RCP8.5 scenarios

Based on formula (1) and mean SLR curves of IPCC (Church et al. 2013), impacts of SLR on future erosion for low (RCP2.6) and high (RCP8.5) scenarios are shown in Figure 5. Accumulative amounts of erosion by 2100 are 6.4, 6.8 and 9.4 m in Giao Phong, Hai Dong and Thinh Long, respectively. They are similar in both low and high scenarios. By 2100, amounts of erosion reach to 34-50 m for low scenario and 56-83 m for high scenario.

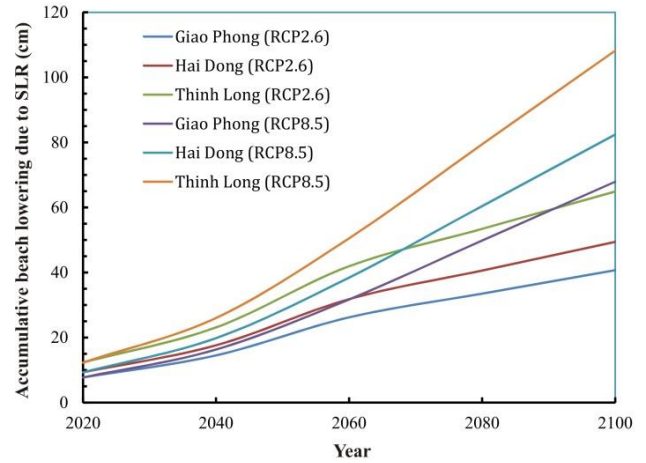
Figure 6 Beach lowering in Hai Hau coast due to SLR of RCP2.6 and RCP8.5 scenarios

Rates of beach lowering were high at Hai Ly, Hai Chinh, Hai Trieu, and Hai Hoa (Table 2) with values of 15-25 cm/y in the period from 1985 to 1995. The current concrete coastal dykes have foots placed at the depth of 1.5 m. Therefore, assumed same rate of lowering, the current dyke's foot may be destroyed in only 6-10 years. Recently, beach lowering has been very serious in Thinh Long town, where the rate was up to 156 cm/y. The situation is more serious with the impacts of SLR. As shown in Figure 6, SLR causes 8-12 cm of beach lowering in Hai Hau by 2100 in both low and high scenarios. By 2100, the beach is lowered from 41-65 cm for low scenario to 68-108 cm for high scenario. Therefore, lowering of beach profile is the most serious threat to the long-term stability of coastal dykes.

Lowering of beach profile is the most serious threat to the long-term stability of coastal dykes. SLR causes 8-12 cm of beach lowering in Hai Hau by 2020 in both low and high scenarios, and 41-65 cm for low scenario, 68-108 cm for high scenario by 2100.

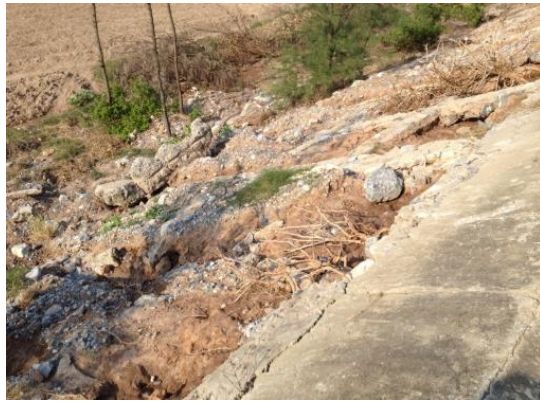
a) Destruction of outer slope by wave attacks, Thinh Long  
22 Feb 2012

In the current design, the heights of the coastal dykes in Hai Hau can only stand typhoons in the lower tenth of intensity (Beaufort scale) in the mean tide. Another problem with the instability of the dykes is admissible wave overtopping. The situation becomes much more serious during typhoons as the Hai Hau coast has experienced severe storm surges, which were up to 0.8-2.6 m high (Table 4). When the wave run-up distance is higher than the crest freeboard (the vertical distance between the mean sea level and the top of the structure), the water will overtop the structure in a continuous sheet of water. The possibility of crest and inner slope to resist erosion and local sliding triggered by overtopping water in Hai Hau (Figure 7) must seriously be considered.

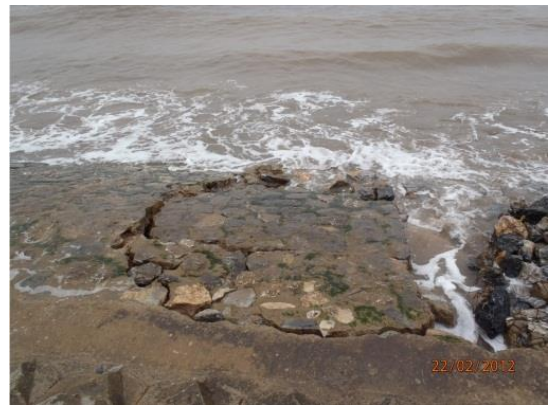
b) Destruction of inner slope by overtopping, Thinh Long  
4 Dec 2013

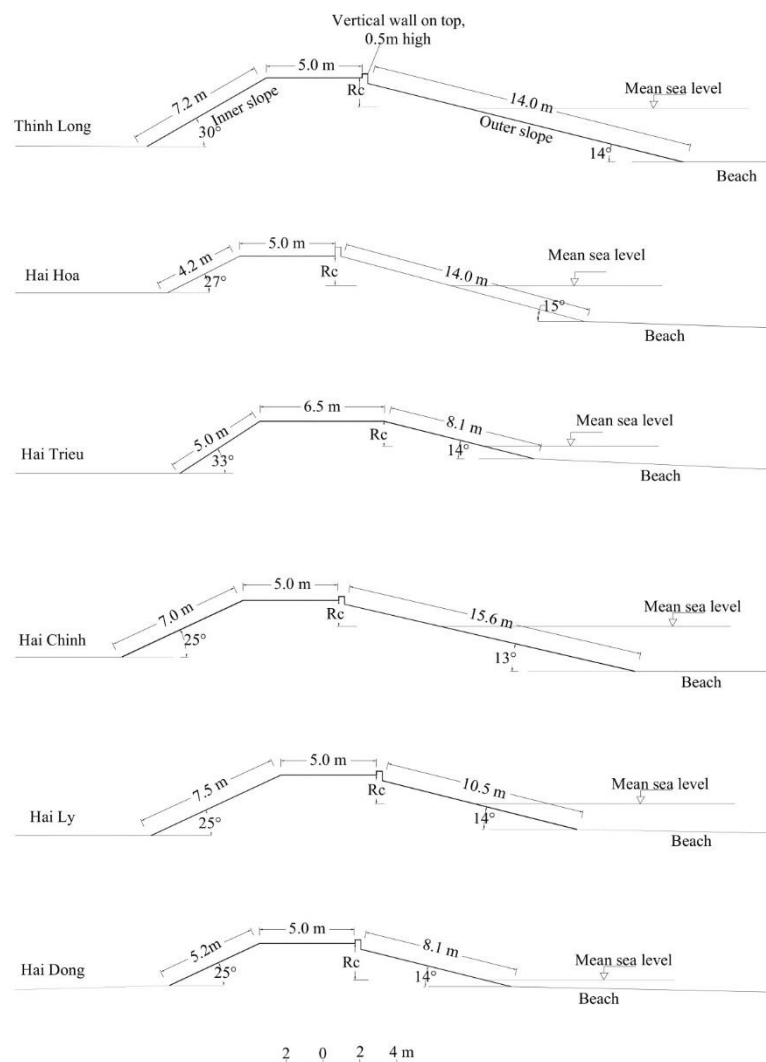
Figure 8 Typical cross sections of coastal dykes on the Hai Hau coast

Geometrical characteristics of coastal dykes in Hai Hau are shown in Figure 8. According to the Unified soil classification system (ASTM 2001), the materials used to build the coastal dyke on the Hai Hau coast are mostly clayey sand (SC) with medium compaction and

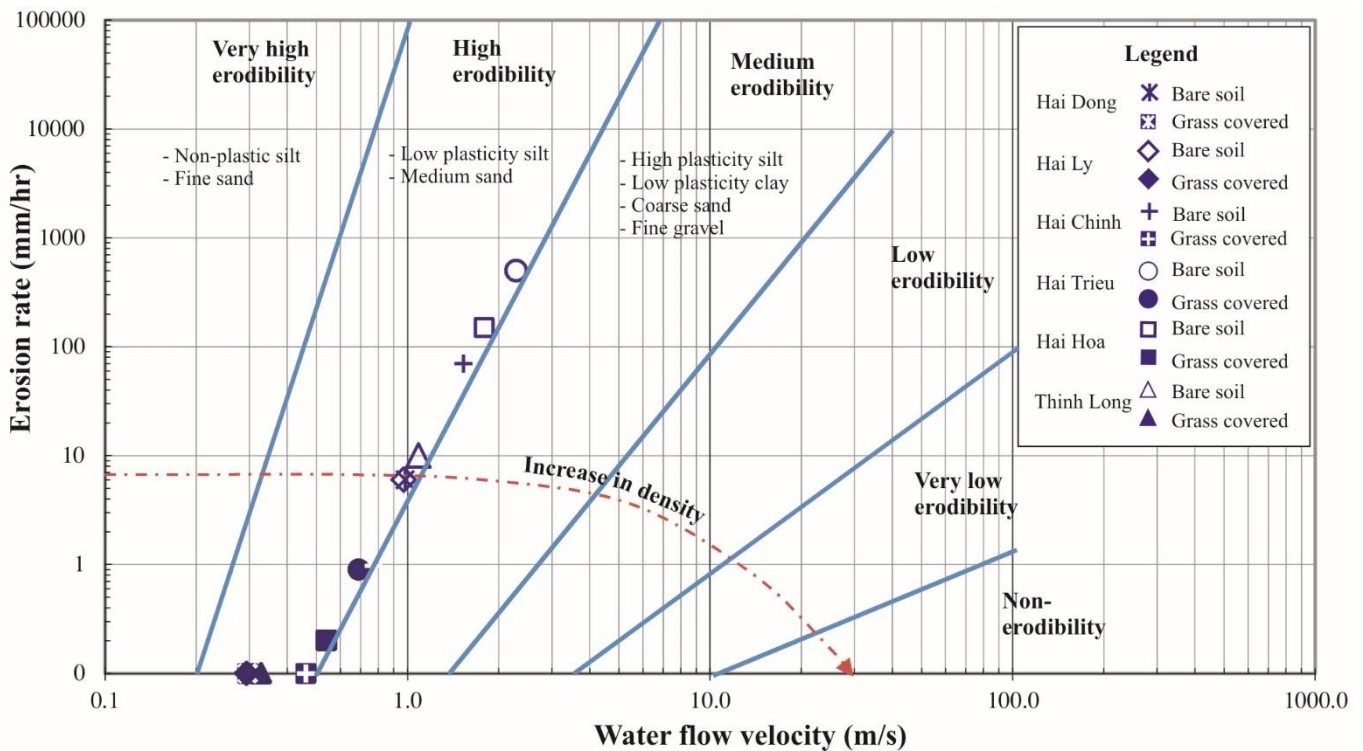
Figure 9 Estimation of soil erosion rates at inner slopes of the coastal dykes in Hai Hau coast

low plasticity (Table 5). Based on empirical relations between water velocity and erosion rate for various types of soils (Figure 9) of Briaud (2008), erosion rates at the inner slopes of the Hai Hau dykes are shown in Table 6.

Erosion is ignorable at Hai Dong, Hai Ly and Thinh Long. However it is severe at Hai Hoa, Hai Trieu, especially in Hai Trieu, where the inner slope was bare soil with no vertical concrete wall to prevent waves from running up. The erosion rate at Hai Trieu was estimated up to 50 cm/h. In the cases of vegetated inner slope, velocities of overtopping water flows were significantly reduced. Erosion rates at inner slopes were negligible (Table 6).

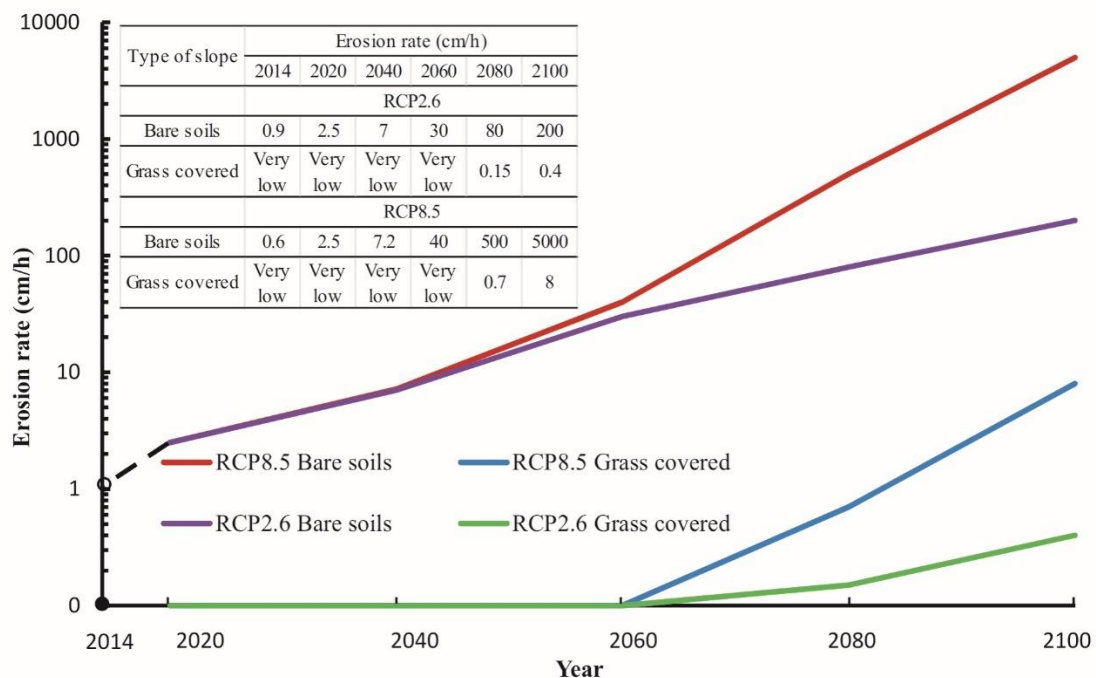
Figure 10 Erosion rates at dyke inner slopes of Thinh Long town in RCP2.6 and RCP8.6 scenarios (geometrical parameters of dykes, beach slope were measured in 2012, and assumed to be constant in the calculation)

With similar data, in Thinh Long, as an example of Hai Hau coast, erosion rates at inner slopes increase sharply due to future SLR (mean

SLR curves as in Figure 13.11 of Church et al. 2013). The rates are serious after 2040 in both RCP2.6 and RCP8.5 scenarios (Figure 10). The difference in erosion rates between RCP2.6 and RCP8.5 scenarios is only significant after 2060. However, erosion rates in bare soils for RCP8.5 scenario are about ten times as those for RCP2.6 scenarios by 2080 and 2100. It is significant to note that erosion rates by 2100 are still not so serious in both scenarios if the inner slopes densely covered by grass.

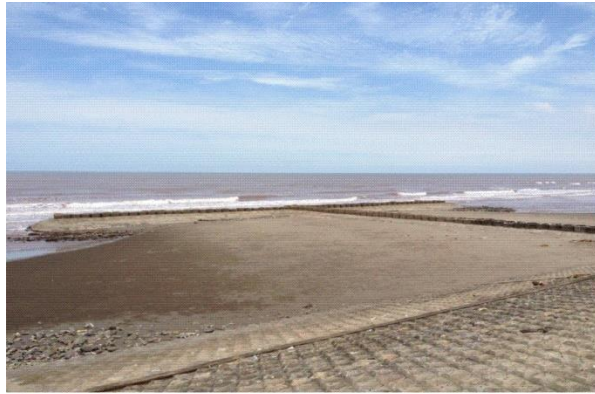
a) T-groin

Therefore, the dykes are easily eroded and severely damaged in a typhoon (Vinh et al. 1996). Dykes of such type are still used in some parts of the Hai Hau coast, including the Hai Chinh and Hai Dong communes. To reinforce the dykes, groins are used. The groins are built of concrete reinforced with concrete tubes, which are 10-cm-thick and 1 m in diameter, and placed continuously at a depth of 0.5

m under the tidal flat and a height of 1.5 m with sandbags inside. The distance between the links is 80 m (Figure 11a). Mangrove forest is being replanted in Hai Dong (Figure 11b) where coastal sediments are now accreting. With investments from PAM (Programme Alimentaire Mondial) and the government from 1998 to the present, the coastal dyke system in Hai Hau has been intensively reinforced (Figure 11c). The coastal dyke height has been improved by 4.5–5.5

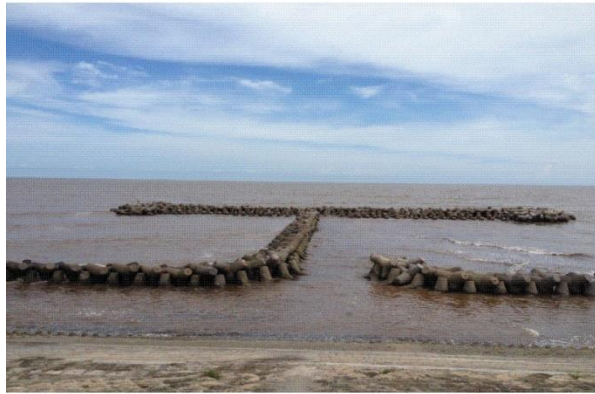
c) Tripods

m. Footings were placed at 1.5 m depth, and the dyke was reinforced by lines of tripods and covered by polygonal pre-cast concrete of 100-kg mass, even reaching 200 kg on the slope of 1: 2.2–3 (Figure 11d). In segments of the soil dykes, standby blocks of limestone are disposed nearby for emergency rehabilitation in bad weather conditions.

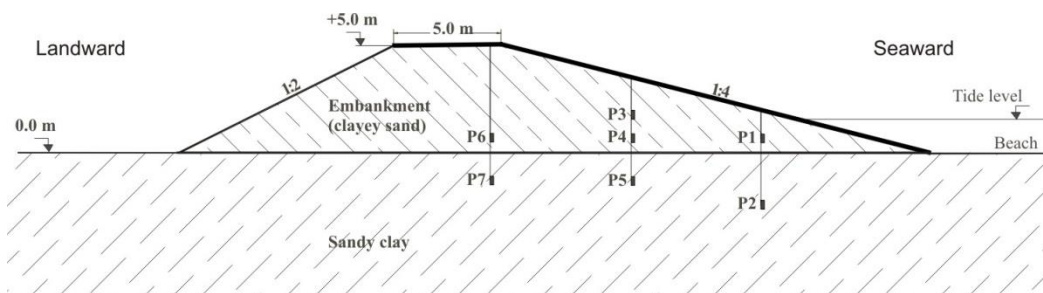
Figure 12 Sketch of the PWP monitoring system

In order to have a precise insight into changes of pore water pressure (PWP) in the dyke body and foundation, a PWP monitoring system was installed. Equipment used for the system was purchased from Slope Indicator. Sensors are vibrating wire type which posse a high accuracy in a range of pressure from 0.7 bar to 35 bar. Totally, 7 piezometers were installed in January 2013 (Figure 12). The piezometers were installed at different depths and isolated from each other to form a net of multi-level PWP inside and under the dyke. The data is recorded every 10 minutes. Recorded PWP have different values depending on depths and locations. Tide levels of lower than 0.5 m have no impacts on PWP changes (Fig. 13a). PWP at piezometers 1, 3 and 6 showed negative values because these were

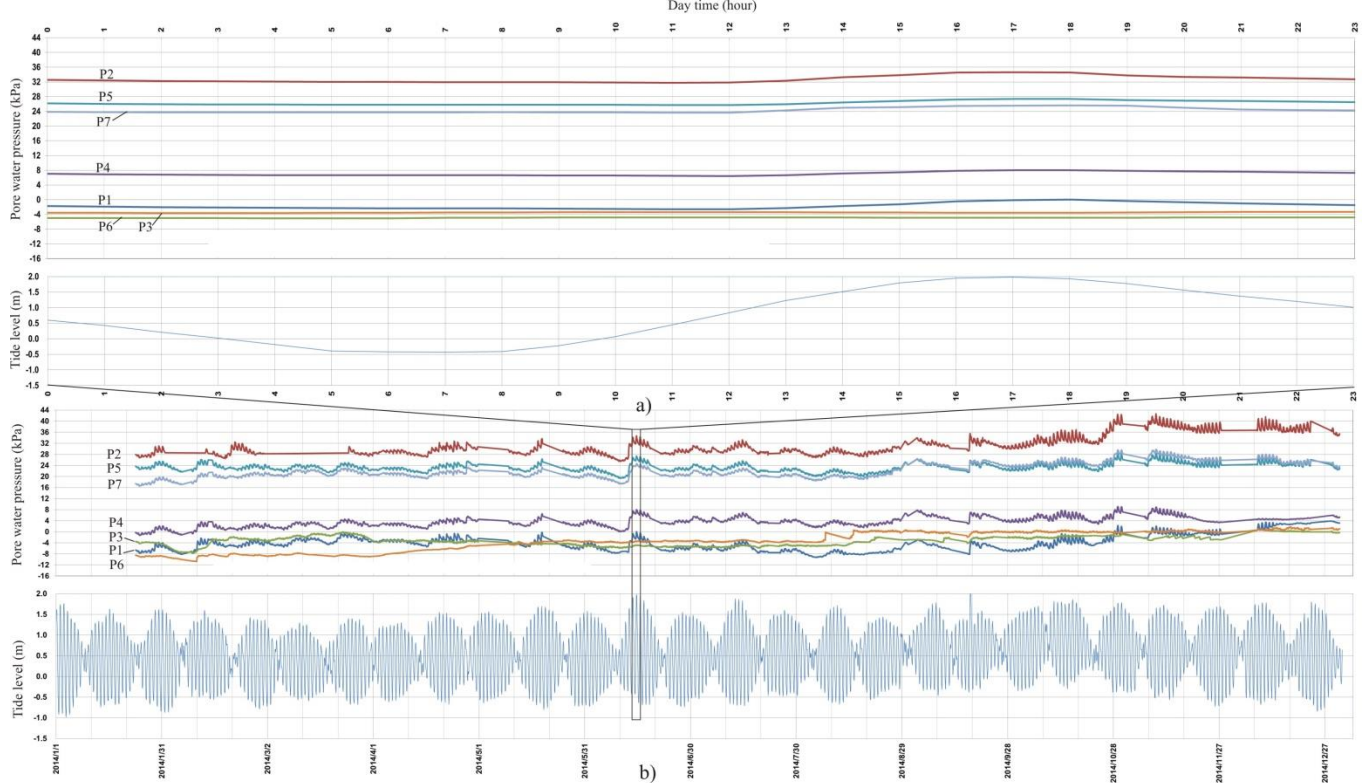
Figure 13 Relationship between tide level and PWP in Hai Hoa (a. A daily record on 14 June 2014, b. Long-term record)

put above the groundwater table, meanwhile piezometers 2, 4, 5 and 7 showed positive values. High conductivity zones near the coast lead to similar curves of fluctuation between daily tide levels and PWP in all piezometers with positive values (Figure 13a). It is well known that the response to harmonic fluctuation of tide level decreases exponentially with distance inland (Slooten et al. 2010). Therefore changes of PWP at piezometer 7 (the most landward site) proves high potential of seawater intrusion through dyke bodies which will seriously affect landward rice fields. Northeast monsoon induces 2–5 kPa higher in PWP even in low tide level conditions (Figure 13b). Fluctuation in tide levels changes PWP distribution in the dykes, and therefore changes seadyke stability, which can be more detail analysed in another study.

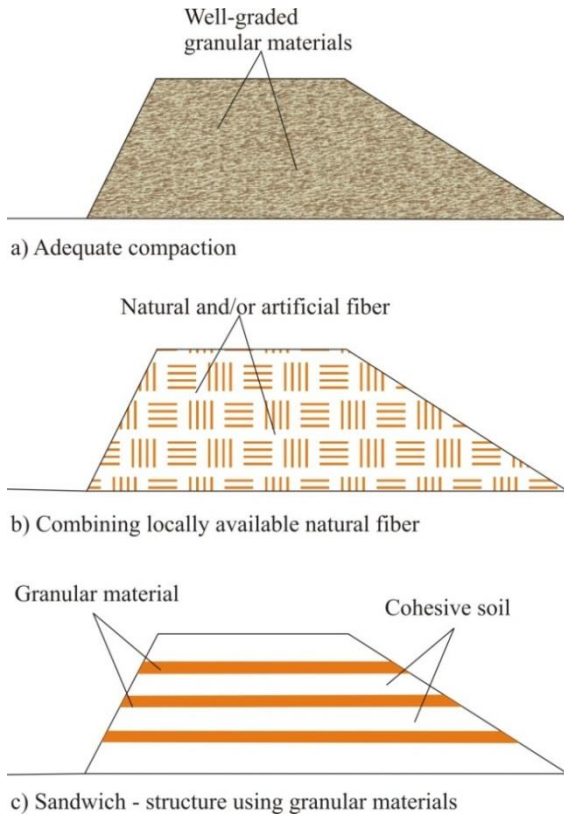
Figure 14 Several options for reinforcement for coastal dykes (after Yasuhara et al. 2012c)

Matsushima et al. (2011) presented a case study of the successful use of jute inclusions in soils used for local agricultural road embankments to resist climate change events as depicted in Figure 11. From the perspective of cost savings, several measures can be used for reinforcement dykes, including the usage of locally available materials. Adequate compaction is fundamentally important but sometimes difficult, particularly when aiming for high compaction, such as 90–95% of maximum dry density of soil (Figure

14a). Compaction can be improved with natural (coconut, bamboo) or artificial (i.e., plastic) fibres (Figure 14b) (Sato et al. 2013). Sandwich structure dykes (Figure 14c) are suitable for the construction of dykes using cohesive soils. Therefore, locally available granular materials are promising for the formation of sandwich layers among cohesive soil layers (Yamazaki et al. 2007; Yasuhara et al. 2012b).

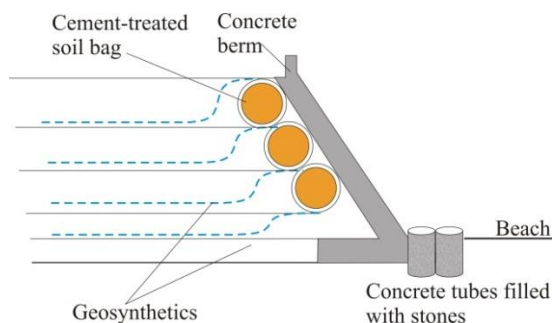
Figure 15 From single to hybrid use of reinforcement and improvement (modified from Yasuhara et al. 2013)

A necessary issue is the construction of countermeasures against inundation caused by the combination of storm surge and SLR. For the successful execution of countermeasures, the authors propose reinforcement techniques combining soil bags with geosynthetics, as presented in Figure 15, which belongs to a permanent countermeasure. To upgrade the reinforced sea walls with geosynthetics, other work such as the injection of cement mortar into soil bags can be undertaken, as presented in Figure 16.
