SAFE AND GREEN SLOPES THE HOLISTIC HONG KONG APPROACH

R. K. S. Chan¹

¹ Head, Geotechnical Engineering Office, Civil Engineering & Development Department

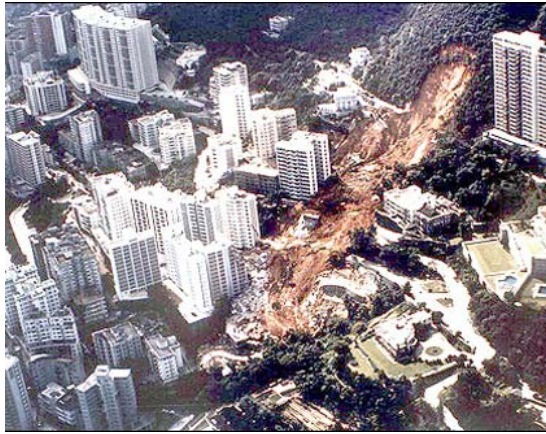
Figure 1 - 1972 Po Shan Road Landslide

In the 1970s, Hong Kong experienced a number of disastrous landslides (Figures 1 to 3), notable ones being the 1972 Po Shan Road landslide and the 1972 and 1976 Sau Mau Ping fill slope failures. In the 1980s, the landslide problems were mainly associated with un-engineered squatter developments on the hillside. In the 1990s, several serious fatal landslides aroused much public attention, e.g. the 1994 Kwun Lung Lau retaining wall collapse (Figure 4), the 1995 Fei Tsui Road landslide (Figure 5) and Shum Wan Road landslide (Figure 6) and the 1999 Sham Tseng San Tsuen debris flow (Figure 7) and Shek

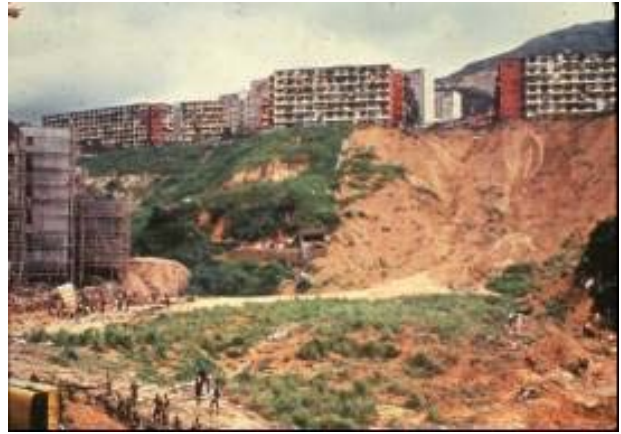
Figure 2 - 1972 Sau Mau Ping landslide

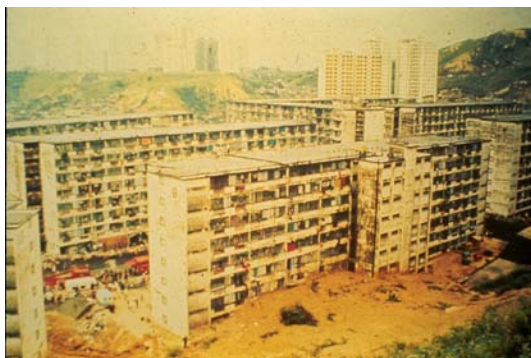
Figure 3 - 1976 Sau Mau Ping landslide

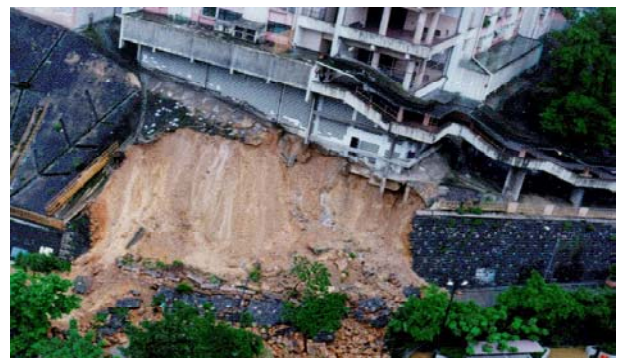
Figure 4 - 1994 Kwun Lung Lau landslide

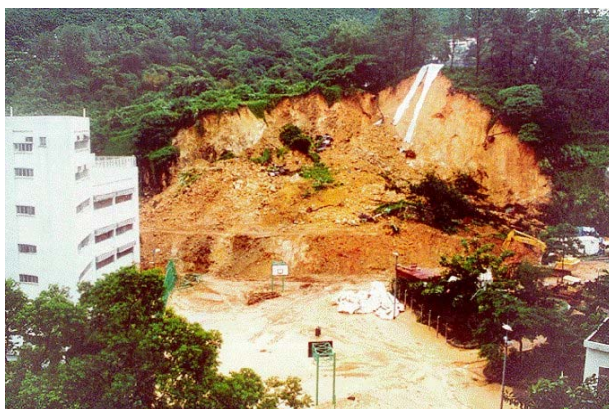
Figure 5 – 1995 Fei Tsui Road landslide

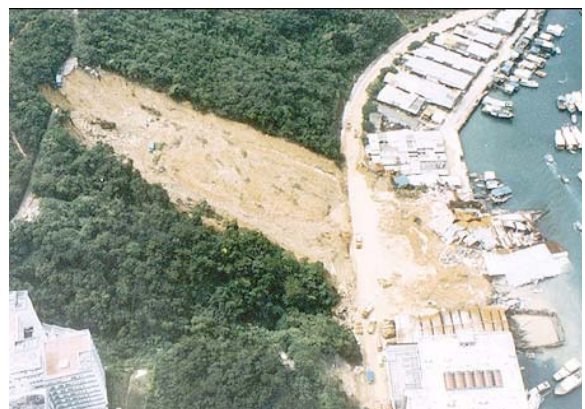
Figure 6 - 1995 Shum Wan Road landslide

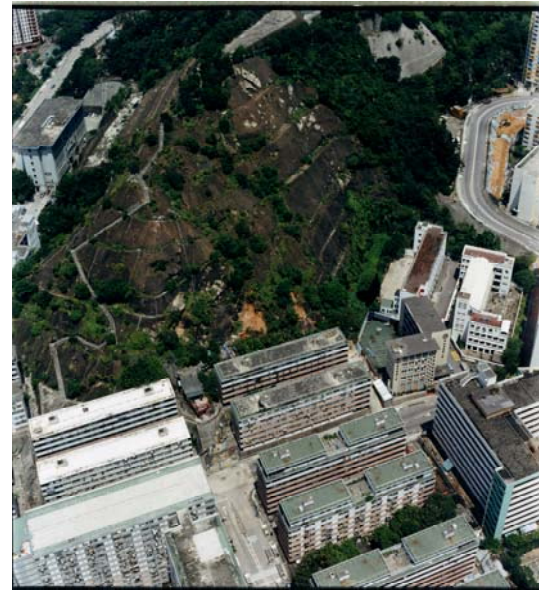
Figure 8 - 1999 Shek Kip Mei landslide

Kip Mei landslide (Figure 8). Although serious landslides still occurred from time to time, the scale and severity of the landslide problems have been decreasing. Landslide fatalities have been significantly reduced in recent years (Figure 9). This is attributed to the development of a comprehensive Slope Safety System (Chan, 2000) and advancement in geotechnology and practice (Chan, 2003).

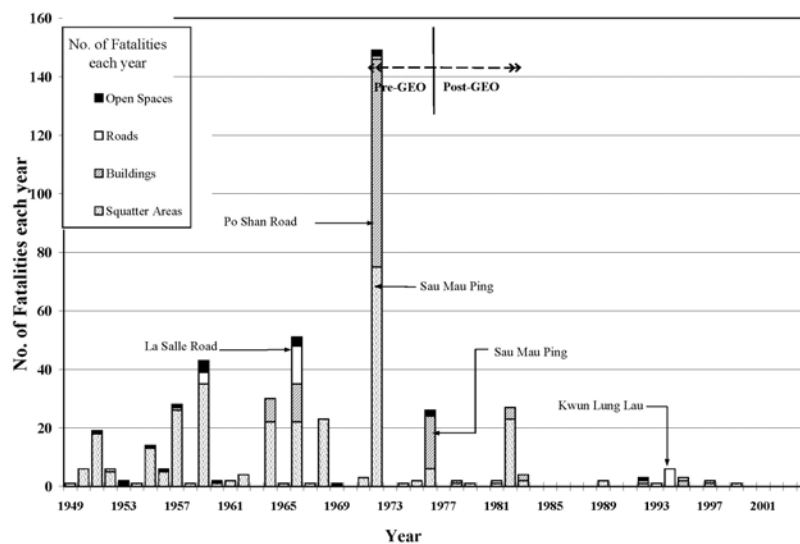
Figure 9 - Known landslide fatalities in Hong Kong

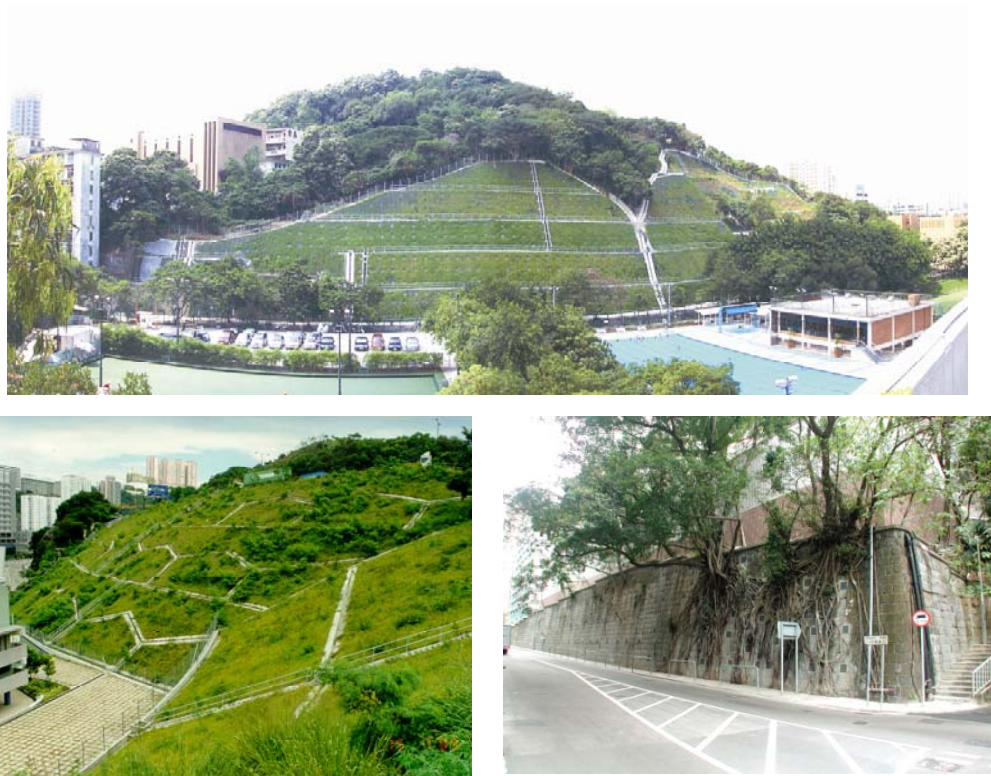
Figure 10 – Examples of vegetated slopes and an upgraded masonry wall with wall trees preserved

Over the years, the appearance of man-made slopes and retaining walls has been much improved through the concerted effort of the HKSAR Government and all the related professions. In the past, vegetation covers were provided only to the gentle slopes. Improvement in detailing of surface covers, involving the use of erosion control mats and steel wire mesh in soil nailed slopes, has allowed the provision of vegetation covers to slopes with steep gradients. Many more slopes can be vegetated. The proportion of vegetated surface covers on soil slopes upgraded under the Government's Landslip Preventive Measures (LPM) Programme has increased from around 50% in the past to over 70% now (Figure 10).

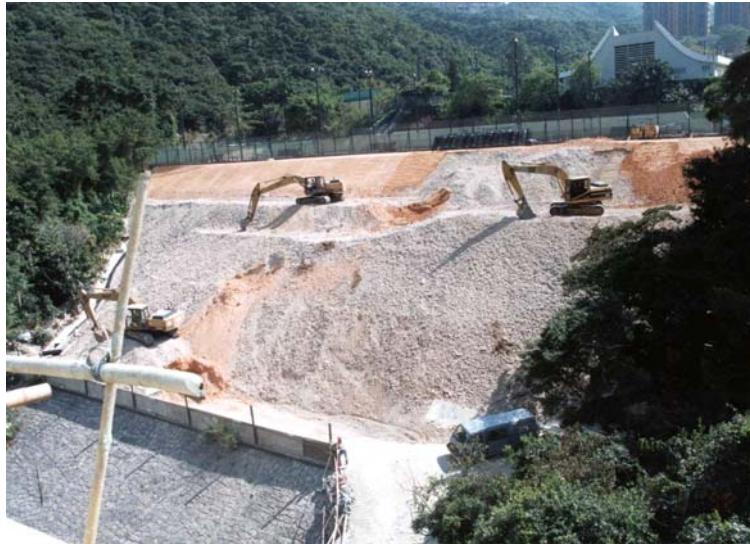
Figure 11 – Recompaction of granular fill in upgrading a loose fill slope

slope formation both in the private and public sectors. Hence, the safety standards of many old man-made slopes are in doubt. About 10,500 of the 39,000 old government man-made slopes affect developments and major roads. The Government has therefore been maintaining an on-going LPM Programme to systematically rectify substandard slopes so as to progressively reduce the risk from man-made slopes which affect the community directly (Figure 11).

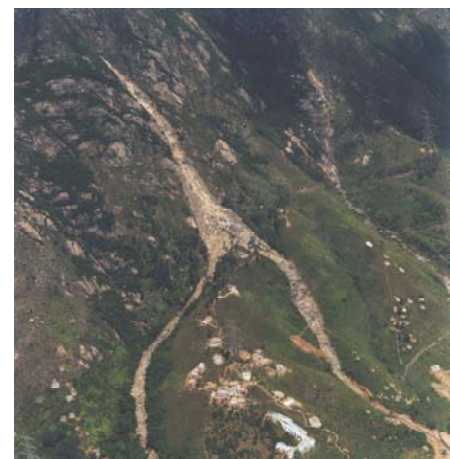
Figure 14 – The Tsing Shan debris flow in 2000

During the wet season, these slopes are subject to frequent intense rainstorms, so landsliding on natural terrain is a common occurrence (Figure 14). In the past, such landsliding has not been of great consequence, as it has occurred in relatively remote areas and hence has not posed a significant threat to life or property. Also, unlike man-made slopes, there have been no recorded fatalities in planned developments (i.e. excluding squatter areas) resulting from landsliding on natural terrain. In contrast, over the past 50 years, more than 470 people have died as a result of failures of man-made slopes and retaining walls. However, development has been continuing to extend into areas close to steep natural terrains, thereby increasing the risk (Figure 15). Indeed, there have been some ‘near miss’ cases involving landslides on natural terrain in which the consequences could have been very serious if the existing or planned developments below had been in use or occupied at the time when the landslides occurred (Chan, 1998).

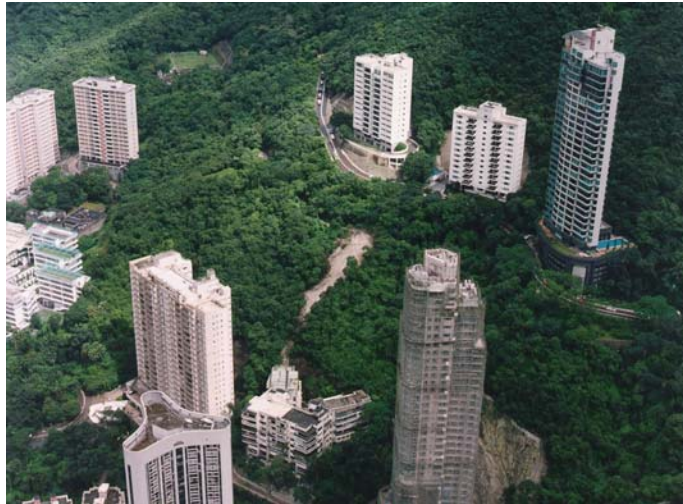
Figure 15 – A 20 m³ landslide in 1998 resulted in damage to property

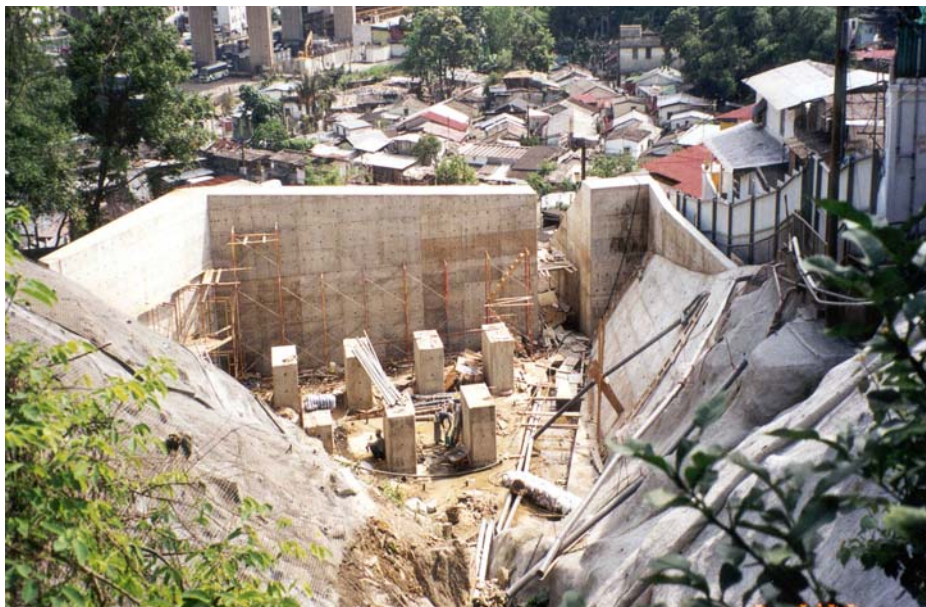
Figure 16 – Check dam built in Sham Tseng San Tsuen

Apart from hazard assessment, there has been substantial advancement in the design of mitigation measures. Lo (2000) reviewed typical mitigation measures applied in Hong Kong and established guidelines on the design of debris-resisting barrier. Various kinds of mitigation measures including insitu stabilisation, boulder fences, check dams, landslide debris barriers, etc (Figure 16 and 17) have recently been used in Hong Kong and the experience gained has provided much better understanding of the effectiveness and practicality of these measures (Tse et al, 2003). Other measures like bio-engineering are being tried (Campbell et al, 2005).

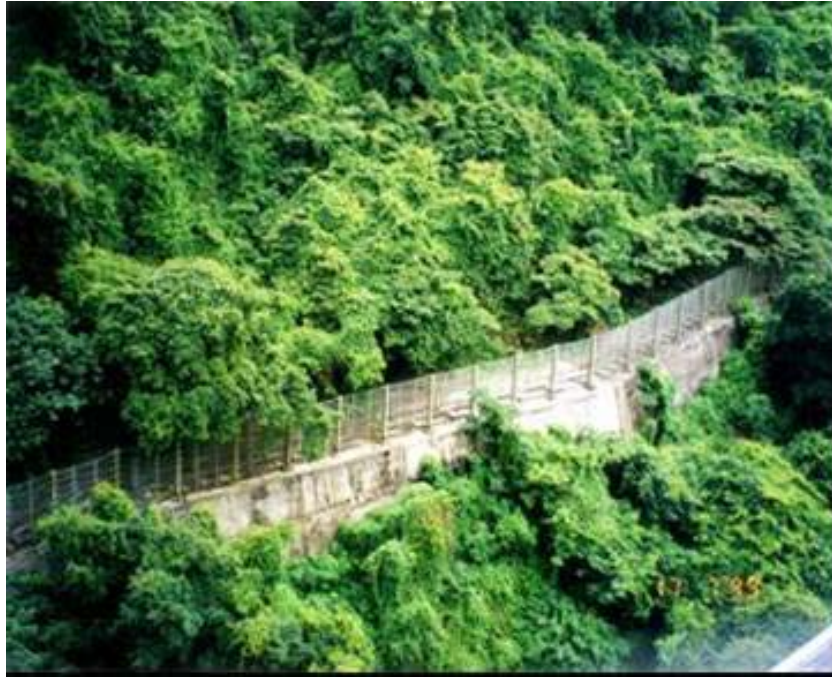
Figure 17 – Boulder fence at Mid-levels

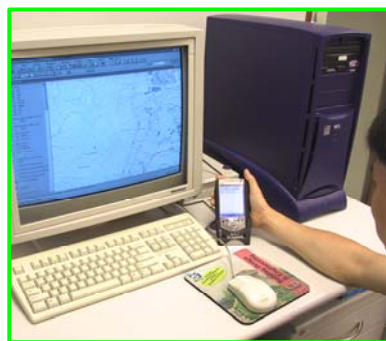
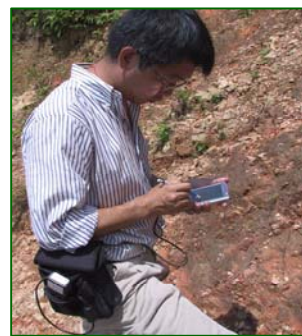
(a) Uploading GIS data to the mobile mapping system

(b) On-site navigation, data retrieval and mapping using the mobile mapping system

(c) Orthoimage, topographical map, ground features and GPS location displayed on a pocket computer

Figure 18 –Geotechnical mobile GIS mapping system

Over the years, significant advances have been made in information and related digital technologies. The technologies have become more readily accessible with improved capability and reduced cost (Wong et al, 2005). The GEO plays a key role in a number of areas of geo-informatics, including compilation and dissemination of geo-informatics datasets such as geological maps, Slope Catalogue, landslide data, ortho-rectified historical aerial photographs and digital elevation model; application of geo-informatics involving Geographic Information System (GIS), remote sensing and engineering analytical techniques; and development and promulgation of application of geo-informatics. In the last few years, development and applications of GIS expanded the capability of the GEO in natural terrain landslide management. The advances include advanced GIS search, browsing, editing and publication; GIS analysis; GIS modeling; mobile-location-based application; 3-D visualization and virtual reality application; and integration with remote sensing (Figure 18 and 19).

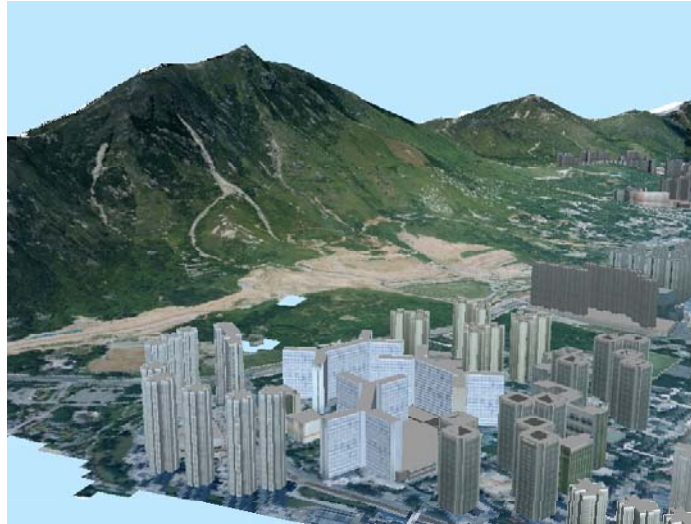
Figure 19 – 3-D virtual reality model of Tsing Shan Foothills in Hong Kong

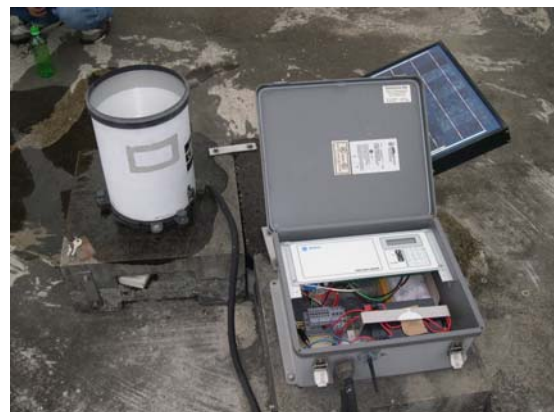
Figure 20 – Automatic rain gauge

The GEO operates an extensive network of automatic raingauges (Figure 20) providing real-time rainfall data to the Landslip Warning System. This network, which dates back to 1984, was upgraded in 1999 to improve coverage in the new development areas. The network now comprises 86 raingauges located throughout Hong Kong.

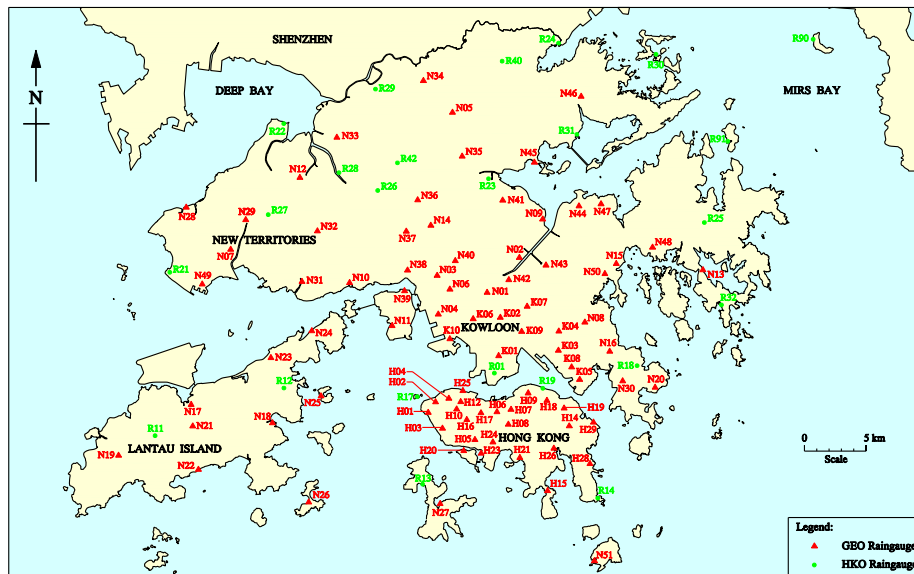
Figure 21 – Locations of the automatic raingauges in Hong Kong

The data capture, control and processing system, which was also upgraded in 1999, receives data from the 86 GEO raingauges and from an additional 24 automatic raingauges operated by the HKO (Figure 21). The system is now being upgraded with General Packet Radio Services (GPRS) for data transmission, replacing the telephone lines for the raingauges. At the completion of the upgrade with GPRS, data transmission can be enhanced and can become more cost-effective.

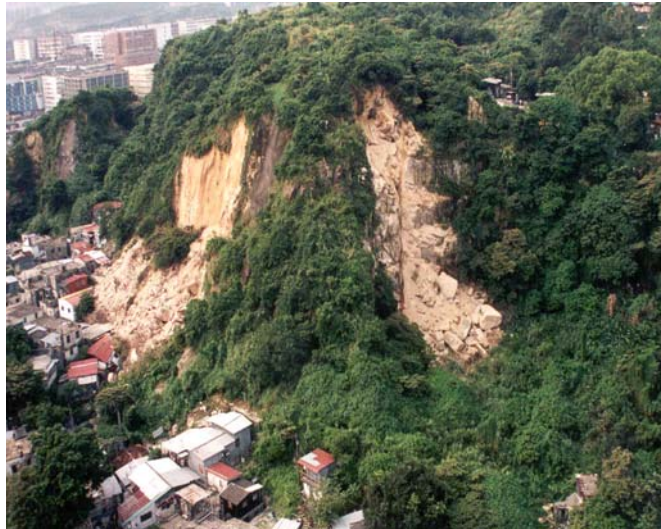
Figure 23 – Landslides in August 1995 affecting the Lei Yue Mun Squatter Area

A large proportion of landslide fatalities took place in squatters (Figure 23). Special non-development clearance (NDC) studies have been carried out by the GEO since 1982 to identify squatter structures which are especially vulnerable to landslide danger. Once squatter structures are identified as especially vulnerable to such danger, the Government will offer rehousing to the affected squatters. Since the mid 1980s, some 75,000 persons living in tolerated squatter structures on steep hillsides have been rehoused and the affected structures cleared. Some 58,000 of those cleared to date have been from the urban areas of Hong Kong and Kowloon. The GEO has also been carrying out inspection of tolerated squatter structures in the New Territories since the mid-1980s. Up to the end of 2003, inspections have been made of about 400 squatter areas and their nearby isolated structures, covering the more vulnerable parts of the squatter areas in the New Territories, and including dwellings adjacent to stream courses that might be subject to hazard from debris flows. This NDC inspection programme was completed in September 2003. From 1992 to September 2003, the GEO has recommended clearance for some 20,000 persons. Housing Department, Lands Department and Buildings Department are implementing the clearance recommendations. About 9,800 of these persons are yet to be rehoused. The GEO issues warning letters to squatters who have been recommended for clearance on slope safety grounds. Since 1998, the GEO has also been erecting warning signs in squatter areas where clearance recommendations are being processed. Squatters are advised to follow the safety advice given pending action for rehousing. When the Landslip Warning

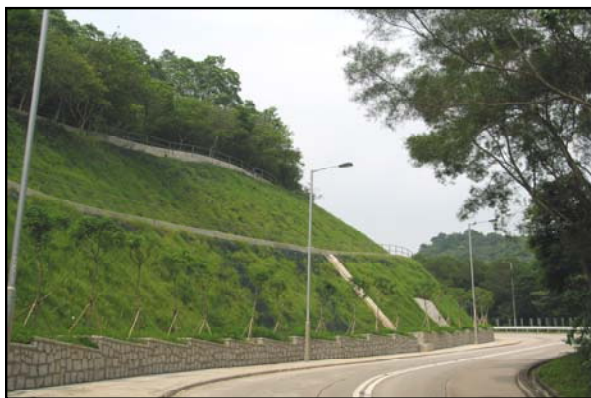
Figure 25 – A slope with landscaped treatment implemented during upgrading

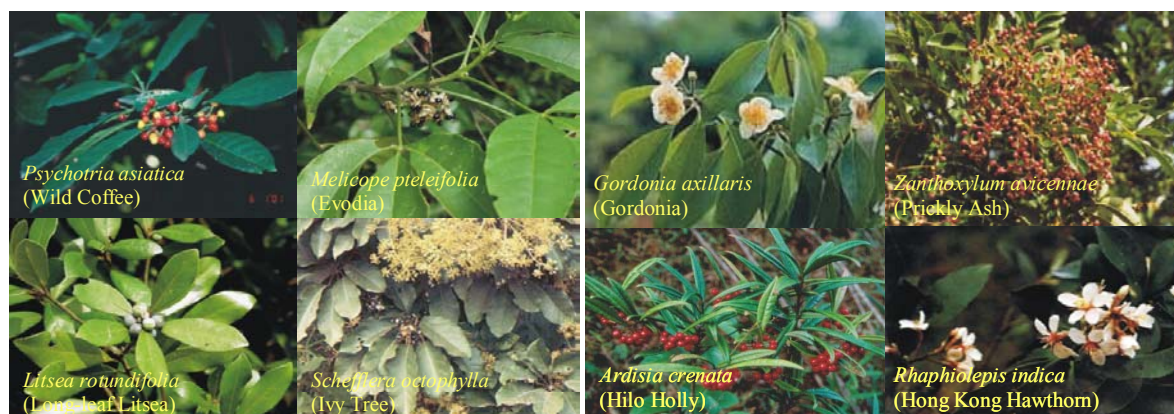
Figure 27 – Native vegetation species in Yuen Tun trial site

To study the performance of vegetation establishment on steep man-made slopes, the GEO carried out a planting trial of eight native small tree and shrub species (Figure 27) at Yuen Tun, Tai Lam Country Park in collaboration with the Kadoorie Farm & Botanic Garden Corporation. Seedlings of 8 native species were planted on slopes with gradient of about 50° following hydroseeding. The trial commenced in July 2001 and monitoring of the vegetation growth has been carried out on a yearly basis.

According to the monitoring results, the survival rate of the plants is over 70% and the seedlings have grown over 100% from its original size. At places with more favourable soil and environmental conditions, some seedlings have become small trees. Among the eight species used in the trial, *Zanthoxylum avicennae* (Prickly Ash, 筋櫟), *Schefflera*

heptaphylla (Ivy Tree, 鴨腳木) and *Gordonia axillaris* (Hong Kong Gordonia, 大頭茶) show better performance in terms of growth.

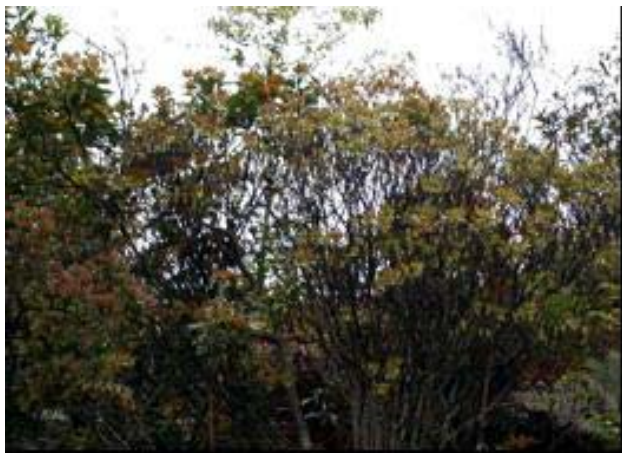
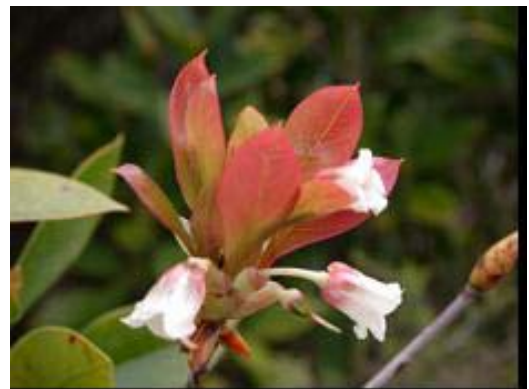
Figure 29 – Chinese New Year flowers identified in a slope upgrading work site

- Project 2 – Slope upgrading works along Keung Shan Road and South Lantau Road near Shek Pik Reservoir, Lantau: Chinese New Year flowers (*Enkianthus quinqueflorus*) (Figure 29) were identified. These flowers were classified as locally protected species found on a slope feature at Keung Shan. For those not affected by the works, the flowers were protected by chain link fence. If the flowers were affected by the works, the flowers were transplanted by a specialist landscape contractor.
