Geophysics Case Studies: Slope Investigations

Prof. Bob Whiteley
Senior Principal

Unexpected slope & embankment collapses can have catastrophic consequences

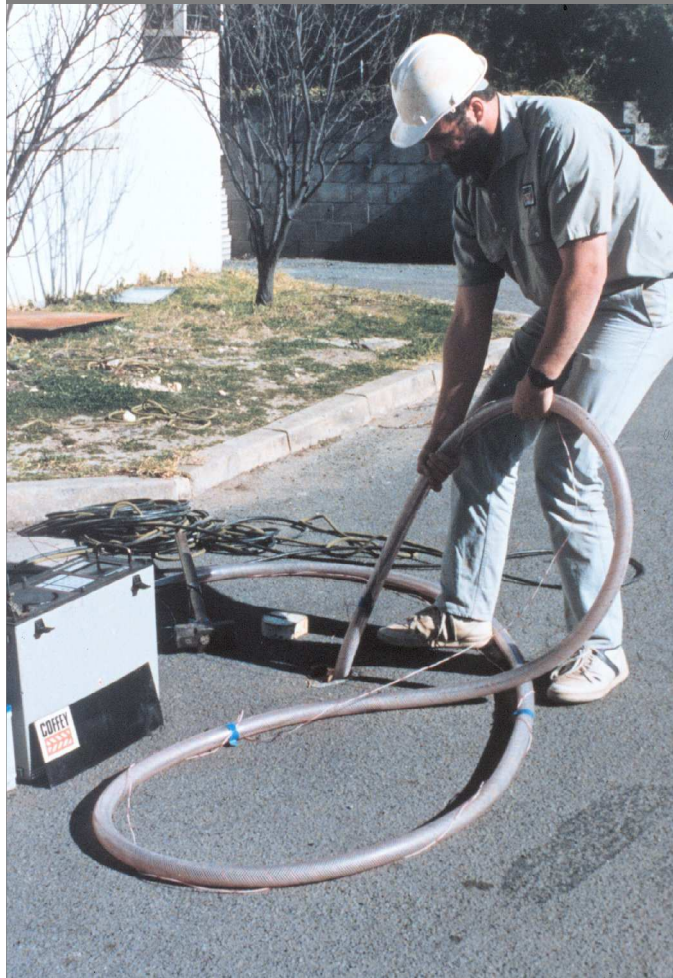
Borehole Seismic

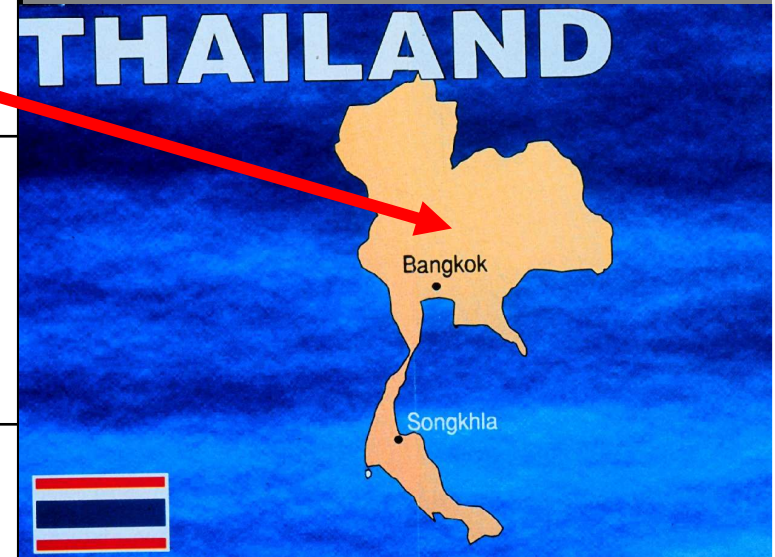
Seismic refraction data

Project	Kwae Noi Dam Site Thailand
Nature of Instability	Slump failure right abutment
Task	Define unstable rock mass
Geophysical Technology	Seismic refraction

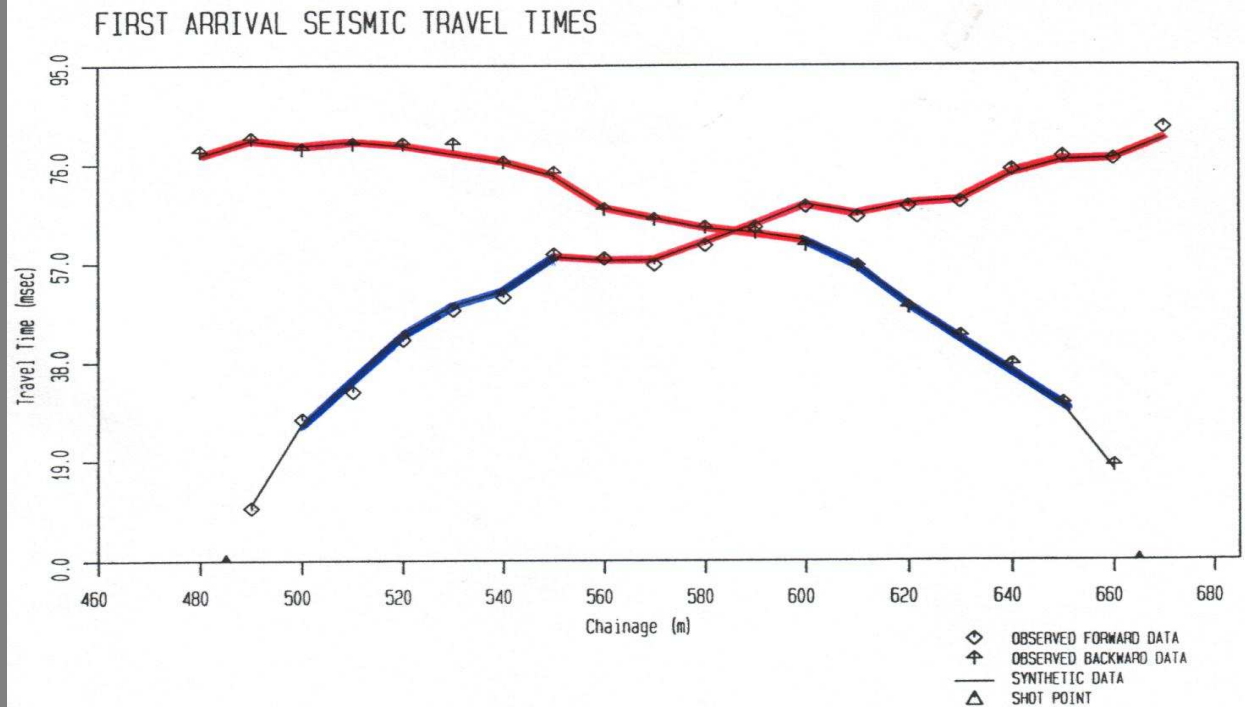
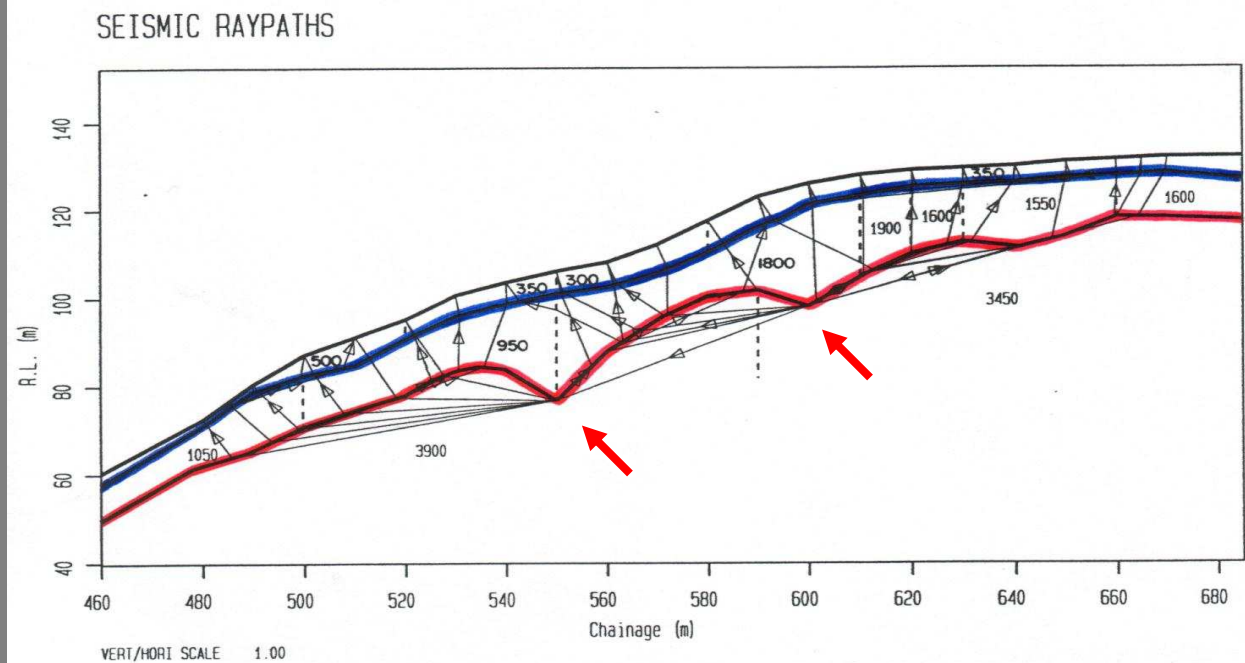
Re-interpretation

Visual
Interactive
Ray
Tracing

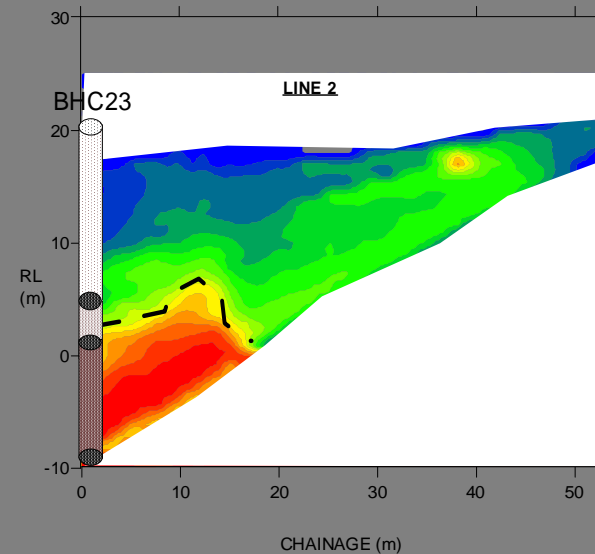
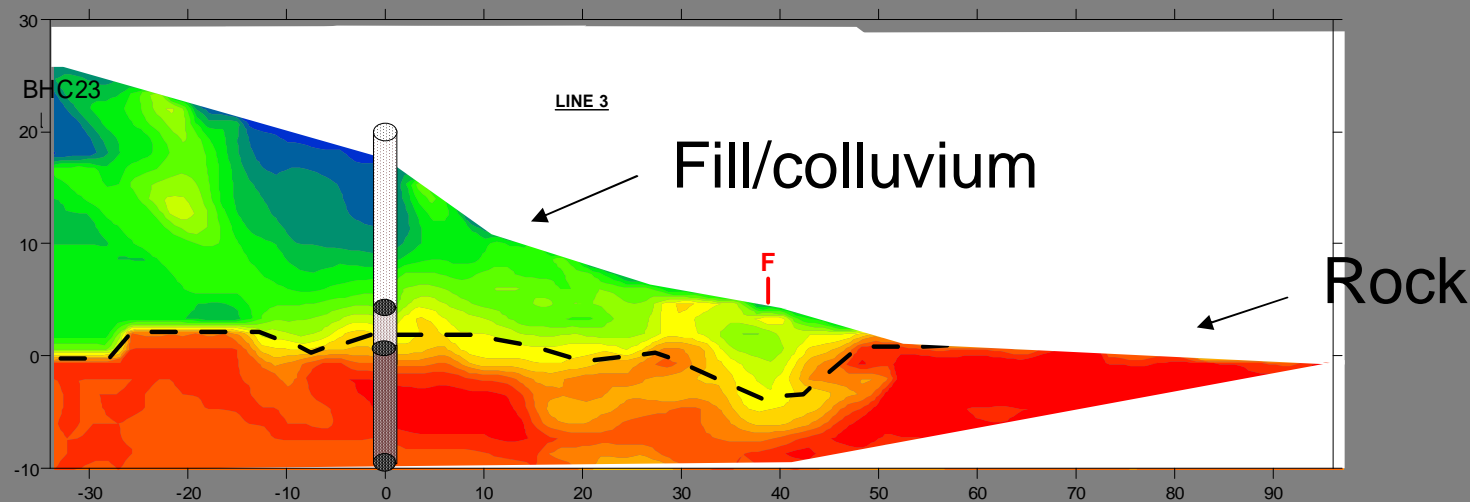
SEISMIC VELOCITY
(Km/s)

- FILL/COLLUVIUM
- EW/HW SILTSTONE/SANDSTONE
- SW/F SILTSTONE/SANDSTONE
- INTERPRETED ROCK LEVEL (SW/F SILTSTONE/SANDSTONE)
- POSSIBLE FAULT

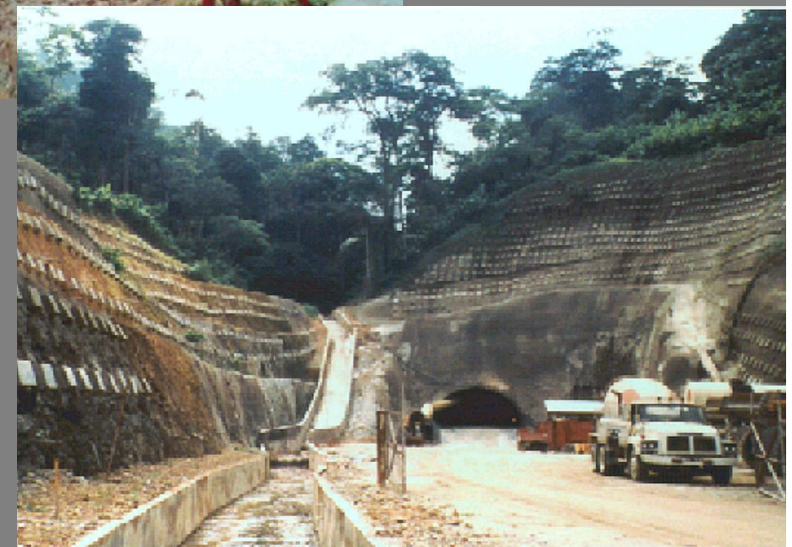
The shear zone exposed
