Taro Uchimura⁽¹⁾, Ikuo Towhata⁽¹⁾, Lin Wang⁽²⁾, Jianping Qiao⁽³⁾

Validation and Interpretation of Monitored Behavior of Slopes Vulnerable to Failure

(1) University of Tokyo, Department of Civil Engineering, Tokyo, Bunkyo-ku Hongo 7-3-1, +81 3 5841 6120

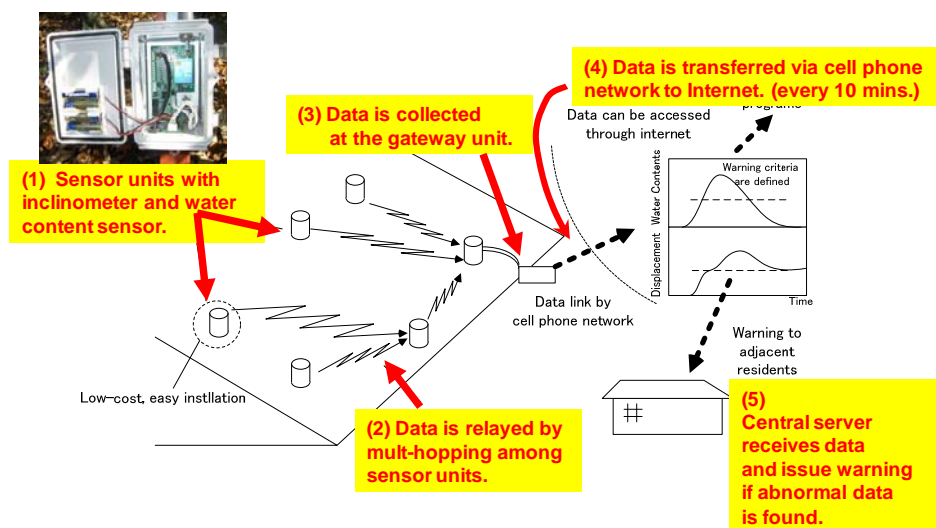
Figure 1. Outline of wireless monitoring and early warning system for slope failure

Figure 1 shows the basic concept of the wireless monitoring and early warning system proposed by the authors. A group of low-cost and simple sensor units (Figure 2) are placed on the slope. The system is designed to be wireless, that is, each unit works autonomously

with micro computer with independent power supply by batteries or solar cells. The sensor units measure the condition of the slope periodically, every 10 minutes for example. The data is transferred to a gateway unit, which is also placed near the slope, by using low power radio communication modules. Its communication distance is 300 m under typical conditions in the field. The gateway unit collects the data from all the sensor units, and sends them to a data server on internet through a cell phone network. Thus, the data can be browsed anywhere and anytime on Web site. The data is processed by the server, and any abnormal behaviour of the slope can be detected as a precaution of failure, and then warning is issued. Each sensor unit works for duration of more than 1 year with 4 AA Alkaline batteries.

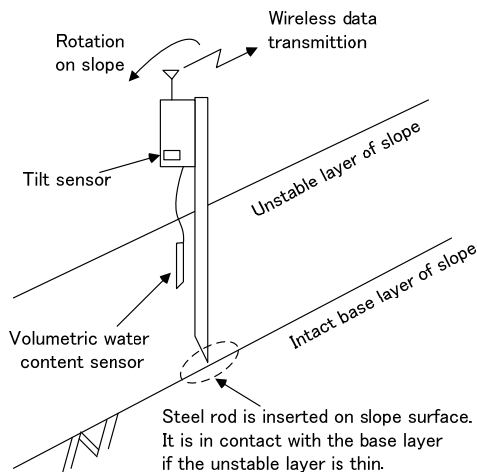
Figure 2. Wireless sensor unit with tilt and water content sensors on a slope.

The proposed system watches the rotation on the slope surface and the volumetric water content in the slope. A MEMS tilt sensor (nominal resolution = $0.04 \text{ mm/m} = 0.0025 \text{ degree}$) is installed in each sensor unit. At each monitored point, a steel rod is installed through the thickness of unstable soil layer on the slope surface. If the unstable layer is too thick, the rod is installed for 50 to 100 cm-deep. Then, the wireless sensor unit is attached at the top of the rod. Consequently, the tilt sensor detects the average shear deformation of the slope surface layer as the deformation of the slope. Extensometer is commonly used for monitoring the displacement of slopes, but the advantage of using tilt sensor is that a long wire of an extensometer is not required, and therefore, the installation and maintenance is simple and inexpensive.

The water content is measured at a shallow position (typically 30 cm-deep) of slope by using a volumetric water contents sensor. This sensor measures the dielectric constant of the surrounding soil, which corresponds to the water contents. The soil mechanics theories say that the slope stability directly depends on the suction, or pore water pressure, rather than water content. But, measurement of suction of unsaturated soils is usually difficult, and careful maintenance of the sensors is required. Therefore, use of volumetric water content sensors is more suitable for low-cost monitoring.

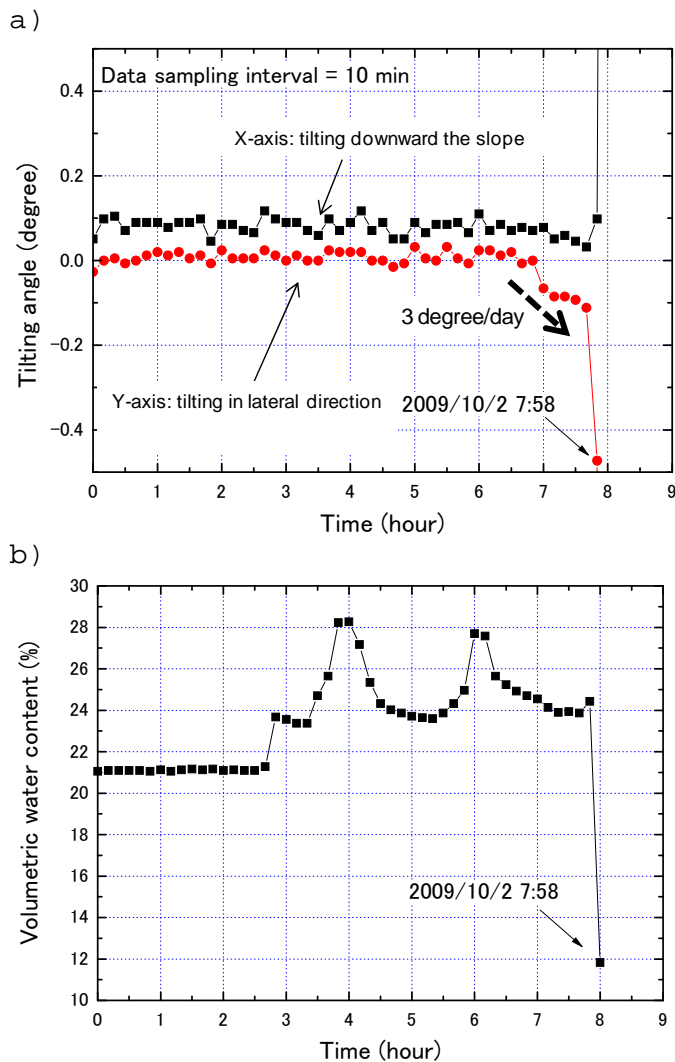
Figure 4. a) Tilting angle and b) volumetric water content obtained by sensor unit 2 on the slope site along highway just before the second failure.

Figure 4a shows the records of tilt sensor of the unit, in directions toward and lateral to the slope, respectively. Specially, the tilting in Y-axis (lateral direction) showed extraordinary behaviours 50 minutes before the second failure. Its tilting rate was around 3 degrees per day (0.12 degrees per hour). Figure 3a also shows the directions of the sensor units. The negative changes in Y-axis mean that the sensor unit 2 tilted in the backward direction to the second failure part. It suggests a failure mode with a slip surface in the slope.

Figure 4b shows the behaviours of volumetric water contents at the unit. The slope did not failed when the water content recorded its peak value, but it failed after 2 hours of drainage stage. This may be because the distribution of water in a slope is quite non-uniform, and the measured value of volumetric water content depends on the position of the sensor. Thus, it is difficult to detect a precaution of slope failure only watching the water content.

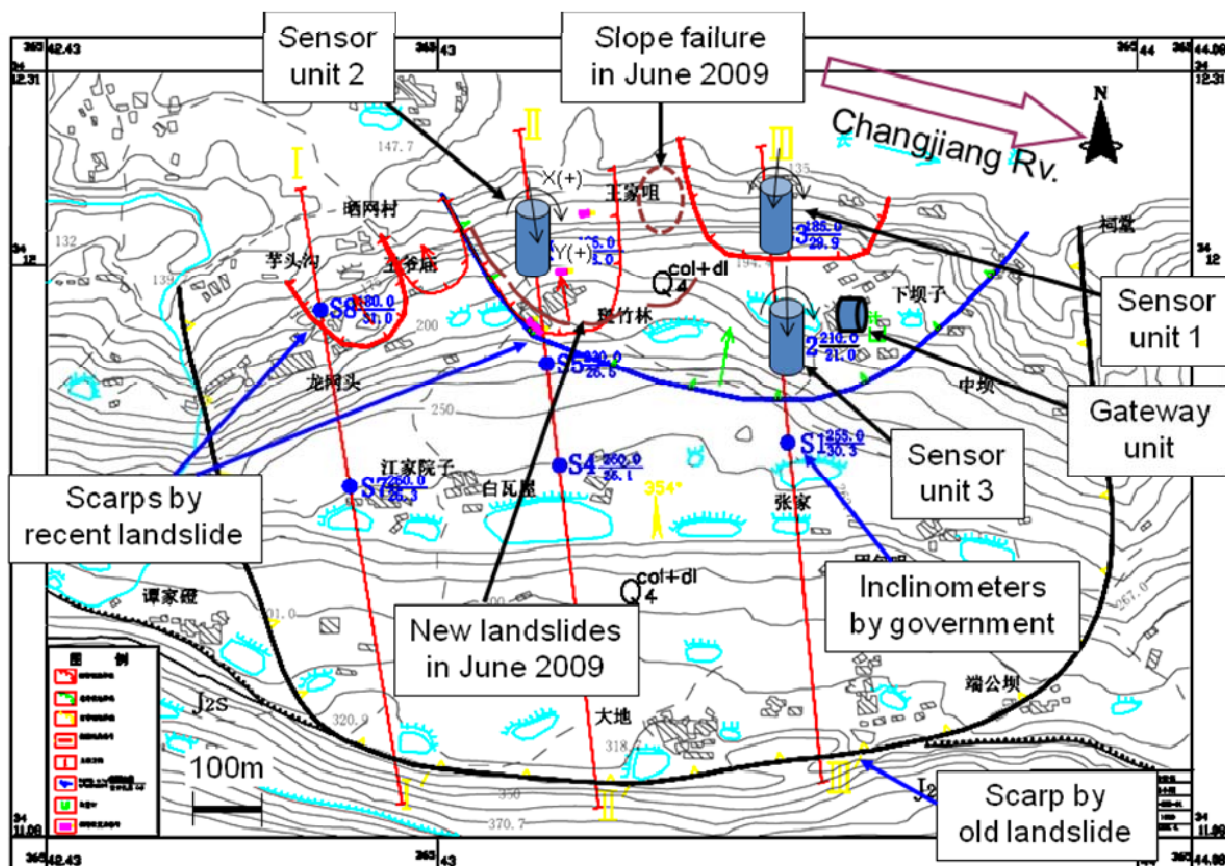
Figure 7. Plan view of Sai Wan Ba landslide site and locations of sensor units.

The site, Sai-Wan-Ba area, is located on the right side of the dam lake, near Wanzhou Ward, 80 km eastward from Chongqing City (Figure 5). Several landslide bodies, are found by geological investigations as shown in Figure 6 and 7. The locations of three sensor units deployed by the authors are also shown in Figure 7. They are responsible for each recent landslide bodies respectively.

The monitoring system has been in practice since October of 2008. Meanwhile, a heavy rainfall event on June 7 and 8, 2009, caused significant displacements in landslide bodies including the position of the sensor unit 2. The locations of the landslides are shown in Figure 7. It includes a slope failure at 150 m eastward of the sensor unit 2 as shown in Figure 11, where more than 10 m of displacement was observed in the sliding body.

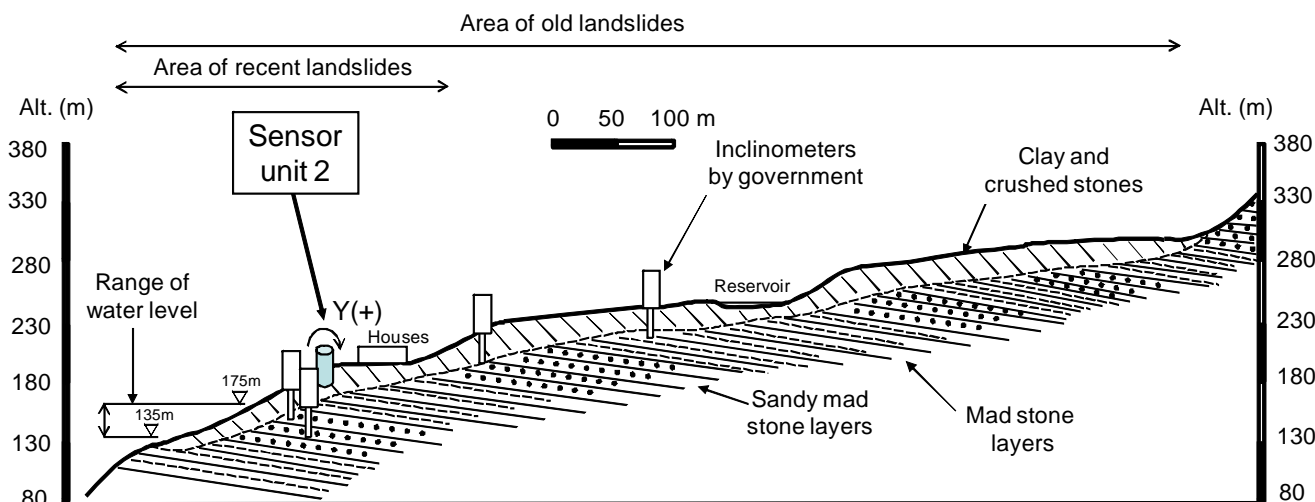
Figure 8. Cross sectional view of Sai Wan Ba landslide site passing the position of sensor unit 2.

Figure 8 show the cross-section of slope passing the position of “sensor unit 2” shown in Figure 7. The slope mainly consists of mad stone or sandy mad stone layers, and a deposit layer of clayey soil with some crushed mad stone covers the slope surface with an average depth of 15 m. The length of the recent landslide body is around 350 m, with slope angle of 5 to 15 degrees.

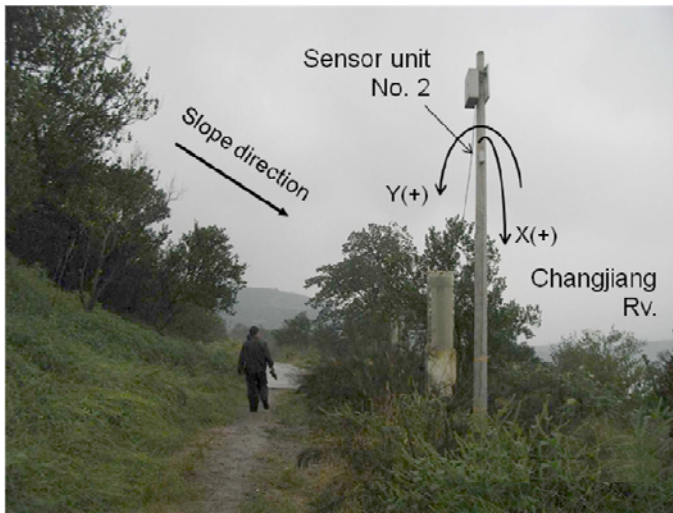
Figure 9. Installation of a sensor unit.

The sensor unit by authors are attached to a pole installed on the slope (Figure 9). Each sensor unit has a MEMS tilt sensor attached on the pole and a volumetric water content sensor buried into the ground at a depth of around 30 cm. The data was obtained every 10 minutes, and transferred to a gateway unit (Figure 10), which is placed on a roof of a private house nearby, by radio communication. The gateway unit collects the data from all the sensor units, and sends them to a data server on internet through a cell phone network.

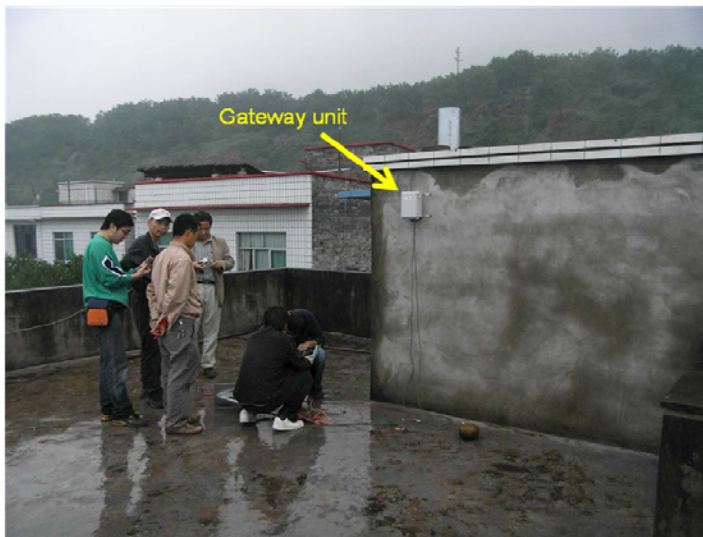
Figure 10. Installation of a gateway unit.

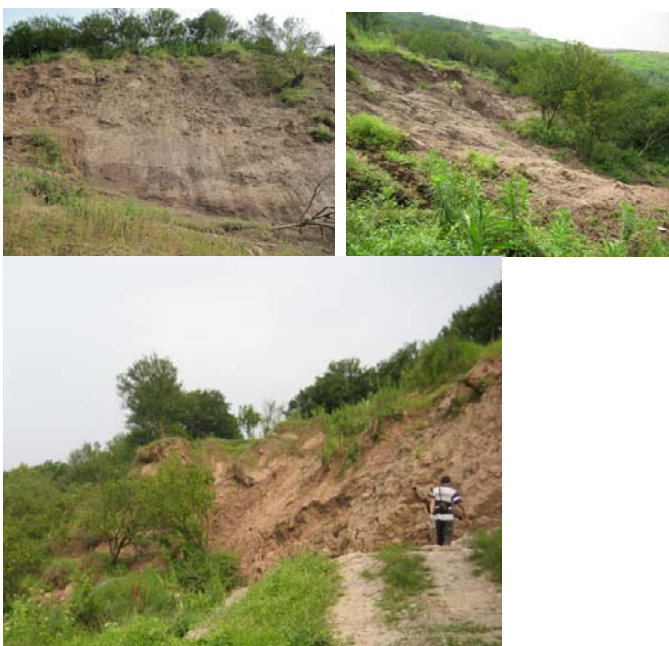
Figure 11. New landslide on June 7, 2009.

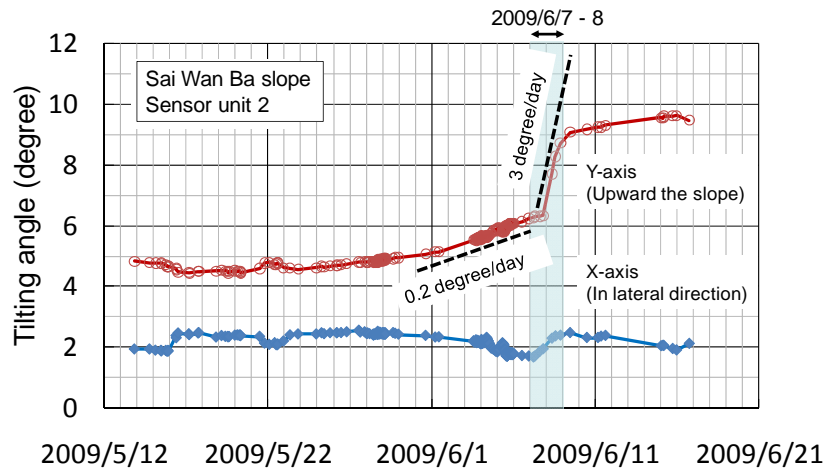
Figure 12. Time histories of tilting angle obtained by Sensor unit 2.

The time histories of the tilting angles of the pole in X-axis and Y-axis, the volumetric water content at a depth of 30 cm on the ground surface, and the record of precipitation are shown in Figure 12 and 13 respectively. While receiving frequent rainfall events, the tilting angles showed gradual progress, and the tilting angle in Y-axis reached around 5 degrees at the beginning of June 2009. As shown in Figure 9, positive values of tilting angle in Y-axis means that the pole tilted upward the slope. Correspondingly, the tilting angle in X-axis in lateral direction on the slope, showed relatively smaller values.

A quick increase in the tilting angle in Y-axis, and a small increase in the X-axis are recorded on June 7 and 8. The precipitation for these 2 days was 65 mm, while the criteria for heavy rain warning was decided to be 30 mm per day in this area. The increasing rate of the tilting angle in Y-axis was 3 degrees per day during this event, while the rate just before this event was around 0.2 degrees per day. This quick behaviour should be corresponding to the landslide event in this period. According to village people in this area, the slope failure near the sensor unit 2 took place at noon of June 8, while the quick increase in Y-axis started in late night of June 7. Therefore, there was a time margin sufficient for issuing early warning in this area.

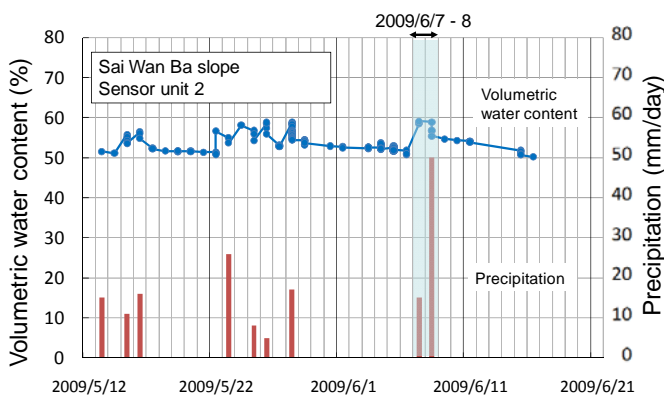
Figure 13. Time history of volumetric water content transducer at Sensor unit 2, and records of rainfall intensity.

As the slope surface consists of clayey soil deposit, the volumetric water contents showed high values between 50 and 60 % throughout the monitoring period. It responded to every rainfall events, but no extraordinary response was recorded at the time of the landslide on June 7 and 8. As the volumetric water contents sensor was buried at a shallow part of the slope, only 30 cm from the ground surface, the obtained values are not corresponding to the conditions at the depth of slip surfaces. So it is not relevant to define the criteria of early warning based on use these values only.
