PAVEMENT REHABILITATION

DEFECTS AND CAUSES

UNDERSTANDING THE REASONS FOR
PAVEMENT FAILURES IS THE FIRST STEP
TOWARDS MINIMISING RISKS TO GOOD
PERFORMANCE

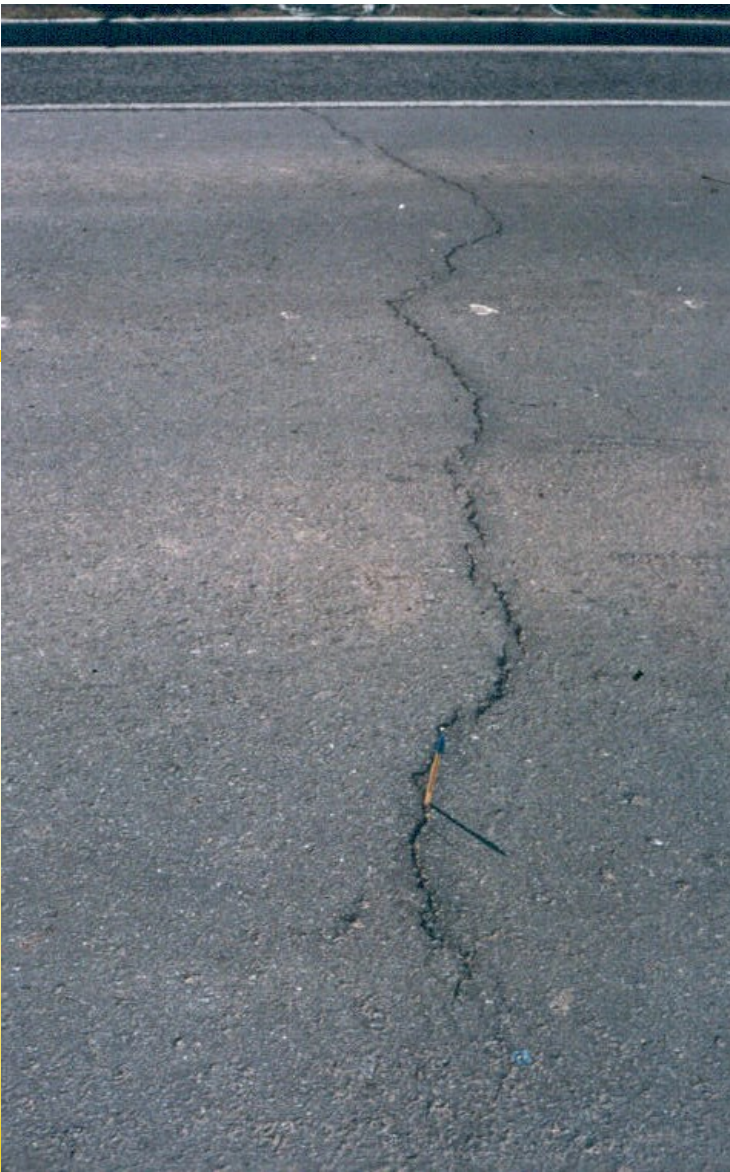
Transverse Crack (CT)

- Reflection of a shrinkage crack or joint in an underlying base (commonly port-land cement concrete or cemented materials)
- Construction joint or shrinkage crack (due to low temperature or bitumen hardening) in asphalt surfacing
- Structural failure of portland cement concrete base

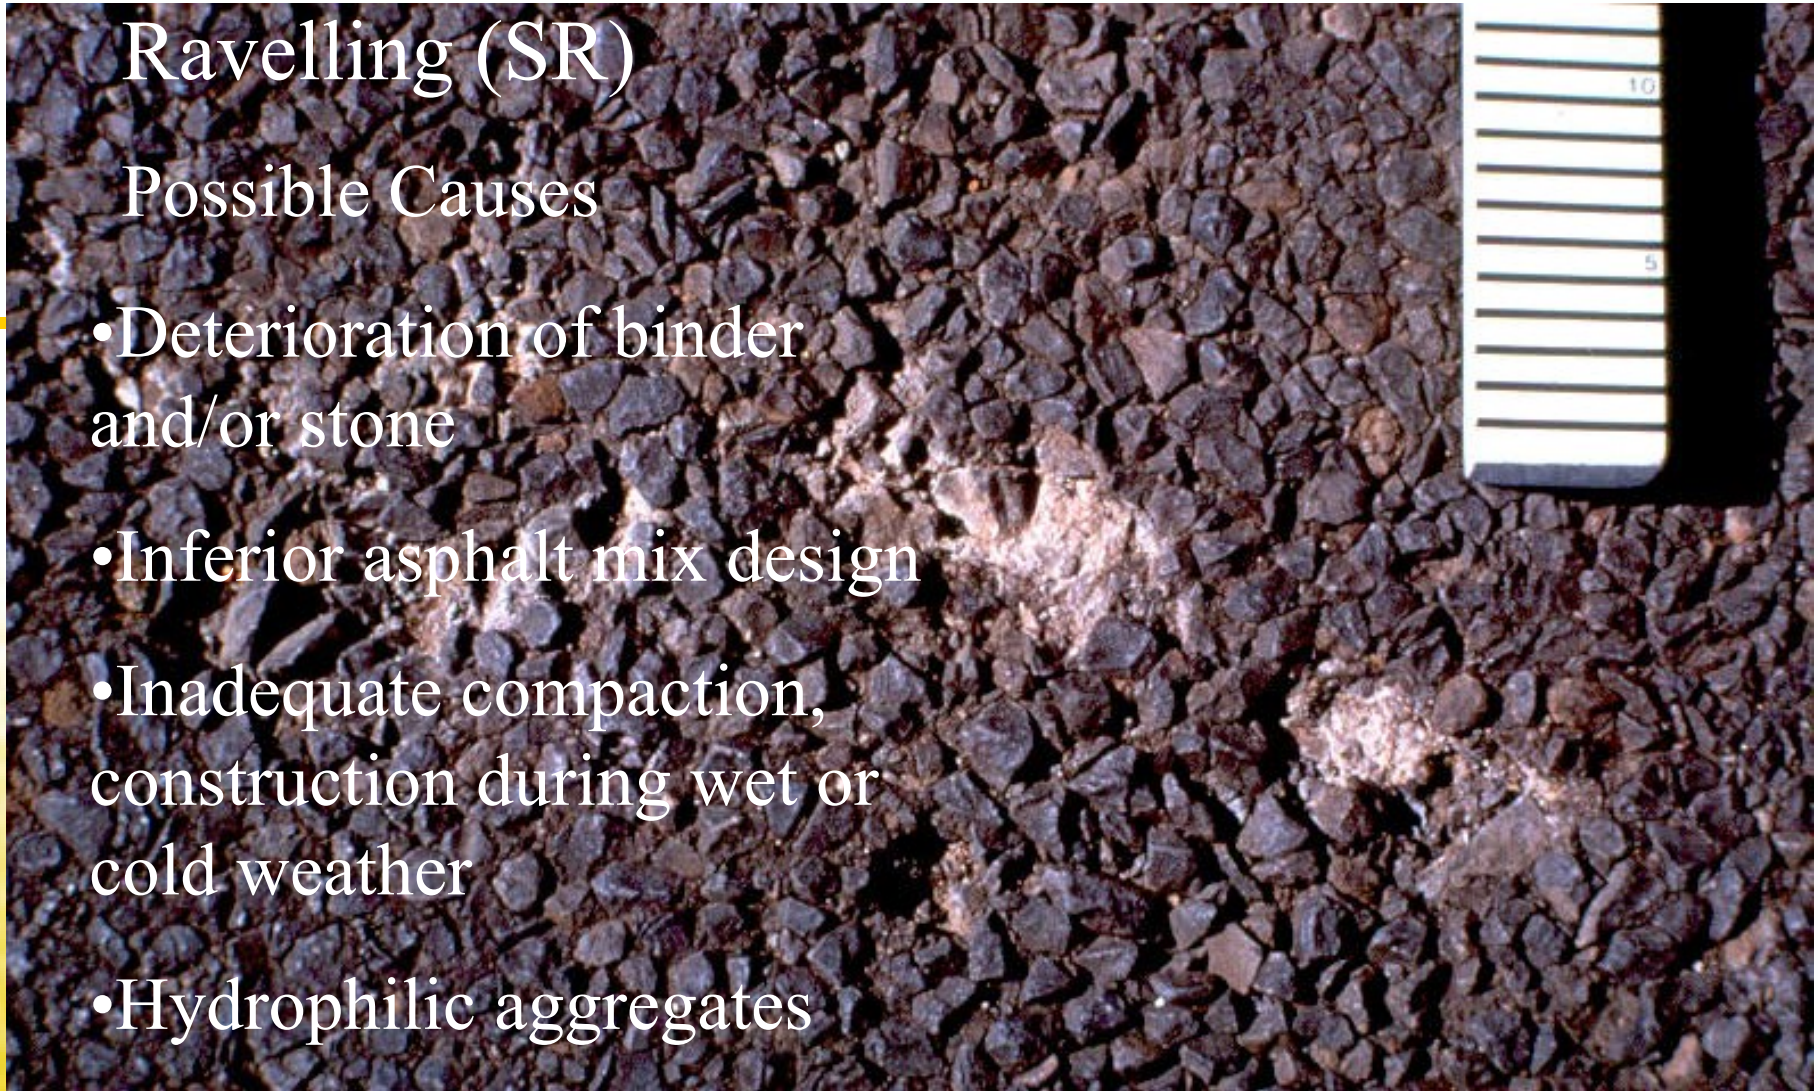
Ravelling (SR)

- Deterioration of binder and/or stone
- Inferior asphalt mix design
- Inadequate compaction, construction during wet or cold weather
- Hydrophilic aggregates

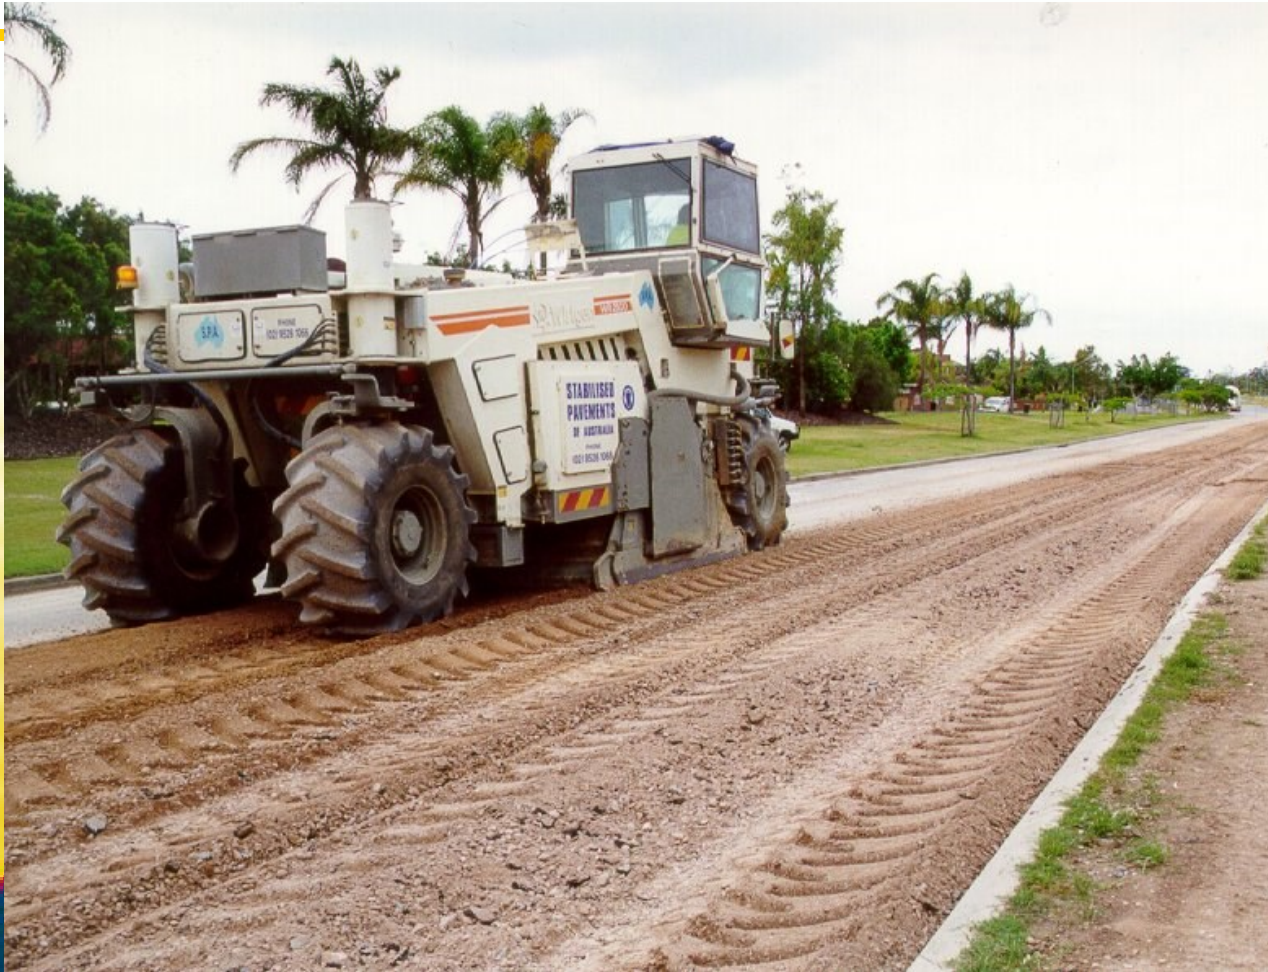
Pulverising prior to stabilisation

- Breaks up wearing course (seal or thin asphalt) and any patches

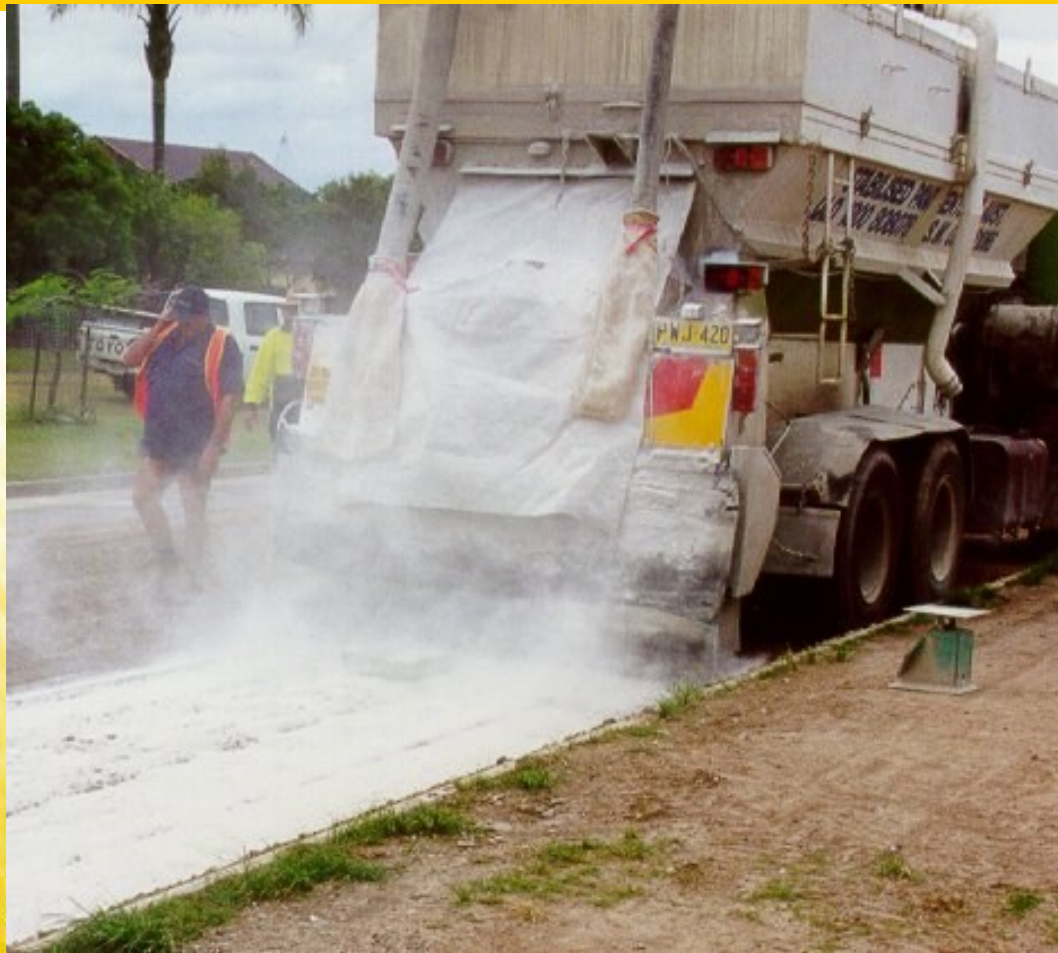
Apply Lime

- Quicklime depicted here
- Dust is a hazard to construction personnel and public

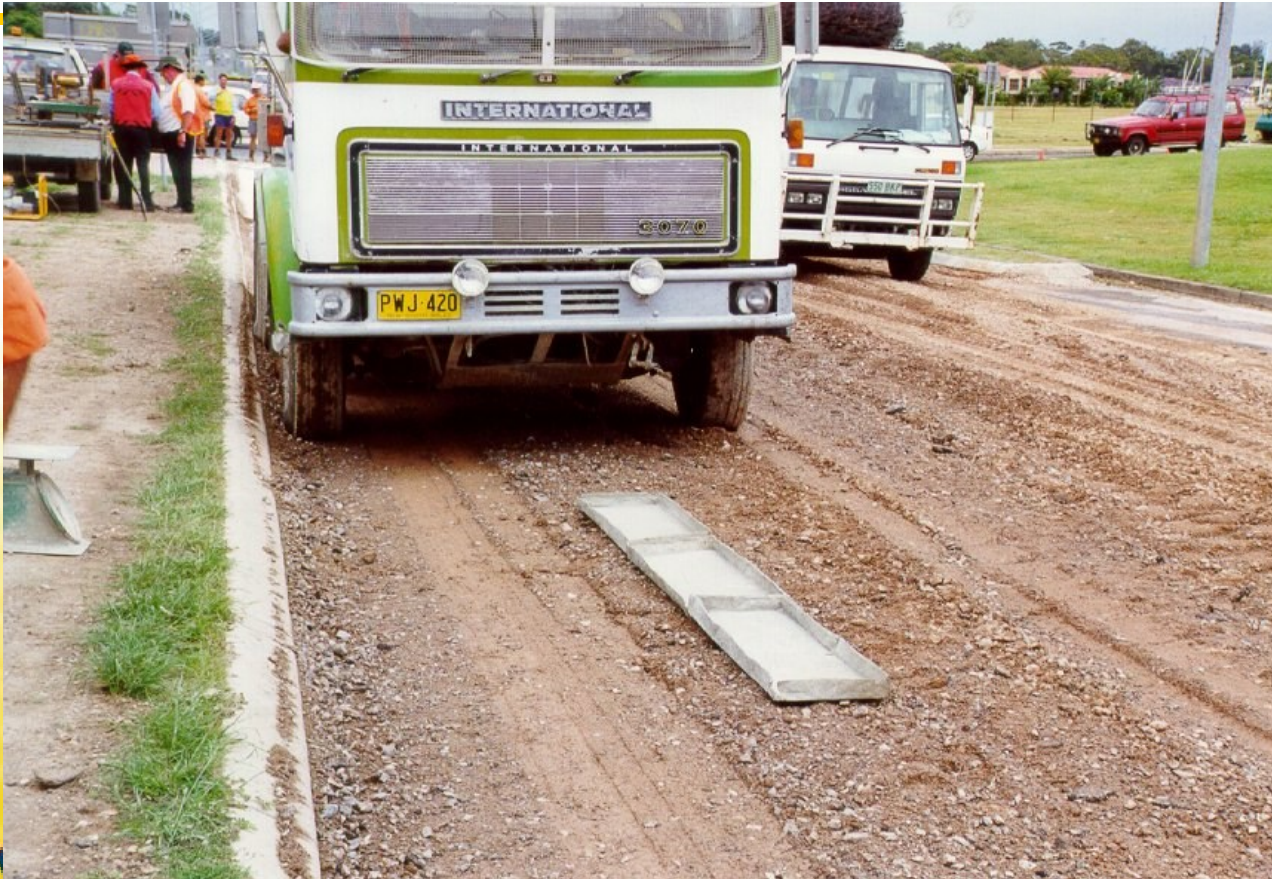
Tray tests 1

- To check application rate
- Should be done regularly
- Usually 3 trays, each a third of a square metre

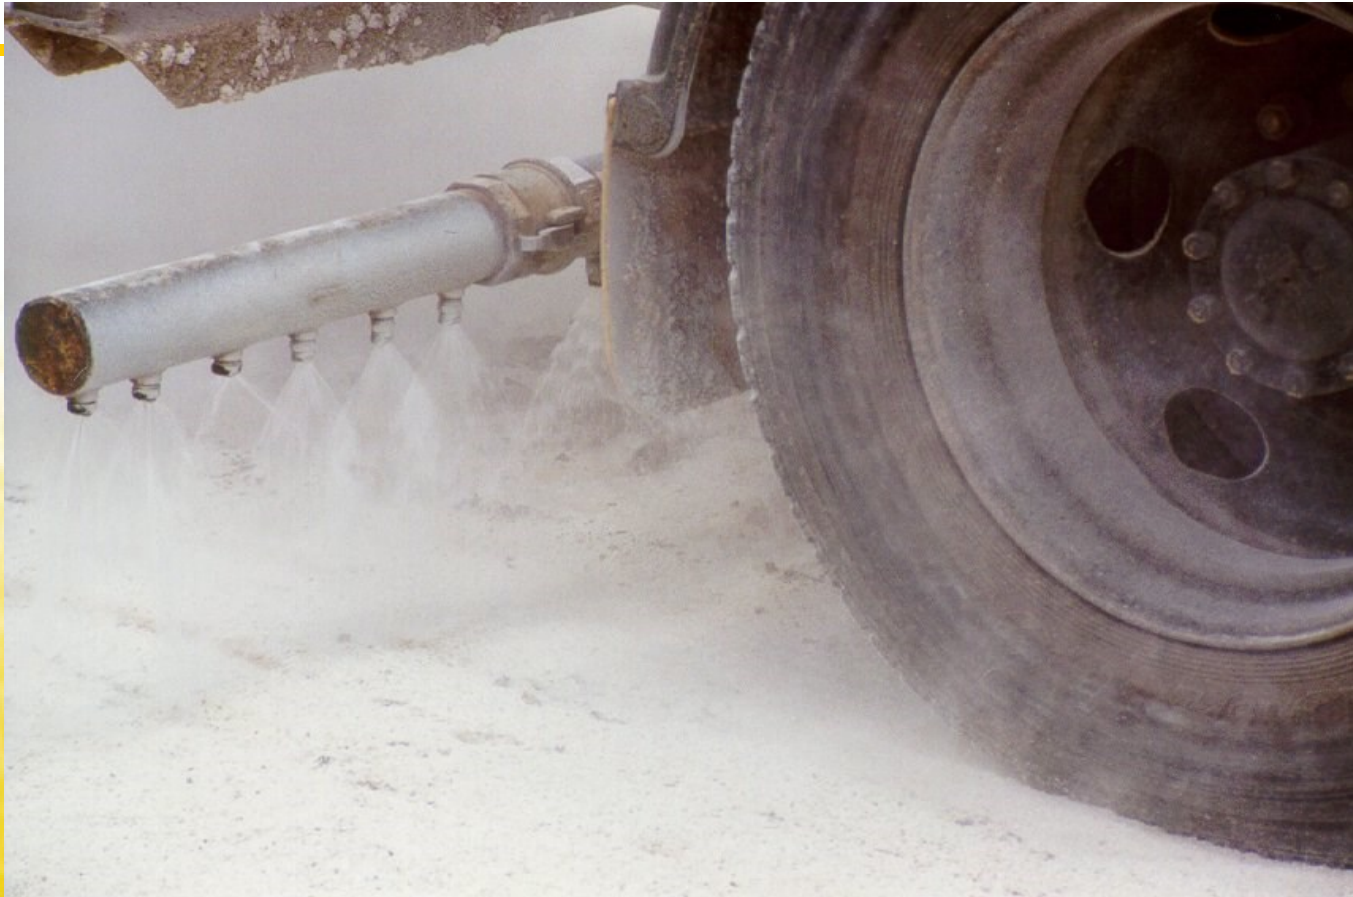
Slake Lime 1

- Necessary for quicklime only
- Multiple passes may be necessary to ensure full slaking

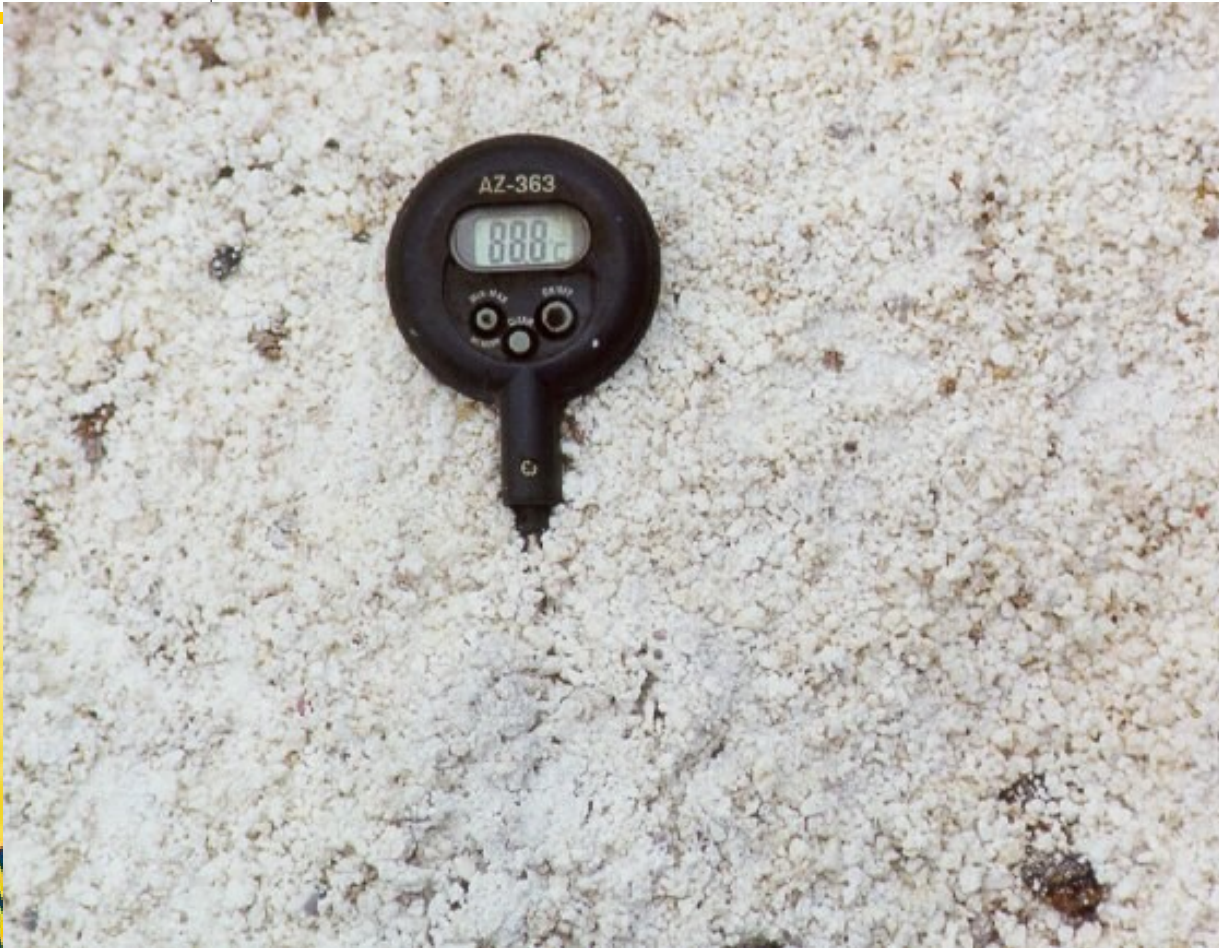
Slake Lime 3

- Temperature may indicate if hydration is complete

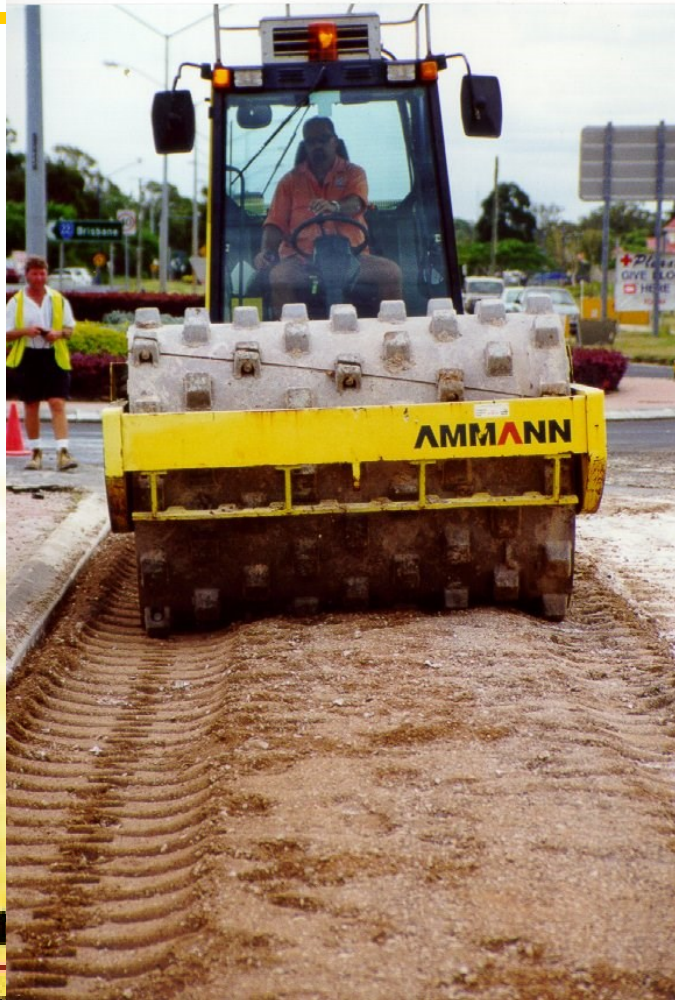
Compaction

- Follow stabilising run with compaction equipment
- Be aware if padfoot allowed too close to surface its pattern will reflect through to the seal.
