# Restoration of retaining structures for steep pyramid temples in Angkor and disclosed soil conditions allowing construction of high rise manmade fill of 800 years old and still standing

## ABSTRACT

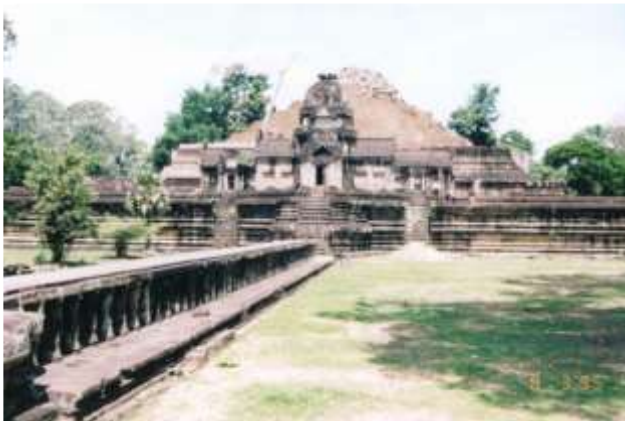
Figure 3 Baphuon Temple

Baphuon temple is shown in Fig. 3 and the plan and section are shown in Fig.4.

completed. The side slopes of the pyramid are very steep with an angle around 45 degrees. EFEO (École Française d'Extrême-Orient) made great efforts to reconstitute the Baphuon temple which suffered serious landslide in 1943. The reconstruction of the temple begun in 1950 and was completed in 2012. The design of the reconstruction is based upon reinforced concrete retaining wall keeping the slopes stable.

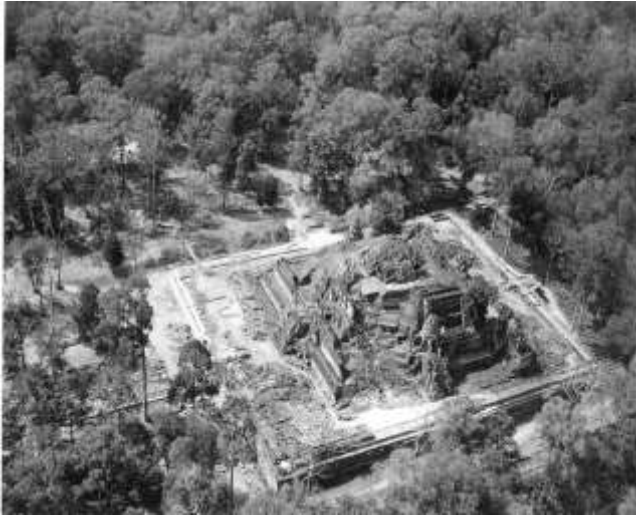
Figure 6 Failure of Baphuon in 1943

The northeastern side of the slope of the Baphuon temple failed in 1943 (Fig.6). Borings were carried within the collapse zone which suggested circular failure line. Back analysis

resulted in the possible parameters of soil strength as  $C=50\text{kPa}$  and  $\phi=25^\circ$ . The sampled soil was tested and classified as silty fine sand based upon the results of grain size distribution as shown in Fig.10.

The failure mechanism was considered to related to build-up of water pressure linked to large quantity of infiltrated rain water into the fill behind the retaining wall. The decreasing drainage quality of the embankment with time (drains clogging) did not allow to avoid pore pressure to develop within the embankment with the well-known consequence of shear

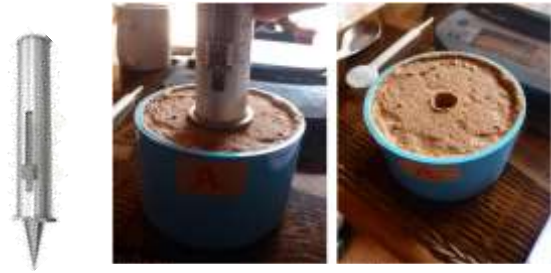
The filled soil was compacted with the initial water contents of 15%. The change of the strength of the soil was studied by Yamanaka cone tester with the decrease of water contents with time by drying.

Figure 11 Strength test by Yamanaka Cone with time  
The results are shown in Figure 13, which indicates an amazing increase of strength of 60 times or 6 MPa of one bearing strength.
