Performance of Rapid-Jet system for soil improvement works in soft marine clay

This paper reports a case study of using the Rapid-Jet system for installation of jet grout piles (JGP) in soft marine clay of up to 44.8 m. The use of JGP is part of the ground improvement works for the construction for one of the tunnelling project that are constructed by China Railway First Group Co. Ltd. Singapore Branch in Singapore. The tunnel went through a soft marine clay layer which needed to be grouted from below the tunnel to the Old Alluvium (OA) layer. At the project site, there was a 1.8 m outer diameter storm water pipe crossing the tunnel alignment at 8m below ground level. The pipe obstructed the installation of JGP piles in marine clay. The Rapid-Jet method was adopted. The nominal diameter of the JGPs was 3.0 m which was verified by the sound detector during jet grouting and excavation after installation. 24 samples were taken for unconfined compression tests. The total coring recovery (TCR) for each core were also recorded. Based on the JGP trial panel testing results, the working parameters were proven to be suitable for the formation of 1.5, 2.0, 2.5 and 3.0 m diameter grouting co

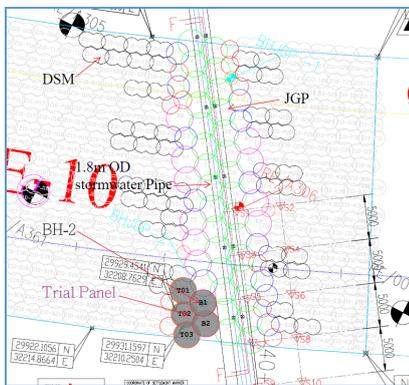
Fig. 1. Site and trial panel location

The site and trial panel location is shown in Figure 1. The soil profile along Section F is shown in Figure 2. The existing ground level was at 105.5 mRL. The 1.8 m outer diameter storm water pipe is shown in Figure 2. At 8 m below the ground level, the storm water pipe

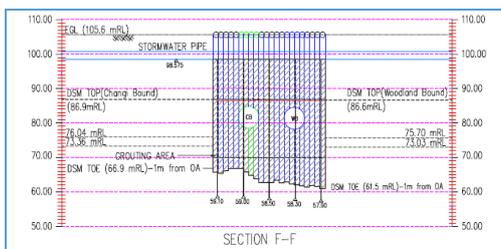
Fig. 2. Cross section F-F

was used to channel excessive rainwater from the golf course crossing the site to the Reservoir. The cross-sections of the two tunnels passing through soft marine clay is also shown in Figure 2. The groundwater level was about 1.8 m below the ground level. The soil profile can be divided into five layers: (1) the sand fill layer with an average depth of 14.5 m consisting of fine to coarse grained sand with gravels. The SPT N value ranged from 3 to 16 in this layer; (2) the very soft upper marine clay layer (Kallang Formation) with a depth to 23 m; (3) the stiff fluvial clay layer (Kallang Formation, F2) with a depth to 28.7 m and SPT N value of 8 ~ 9; (4) the very soft lower marine clay layer (Kallang Formation) with a depth to 44.8 m; and (5) the Old Alluvium (OA) layer consisting of medium-dense to dense cemented clayey sand with a depth to 44.8 m and SPT N value of 24 ~ 36.

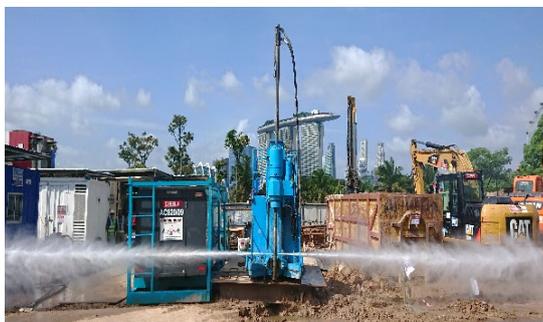
Fig. 3. Water jet of Rapid-Jet (Type R2)

Similar to the commonly used JSJ method, the large diameter jet grouting method (commercially named the Rapid-Jet method) uses a double-tube grouting system with two nozzles on the opposite side of the monitor. The latter also uses air and jet stream to cut and mix the in-situ soil with grout. A larger nozzle diameter of 3~4.2 mm is used to allow for a larger grouting rate. The jet grouting parameters of this

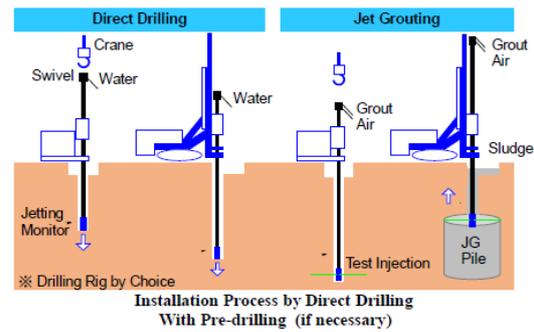
Fig. 4. Typical Rapid-Jet Installation Procedure

method are similar to those proposed by Burke (2004) and Lunardi (1997). The grouting parameters used here are as follows: grouting pressure = 30~34 MPa, grouting rate = 120 ~ 380 L/min, and rod rotation and withdrawal rate = 3~10 rpm and 10~12 min/m. Using these parameters. So, it can rapidly install a grout pile with a diameter up to 2.0~3.5 m at a depth up to 50 m below ground surface. There are two categories in Rapid-Jet system – R1 and R2, in which particular parameters are available as shown Table 1. Each category involves representative equipment. Rapid-Jet monitor water test and typical installation procedure as shown in Figure 3 and 4. Acoustic monitoring device is shown in Figure 5, it can be used to detect the quantitative intensity of erosion by jet grout and helps to assess the column diameter (Cheng et al. 2017). This system collects eroding sound at monitoring pipes located on several positions as shows in Figure 5. Sound collectors are synchronized with jet grout depth.

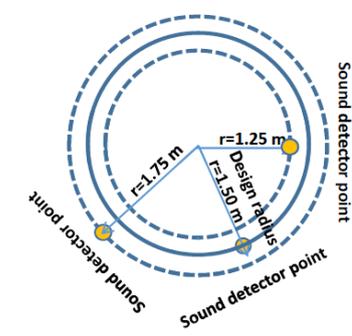
Fig. 7. Layout of sound detector points

In order to verify the pile diameter constructed by the Rapid-Jet method under various grouting parameters and in different soil conditions, Pile T01 was selected to test the grouting diameter using the Jet Wave Monitoring System (JWM). Prior to the JGP works, 3 pipes were installed vertically from the ground level to 3 m into the OA layer by drilling method. Positions of these 3 points were 1.25, 1.5 and 1.75 m from the center of T01 respectively. The layout of sound detector points is shown in Figure 7. A surface test at depth 0.5 m with thickness of about 1 m was done. After excavation, a pipe head with a diameter of about 3.5 m was exposed as shown in Figure 8. The jet

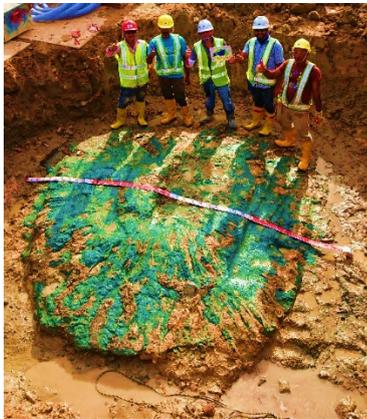
Fig. 8. Exposed Jet Grouting column of T01 with a diameter of 3.5 m.

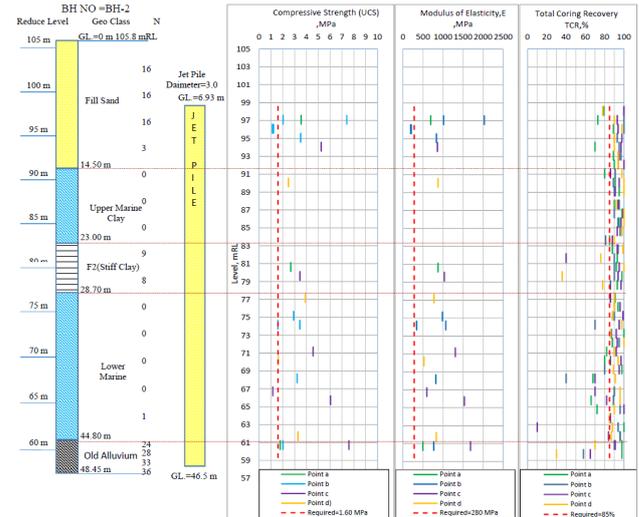
The treated soils shall obtain a minimum compressive strength of 1.6 MPa, and a minimum stiffness of 280 MPa as evaluated in accordance with BS1377 (1990: Part 7). The minimum Total Coring Recovery (TCR) required is 85%. Variations in Unconfined Compressive Strength (UCS), Modulus of Elasticity (E₅₀), and TCR with depth as shown in Figure 10. Summary of JGP test results based on coring points and soil stratum as shown in Tables 3 and 4.

Fig. 10. Variations in UCS, E50 and TCR with depth and approximate soil profile. 5.1 Unconfined Compressive Strength

The average of UCS for points a, b, c, d are 2.70, 2.85, 4.67 and 2.82 MPa, respectively, and is ranging from 2.48 to 4.09 MPa for all soil layers. The minimum UCS is 1.13 MPa which is less than the required 1.6 MPa. The maximum UCS is 7.58 MPa. We noted that the strength verification for point a & d complied with the requirement for all levels. There are 2 samples from point b (at 96.575 - 95.575 mRL & 74.675 - 73.675 mRL) and 1 sample from point c (at 67.225 - 66.225 mRL) did not meet the strength requirement. Subsequently additional 2 samples were selected above and below the failed samples (6 in total) and sent for testing. Unfortunately one of the sample (Point b at 96.575 - 95.575 mRL) still did not meet the strength requirement. By examining the samples tested, a pocket

The average E_{50} for points a, b, c, d are 660, 827, 1169 and 752 MPa and is ranging from 817 to 1108 MPa for all soil layers. The minimum E_{50} is 190 MPa which is less the requirement of 280 MPa and the Maximum E_{50} is 2034 MPa. We noted that the E_{50} verification for point a, c & d complied with the requirement at all levels. There is 1 sample from point b (at 96.575 - 95.575 mRL) E_{50} is 190 MPa. Subsequently one additional sample was selected and sent for testing and the measured stiffness is 207 MPa which failed to meet the strength requirement too.

The average value of TCR for points a, b, c and d are 89, 89, 88 and 88% respectively. The average TRC ranges from 63% for the OA layer to 94% for the Upper Marine Clay layer, and the minimum value for Fill Sand, Upper marine Clay, F2, Lower Marine Clay and OA are 70, 81, 36, 10 and 30% respectively. There are several reasons for causing the TCR to be less than 85% which include:
