## Field performance of vegetated flapped soil-bag retaining structure along a stream bank

### ABSTRACT

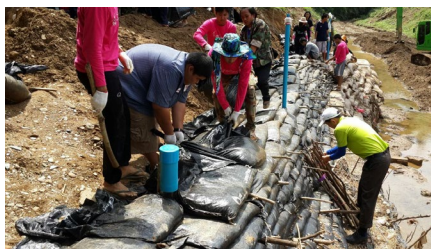
Fig. 4. Placement of flapped soil bag with live stake

Plot A involved gabion wall at the toe, overlain by flapped soil bags. The flapped soil bag's dimension is shown in Figure 3. The connection between bags is enhanced by the friction force imposed on its flaps due to the surcharge weight from overlying and adjacent bags. In this study, live stake (0.8 to 1m long and 18-25cm in diameter) of various species were placed horizontally between each flapped soil bag at spacing of about 0.5 m as shown in Figure 4. The species of live stakes used at the test slope included *Bougainvillea*, *Erythrina subumbrans*, *Salix tetrasperma*, *Spondias pinnata*. The lower end of the live stake was cut sharply and laid down to touch the soil behind the soil bags so that root could grow out of the live stake end and act as

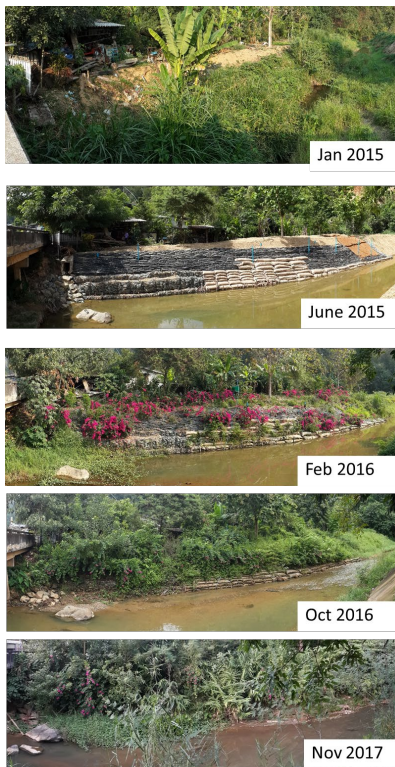
Fig. 6. Appearance of the vegetation cover of the test plots over time

Figure 6 shows the appearance of the test plots at different stages; i.e. before the construction (Jan 2015), immediately after construction (June 2016), 8 months (Feb 2016), 1 year and 4 months (Oct 2016) and 2 years and 5 months (Nov 2016). It can be seen that 8 months after the construction, the aesthetic value of bio-engineered wall was clearly improved and the flapped bags were almost fully covered by the vegetation which contribute to further protection of the bags from UV rays. After one year, vegetation on the

flapped soil bag started to change into local species and bio-diversity was evident after two years (Nov 2016). In general, the ecological restoration of the stream bank was considered significantly improved in the long term.
