Execution of vertical/horizontal jet grouting under crossing point of two existing MRT lines to improve Singapore marine clay

ABSTRACT

Keywords: ground improvement; jet grouting; unconfined compressive strength; shield tunnel

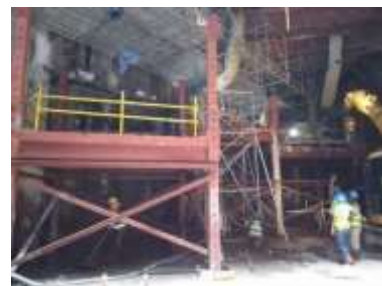
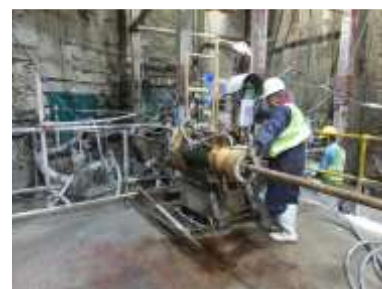
Fig. 7. Horizontal jet grouting work.

(a) Working lift fabricated in vertical shafts

(b) Execution of horizontal jet grouting

Fig. 6 shows the arrangement in a plan view of the horizontal jet grouting piles between two shafts along with that of the vertical jet grouting piles. The lengths of horizontal jet grouting were not more than 15 m and areas behind existing piles remained inevitably unimproved. From both the shafts-1 and -2, total 360 horizontal piles with arrangement of 30 in row and 12 in stage were conducted from the top stage. To secure the working space for three sets of the grouting rig, working lifts were fabricated, as shown in Fig. 7.
