Performance of overpass structures with reinforced earth walls in the Kaikoura earthquake

John Wood¹, D. Asbey-Palmer², and G. Power³

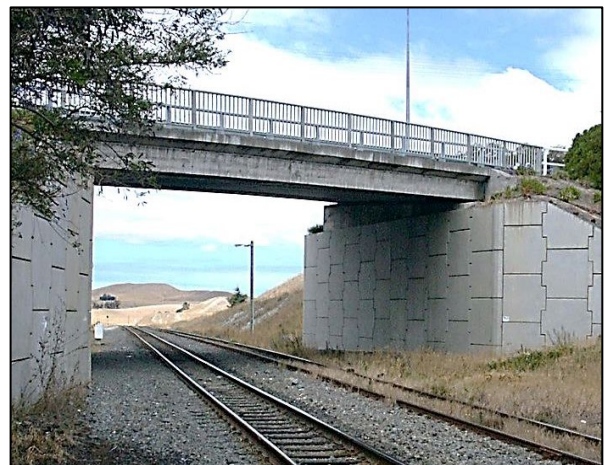
Figure 1. Seddon Railway Overbridge.

The Seddon Railway Overbridge, constructed in 1991, is an 18 m long single-span bridge with a superstructure constructed of ten pretensioned double hollow core beam units. Reinforced concrete (RC) spread footing abutment beams sit directly on the RF.

The structural arrangement is shown in Figure 1 and a typical section through the main abutment walls is shown in Figure 2.

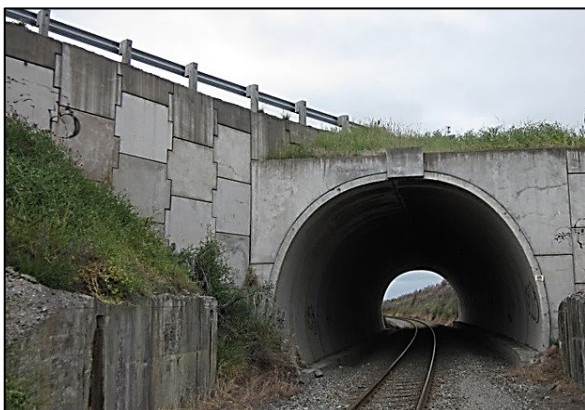
Figure 8. Hawkswood Railway Overbridge. Looking to south.

The Hawkswood Railway Overbridge, constructed in stages between 1999 and 2001, is a 42 m long TechSpan® buried arch with an average soil cover of 1.4 m. Precast RC arch segments, 2.0 m wide by 200 mm thick, were assembled in two halves to form a three-hinged arch 6.7 m wide by 5.2 m high with a shape designed to be a funicular curve under gravity loading. The arch is founded on 1.5 m wide by 400 mm deep RC strip footings.

The arch and wing walls are shown in Figure 8. Typical sections are shown in Figures 9 and 10.

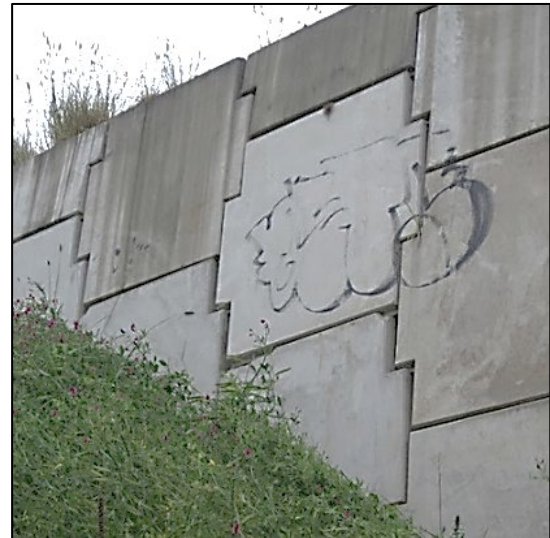
Figure 11. North-east wing wall. Spalling damage and minor misalignment of panels.

Facing panels in the northeast wingwall experienced some rotation and dislocation (see Figure 11). A depression in the road surface behind this section of wall indicated minor outward movement of the top of the wall. There was no damage to the panels in the other wingwalls.

The critical acceleration to initiate outward failure in the highest wingwall section was $0.37 g$. Since there were no ground motions recorded close to the site the outward displacements were estimated by the Jibson (2007) correlation equation (derived from Newmark sliding block analyses). For an assumed PGA of $0.6 g$, a critical acceleration of $0.4 g$, and a 10% probability of exceedance the estimated displacement was 21 mm . For a 50% probability of exceedance this value reduced to 6 mm . A check was made on the Jibson equation displacements by carrying out a sliding block analysis using the SEDS Kaikoura Earthquake record used for the analysis of the Seddon Overbridge scaled to a PGA of $0.6 g$. This gave a displacement of 10 mm which was within the limits of the Jibson equation predictions. Minor misalignment of some of the panels indicated that outward sliding of the order of 10 to 20 mm may have occurred.

The observed minor cracking in the arch and the wing wall misalignment had no detrimental structural effect.
