# Application of risk management in the design and construction of deep circular excavation with 140 meters in diameter

Chen-Han Lin<sup>1</sup>, C.-M. Lai<sup>1</sup>, C.-H. Chang<sup>1</sup>, and Y. Tada<sup>2</sup>

<sup>1</sup> Mass Transit Engineering Department, Sinotech Engineering Consultants, Ltd., 171, Nanking E. Rd., Sec. 5, Taipei 10570, Taiwan.

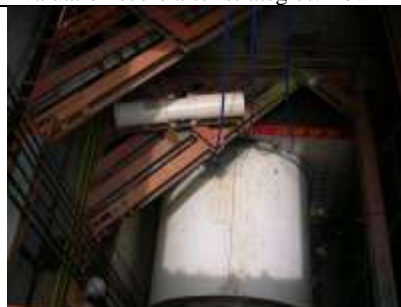
Figure. 5. The proceeding of shield machine.

Table 7. Step6: The proceeding of shield machine

Risk Identification	<ol style="list-style-type: none"> <li>1. During the proceeding, the shield machine cut and broke the diaphragm wall. The stress of structure and circumference was uneven because of the cutting effect.</li> <li>2. With the irregular displacement of diaphragm wall, leakage at breaking point of diaphragm wall, or poor quality of ground improvement, it was likely to cause the settlement of the road or surrounding buildings.</li> </ol>
Evaluation score: High	
Strategies	<ol style="list-style-type: none"> <li>1. In the design phase, ground improvement and waterproofing grouting method were conducted outside the mirror face breaking point. FRP(Fiberglass Reinforced Plastics) was conducted at the mirror face breaking point for the proceeding of the shield machine.</li> <li>2. In the construction phase, the installation of the steel cage and FRP must be accurate and high quality. The automatic monitoring system was used during the proceeding to monitor the displacement of the diaphragm wall.</li> </ol>

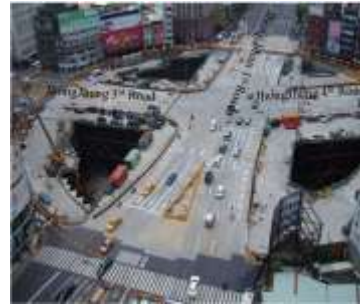
Figure 6. Traffic maintenance plan.

Table 9. Step8: Traffic maintenance plan

Risk Identification	<ol style="list-style-type: none"> <li>1. The traffic flow was likely to transfer into S route because of the incoming excavation machine and relevant equipment before the construction of diaphragm wall.</li> <li>2. The damage of the road deck due to the insufficient strength of road deck or earthquake caused traffic jam, traffic accidents, road closed, and even other issues that might affect the schedule of the construction.</li> </ol>
Evaluation score: Medium	
Strategies	<ol style="list-style-type: none"> <li>1. Increase the width of a temporary road. With appropriate construction and traffic maintenance plan, arrange traffic guide and signals and adjust the incoming time of equipment to save time.</li> <li>2. The overload and earthquake must be included in the capacity of road deck's, and construction equipment near the construction platform must be controlled at the same time to maintain the safety of construction site.</li> </ol>
