## Methods of restoration of deformed retaining walls in seismic conditions

Vitaliy Khomyakov<sup>1</sup>, Y. Yemenov<sup>2</sup>, and N. Zhamek<sup>3</sup>

### ABSTRACT

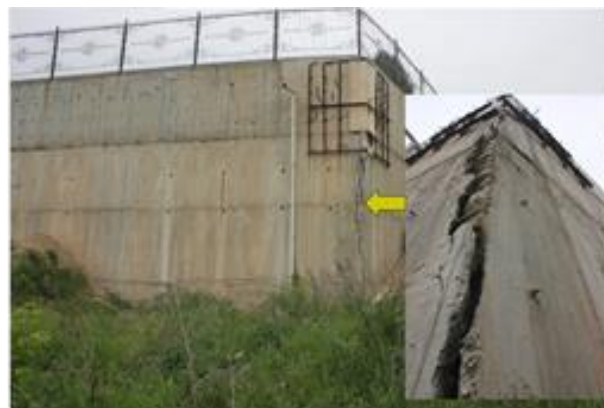
Fig. 2. Opening cracks in the corners of the retaining wall.

The retaining wall is located in Remizovka gorge and blocks the site from three sides. The wall was built in 2010 and is made of reinforced concrete. The dimensions of the wall in terms of 105 meters. The maximum height of the retaining wall is 12 meters. Retaining wall in cross section has a corner shape. In 2017, as a result of uncontrolled inflow of water from the water supply system and overmoistening of the soil, cracks appeared in the walls and its destruction began. Arresting and stratification of concrete appeared especially intensively in corners. Figure 2 shows the type of deformations. The use of amplification in the form of buttresses was not possible. Outside the walls is the territory of other owners. To maintain the wall in a steady state, it is proposed to use ground anchors. The layout of the anchors is shown in Fig.3. To fix the wall, especially in the corner parts, it was proposed to use metal belts consisting of two rolled I-beams, with a wall height of 220 mm.

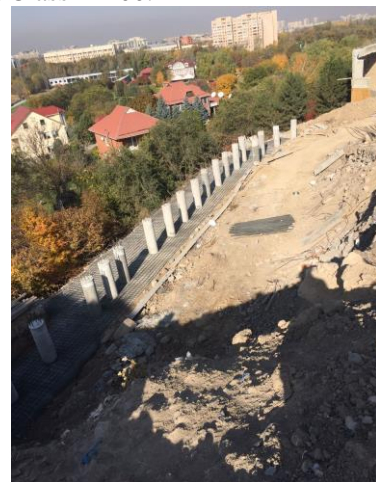
Fig. 5. General view of the reinforcement of the retaining wall after the installation of bored piles.

The remaining part of the retaining wall is attached to the bored piles using a horizontal reinforced concrete slab, Fig.5. The plate is reinforced with a double reinforcing mesh Ø22mm., With a step of 200mm. The top of the piles is combined with a horizontal grillage. Subsequent retaining walls were installed in steps. The dimensions of the walls in height were about 2.0 m.

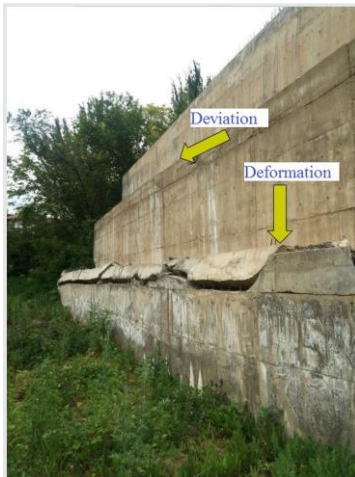
Fig. 6. Deformation and destruction of concrete retaining walls.

The retaining wall has a rectangular configuration and was erected in 2017. In 2018, after intensive rains, the soil of the backfill and foundation moistened. The wall completely deformed and began to collapse. As a result of the survey, it was determined that there are no drainage holes in the wall, and the backfill soil is in a loose state. As a result of water saturation of the soil, the bearing capacity of the base under the walls has decreased. The walls began to settle and destroy the concrete in the joints, Fig.6. The house and the outbuildings located up the slope began to deform.
