TECHNICAL ARTICLE ON COMBINED EFFECTS IN NATURAL DISASTERS AND THEIR MITIGATION

Ikuo Towhata, University of Tokyo, Appointed Board Member of ISSMGE

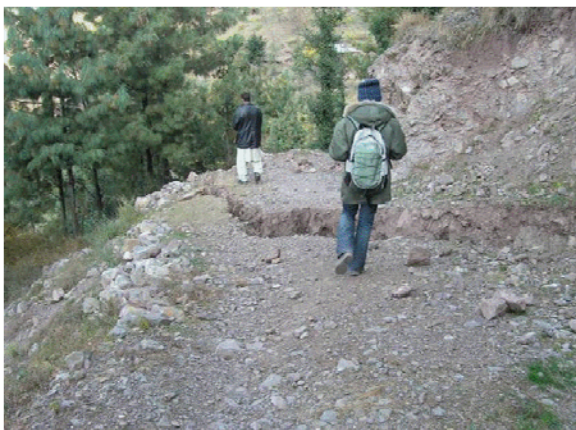
The author made a technical investigation in 2005 immediately after the Kashmir earthquake. Among many slope failures in weathered surface materials, the situation in Fig. 1 was impressive in that the crack apparently provided a water channel into the subsoil. During a rainy season, the surface run-off water would easily flow into the slope and increase the weight of soil, reduce the effective stress, and possibly deteriorate the mechanical properties of the submerged soils. Thus, the negative effects of a heavy rain fall were made worse by the preceding strong earthquake shaking, which is herein called the combined effect.

Fig. 1 Earthquake-induced crack in mountain slope (after the 2005 Kashmir earthquake).

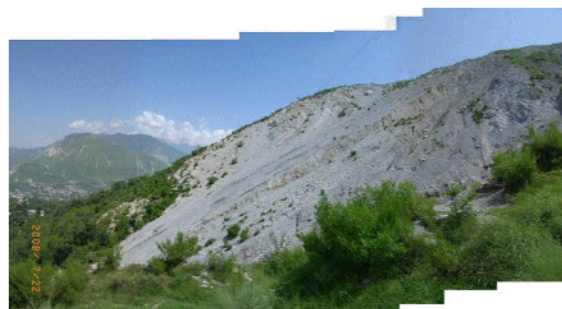
Fig. 2 Continuous failure of mountain slope initiated by strong earthquake motion (in Muzaffarabad after the 2005 Kashmir earthquake).

It was peculiar that the same earthquake triggered a long-term slope failure in a mountain behind a local capital of Muzaffarabad City (Fig. 2). Possibly the mechanical properties of the rock was disturbed by strong shaking and minor cracks were created. Consequently, the continuous failure of the slope and falling of debris especially during heavy rains have been a significant threat to the local community. These cases described above illustrate a combined effect of earthquake and rainfall.

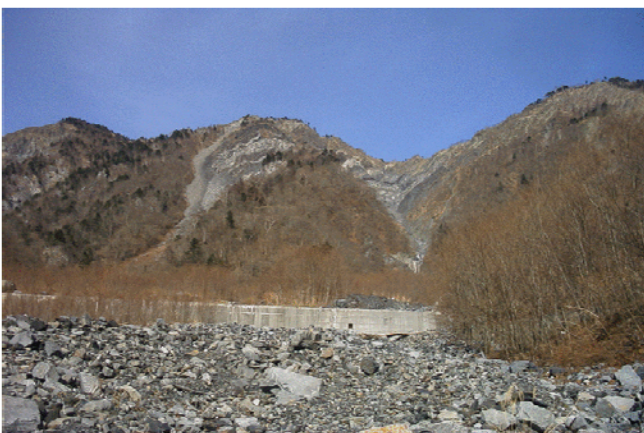
There are more examples, similar to the aforementioned ones, where a preceding strong earthquake impact induced a long-lasting slope instability problem during rains. Fig. 3 illustrates the Ohya slope in Japan (Imaizumi et al., 2005; Shizuoka Prefecture at about 100 km to the west of Tokyo) that was most probably destroyed by the 1707 Ho-ei earthquake of $M_w=8.7$. Since then, slope instability and debris flow upon every heavy rain have continued for 300 years, and slope stabilization works are going on intensely even now. This situation will continue further as suggested by the current slope surface that is still covered by unstable stones and debris (Fig. 4).

Fig. 3 Unstable Ohya slope.

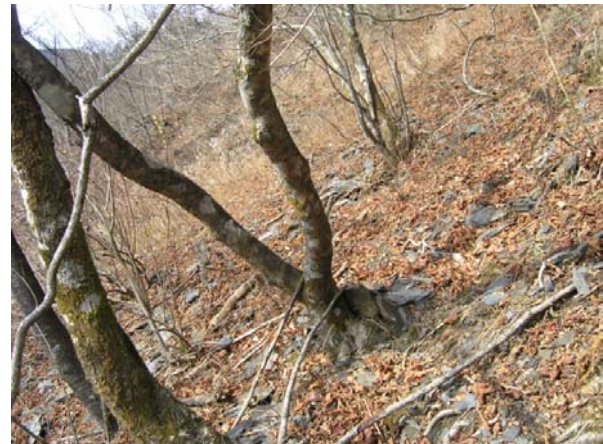
Fig. 4 Surface of Ohya slope covered by debris.

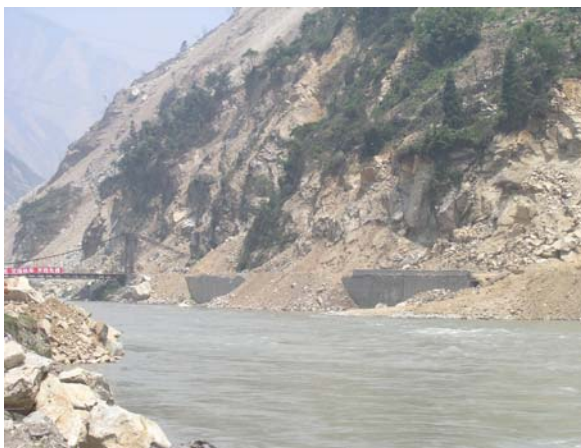
Fig. 5 Slope failure that occurred during the 2008 Wenchuan earthquake.

Similarly, the Sichuan Province of China has suffered from many slope failures and debris flows after the 2008 Wenchuan earthquake of $M_w=7.9$. During the earthquake, first, many slope failures occurred; see Fig. 5. It seems that the many mountain slopes were disturbed significantly by the strong shaking, even if they did not fall down, and produced instability problems during the following years. One of the examples of this type of disaster is found in the local capital city of Beichuan. Fig. 6 illustrates two slope problems in this city. The upper one is a failure of a mudstone slope that started after the earthquake and the slope has been falling down repeatedly upon heavy rains. Another one seen near the bottom of the photograph is a debris flow that came down along a valley. The channel of this debris flow is extremely unstable (Fig. 7) and therefore the problem will continue for many years from now on. Both problems started after the earthquake. Because this dangerous situation could not be overcome by emergency works, the local capital was moved from Beichuan to a safer place.

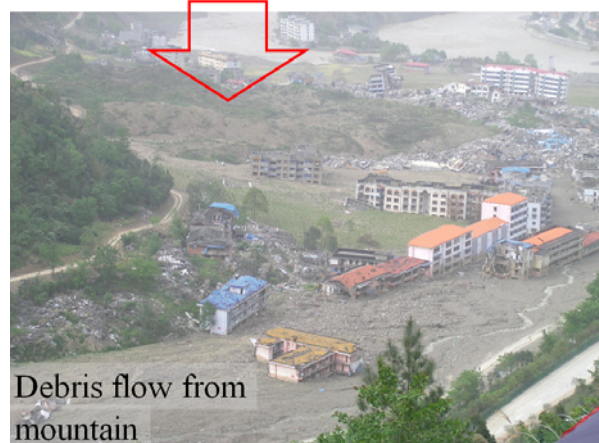
Fig. 6 Continued slope disasters in Beichuan after the earthquake on May 12th, 2008 (photograph taken on April 20th, 2009).

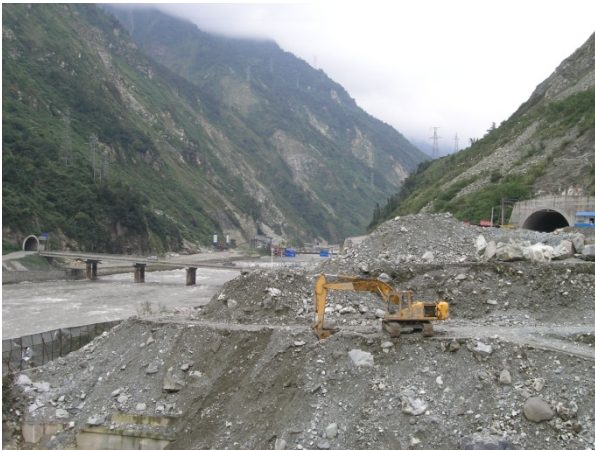
Fig. 7 Debris channel behind Beichuan City.

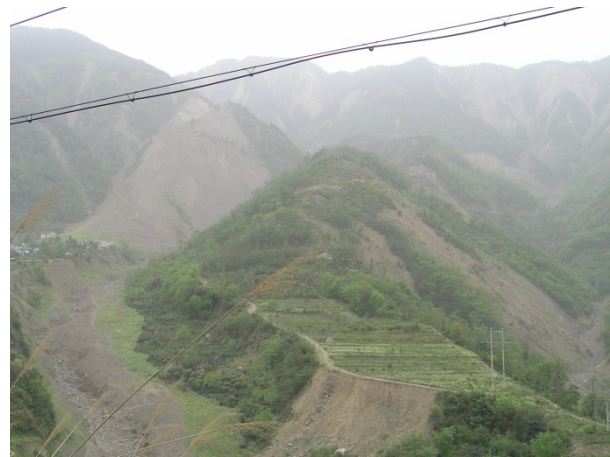
Fig. 8 Debris flow in front of Yinxiu City.

The epicenter of the Wenchuan earthquake was near Yinxiu City. In 2008, an expressway was under construction to connect this city as well as Wenchuan City, both being situated in a mountainous area, with the main part of the Sichuan Basin. Although the construction was stopped for some time because of the earthquake, it was resumed and became nearly completed in the part near Yinxiu. In 2010, however, a heavy rain induced debris flow and destroyed the expressway (Fig. 8). Probably because of this unstable slope conditions along this part of the expressway, the expressway is now situated in the center of the valley; away from the slope and hence above river water.

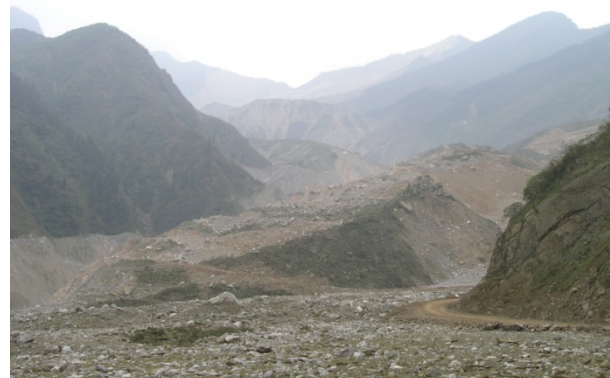
Fig. 9 Huge volume of debris deposits in the valley bottom at Wenjiagou.

Combined disasters are more powerful than an individual event whether they occur simultaneously or sequentially. To manage this extreme condition, it is often stated that relocation to safer places and/or evacuation in advance are essential. The case of Fig. 9 is one of the successful examples of this idea. It seems, however, that there are still points to be noted. In this regard, the authors visited the Mayon Volcano area in the Philippines and interviewed local people about the ongoing disaster mitigation efforts against lahar. Lahar is a flow of volcanic debris that is induced by heavy rain. Because the ash deposit was made by a preceding volcanic eruption, lahar is a combined disaster caused by eruption and rain.

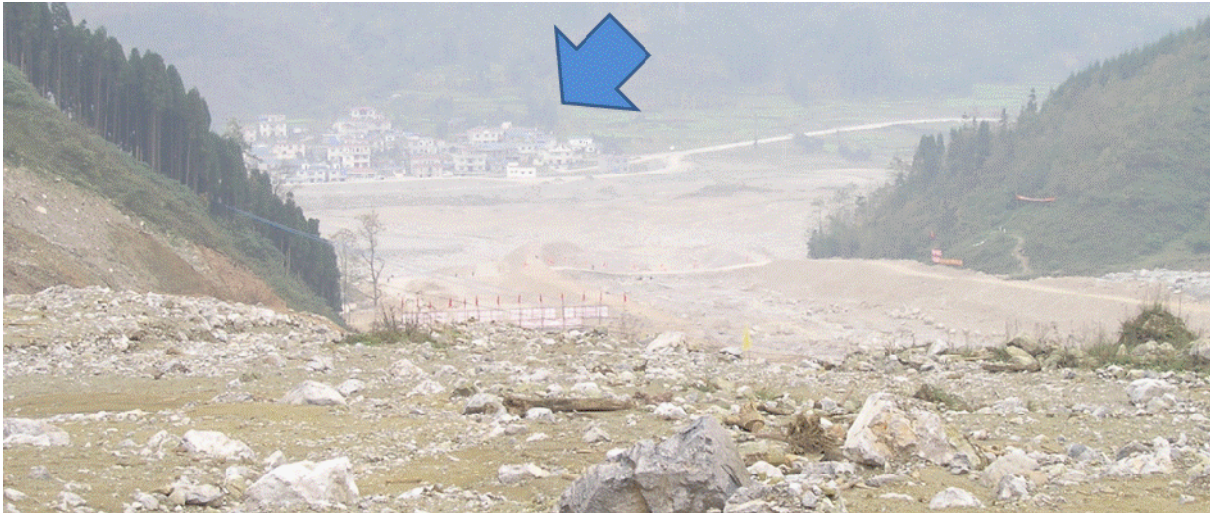
Fig. 10 Township located at the exit of a valley prone to debris flow.

The tragedy in Zhoqu was a good lesson to local officials. One week later, another heavy rain occurred in a mountain area of the nearby Sichuan Province. Because the valleys in the area had a significant amount of debris deposits because of slope failures during the Wenchuan earthquake, an evacuation order was issued immediately. Fig. 9 illustrates a situation in Wenjiagou valley in November of 2010 where a huge debris deposit was washed by heavy rain. This case implies a long-term hazard of debris flow after a strong earthquake induced falling of slope material into the valley. Although human life was thus saved, more fundamental care is needed of land use and development design. Fig. 10 shows that there is a town at the exit of the hazardous valley. Safety planning should relocate human habitations away from this dangerous place.

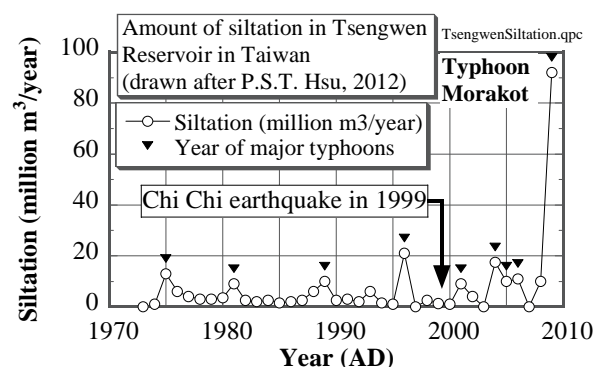
Fig. 12 Siltation rate in Tsengwen Dam Reservoir (drawn after Hsu, 2012).

The 1999 Chi Chi earthquake in Taiwan probably affects today the stability of mountain slopes; see Fig. 11. Fig. 12 illustrates the rate of siltation (soil flux per year) at the Tsengwen Dam Reservoir that is situated in the downstream area in south Taiwan. Generally, the extent of siltation has increased in the years when strong typhoons, particularly the Typhoon Morakot (Lee and Towhata, 2010), hit the upstream area. From a long-term viewpoint, however, it is further interesting that siltation increased around the year of

1999, possibly suggesting that the mountain slope was disturbed by the Chi Chi earthquake and more amounts of soils are eroded afterwards during heavy rain falls.

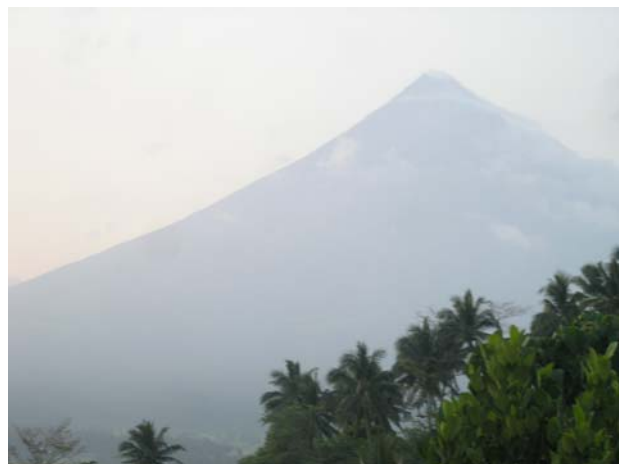
The Mayon Volcano (Fig. 13) is a very active volcano in the Albay Province, Luzon Island, the Philippines and measures 2,463 m in altitude. It erupts very often and deposits ash in its slope. The disaster mitigation program has been conducted by a public sector named Albay Public Safety and Emergency Management Office (APSEMO) in Legazpi City. Its basic activities are relocation and evacuation (Delos Reyes et al., 2006). The ongoing program is accepted and supported by local people because they remember a very bad lahar disaster in 2006. The information obtained from interviews in several villages is introduced in what follows.

Fig. 13 Mayon in Albay Province of the Philippines.

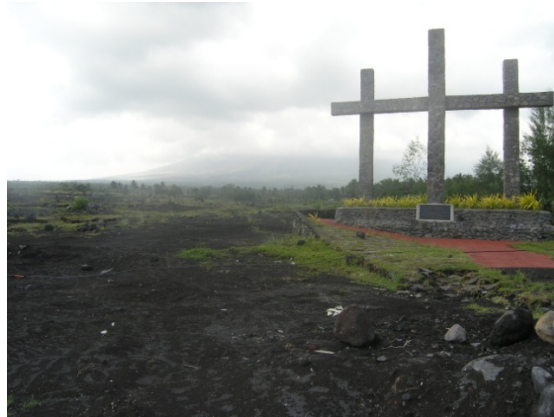
Fig. 14 Lahar channel in Padang Village.

In the Padang Village that was devastated by lahar in 2006 (Fig. 14), a male resident who was able to survive the 2006 disaster made the following remarks:

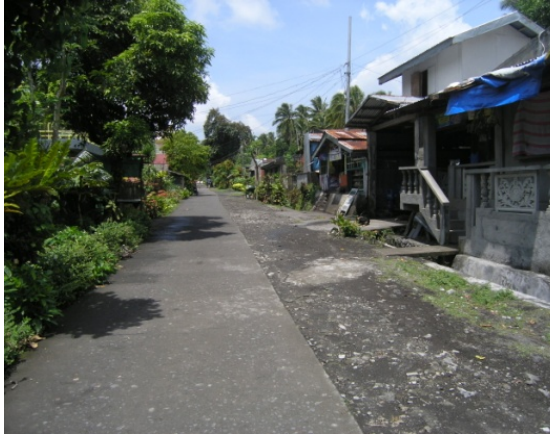
In Salvacion Village (Fig. 15), people made the following remarks;

Fig. 15 Salvacion village that is situated upon relatively high place.

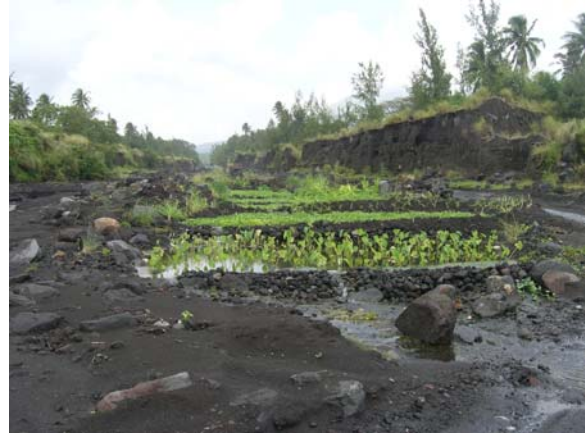
Noteworthy is that the current risk of lahar is low because Mayon has not made big ash eruption since 2006 and hence there is not much ash deposit in the mountain slope. Accordingly, people use river channel for small agriculture (Fig. 16). This implies that people are keen to work in order to make their living even along slopes within the 6-km Permanent Disaster Zone (PDZ).

Fig. 16 Small agriculture in lahar-prone river channel.

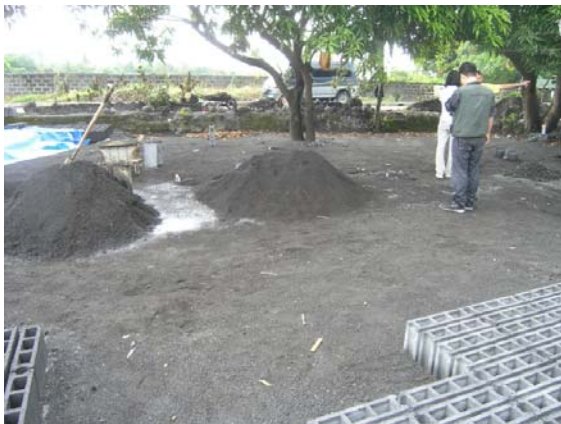
A local block manufacturer in lahar-prone Bunot Village (Fig. 17) said that he wished to live in his home place because the home was next to a local main road where many customers come. Again, income is more important than relocation.

Fig. 17 Block production in lahar-prone village of Bunot.

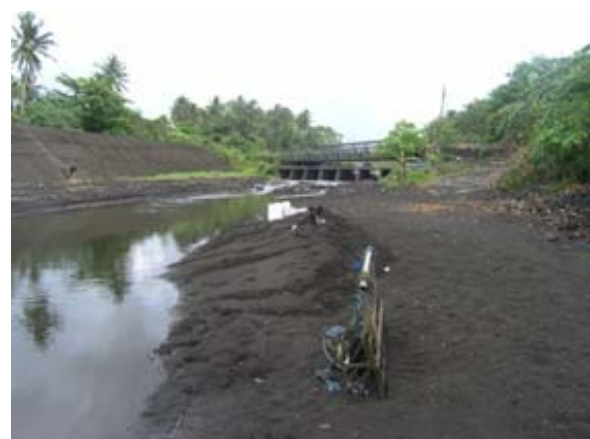
Fig. 18 River channel in San Rafael.

- Her family cannot move to a safer place because there is no money to employ a carpenter and build a new house, although land and building material are supplied by the government.
- The family collects aggregates from a river channel (Fig. 18) behind her house.
- Children's school is close to the present place.

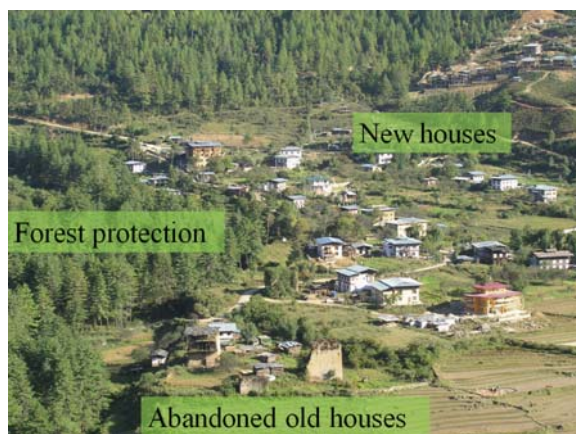
Figure 19 indicates a situation in an alluvial fan near the capital (Thimpu) of Bhutan. An alluvial fan is subject to flooding and other slope disasters. In contrast to old and abandoned houses that are situated behind a protection of forest, newer houses are located in the center of the fan which is more convenient for working. This may imply that recent people are forgetting old wisdom and put more emphasis on daily conveniences. Fig. 20 indicates that houses are located on parts of a slope that did not fail during the 2004 Niigata-Chuetsu earthquake in Japan. The first author was impressed after that earthquake to find that people's residents were not much affected by slope failures, while public buildings that came only recently were situated on less stable parts of slopes and were affected by the earthquake-induced slope failures. Probably the long (nearly 1000 years) history of the local community has taught people which parts of slopes are safer.

Fig. 19 Location of old and new houses in an alluvial fan near Thimphu of Bhutan.

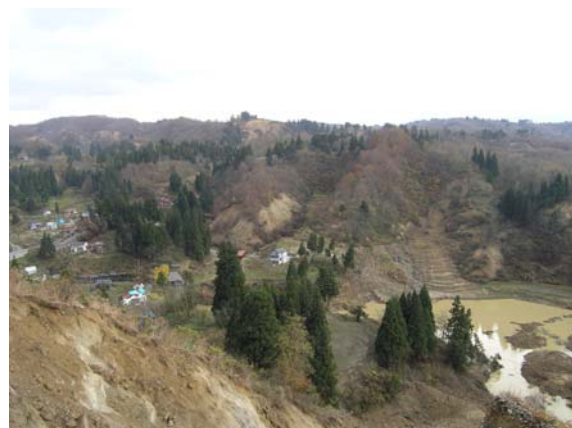
Fig. 20 Houses located on safer parts of seismically affected slope (Yamakoshi Village, after 2004 Niigata-Chuetsu earthquake, Japan).

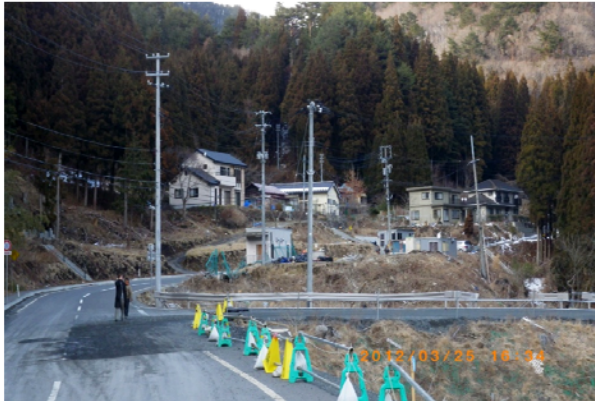
Fig. 21 Village at tsunami-free high place (Karani-Hongo, Iwate).

before and started to live at low places behind the wall. This situation led to a tragedy again in 2011 because the tsunami height exceeded the height of the wall. Houses at low elevation were totally washed away, while those at high places survived the disaster (Fig. 23).

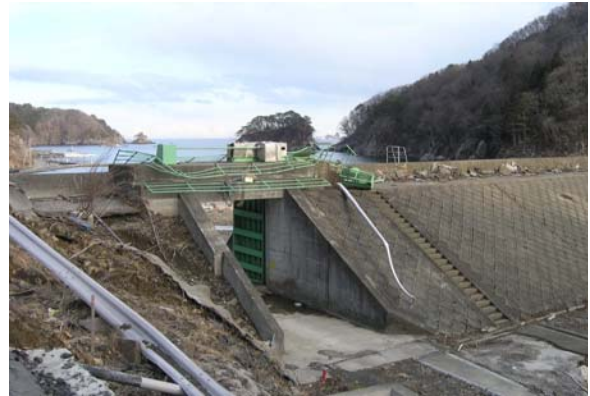
Fig. 22 High sea wall against tsunami attack (Karani-Hongo).

Relocation of human habitation to safer places is often discussed. The recent gigantic earthquake and the associating tsunami disaster in Japan are demonstrating a significant problem concerning the relocation. After the previous big tsunami disaster in 1933, a relocation program was conducted extensively in the affected coastal area and people started to live at high elevations. Fig. 21 shows one of the examples of this type. Later on, further safety efforts were made to construct a high sea wall (Fig. 22) so that the highest ever-known tsunami in 1896 would be stopped. Consequently, the local people felt safer than

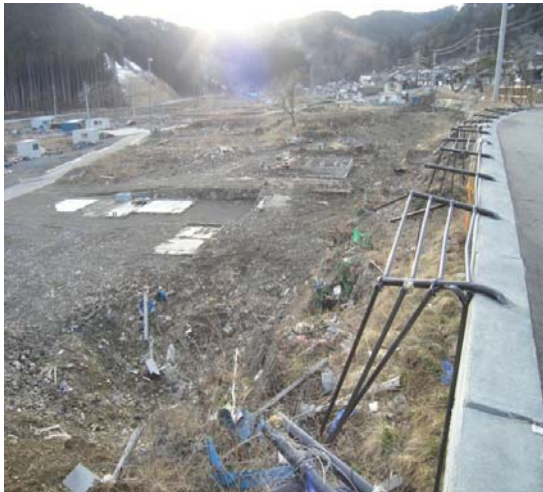
Fig. 23 Tsunami disaster behind the sea wall of Karani-Hongo (houses at higher elevations in the top right survived the tsunami).

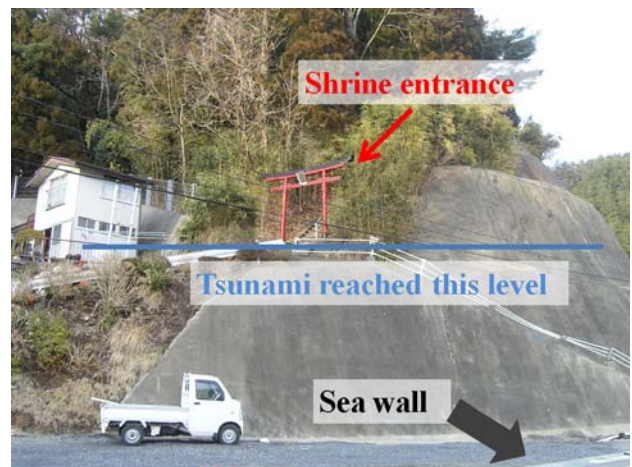
Fig. 24 Tsunami water level well above the sea wall and close to the entrance gate of a local shrine.

The fundamental problem here was that people had been wishing to live near the sea because the main industry in this locality was fishing. Obviously, low places were much more convenient for daily life than high places. Hence, the construction of the high seawall gave people a good reason to move to the low places. People in 2011 did not take the earthquake and tsunami alert seriously because they fully trusted the “high” sea wall. Unfortunately, the tsunami evacuation drills and education in the local community were not very helpful. Probably similar situation occurred at many other places and increased the number of victims. Fig. 24 indicates that the tsunami reached an elevation much higher than the wall and close to the entrance gate of a local religious shrine.

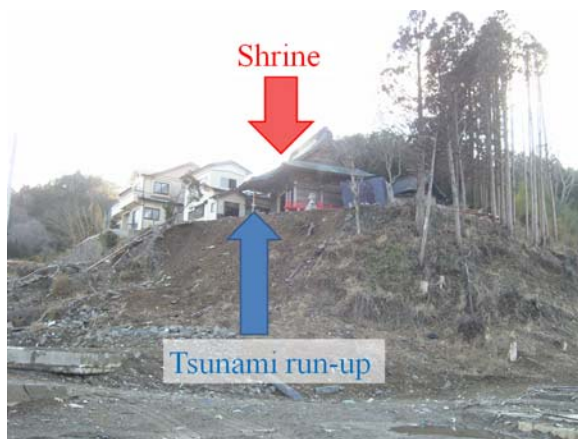
Fig. 25 Shrine in Onagawa.

An interesting wisdom of people reasonably suggests the ever-greatest height of tsunami. This height is now very important for design of the local communities subjected to extremely high but rare tsunami. In the affected region, the record of tsunami in the modern sense dates back only to 1896. Height of older tsunamis may be found only by excavation of soil for deposits of tsunami sand. In addition to this way of study, another approach to the ever-highest tsunami is supplied by the location of holy gates of shrines (Fig. 24). Since the gate and shrine are holy, local people have been reconstructing shrines at higher and safer places after every tsunami disaster. Hence, today, it is possible that the elevation of the gate indicates the highest level of past tsunami; probably a record in the past 1000 years or so. This time length is much longer than modern written records and therefore is very useful. Recent trips of authors to the tsunami-hit area found many holy gates that are located immediately above the tsunami run-up height (Figs. 25 - 28). This probably means that the tsunami in 2011 was one of the highest in the past 1000 years or so.

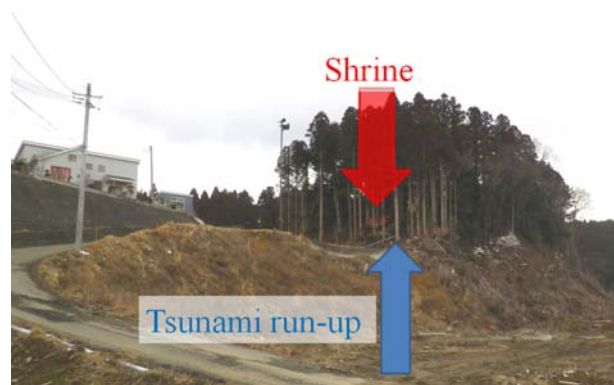
Fig. 26 Shrine gate in Rikuzen-Tokura.

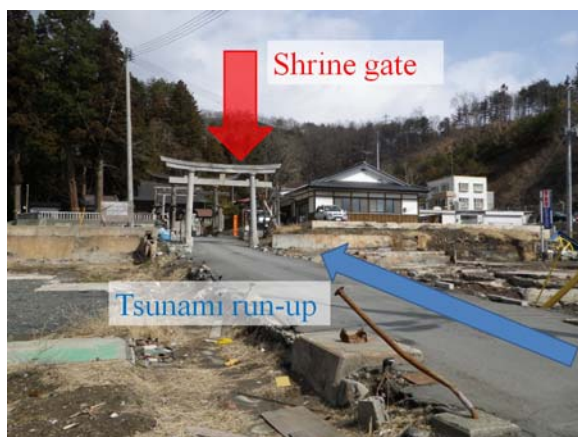
Fig. 27 Shrine gate in Ohtsuchi.
