Preliminary Understanding of the Seti River Debris-Flood in Pokhara, Nepal, on May 5th, 2012

— A Report based on a Quick Field Visit Program —

N. P. Bhandary^{*§€}, R. K. Dahal^{**€}, and M. Okamura^{*§}

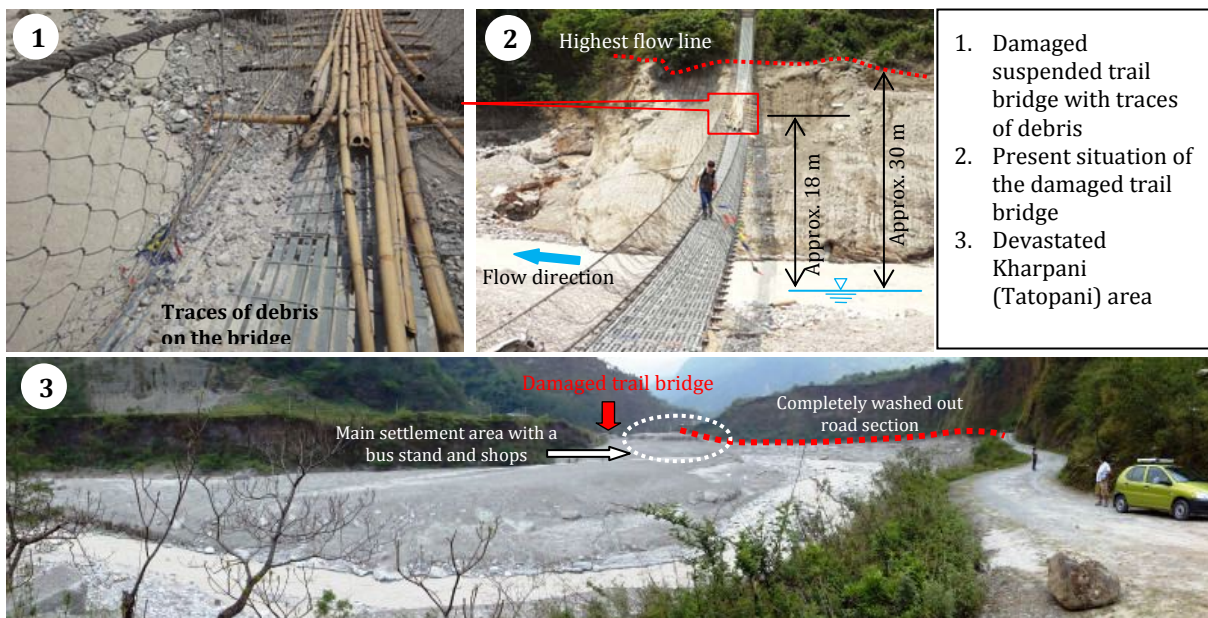
Fig. 5: Damaged suspended trail bridge in Kharpani (Tatopani) area and the devastated Kharpani area (see Fig. 4 for the location).

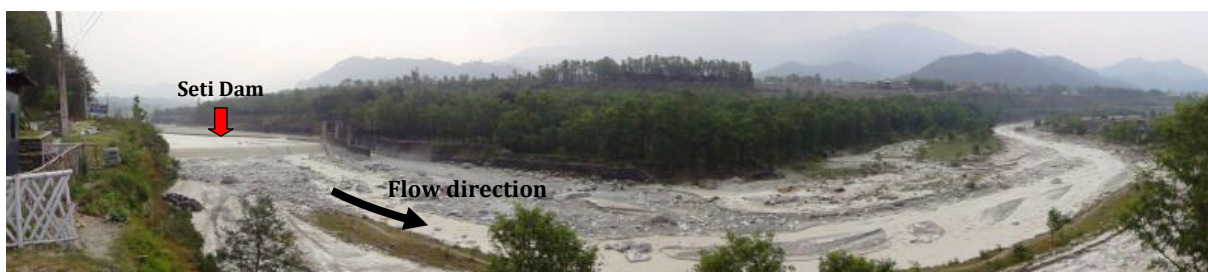
Fig. 6: Seti Dam area, about 4 km upstream from Pokhara city center (most live videos and photos of the flood freely available in the net were taken at this point). The dam structure has sustained the damage, mainly because at this point the debris was composed of less destructive material such as tree logs and finer particles.

We headed for the disaster area on 18 May 2012 for the purpose of preliminary visual inspection of the debris source and disaster-hit areas of Kharpani and downstream locations (as indicated in Fig. 4). On the first day, we went up to Kharpani area, some 20 km upstream from central Pokhara and about 20 km downstream from the Annapurna Greater Depression (or Sabche Cirque), where most human casualties of this disaster are believed to have occurred in the debris mass of depth as much as 30 meters and width about 60 meters that travelled at an estimated speed of about 40 km/h through the section of Kharpani suspended trail bridge (Fig. 5). Also inspected on the same day were three other sections on the downstream: 1) about 1 km downstream from Kharpani, 2) about 8 km downstream from Kharpani, and 3) Seti dam (barrage) site, as indicated in Fig. 6.
