Effects of Geotechnical Interest Caused by the Nicoya Peninsula Earthquake, Costa Rica September 5th, 2012

By William Vargas Monge, University of Costa Rica

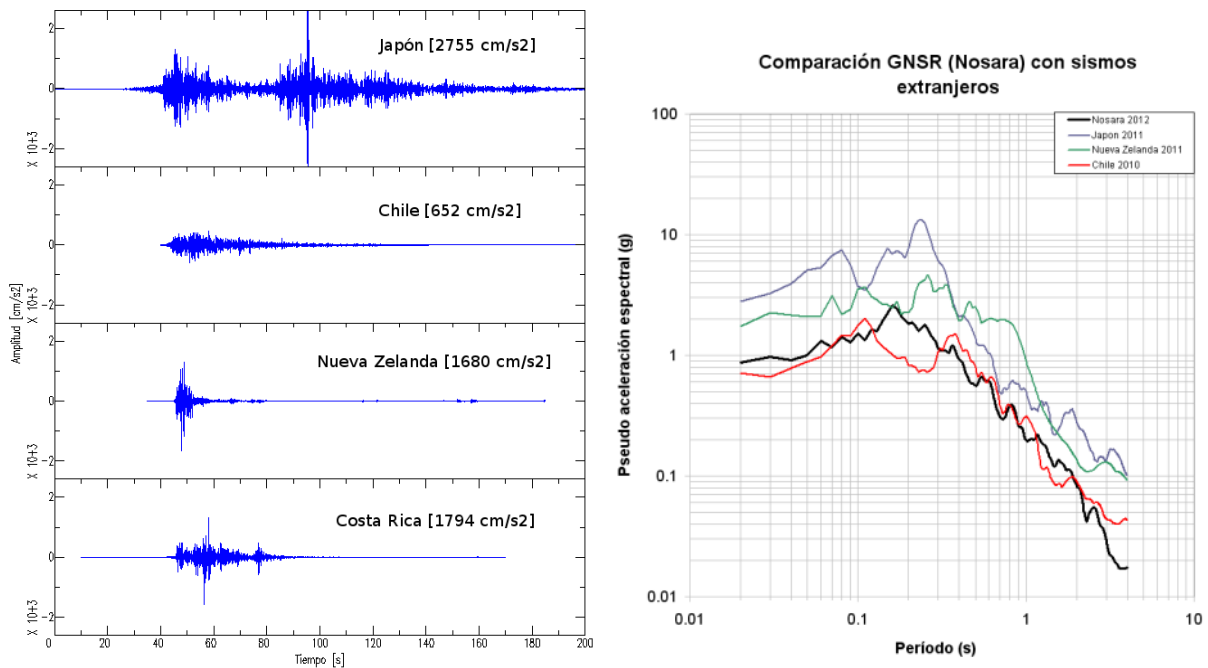
Fig. 4 Comparison of the Costa Rica earthquake and other recent records with high accelerations; Left: time history, Right: response spectra for 5% damping (present earthquake shown by thick black curve).

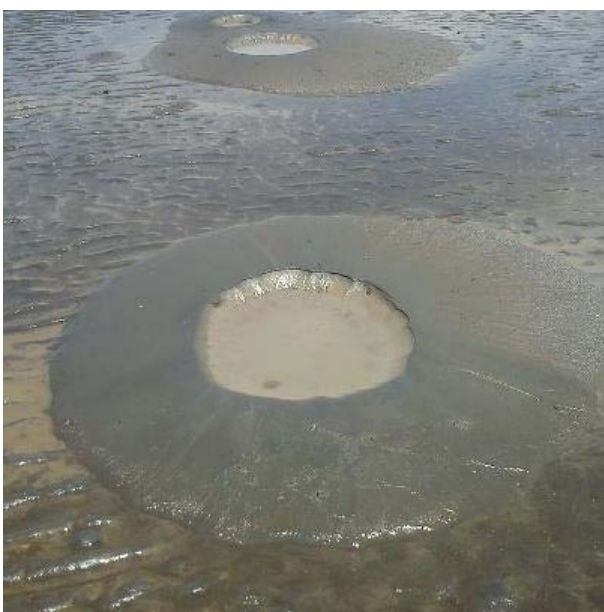
Fig. 5 Sand boiling in the Caldera beach Source: Periódico El Imparcial (online version).

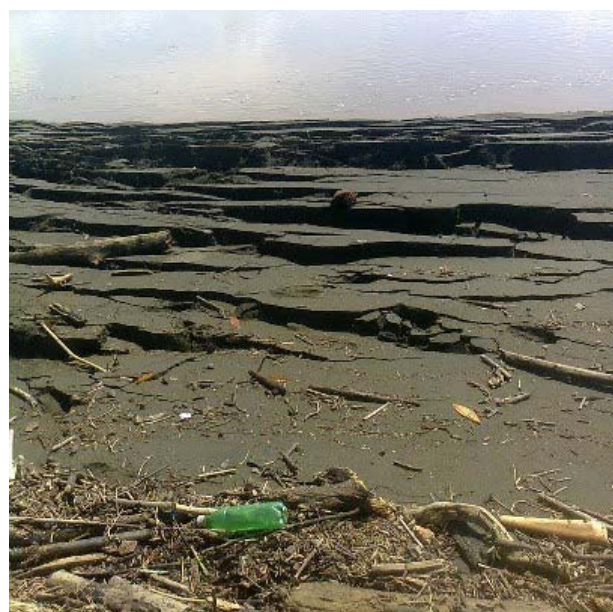
Fig.6 Lateral spreading in the Tivives beach Source: La Nacion (online version).

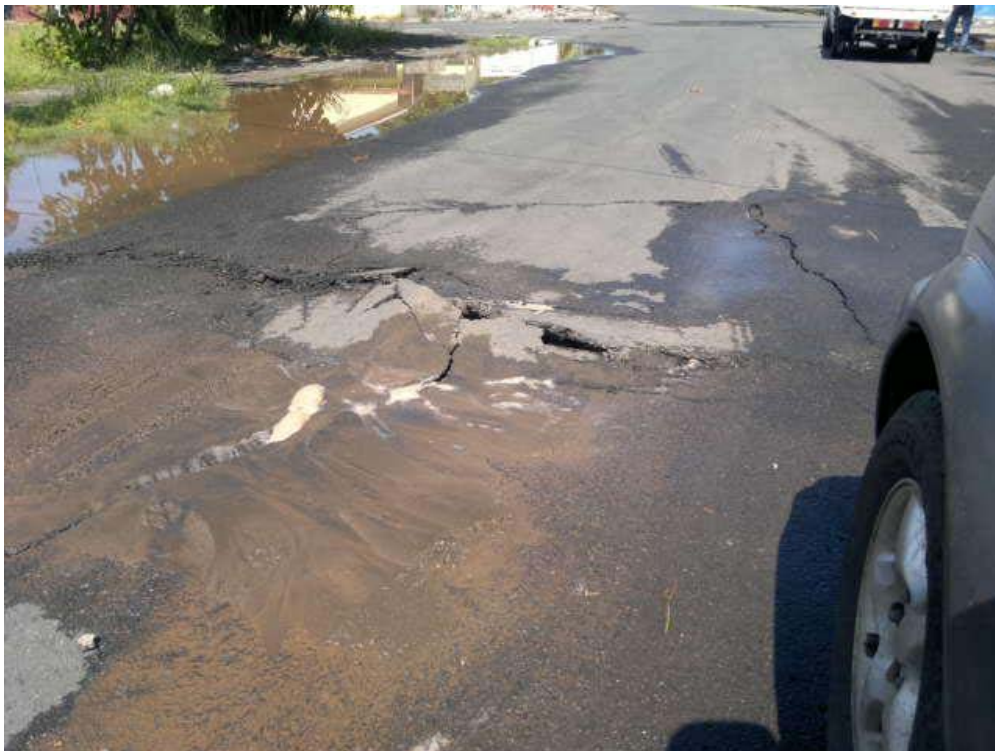
Fig. 7 Sand boiling through a cracked pavement in Puntarenas.

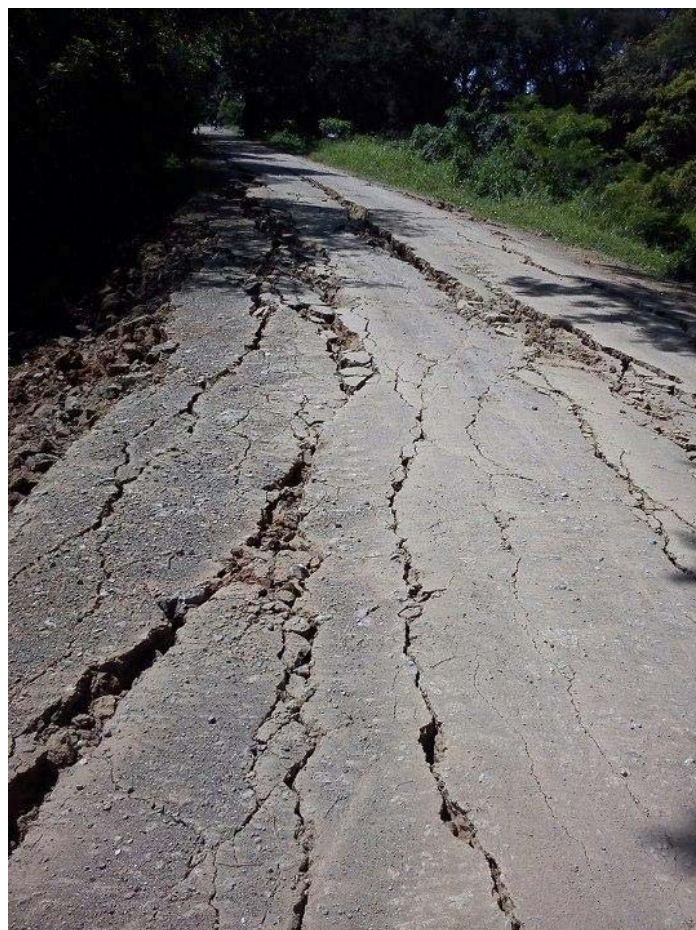
The flood-control levee showed longitudinal cracks (Fig. 8) but no significant settlement or instability failures. The preliminary conclusion from the observation is that the damage was not related with liquefaction of the foundation but with tensional stresses induced by the seismic waves at the crest of the levee. It is however possible that the longitudinal cracks were induced by lateral expansion as a consequence of subsoil or levee liquefaction. The Amistad Bridge over the river Tempisque, built in 2002, is the largest of the country and it is a structure composed of a cable-stayed span and a simply-supported span. The two spans seemingly collided and deformed leaving a horizontal permanent shift of 6 centimeters (Fig. 9). The Monsenor Sanabria Hospital (Fig. 10) is the most important facility of this type in the Pacific coast of Costa Rica. It is a reinforced concrete 10-story building with a combination of flexural frames and shear walls. The earthquake caused damage to non-structural partition walls and façade. There was shear cracks in several floor beams of the stairs (Fig. 11) and the building was therefore evacuated.

Fig. 8 Tension cracking and slope failure of the Tempisque levee at Filadelfia (Source: La Nacion, online version).

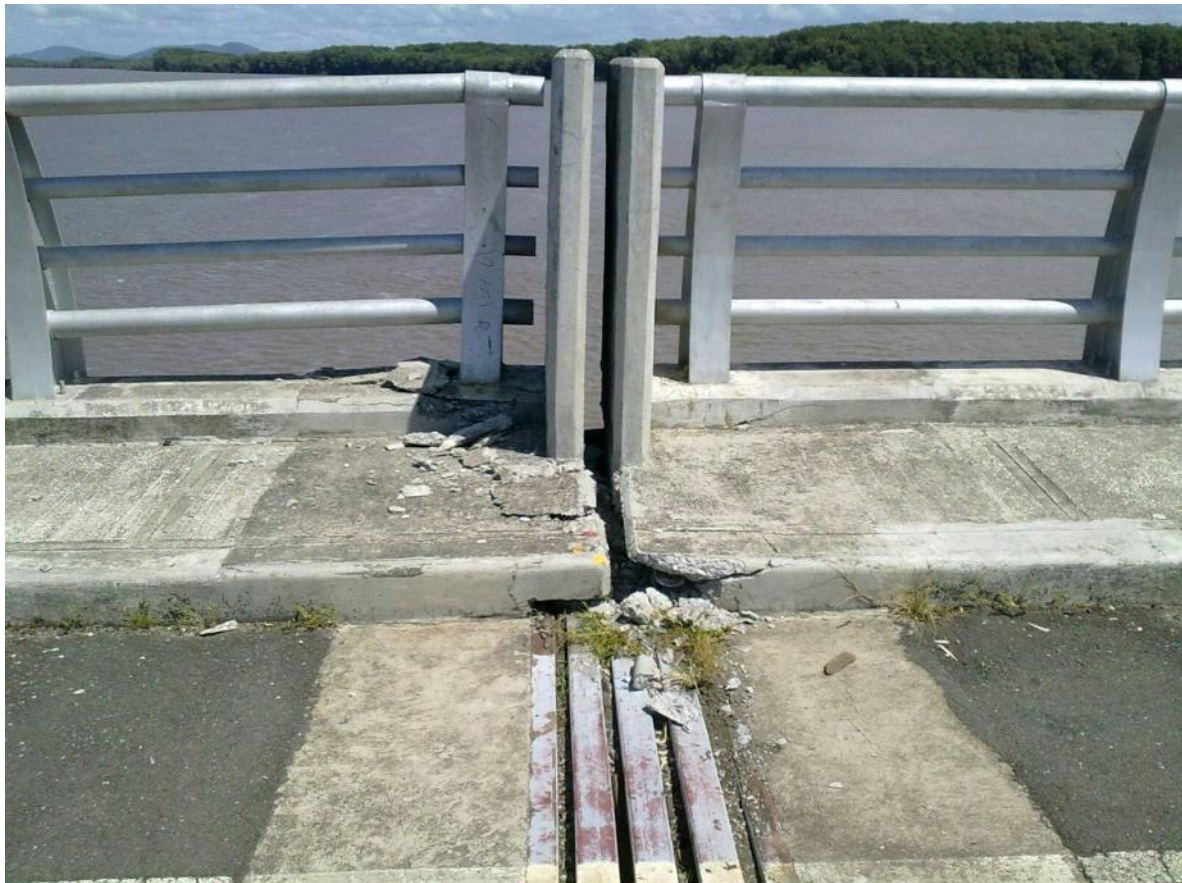
Fig. 9 Collision and permanent relative displacement between the two spans of the Amistad bridge (Source: La Nacion, online version).

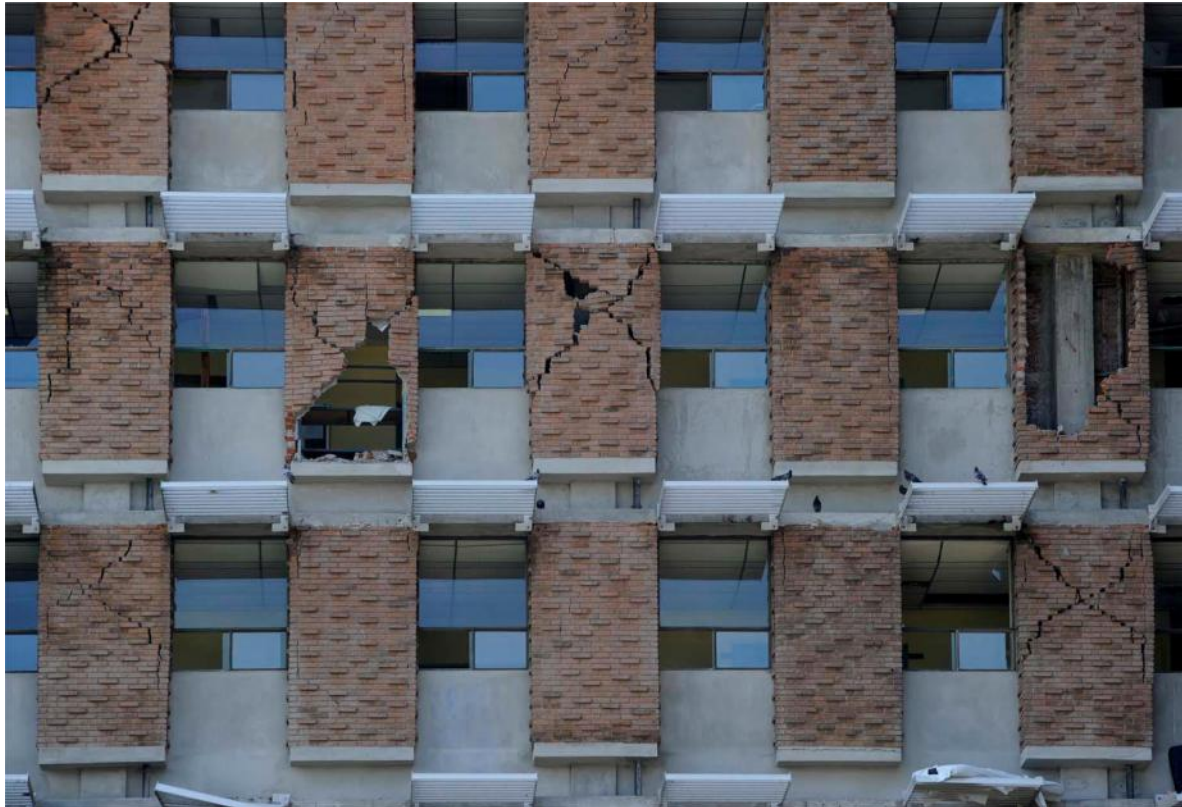
Fig. 10 Shear failure of non structural facade walls of the Monsenor Sanabria Hospital (Source: La Nacion, online version).

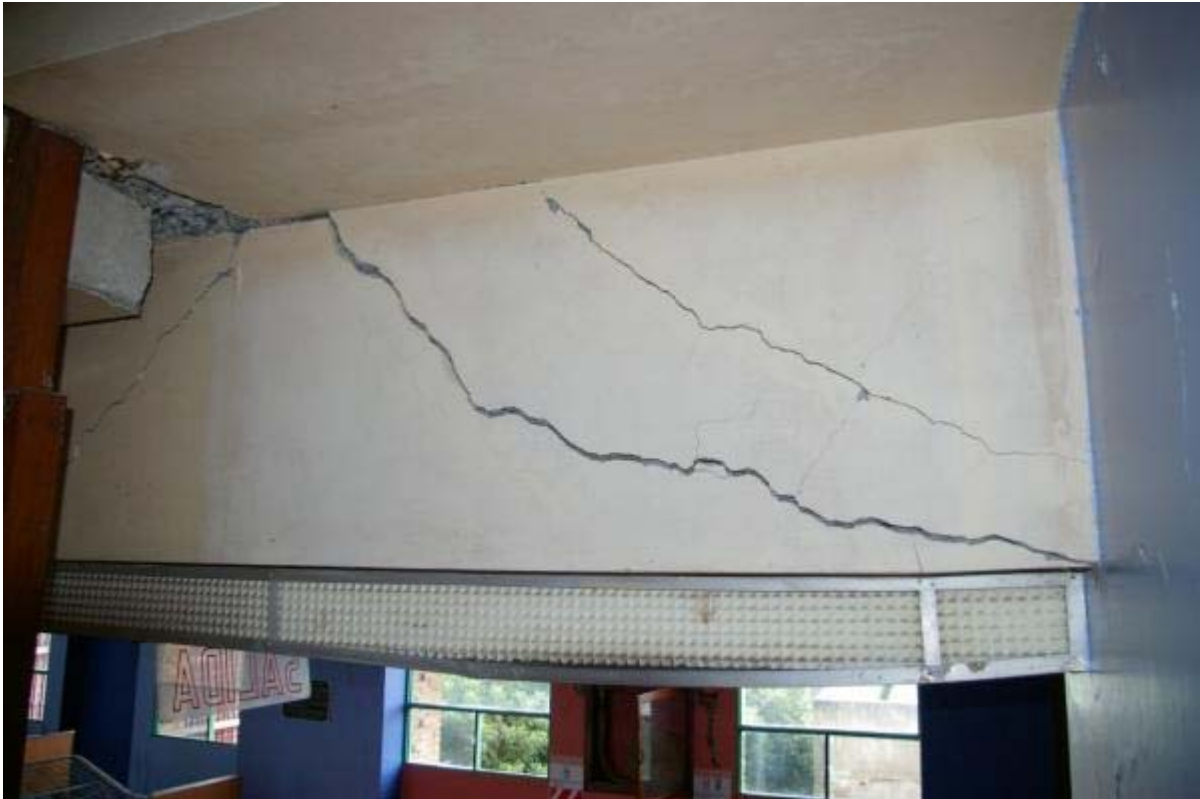
Fig. 11 Shear cracks in the floor beams of the main stairs of the Hospital Monsenor Sanabria. Source: Laboratorio de Ingenieria Sismica, Universidad de Costa Rica.

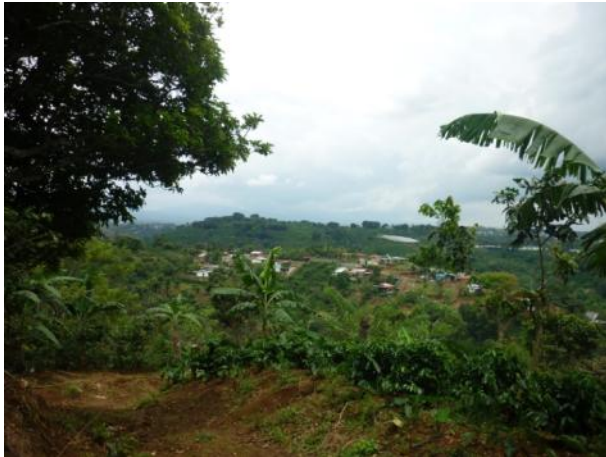
Amplification was the cause of additional damage at as far as 150 kilometers away from the epicenter. In the central volcanic mountain range, amplification was observed along the ridgelines of the foothills located at intermediate elevations between the valley and the mountain ridge (Figs. 14 and 15). The foothills of the volcanic range have an inverted U shape, created by erosion and the natural drainage and the foothill ridgelines are approximately perpendicular to the main mountain ridgeline, becoming radial around the volcanic peaks at higher elevations. Amplification was seemingly more intense in the ridgelines oriented in a perpendicular direction to the wave propagation trajectory. The combination of the two directions produced large displacements and tensional stresses along the ridgeline, which may be associated with the cracking of the ground and the failure of poorly compacted fills. The combination of these two effects caused damage to several houses observed in the towns of Grecia and Sarchi, at over 125 kilometers from the epicenter (Fig. 16).

Fig. 14 Foothills of the mountain range in Sarchi (Photograph by W. Vargas).

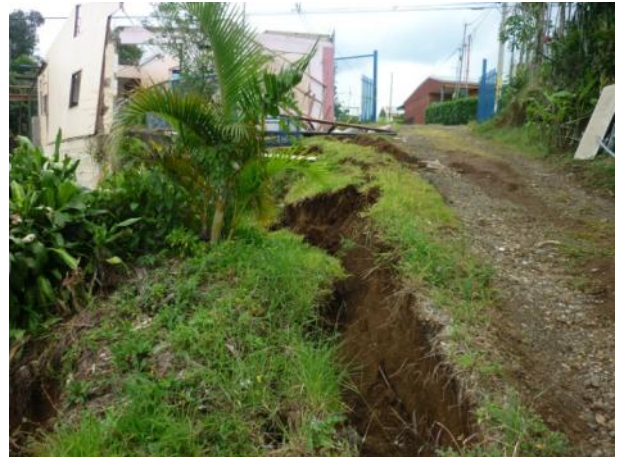
Fig. 15 Failure of unstable fill in Sarchi (Photograph by W. Vargas).

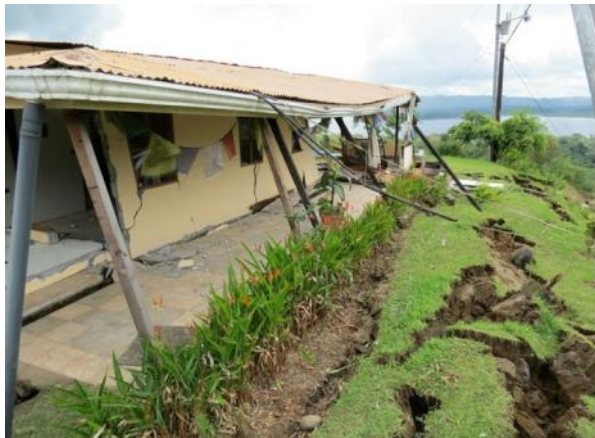
Fig. 16 Tension cracks and failure of a fill in La Fortuna (Source: La Nacion, online version).

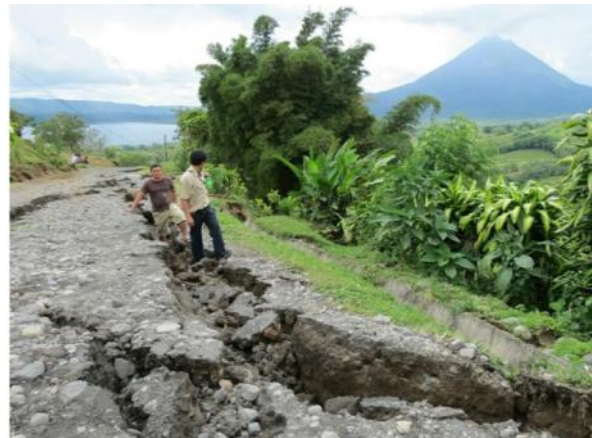
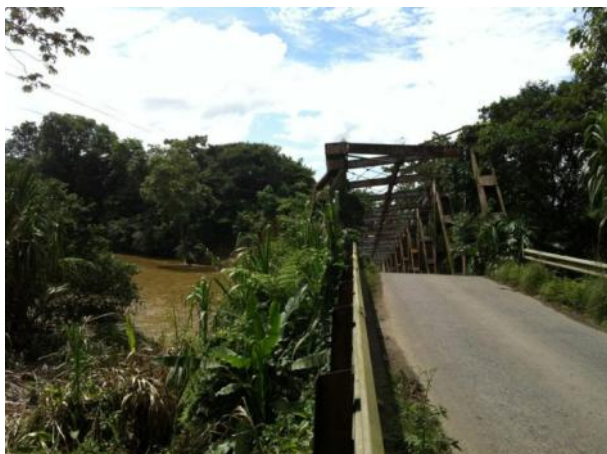
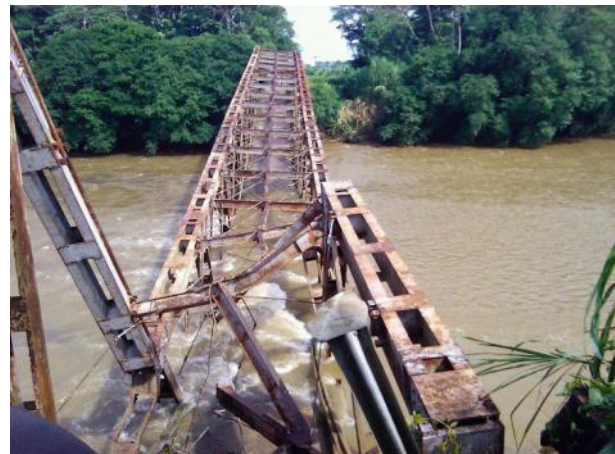
In the Caribbean alluvial plain, the most significant damage was the collapse of a railway bridge in the location of Sarapiquí (Fig. 17). The structure is a steel truss bridge which fell off its support by the excessive displacement, which can be associated with the low frequency content of the seismic waves.

Fig. 17 Collapse of a railway bridge over river Sarapiquí at Puerto Viejo (Source: La Nacion, online version).

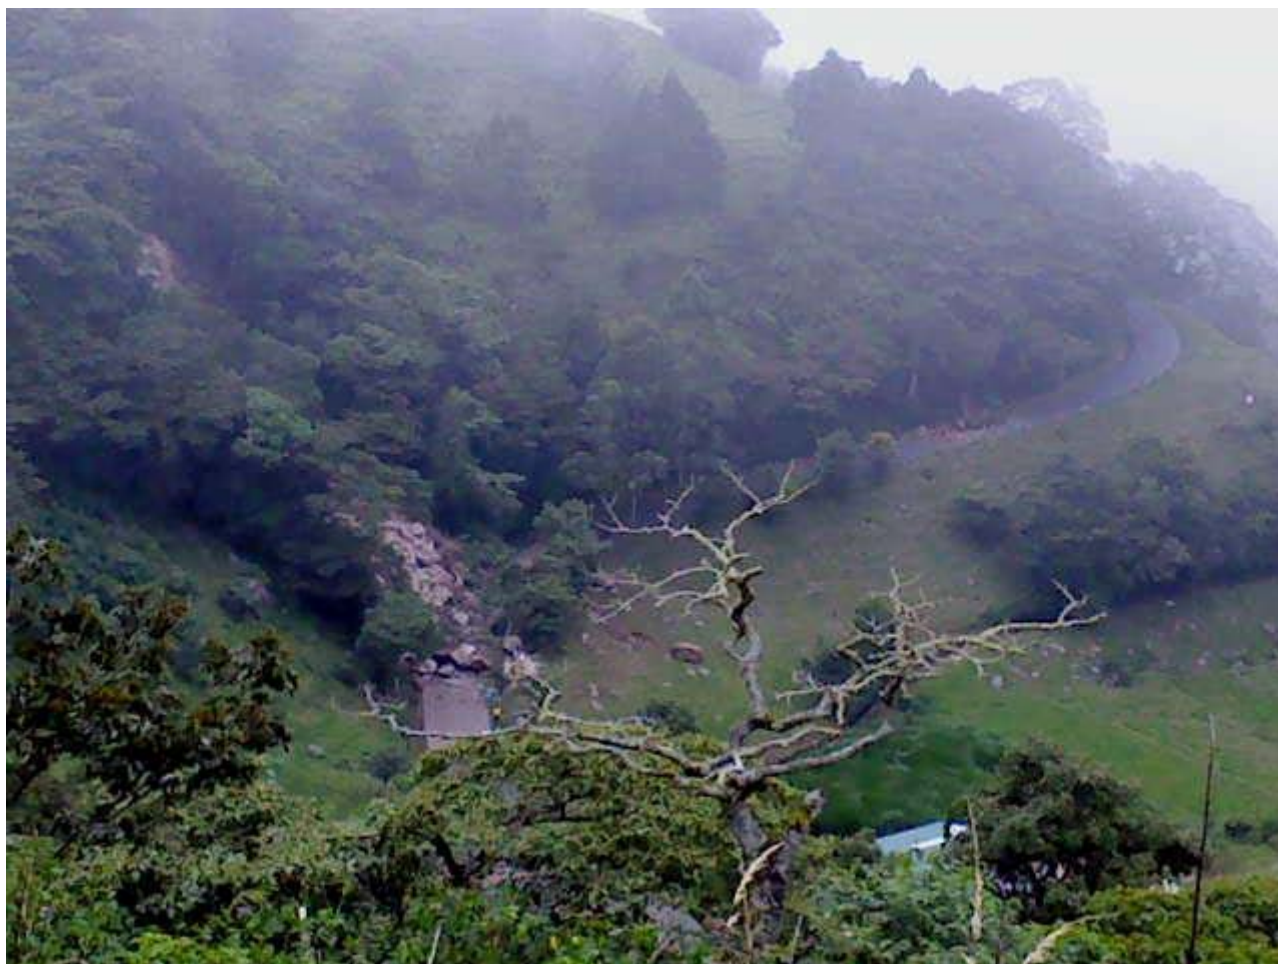
Perhaps the most costly damage caused by the earthquake to public infrastructure was the failure of a rock slope in the national route 141, shown in Figure 18, at 120 kilometers from the epicenter. The route is the main transportation way for agricultural products between the Caribbean plain and the center of the country, where San Jose is located. The Ministry of Public Works and Transportation worked for two weeks on removing the massive failure and repairing the damage while the traffic had to take other routes, causing an increment of at least 50 kilometers in the travel distance.

Fig. 18 Failure of a rock slope on route 141 (Source: La Nacion, online version).
