TECHNICAL ARTICLE

Ongoing Study on Protection of Personal Houses from Liquefaction Problems

Ikuko Towhata Professor, Department of Civil engineering, the University of Tokyo
Kazuo Konagai Professor, Institute of Industrial Science, the University of Tokyo
Takashi Kiyota Associate Professor, Institute of Industrial Science, the University of Tokyo

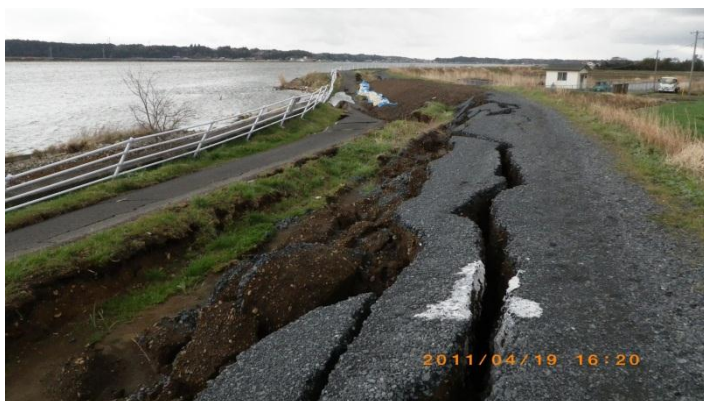
Photo 1. Liquefaction damage in Hinuma levee

During the earthquakes in 2010 and 2011, liquefaction affected such structures as river levees (Photo 1), embedded life lines (Photo 2), and personal houses (see the next chapter). Those structures are characterized by their limited budgets that are available for disaster mitigation. Levees and lifelines are too long for the overall reinforcement against subsoil liquefaction. Their construction cost per unit length does not allow the significant reinforcement either. Consequently, the disaster management philosophy in the past aimed to restore any seismic damage within a short period of time after a quake.

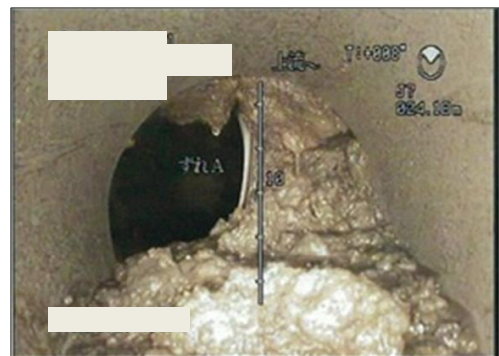
Photo 2. Disconnection of sewage pipeline and deposit of sand after liquefaction (damage study in Tokyo Bay area, 2011)

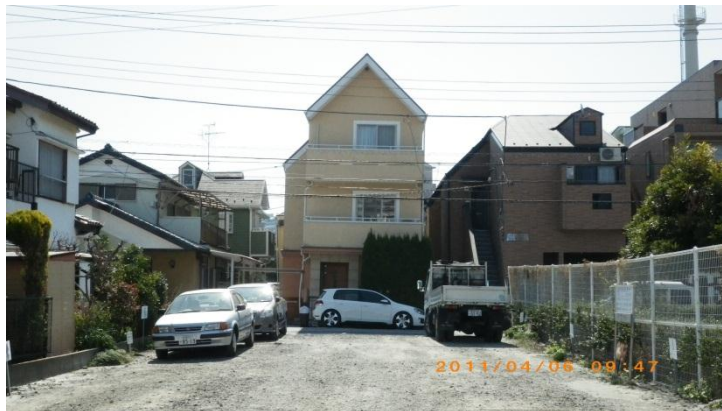
Photo 3. Tilting of house caused by liquefaction in a manmade island in the Tokyo Bay area

There are many manmade lands along the shore of Tokyo Bay. Because of the proximity to the Tokyo downtown and convenience in commuting, those lands have been developed as residential areas. In 2011, liquefaction severely affected houses in the lands (Photo 3). The house damage consists not of structural breakage but of significant subsidence and tilting. Subsidence causes inconvenience in life, poor drainage of rain water, and disconnection of lifelines. Tilting is more serious; tilting more than 1% is fatal in daily life; causing headache and dizziness.

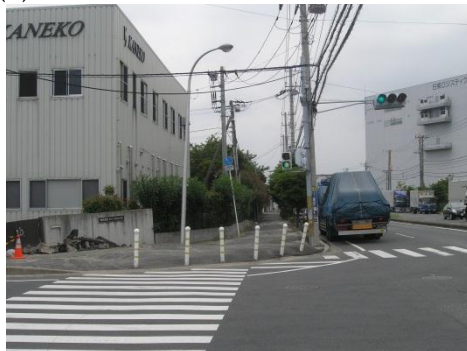
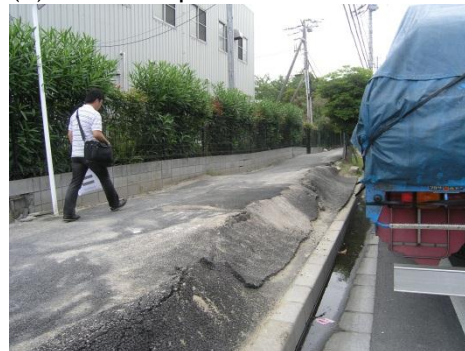
(a) Overall view

(b) Detail of uplifted sidewalk

Photo 5. Distortion of sidewalk probably caused by subsidence of building behind

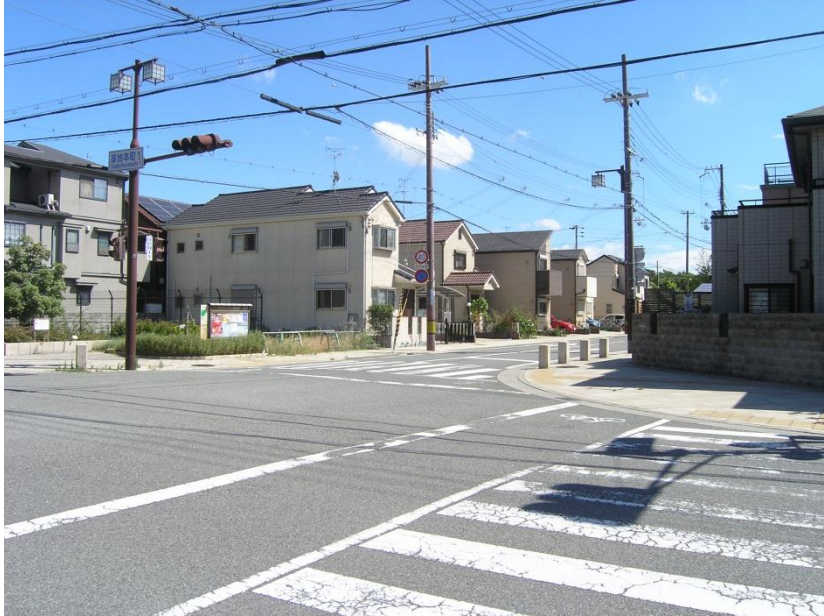
Photo 6 shows another example in which ground water level was lowered for mitigation of liquefaction. Most houses in this area were destroyed by subsoil liquefaction during the 1995 Kobe earthquake. Also, the ground level in this area had been lower than the surrounding sea level because of ground water pumping and consolidation of soft clay, and inundation had been a problem. To solve these two problems at the same time, all the damaged houses were demolished, drainage pipes were installed to lower the ground water level by 1.5 to 2 m, and new soil of 1.5 m in thickness was filled at the surface, thus creating an unliquefiable layer of 3 to 3.5 m in thickness. To date, the weight of the new fill has not caused a problem of consolidation settlement. Most probably, the pumping of ground water was prohibited in 1960s, the water level rose since then, the effective stress in the clayey subsoil decreased, the clay became over-consolidated, and hence the settlement has been kept small even after the placement of the new fill at the surface. In contrast, the soft clay in the Tokyo Bay area is normally consolidated and a care must be taken of significant settlement in case of pumping ground water.

Photo 6. Tsukiji area of Amagasaki City where ground water level was lowered
