### The Pinnacle Tower – Geotechnical Challenges

Dinesh Patel, Sarah Glover, Jonathan Chew, Jenny Austin  
Ove Arup and Partners, London, United Kingdom

The Pinnacle Tower is one of a cluster of towers being constructed in the heart of the City of London. When complete it will be 62 Storeys high - taller than any other building in the UK. The design and construction of the tallest building in the UK, on a central London site occupied by 3 existing buildings presented special challenges. The approach the design and construction team took to these challenges earned them the best geotechnical project over £1M at the recent GE awards.

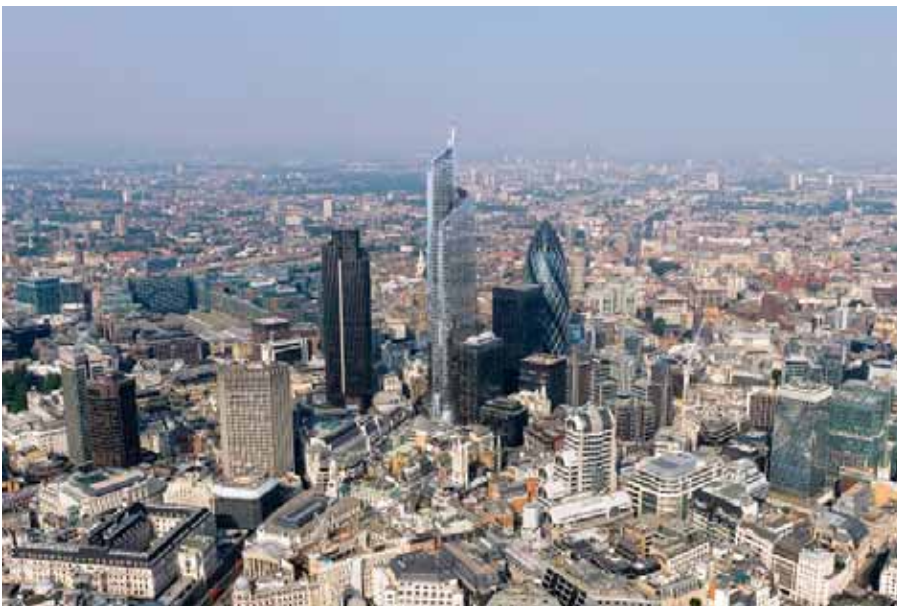
Figure 1: The Pinnacle Tower (copyright KPF web site)

The new building is to be 62 storeys with a 3 level basement (Figure 1) occupying a retail and commercial office space of about 1.4M sq ft. Demolition of the previous 10 storey buildings to ground level started in mid 2007. Pile construction started in July 2008 from the ground level slab, over an existing three level basement which occupied much of the site. Piling is now complete, demolition and basement excavation continues as with pile cap construction progresses. The new substructure and superstructure is planned for completion in 2012.

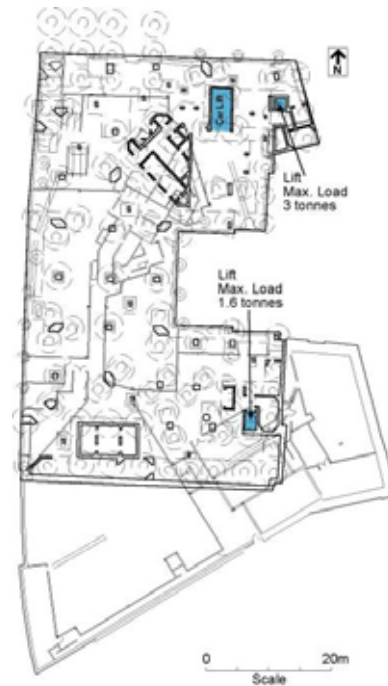
Figure 4: Anticipated layout of underream piles based on original plans

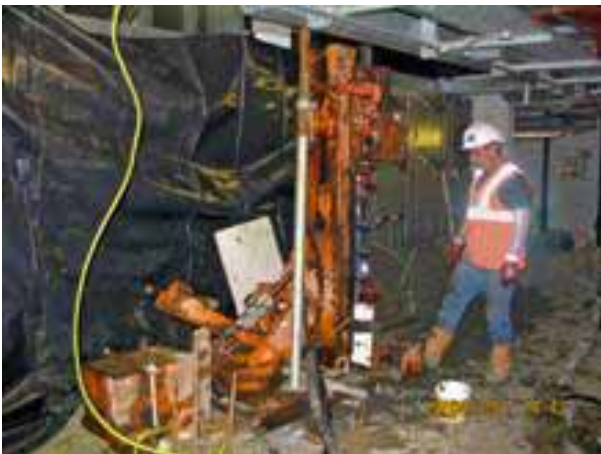
Figure 5: Probing and coring of existing UR piles

Without the as-built sizes of the shafts and under-ream bases the cost and time associated with concrete coring during piling works was still considered a major risk and would have a severe impact on the overall piling programme. To minimise this risk, early in the design process, a probing and coring exercise was carried out to investigate the location, depth and size of the underream bases and the strength of the concrete. This used low headroom Fondedile (now Keller Geotechnique) piling rig, operating within the basement and while the building was still occupied (Figure 5). An investigation of the RC perimeter walls, including old diaphragm walls, was also made. Concrete cores and strength tests allowed the temporary works contractor to design his propping scheme for the existing basement demolition and the piling contractor to determine the most appropriate coring equipment/piling rig.

This information allowed the designers to mitigate the piling risk at an early stage of the design, by minimising the number of new piles that would encounter the existing piles. The pile removal costs and programme implications could then be more accurately assessed before tendering the main contract. This was extremely important as the piling was to be carried out from ground slab level through three floors of existing basement. Therefore adjusting new pile locations once piling works has started was not an option and would have been prohibitively expensive, time consuming and disruptive.

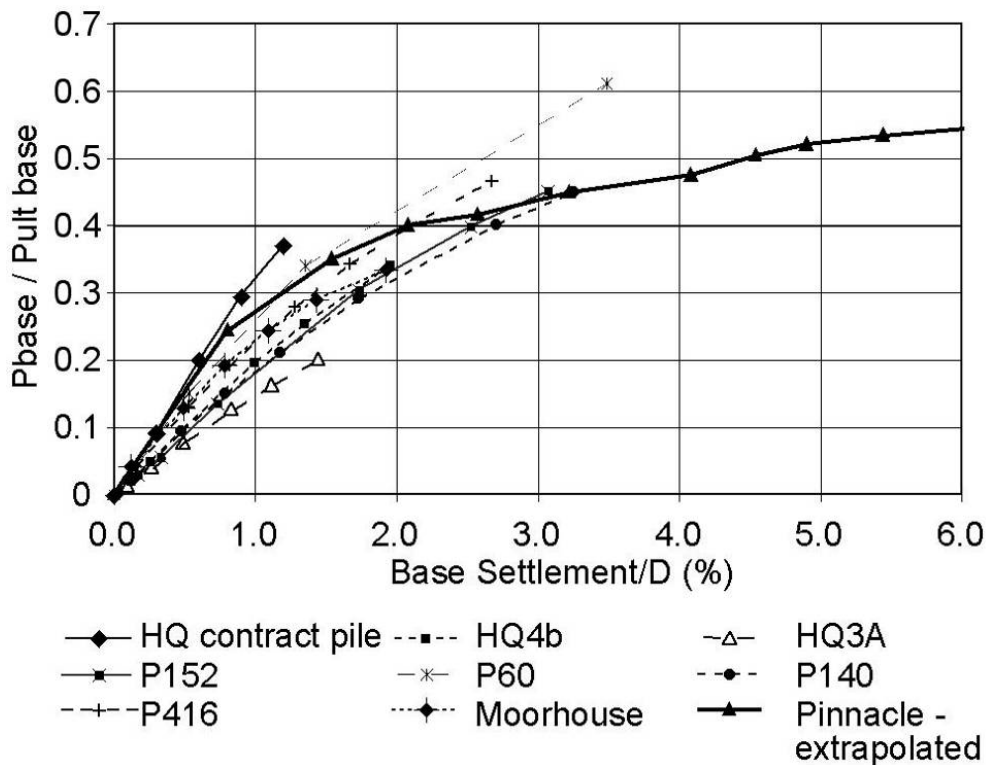
Definitions:

$P_{base}$  - load applied on base ;  $P_{ult base}$  - ultimate base capacity ( $Q_b$ ) ;  $D$  - Base diameter

Figure 14: Normalised base load and settlement plot

The load-settlement curves of preliminary pile tests at Canary Wharf, The Pinnacle and Moorhouse were studied and a normalised base load against normalised settlement plot produced, as shown in Figure 14. These represent load tests conducted on pile sizes from 0.9 to 1.5m diameter. The applied load on the base can be calculated from the working load (WL) and the ultimate base capacity from  $Q_b = N_q^* \cdot \sigma'_m \cdot A_b$ .

The total pile settlement can then be deduced, using Figure 14 to estimate the base settlement and adding this to the calculated elastic shortening of the pile concrete. This approach was used to calculate the individual settlement of the base grouted piles for The Pinnacle at the end of the construction phase. Numerical techniques were used to calculate the long term settlements of the building, due to changes in pore pressures in the London Clay caused by unloading and reloading of the site, and pile group effects.
