# **Case Histories of Failures in Geotechnical Engineering Practice**

**Richard Hwang**

# Case 1 – Human Error (Negligence)

# Case 3 - Unforeseen Condition

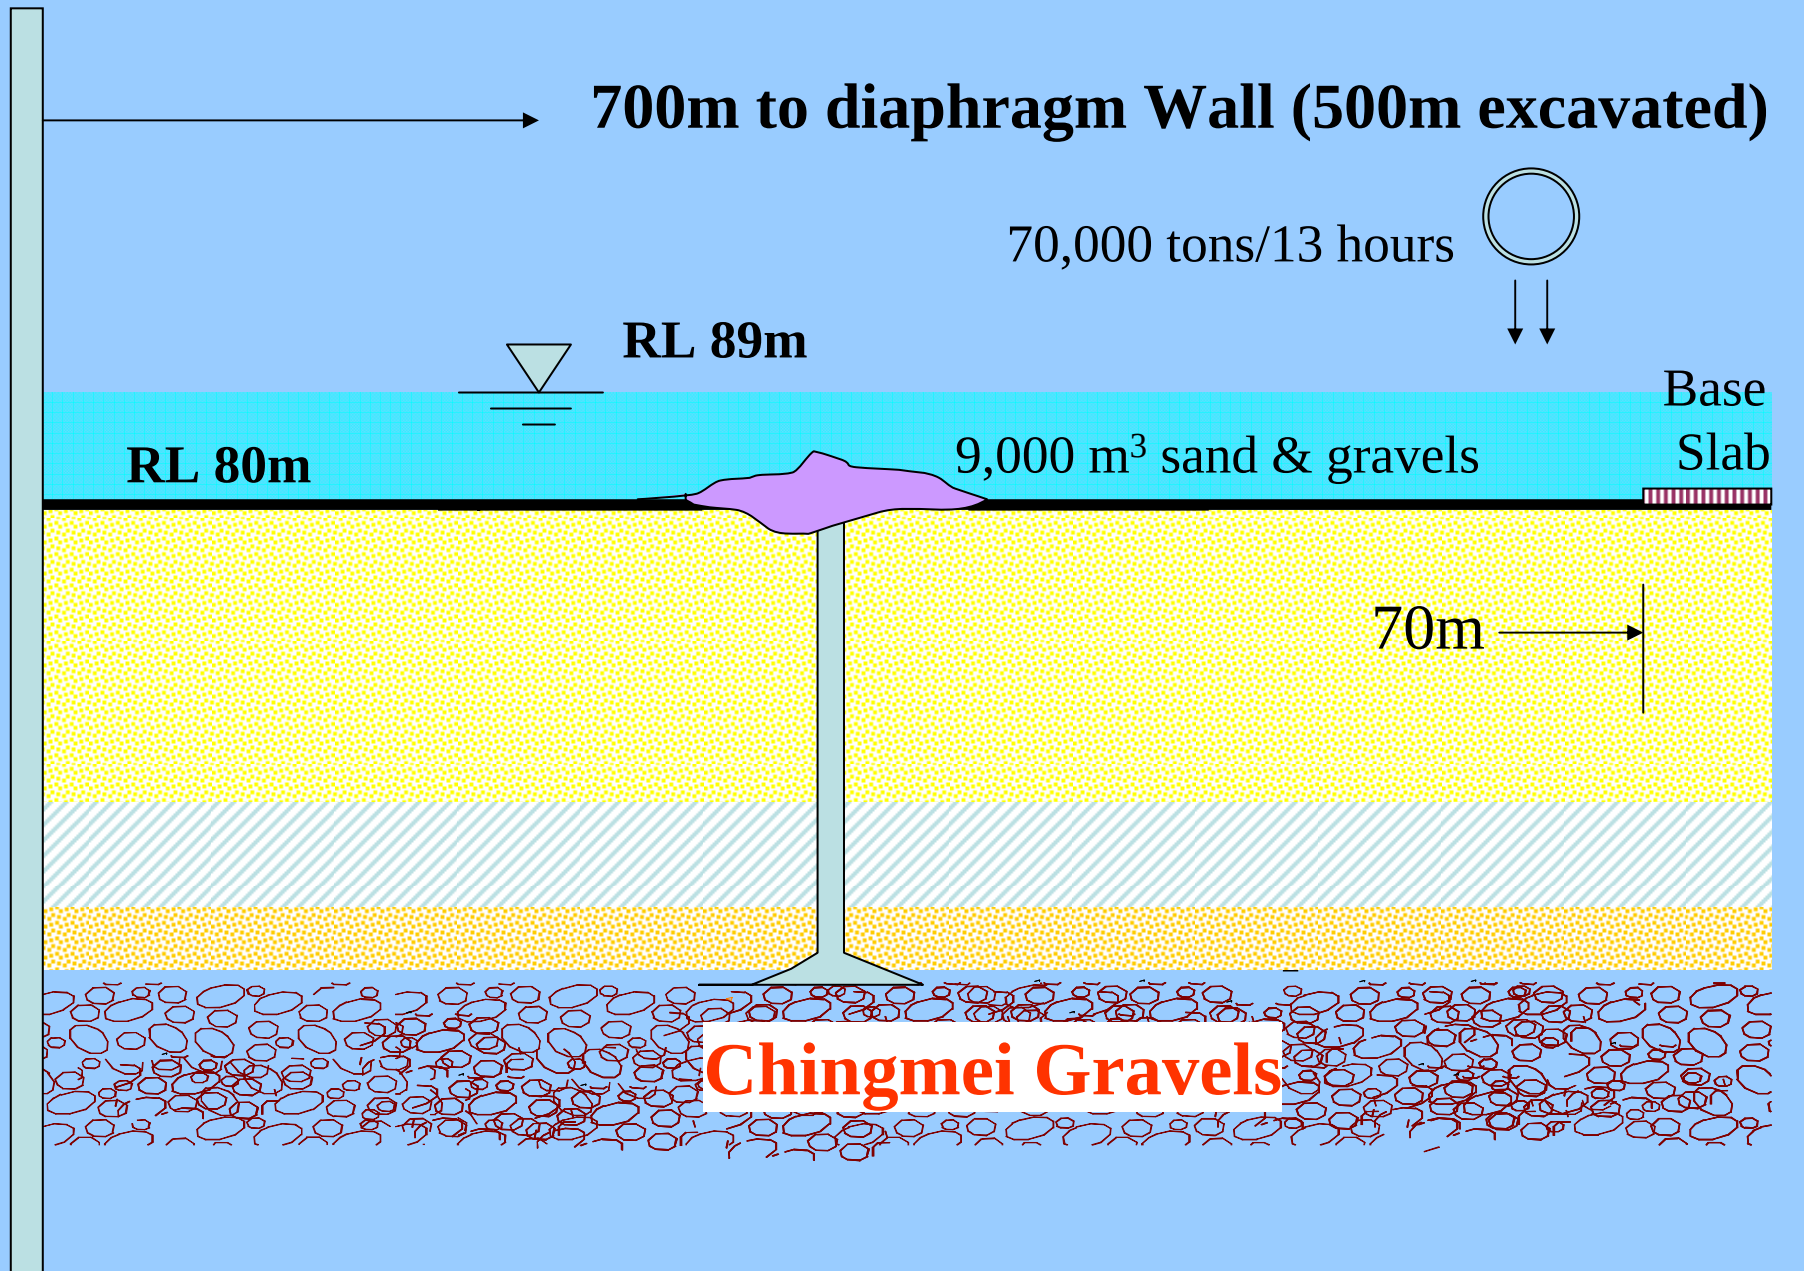
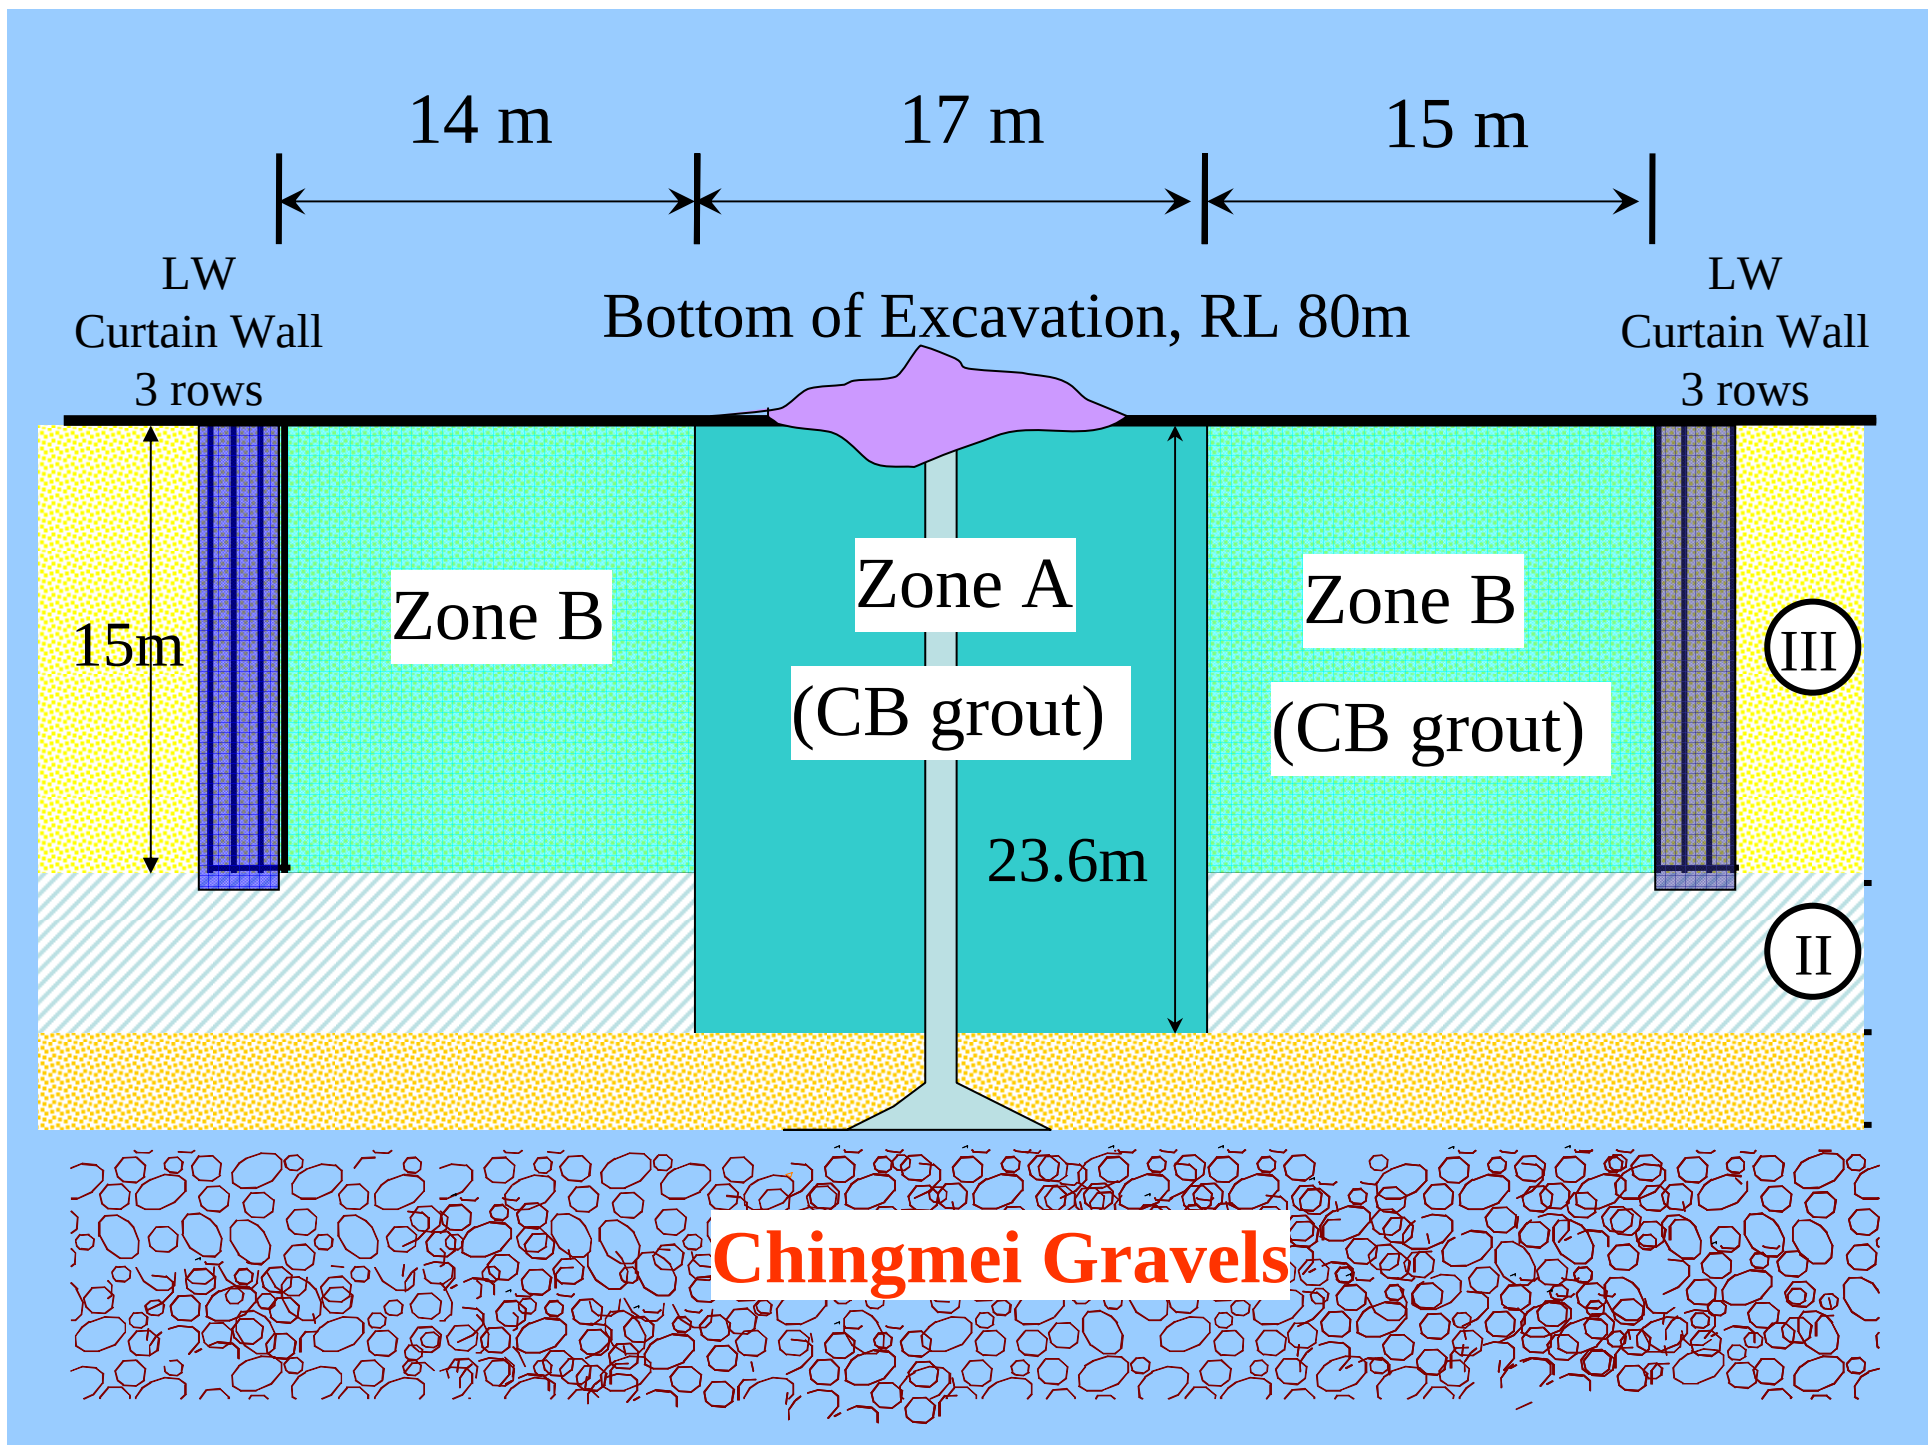
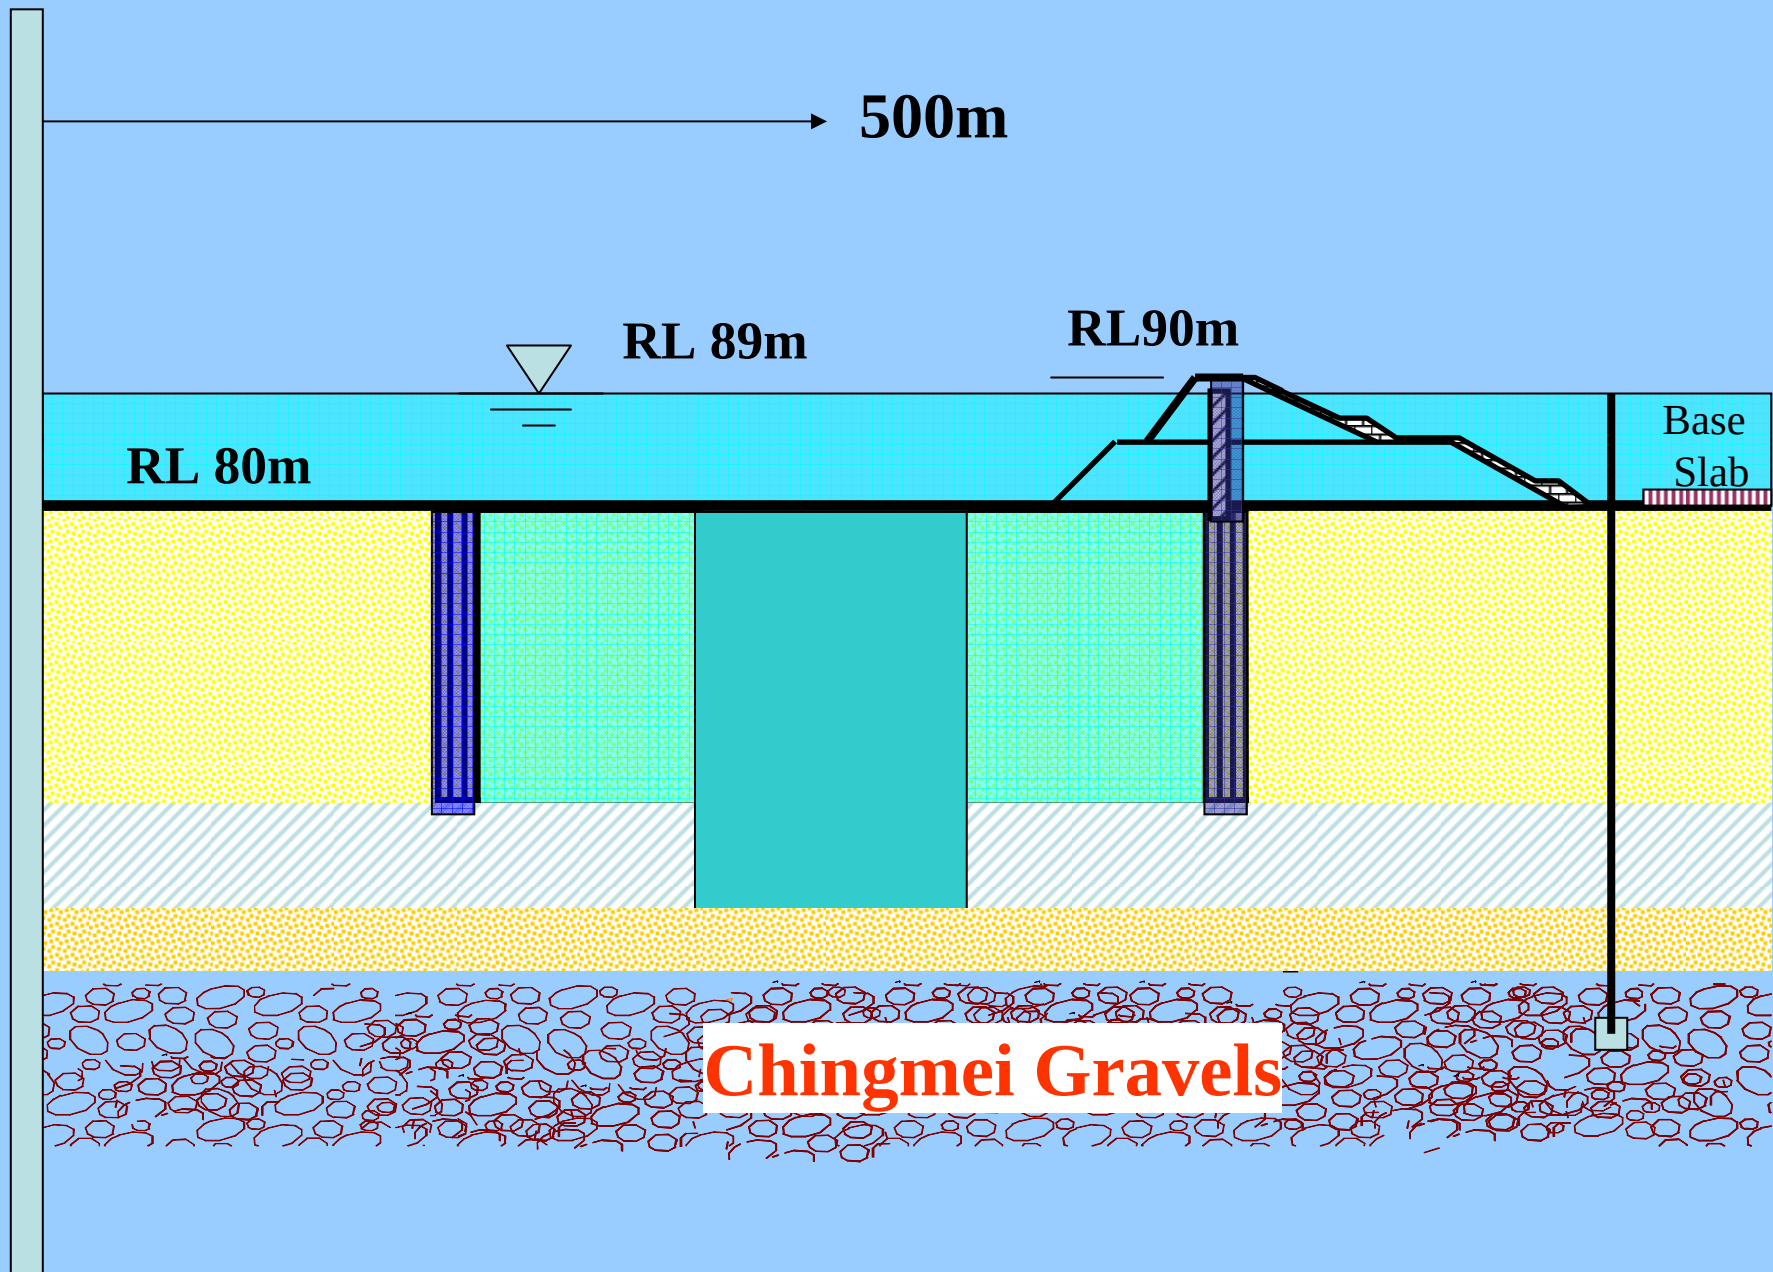
**Scenario of the Incident**

700m to diaphragm Wall (500m excavated)

70,000 tons/13 hours

RL 89m

RL 80m

9,000 m<sup>3</sup> sand & gravels

Base  
Slab

70m

Chingmei Gravels

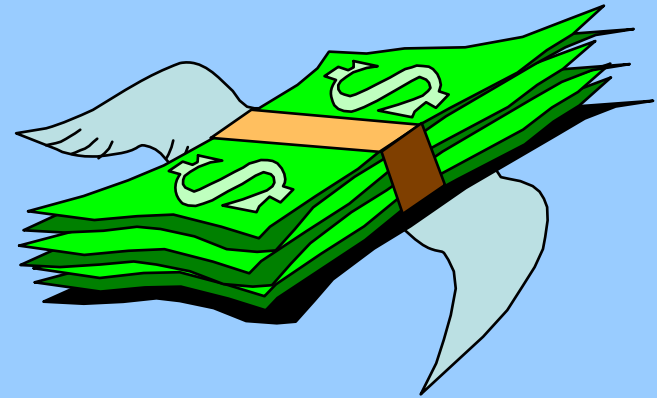
# A Small Hole?

- 70,000 tonnes of water recharged
- 9,000 m<sup>3</sup> of sands and gravels dumped
- 5,400 m<sup>3</sup> of grout injected

A\$4,000,000
