Case Study of a Partially Collapsed RS Wall at a Building Site

EG Balakrishnan¹, Allan Y. L. Chwee² and A. Mohd Redzuan³

¹ Managing Director, GCU Consultants Sdn Bhd, Malaysia

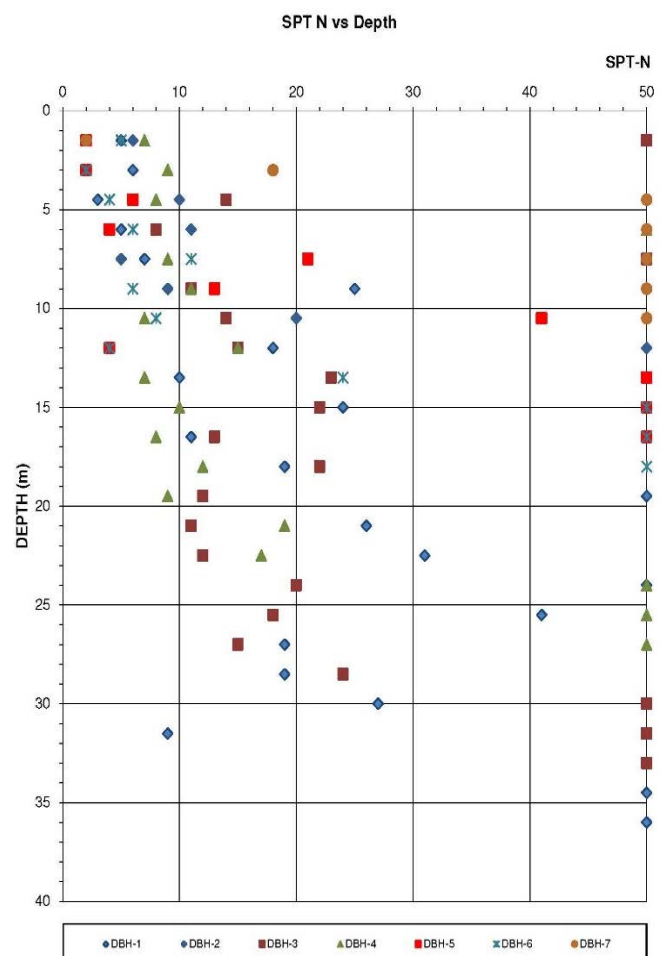
Figure 5 SPT-N versus Depth plot

Based on the soil investigation and laboratory testing results, the subsoil profile is identified to be 3 distinct layers. The first layer consist of fill material with thickness varies between 1m and 25m. This layer consists of a mixture of soft to stiff sandy SILT and loose to dense silty SAND with high content of granular materials. The next layer consists of residual soil of medium stiff to hard sandy SILT with SPT-N value less than 50 blows. The thickness varies from 4 m to 12 m. The final layer consists of hard layer with SPT-N more than 50 blows and generally made up of hard sandy SILT. The SPT-N versus depth plot is shown in Figure 5. The properties of these layers are summarized in Table 1.

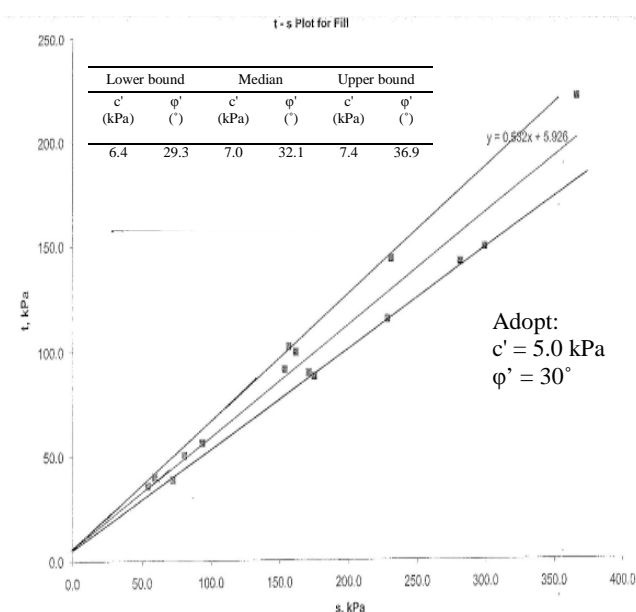
Figure 6a t-s Plot for fill

The typical t-s plots for the fill material and the residual weathered formation to obtain the effective strength parameters are shown in Figure 6a and 6b.

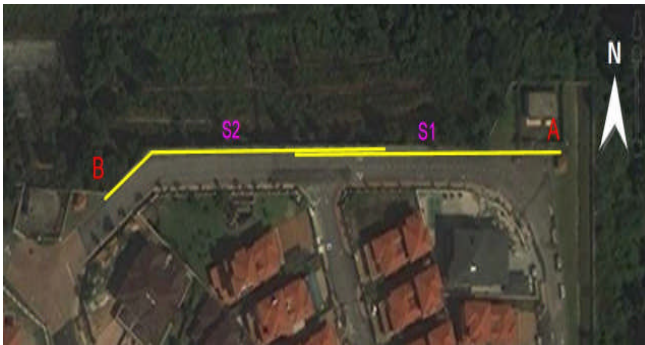
Figure 8 Location of seismic profiles

Seismic refraction survey was carried out along the wall line as shown in Figure 8 and the results in shown in Figure 9. The seismic refraction survey indicates two distinct layers based on the contrast of the velocities. The upper layer is characterized by low p-wave velocity representing the fill materials of sandy SILT or silty SAND. Underlying this fill layer is the highly weathered meta-sedimentary profile with higher p-wave velocity. These results conform closely to the findings of the boreholes.

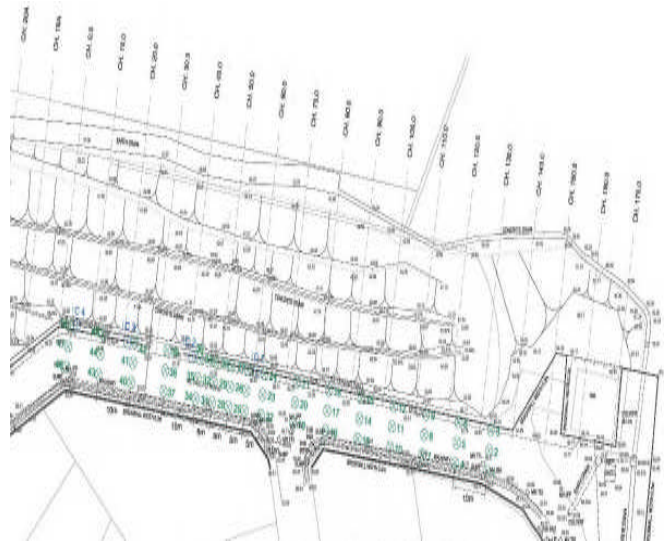
Figure 17 Instrumentation Layout

Instrumentation were installed during the remedial works to monitor the performance of the slopes stabilization measures during and upon completion of construction works. The instrumentation plan is shown in Figure 17.

The instrumentation readings showed that the constructed remedial works have performed as expected and all the readings are well within the acceptable limits. Typical results of the instrumentation readings are shown in Figure 18a and 18b.
