# Forensic Investigation of A Subway Tunnel Construction Failure

**ABSTRACT:** In this paper, the forensic evidences and investigation of a subway tunnel construction failure occurred in Kaohsiung, Taiwan are presented. The studied construction failure occurred during a cross passage excavation of a shield tunnel construction work of the Kaohsiung Mass Rapid Transit System, and resulted in severe tunnel collapse and extensive ground failure that even reached to ground surface 30m above the tunnel depth. Valuable photo images obtained during and post event, as well as results of special geophysical testing methods were presented and compared to verify proposed failure scenario. Information presented in this paper is hoped to be helpful to improve engineers' knowledge for preventing similar construction risks.

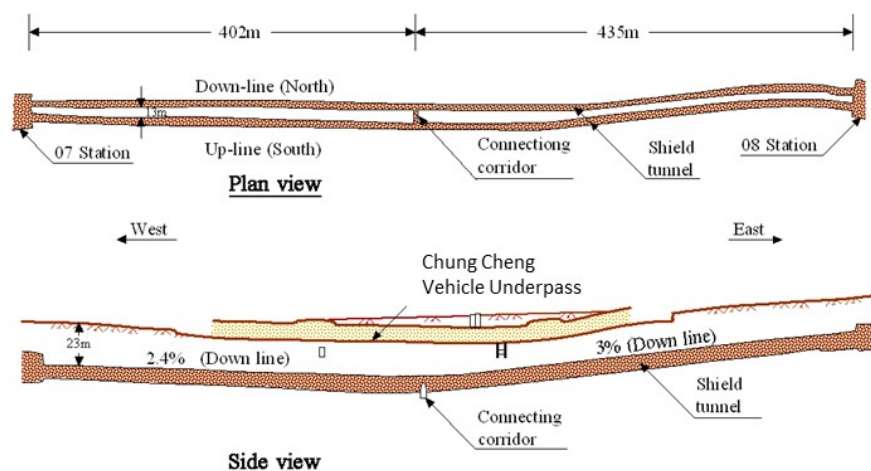
Figure 1 Plan and side views of the studied tunnel site (Ishihara and Lee, 2008)

The plan and side view of the tunnel are shown in Figure 1. It is to be noted that there was a vehicle underpass just above the two subway tunnels. The twin tunnels were constructed by the shield tunnel boring machines (STBM) which can advance by rotating a large steel disk equipped with cutting blades, while the main body of the boring machine is protected inside the shield. Figure 2 shows the plan view of the failure site. The soil profiles at the locations BO29 and BO30 shown in Figure 2 are indicated in Figure 3, where it can be seen that the deposits comprise predominantly of silty sand with occasional layers of low-plasticity clay (CL) to a depth of 40m. The SPT blow count values, as shown, increase with depth and have values of 20 to 30 at the depth where the sump of cross passage for water collection was constructed (Ishihara and Lee, 2008b).

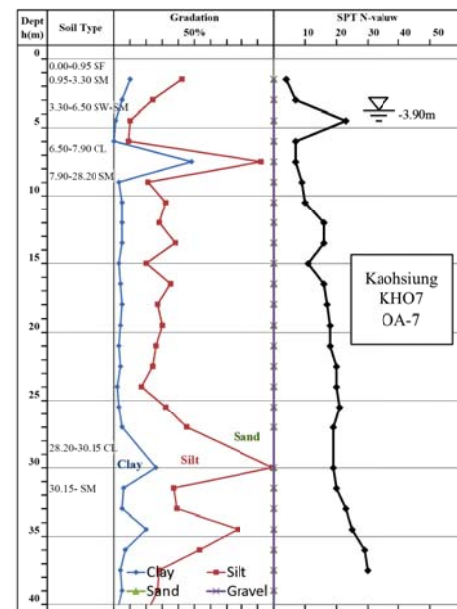
Figure 4 Typical soil profile with gradation data at the site after collapse

Figure 4 also shows a typical soil profile of the studied site after failure with gradation characteristics. As shown in the figure, silty sand deposit at the studied site contains 20% to 35% fines with no plasticity. This silty sand deposit was later studied and confirmed as very sensitive to internal erosion and disturbance (Chen 2012). Ground water table of the studied site is closed to 2~3m below the ground surface. The hydrostatic pressure at the depth where construction failure occurred is over 2.7 kg/cm<sup>2</sup>. Prior to the crosspassage excavation work, soil surrounding the excavation area where the failed crosspassage was located had been stabilized by means of the jet grouting for the purposes of both strengthening the soil and providing water tightness.

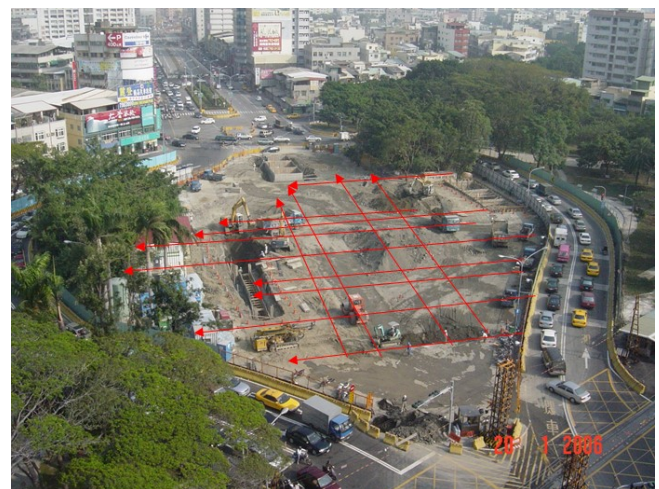
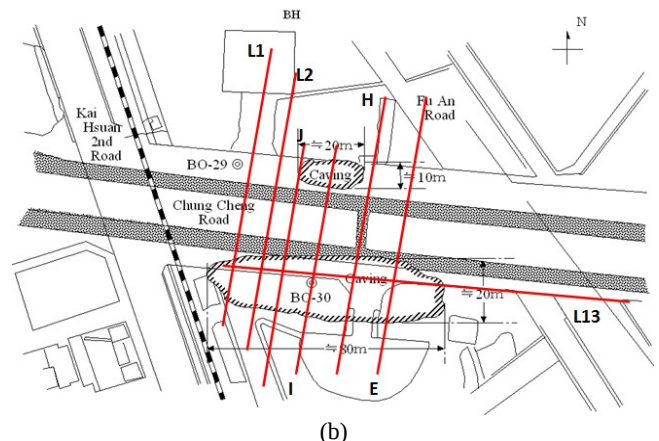
Figure 21 Layout of 2D RIP tests

RIP surveys were conducted. Optimization of sensor layouts and calibrations of the analytical models were the most challenging issues of this forensic RIP testing (Lee and Ishihara, 2008a). Figure 21(a) shows the layout of the 2D RIP testing. As depicted in the figure, total four longitudinal (east-west direction) and nine transverse (north-south direction) survey lines were conducted in an attempt to cover the damaged area. Moreover, Figure 22 shows the top view and the cross section schematic drawings of the 3D RIP testing. Total six boreholes were drilled to a depth of 40m. This 3D RIP survey was in an effort to assess the damage condition of the cross passage and the up-track shield tunnel.
