# Study of Slope Failure and Reinforcement Analysis to Restore and Increase the Slope Stability in Flores, East Nusa Tenggara Using Plaxis 2D and 3D

Rendra Priatno<sup>1</sup>, Ali Iskandar<sup>2</sup>, and Jo Lian Huat<sup>3</sup>.

<sup>1</sup>Geotechnic Engineer, PT. Tarumanegara Bumiayasa, Jakarta, Indonesia.

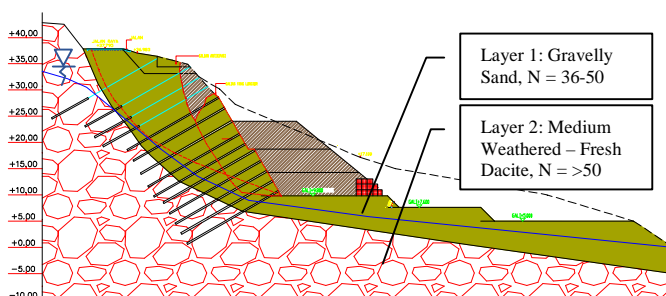
Figure 6: Slope profile and cross section.

The back analysis in Plaxis programs is done in various phases. The phases are the construction stage that will be done in the field if the analysis results have been qualified. The slope geometry is based on post-slope failure cross section.

The Slope stability improvement analysis shall meet the requirement for the safety factor condition with a factor value of 1.5.
