Case Study of Renovation on Alishan Route 18 after Typhoon Morakot

Kung-Tai Chou¹, Wen-Long Wu², Chiao-An Hsiao³, Kun-Hsien Chou⁴
CECI Engineering Consultants, Inc., Taiwan

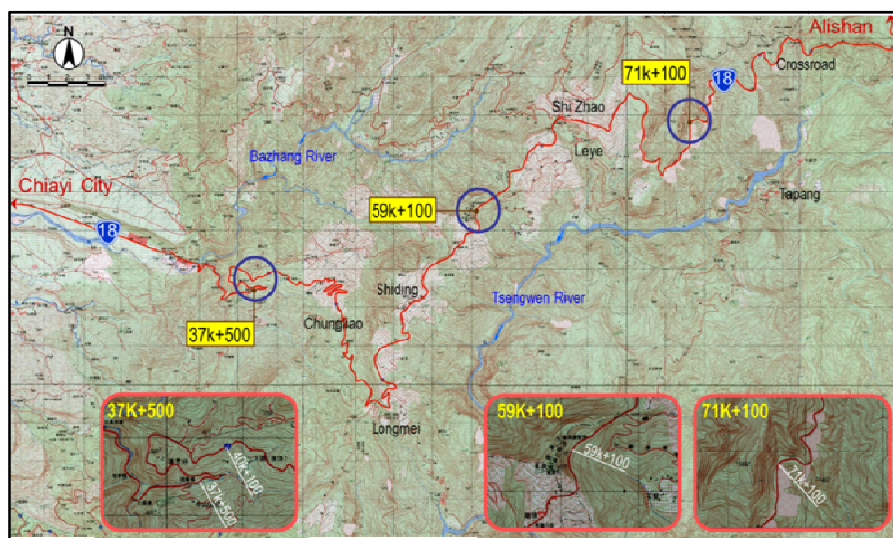
Figure 2 Renovation site of mileage 37.5k, 59.1k, and 71.1k on Alishan Route 18

Typhoon Morakot had damaged more than 40 locations along Alishan route 18, including slope slides and road erosions. Mileages 37.5k~40.1k, 59.1k, and 71.1k are the three most disastrous sites. The main disaster types are upper and lower slope slides, and deep seated landslides. Figure 3~5 show aerial and site figures after Typhoon Morakot. After disaster, temporary road was constructed at the above road sections to maintain accessing. However, due to the unstable roadbed, the temporary road may be unable to withstand the erosion of heavy rainfall in the typhoon seasons.
