FIELD MONITORING OF SUBSIDENCE EFFECTS IN AIT CAMPUS, BANGKOK, THAILAND
D.T. Bergado, A.S. Balasubramaniam and W. Apaipong
Asian Institute of Technology,
Bangkok, Thailand.

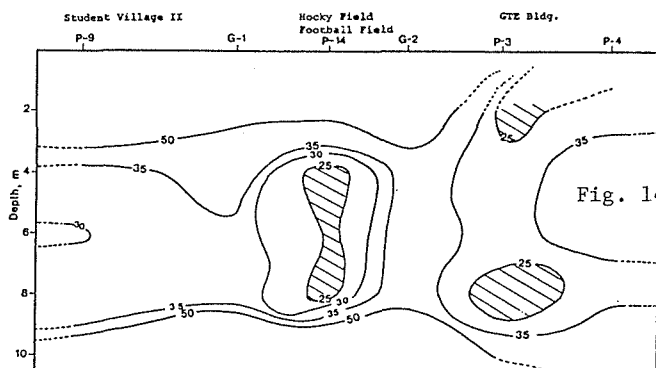
Fig. 14 Profile of Pressuremeter Modulus, E_m in the section A1-E5, AIT Campus (Line P1)

the Academic Buildings. Line D pass through the NZ Housing Area through the Registry Office in the Administration Building to the Academic Buildings. All of these areas have evidences of large subsidence either structural failure or ground depressions. The existence of weaker layers in the soft clay are also confirmed from the results of the pressuremeter tests. The areas where evidences of subsidence occur coincide with the presence of thick, compressible layers with pressuremeter modulus, E_m , below 25 kg/cm^2 . Figure 14 shows the profile of E_m values on line P1 indicated in Fig. 1. The damages are listed in Table 2.

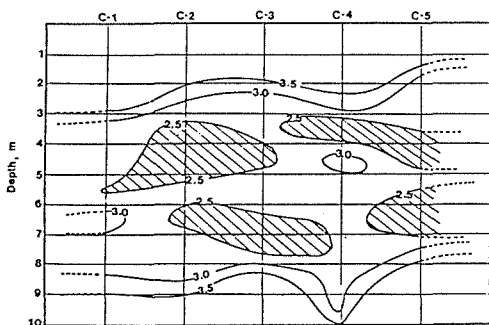
Fig. 15 Profile of Undrained Shear Strength along Section C1-C5 from Field Vane Shear Tests (Line C)

Based on the subsoil vane shear strength profiles (Fig. 12 and Fig. 13) on line C and Line D as indicated in Fig. 1, the areas of large subsidence coincide with weaker subsoil. The vane shear strength profiles are more variable and the presence of a weaker layer pockets (shear strength ≤ 2.5 t/m²) within the soft clay layer is more pronounced (Fig. 15). Line C extends from the NZ Housing Area through the Football and Hockey Fields to

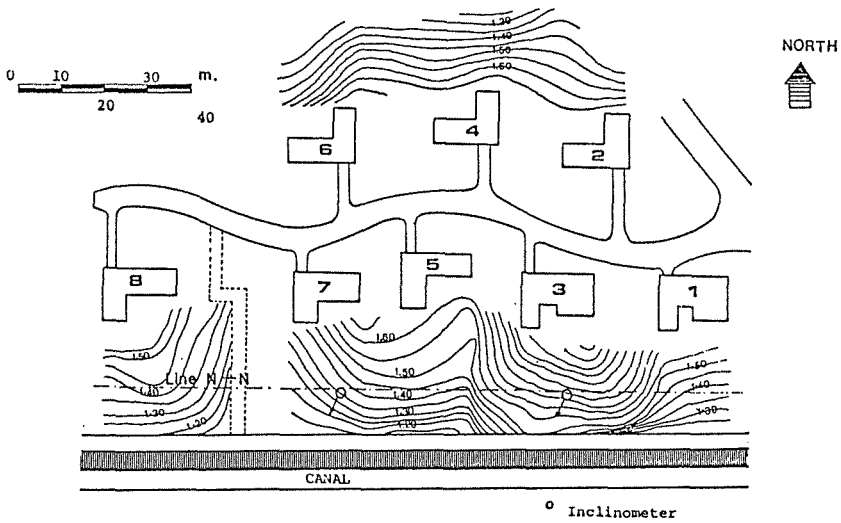
Fig. 16 Contour Elevation at New Zealand Housing, AIT Campus

The subsidence in the NZ Housing Area as discussed previously may be caused mainly by slow lateral movements of the ground towards the adjacent canal. In three months period, the horizontal ground movements measured from inclinometers in the vicinity of House No. 3 and No. 7 were 1.13 cm and 0.55 cm, respectively, with locations and resultant directions indicated in Fig. 16. Soil profile through line N-N (Fig. 17) shows weaker layer with undrained vane shear strengths $< 2.5 \text{ t/m}^2$ in the soft clay at depths of 3 to 4 m. As shown in Fig. 18, the loss of lateral support as a result of the canal excavation may caused the slow lateral creep of the ground due to either the relative displacement of the upper weathered crust over the weaker subsoil or the slow squeezing of the weaker layer underneath the weathered crust.
