# Case Studies on Dam Safety

Dr Gamini Adikari  
Principal Engineer Dams  
SMEC Australia

# Case Studies on Dam Safety Monitoring

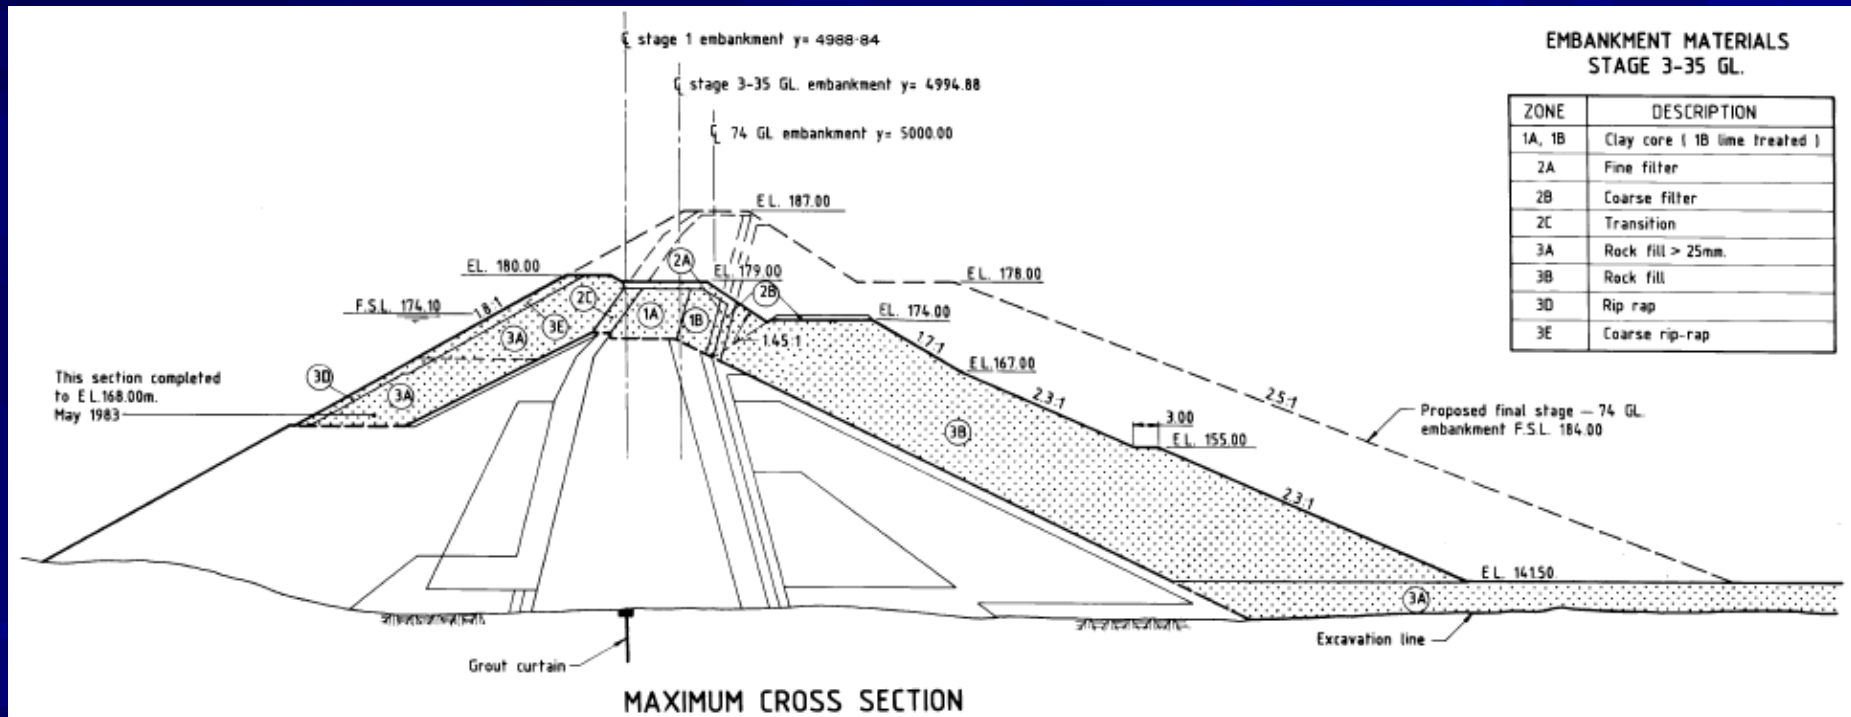
# Merrimu Dam Cross Section

- Compacted Stage 3 rockfill placed over dumped upstream Stage 1 rockfill
- Substantial crest settlement of up to 250mm over the 10 year drought cycle from 1997 to 2007
- Longitudinal cracking observed in 2004, coinciding with core/upstream filter interface
- Differential settlement on the upstream side of crack

- Increase in effective weight in the upper portion of upstream rockfill zone due to drawdown of water during drought compressing the dumped rockfill in the lower portion
- Upper portion of rockfill settling as a block along the core/filter interface causing cracking and differential movement at the crest of the dam

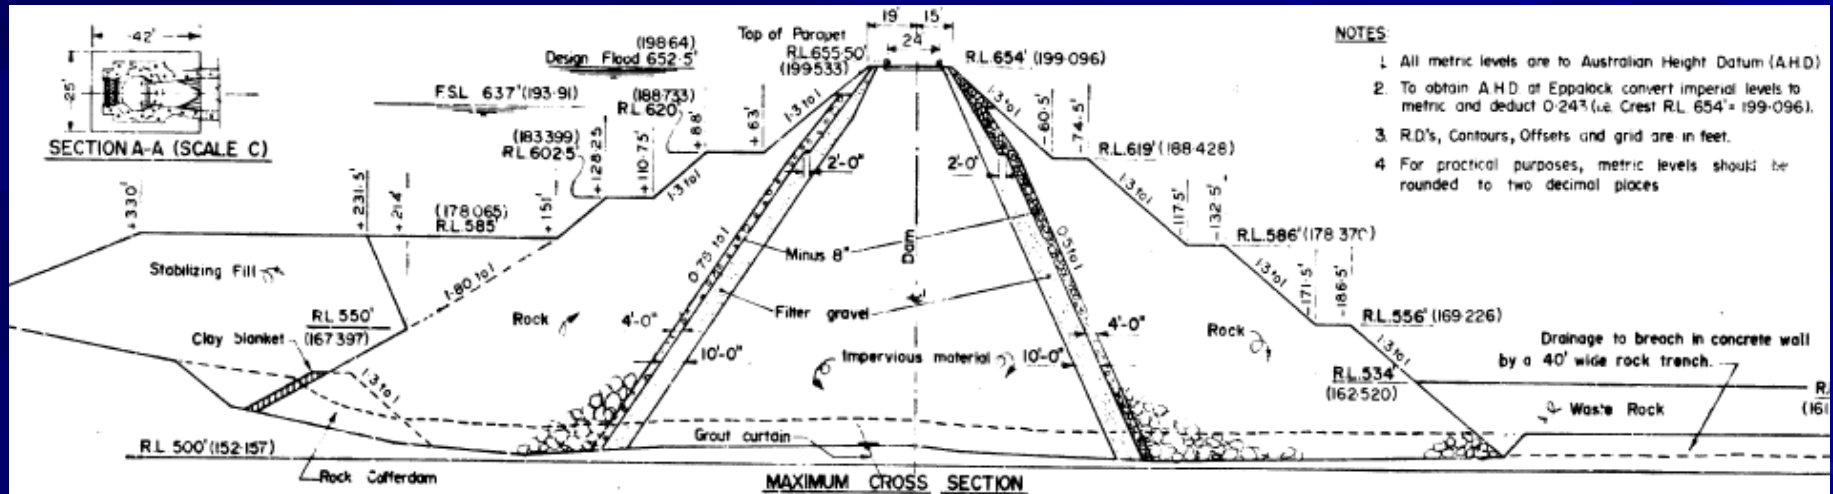
# Eppalock Dam Cross Section

- 47m high central core dam with dumped rockfill zones
- Largest historical drawdown occurred during the 1997-2006 drought cycle
- Reservoir volume down to 1% with no water load acting on the dam
- Crest settlements of up to 400mm were recorded during this cycle
- Substantial longitudinal cracks opened at crest

- Long term consolidation, creep and outward deformation of the dumped rockfill shells exerting downward drag on the clay core, inducing tensile cracks at the crest
- Water ingress to cracks causing instability, softening of core and slope movement
- Increased effective stress during drawdown causing further settlement of rockfill, accelerating settlement and cracking of the core
- Drawdown continued even after 1999 remedial works causing further crest settlement and cracking

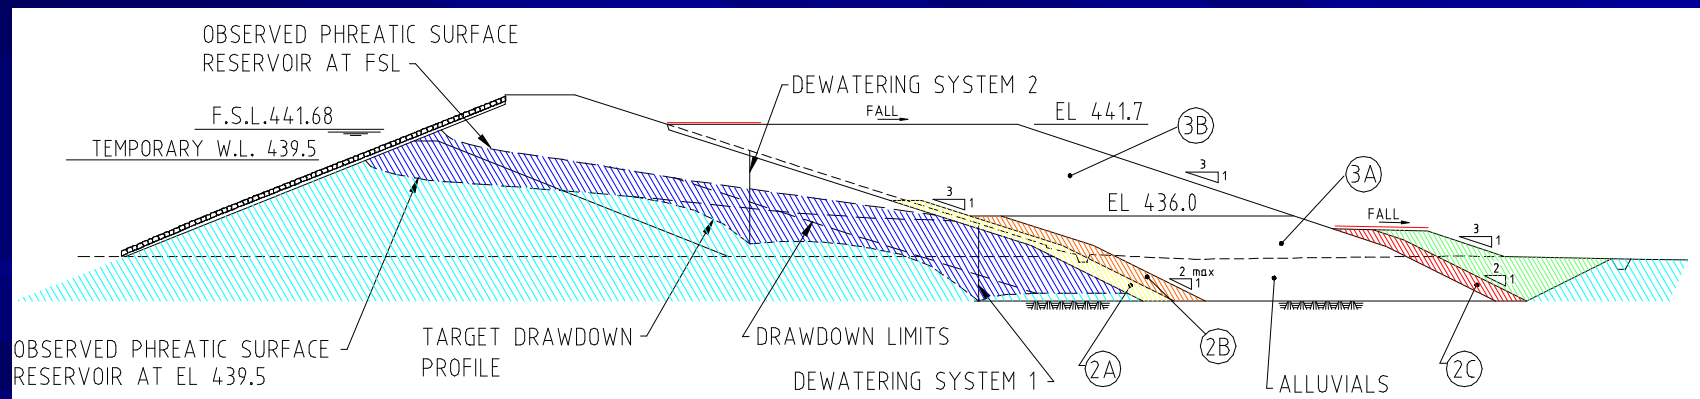
# Wartook Dam Upgrade

- 120 year old embankment predominantly constructed of fine silty sand
- Seismic stability and liquefaction issues
- Work behind a live storage supplying a major regional city posed challenges
- New outlet works required for ensuring further 100 years of service life

- stabilising rockfill, Zones 3A & 3B
- filters to prevent piping due to seepage & liquefaction
- total cost \$ 5M compared to full rehabilitation option with upstream and downstream stabilising shells at \$15M and new dam downstream at \$25M
