NICOLL HIGHWAY COLLAPSE

Introduction

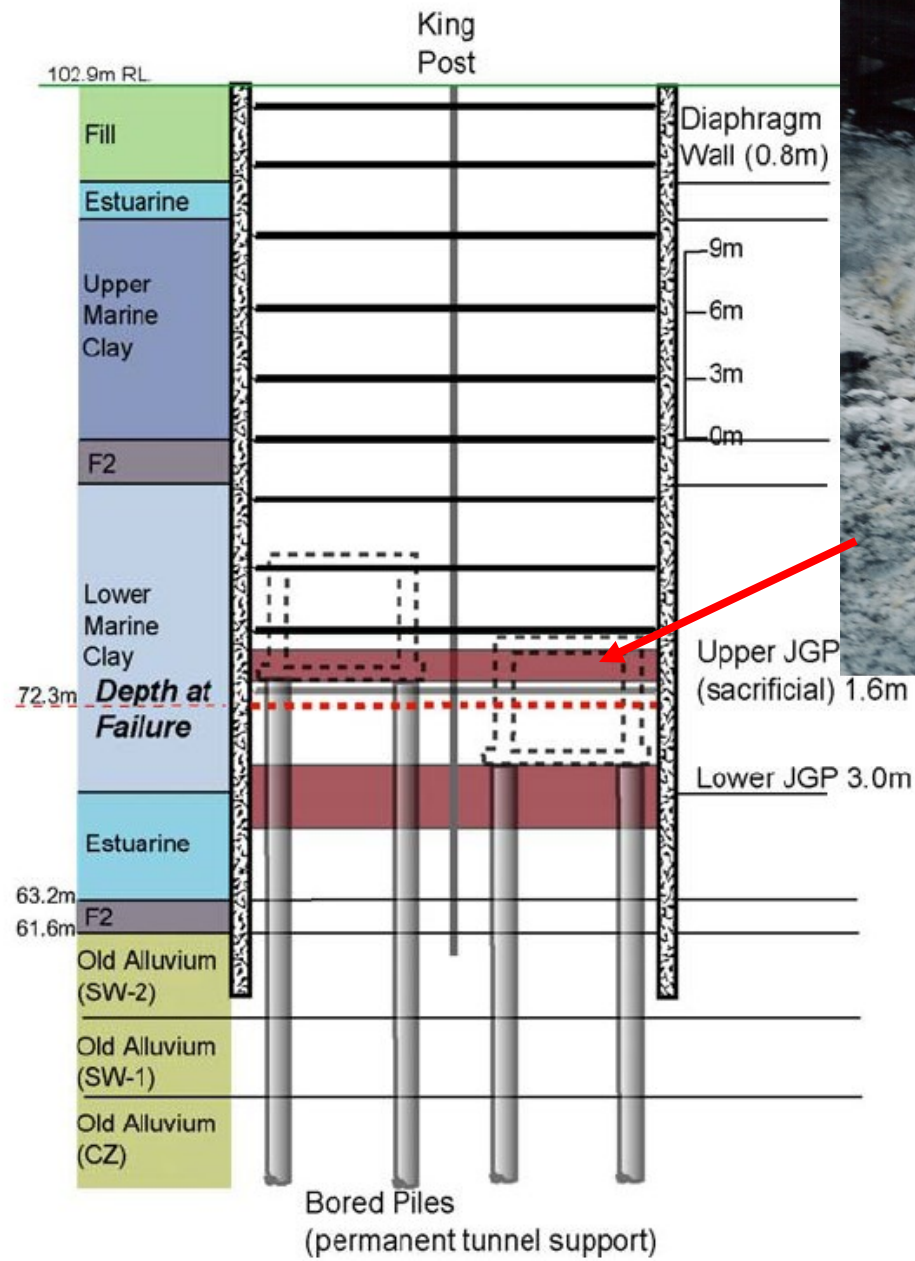
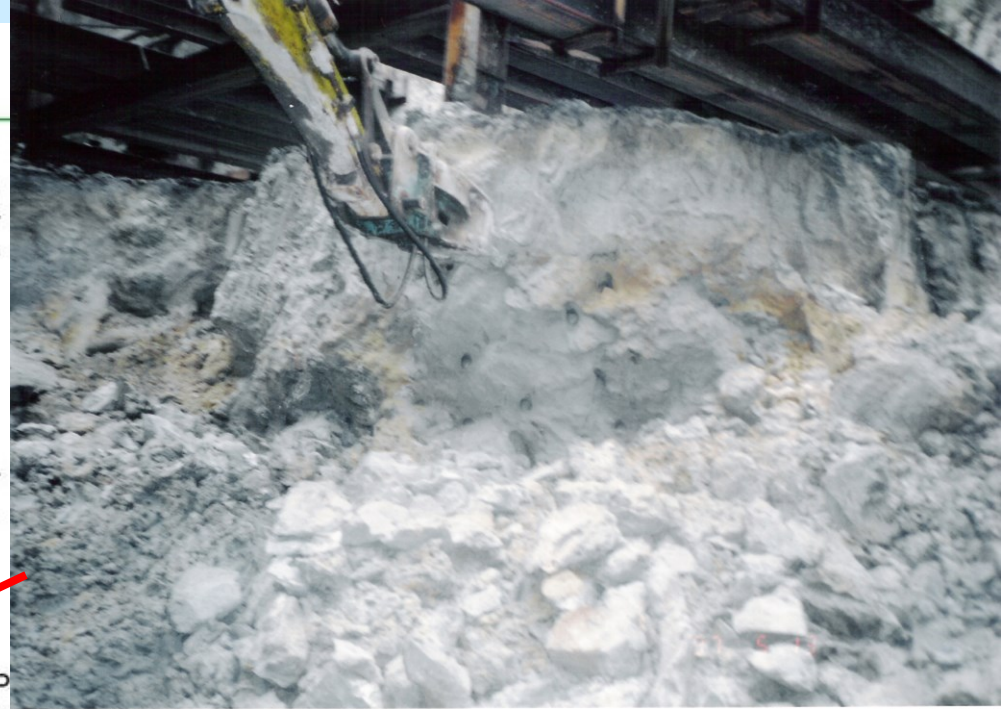
Sacrificial Jet Grout Layer

The jet grout layers were not considered as the main cause for the failure

- ❖ of the reported good quality ‘sacrificial’ jet grout layer; and
- ❖ there were not sufficient evidence to suggest any defects in the bottom jet grout layer

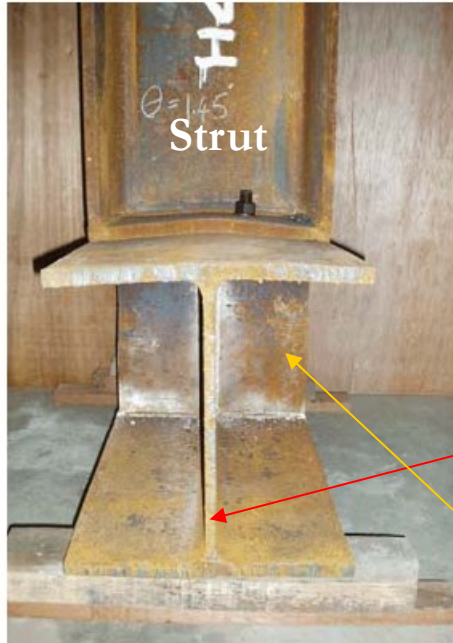
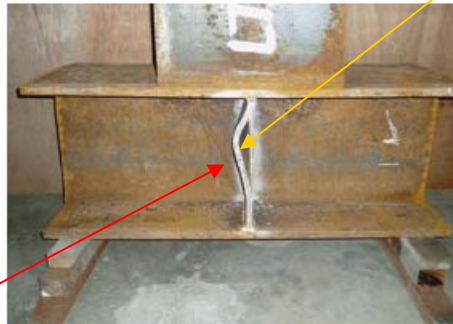
(a) Plate stiffener (non-sway)

Failure is mainly due to the in-plane buckling of the plate and/or web with little or no side sway of the waler flange

In-plane buckling

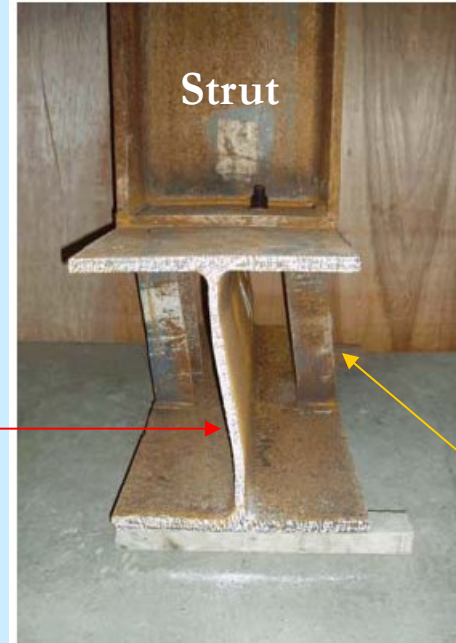
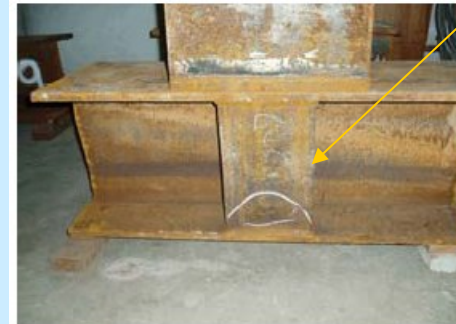
(b) C-channel stiffener (brittle-sway)

C-channel stiffener and web to sway and failure can occur in a sudden manner with drastic reduction in capacity.

More sensitive to the effective length used in calculating the web buckling capacity

Sway failure

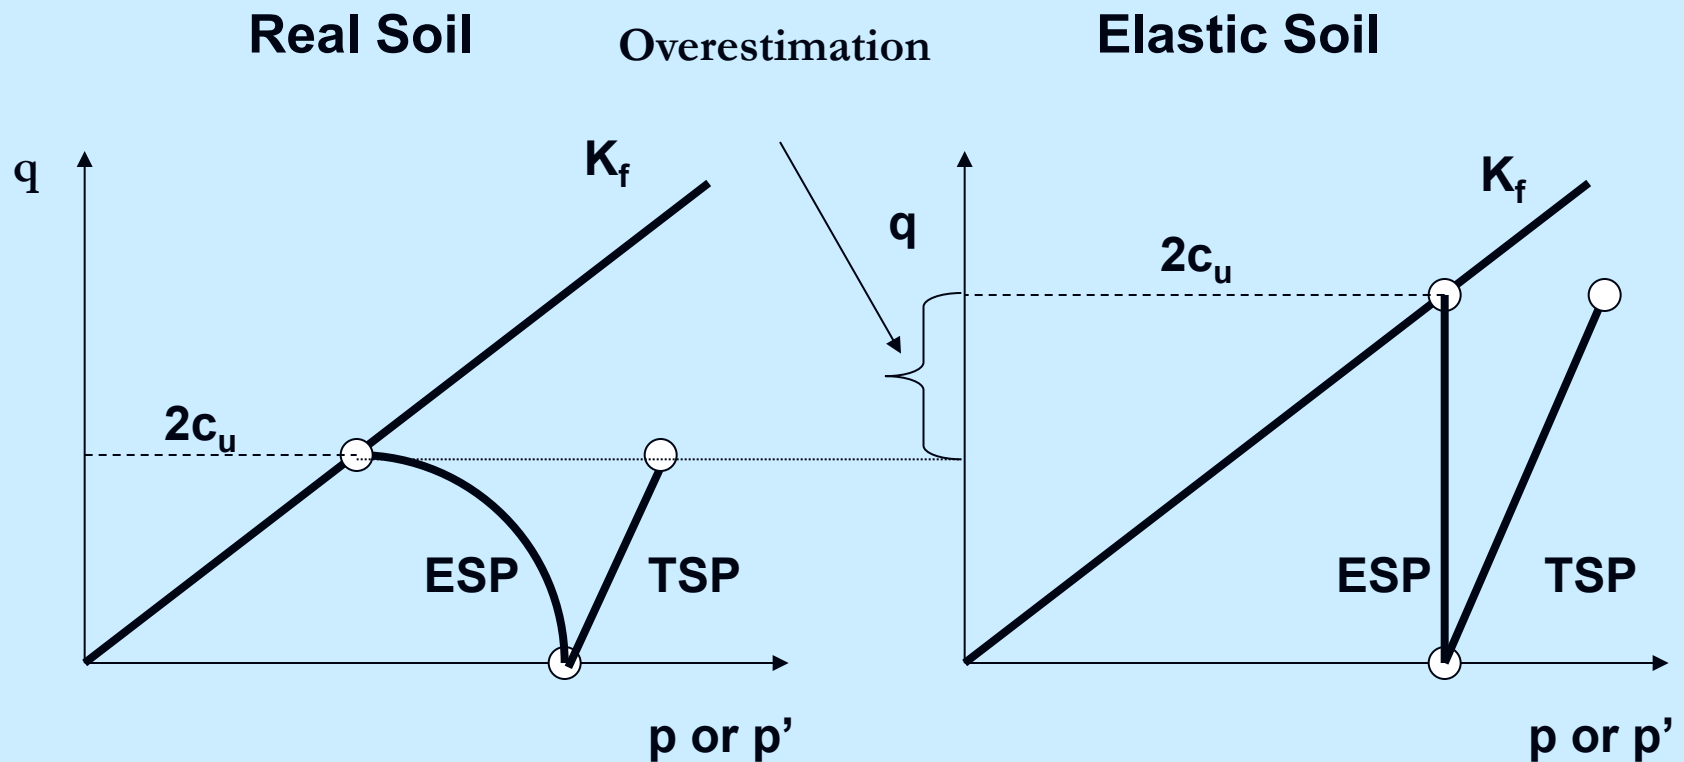
Modeling Undrained condition using M-C Model and Effective Stress Parameters—Why it is wrong for soft clays?

- ❖ Effective stress parameters + Mohr-Coulomb FEM model should not be used to model undrained condition in soft clays
- ❖ Design of strut-waler connection is very important
 - ❖ Design should be done jointly by experienced geotechnical & structural engineers
 - ❖ Design should be checked by an independent design checker
