ENGINEERING GEOLOGY & GEOTECHNICAL MODELS

## Brickworks Stabilisation

# Geotechnical Overview of the Brickworks Projects

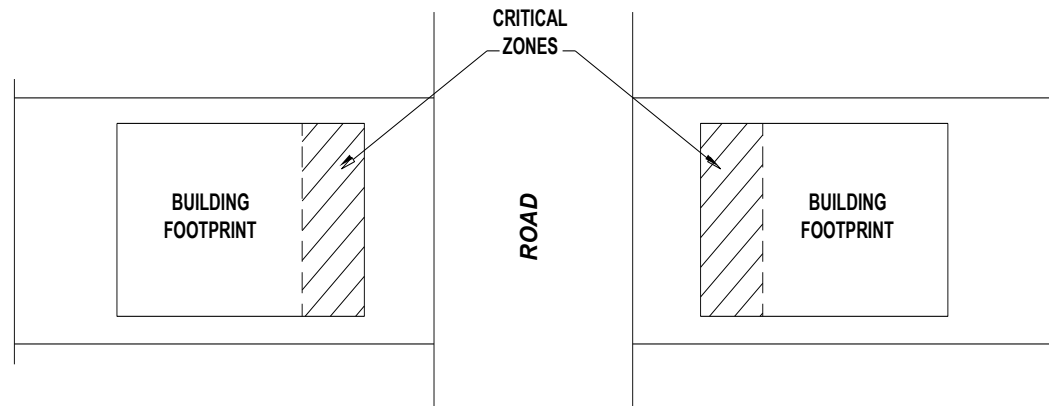
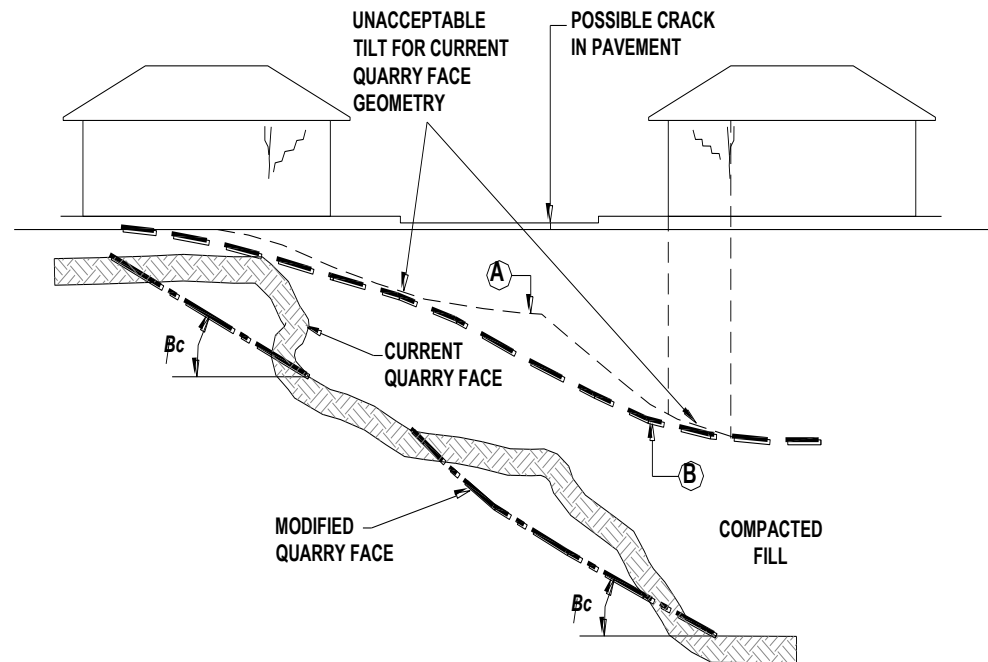
Key consideration  
is tilt resulting  
from differential  
settlement arising  
from variable  
thickness of fill

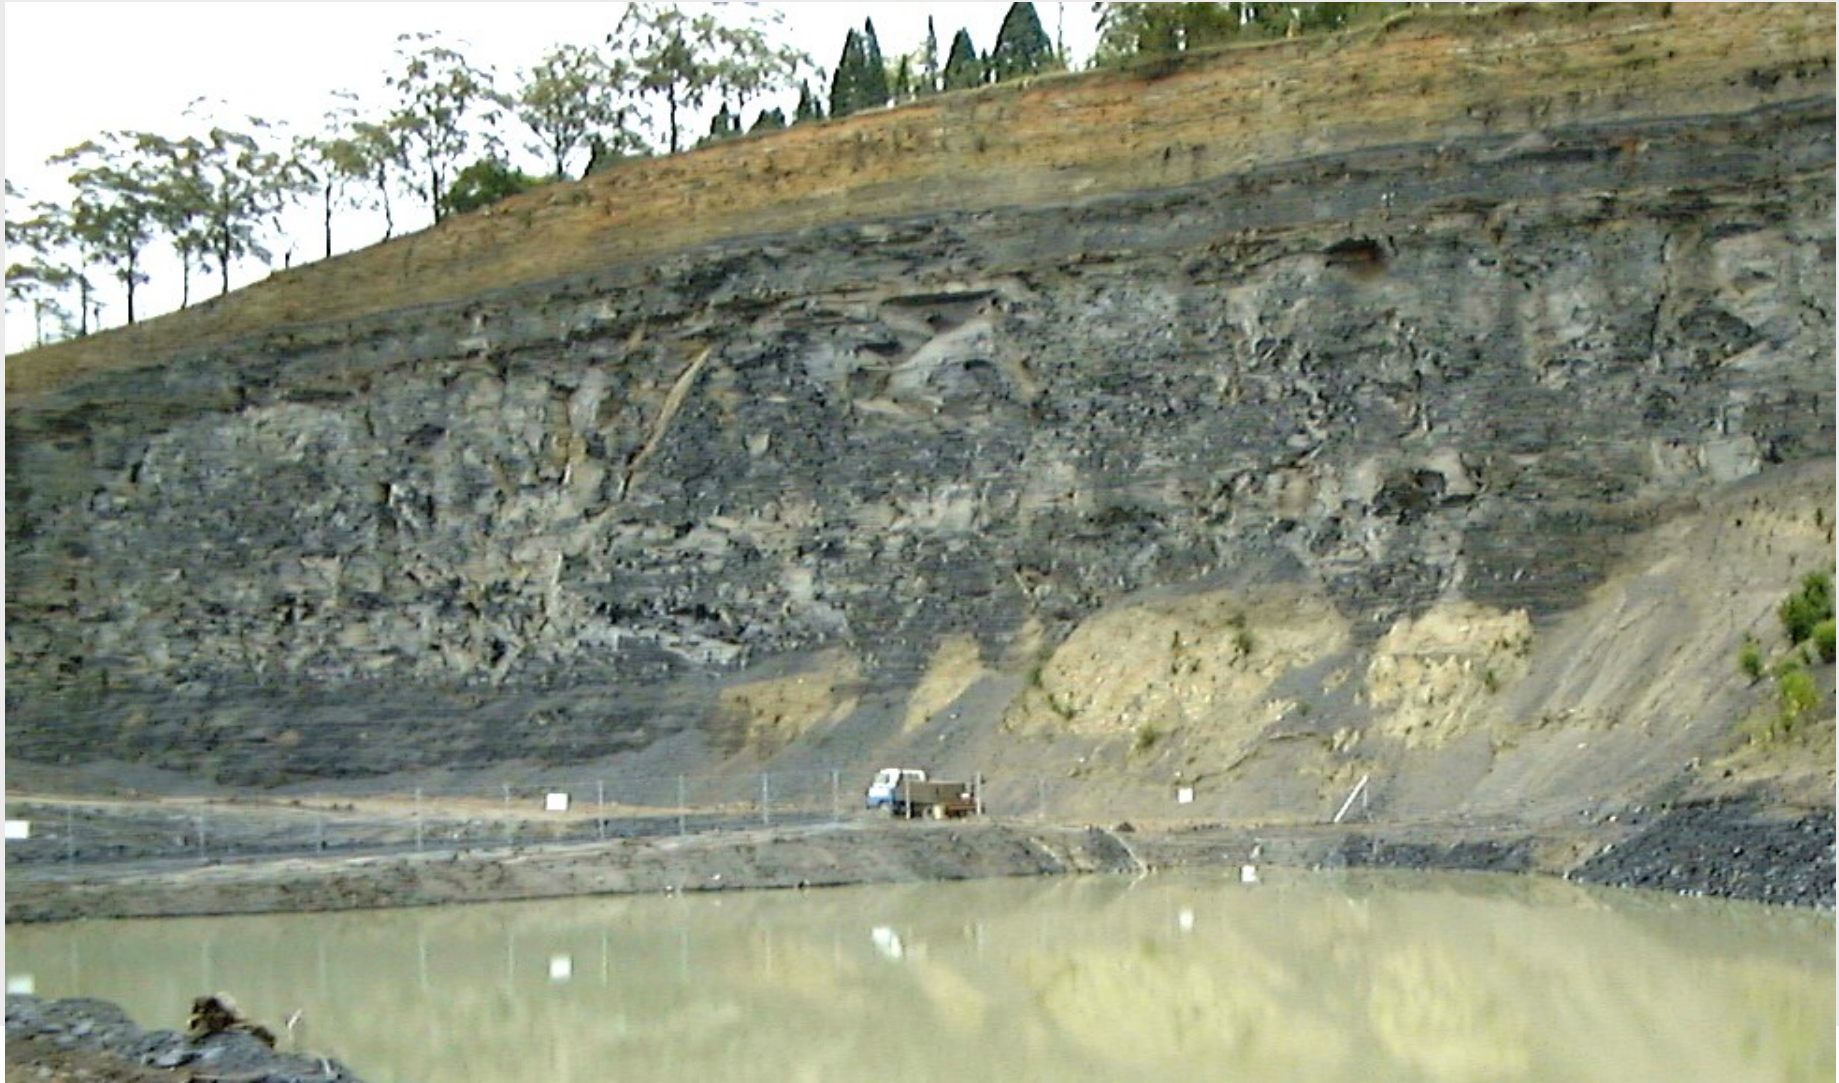
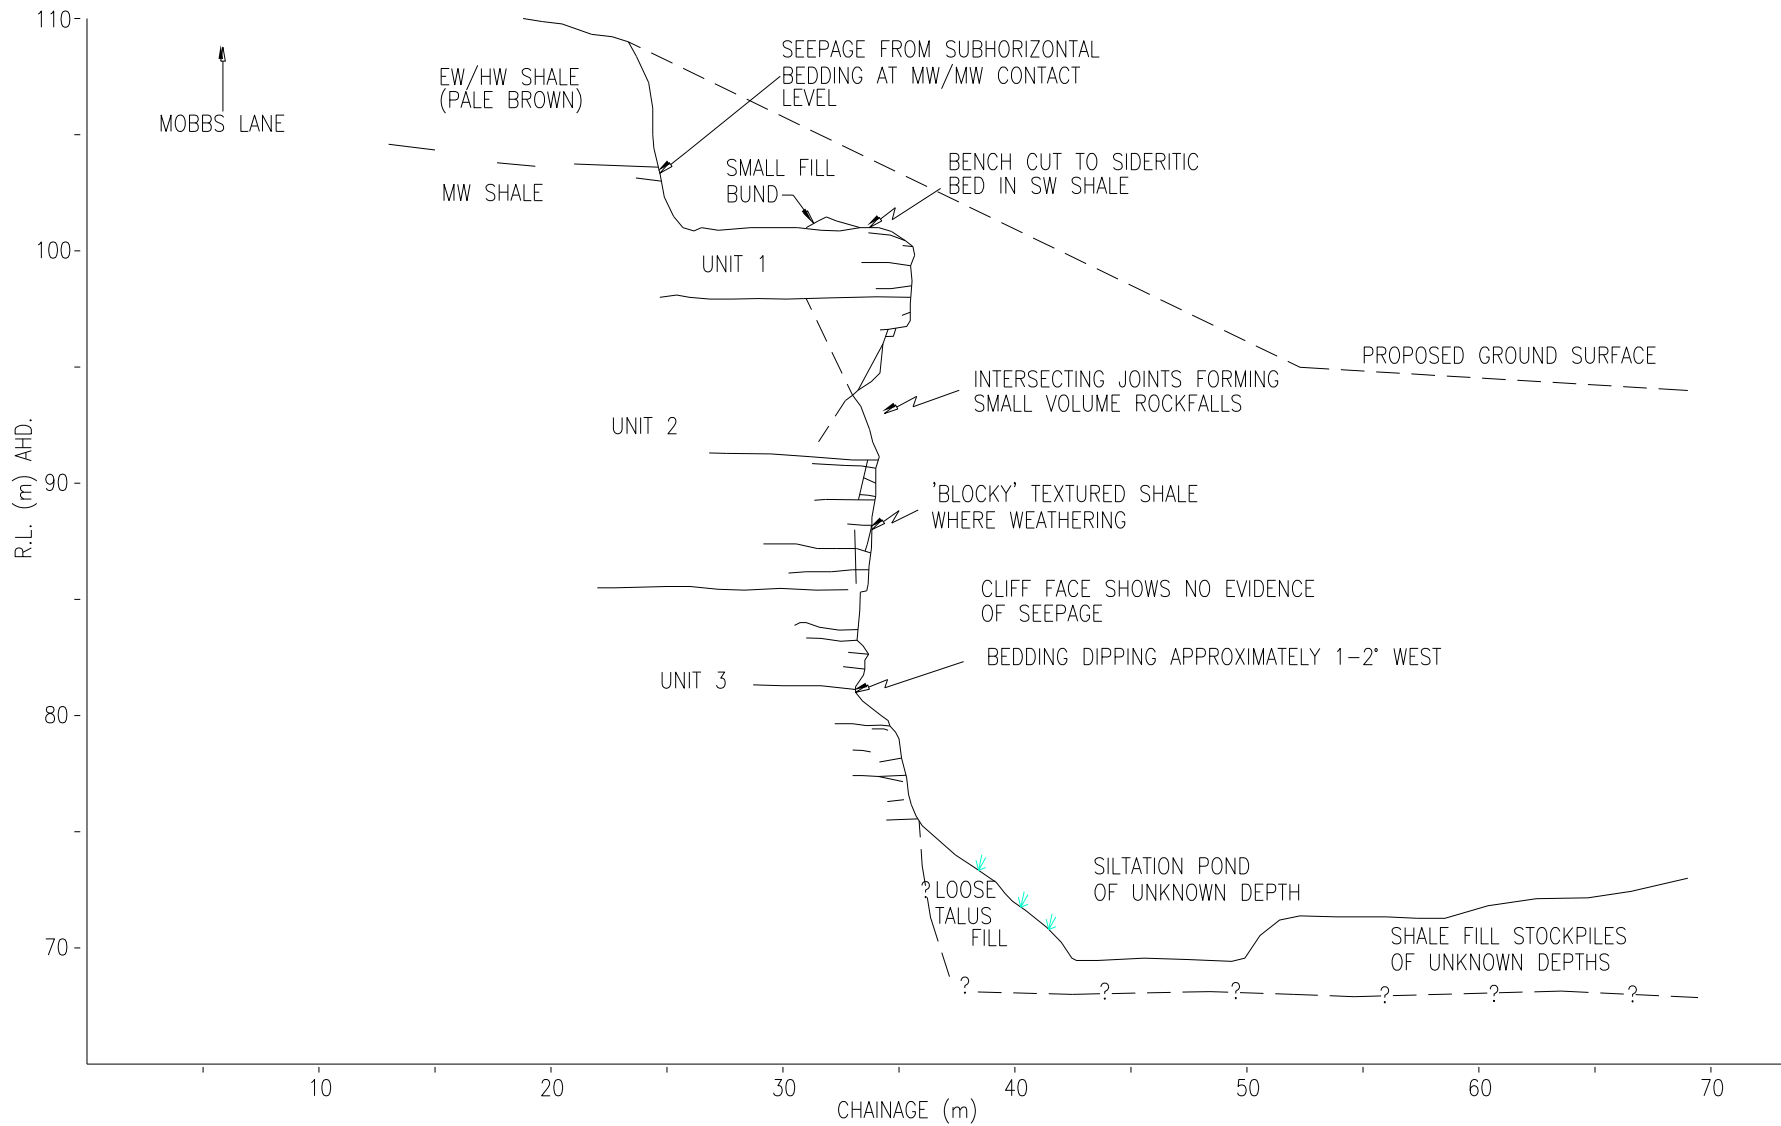
# Mobbs Lane Face

- Near vertical faces that are continually suffering rock falls
- Existing slip at the eastern end of the north face
